## Report of Findings

**Tennessee Titans / Pyro Shows, Inc., Product Evaluation**  
**Claim No: 201905970**

**Rimkus File No: 100015424**

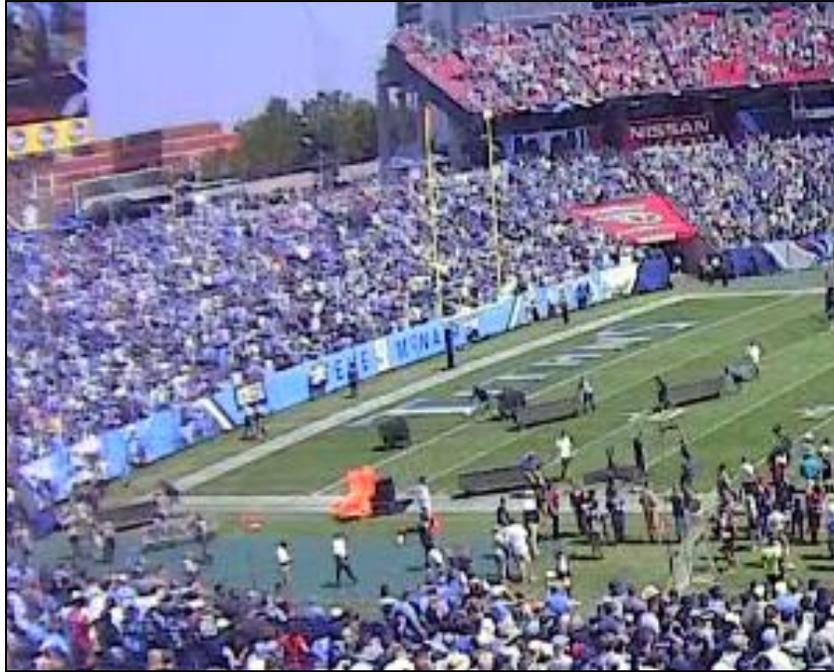
**Photograph 1**

Fueled fire just after incipient stage (clip from NFL video).

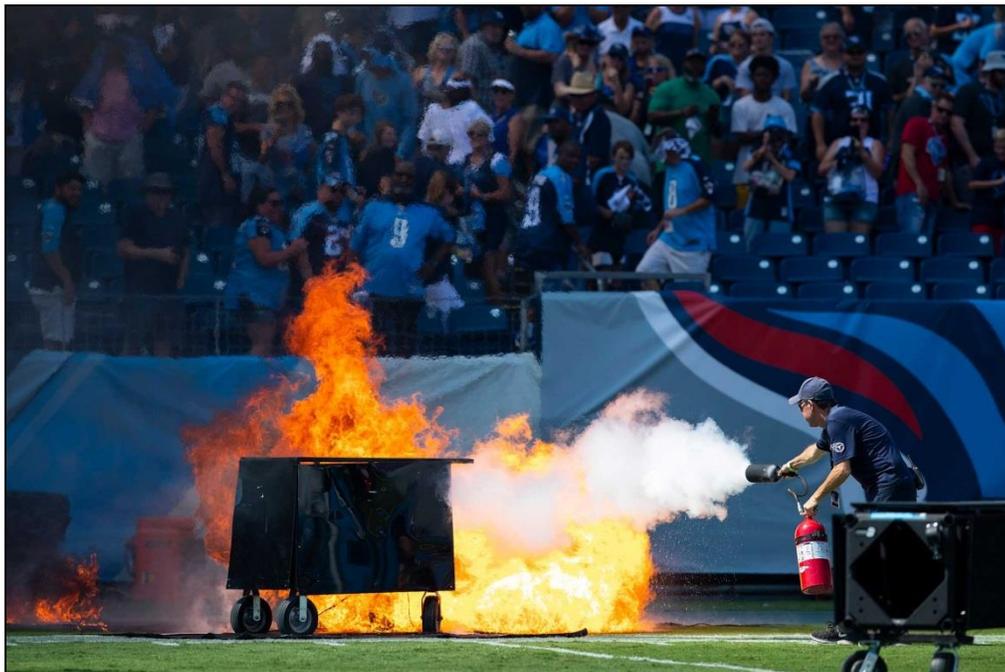
**Photograph 2**

The designated fire watch people responded quickly to the fire with Carbon Dioxide (CO<sub>2</sub>) fire extinguisher, with application within approximately 13 seconds, but the pressurized fuel exceeded the fire extinguisher capabilities (**Photographs 2 and 3**).

Full fuel-engaged stage (photograph provided by others).

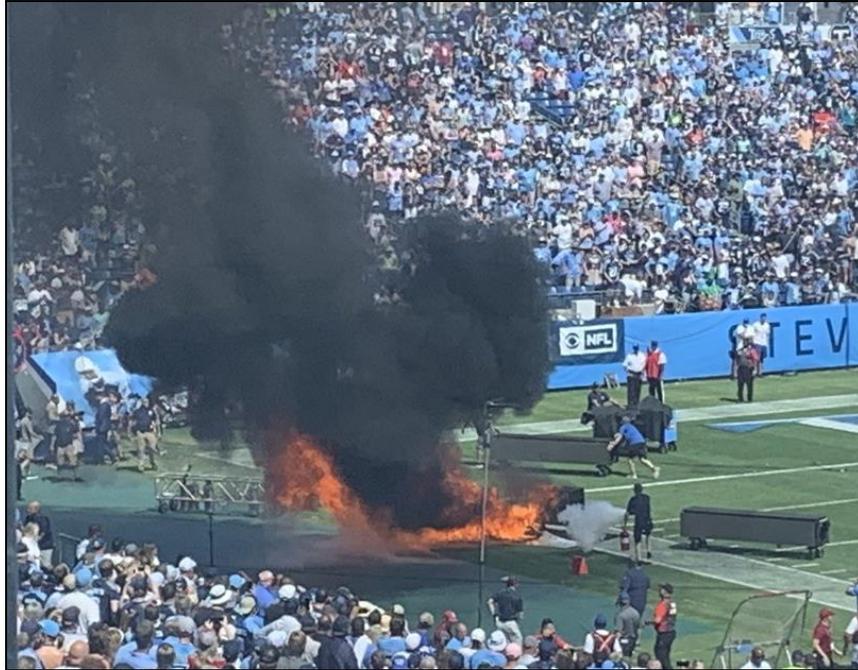
**Photograph 3**

Full fuel-engaged stage (photograph provided by others).

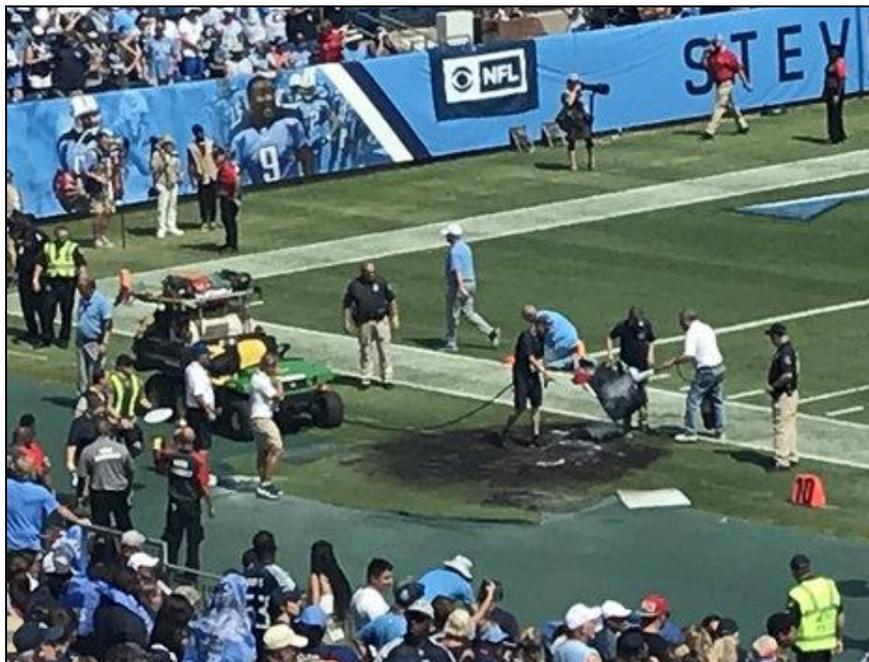
**Photograph 4**

Fire retardant tarpaulins were used beneath all the flame effects machines, as required by the National Football League (NFL). Minor damage was sustained to the natural grass turf and a tarpaulin mat used by players enroute between the field and the players' bench (**Photograph 4**). The area of turf damage was estimated at 80 square feet.

Damaged field area (photograph provided by others).

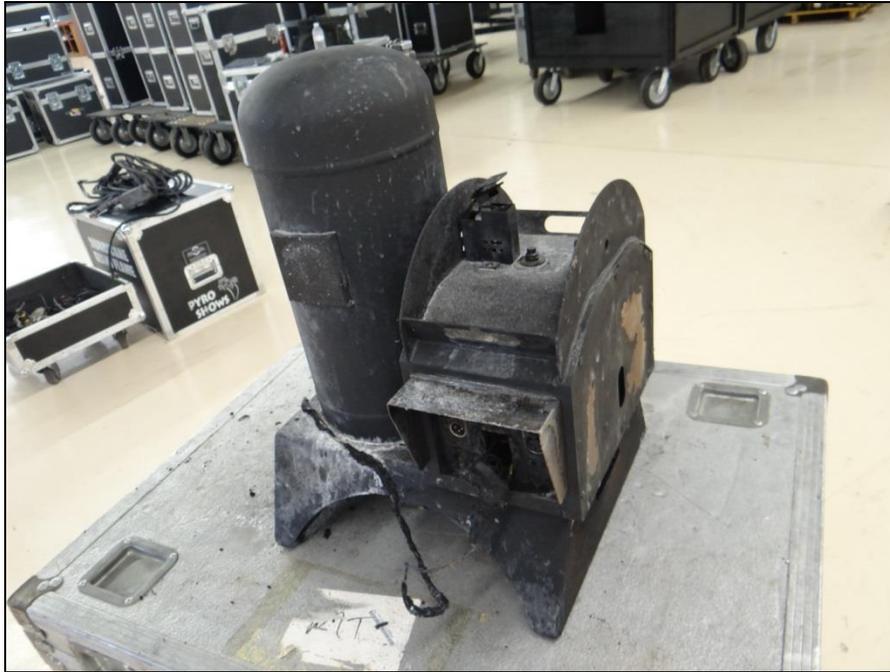
**Photograph 5**  
Flame machine.

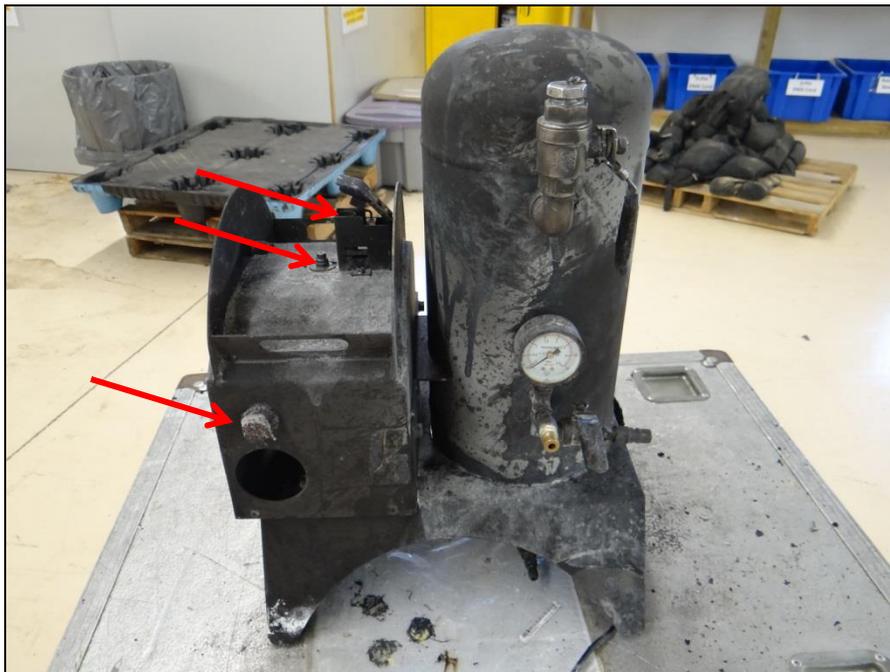
flame head. The fuel reservoir, using Isoparaffinic Hydrocarbon, Isopar G, was pressurized by an upstream external nitrogen gas cylinder, regulated at approximately 240 to 300 pounds per square inch (psi), through a 2.0-millimeter-diameter nozzle. The DMX safety circuit was configured to detect the pilot flame before flame columns could be generated. The pilot controls were equipped with a manually-operated shutoff valve, featuring an E-Stop function (**Photograph 6**).

**Photograph 6**  
Pilot burner, fuel nozzle, and pilot manual shutoff.

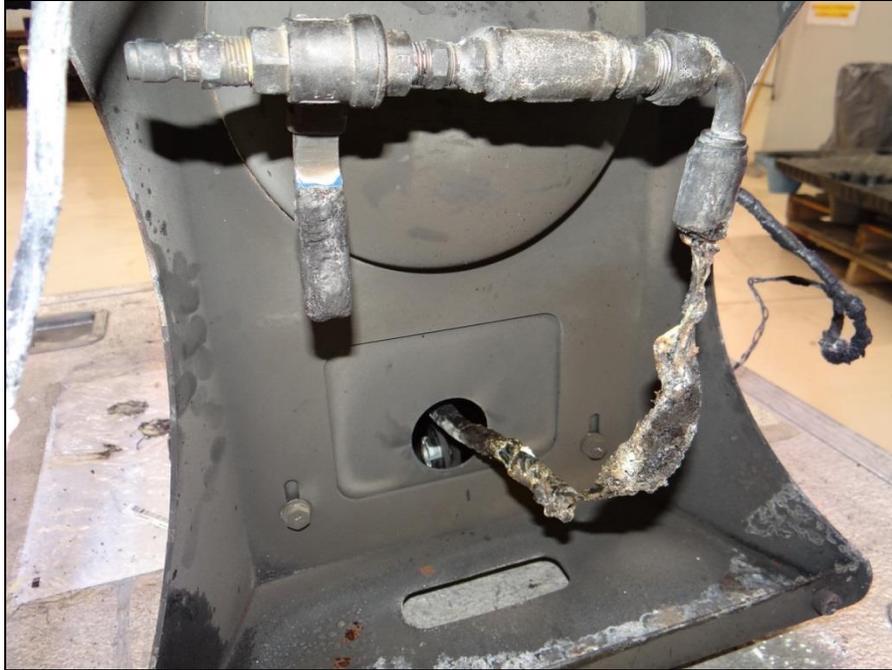
A hydraulic hose, constructed of a 90-degree crimp fitting for the fuel reservoir and a straight crimp fitting for the flame head, had been routed through an approximately 2-inch-diameter through-hole in the steel base in order to feed the pilot (**Photograph 7**). In its re-solidified resting state, the hose passed through the hole within 3/8 inches.

No hose protection, such as a guard spring or insulation, was observed around the hose. The hose was badly burned.

The badly burned hydraulic hose was consistent with the source of the fuel. The ignition source was consistent with a small initial hose leak to which the pilot flame could have migrated and sustained after the pilot had been shut off. The leak of fuel became larger when the hose further deteriorated as the fire progressed

The relatively sharp edge of the through-hole in the steel base was consistent with a source of possible hose abrasion until the hose failed. The hose was not protected, such as with a guard spring or insulation. The NITTA “Linemate” catalog states that “Pressure on hose products could cause interference with surrounding parts on which no interference exists before the pressure is applied. Please handle appropriately e.g. introducing guard parts.”

**Photograph 7**  
Failed hose.

The hydraulic hose was determined to be inadequate in this application. It was not sufficiently protected from external damage, such as from the sharp edge of the base through-hole, a possibly significant contributor leading up to the incident. It also lacked the thermal properties necessary to resist high temperatures, also a possibly significant contributor leading up to the incident. This fluid conductor could have been constructed from hard piping instead of a flexible hose and bulkheaded through the machine base.

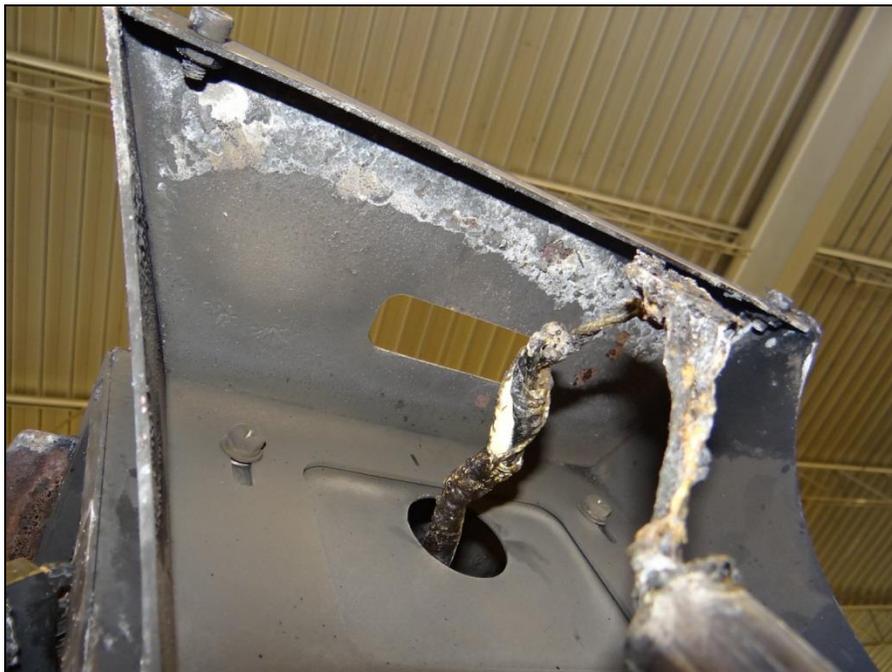
The Hurricane Giant was covered with soot. Severe oxidation was observed on the base interior side opposite the hose drop fitting (**Photograph 8**).

**Photograph 8**  
Heat-affected base.

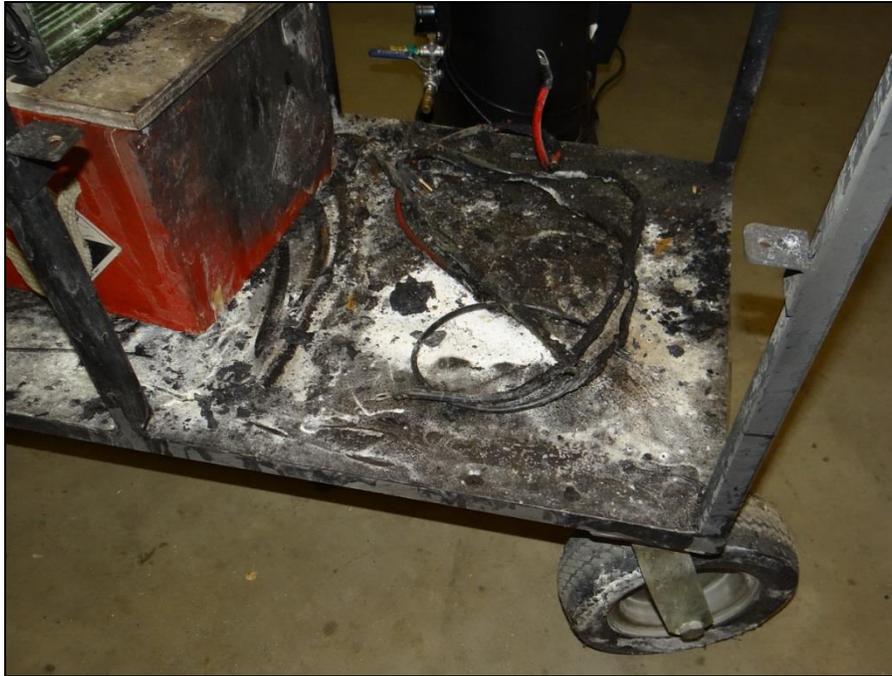
The Hurricane Giant was installed on a steel frame and rubber-wheeled cart (**Photograph 9**). The cart, including the side panels, was specified and built by Pyro Shows. The floor was stipulated by the NFL. Appliques for the side panels were provided by the Tennessee Titans.

**Photograph 9**  
Fire-affected cart base.

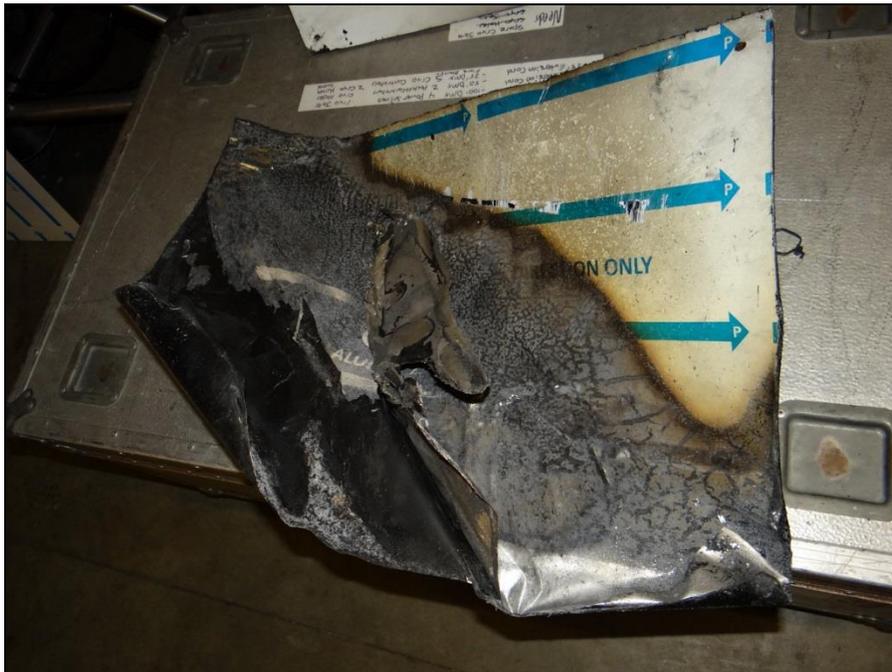
Aluminum signage had covered the four sides of the cart. The signage area, adjacent to the machine, sustained warpage and melting from the fire (**Photograph 10**).

The operators did not visually check for any flames/smoke immediately after the burner pilot was shut off, hindered by signage on the cart sides that was an obstruction to observation. This was considered as contributory factor in not allowing early detection underneath the base of the machine. The enclosed cart also enabled the harboring of fugitive fuel in the early stages of fugitive fuel.

**Photograph 10**  
Signage.
