Project Title: Ducktown Basin Museum Building and Site Restoration

**DUCKTOWN BASIN MUSEUM & BURRA BURRA MINE PROGRAMMING STUDY
DUCKTOWN BASIN MUSEUM & BURRA BURRA MINE STATE HISTORIC SITE
DUCKTOWN, POLK COUNTY, TENNESSEE
SBC #160/000-01-2014**

July 22, 2019

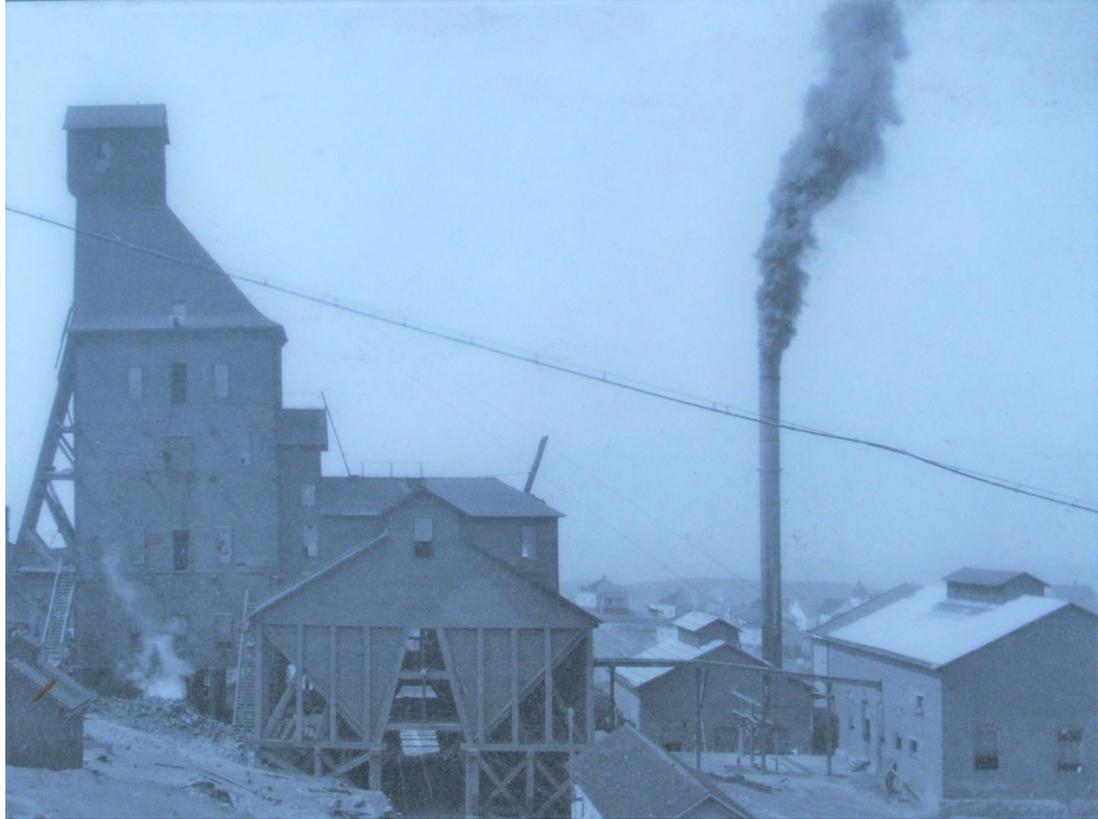
Hoist House – Missing Roof Ventilator

Exterior: rebuild missing ventilator monitor on top of the existing roof.

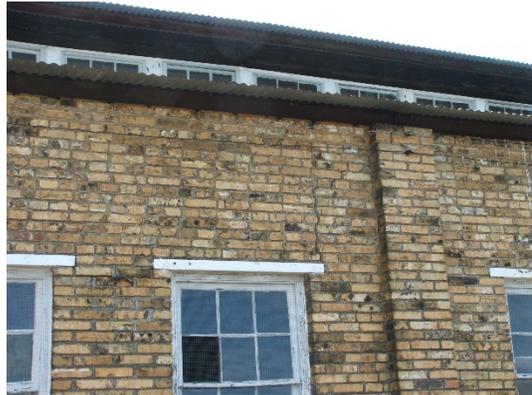
Machine Shop – Masonry Cracks

The masonry wall system has structural cracks at several places around the perimeter; however, historic photos show that the most notable of these cracks are at least half a century old. One wall between the office and acetylene storage room is severely deteriorated

Exterior: rebuild the missing/repair the deteriorated monitor windows, rebuild the missing ventilator monitor on top of the remaining light monitor, repoint the deteriorated or missing mortar joints and cracks in the masonry, replace and paint all deteriorated metal siding/paint, replace the missing wood windows and frames, reglaze the windows as needed. install a new grated trench drain at northeast pair doors and connect to the ditch/ drain by digging up the road and install a new storm

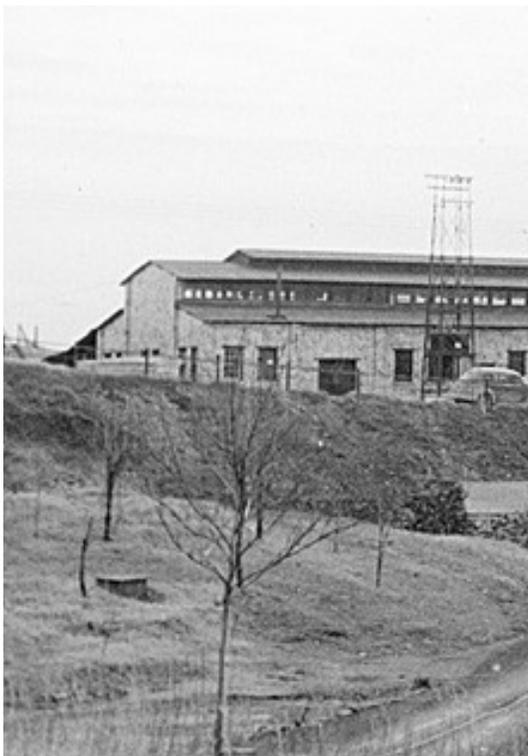
Machine Shop – Masonry Cracks

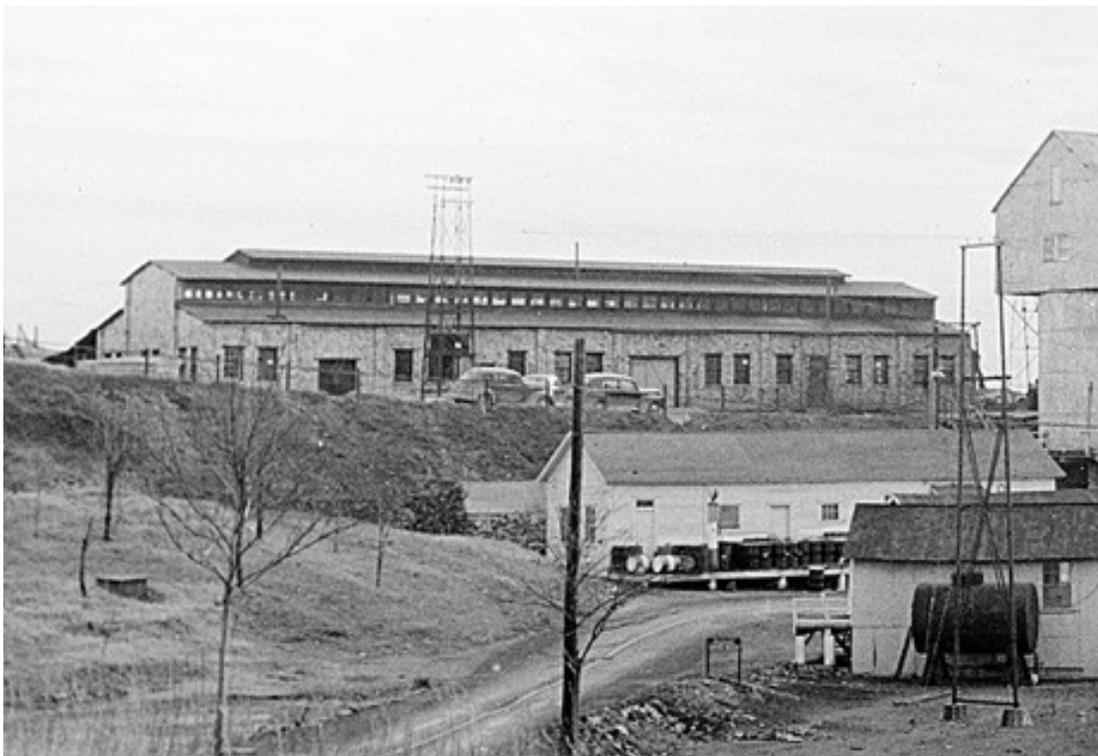
Machine Shop Historic Photo – Note Monitor Windows and Missing Monitor Roof Ventilator

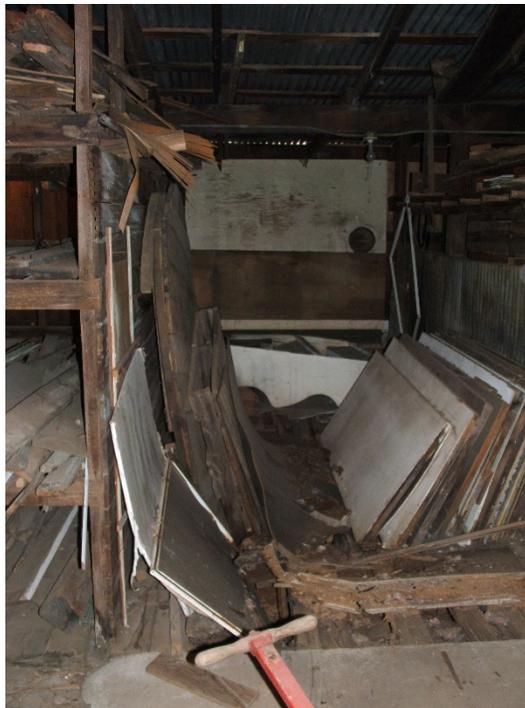
Machine Shop – Carpenter Storage
Deteriorated Flooring

Carpenter storage: remove the plywood ceiling and replace the deteriorated wood flooring and its framing.

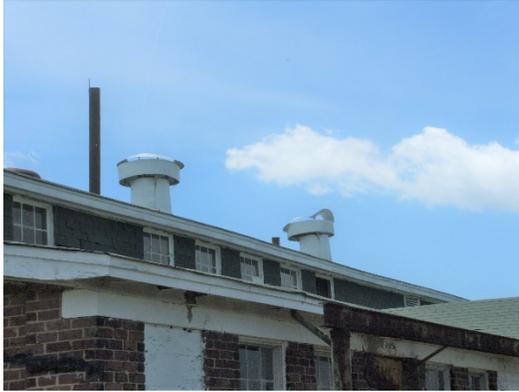
Change House – Damaged Ventilator

Repair the asphalt shingles at the gable ends of the monitor, repair the painted metal ventilator, install a fixed metal panel over the view window in the door in the west elevation (due to a security problem). Repair the damaged roof ventilator on the monitor.

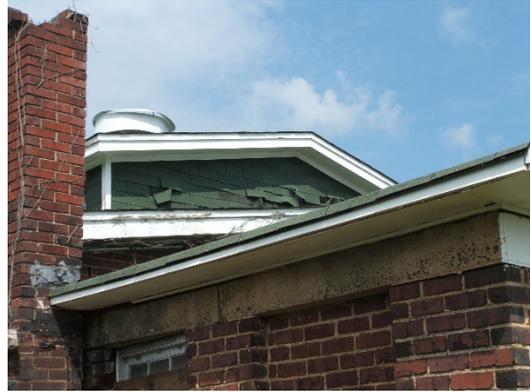
Change House – Repair Shingles at Monitor Gable Ends

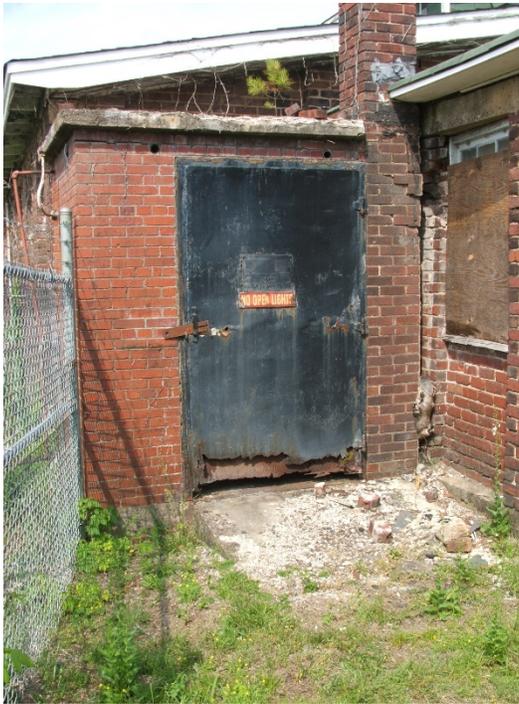
Change House – Deteriorated Door and Frame at Acetylene Room

Replace approximately thirty (30) deteriorated or missing monitor windows (in lieu of new lighting), repoint the masonry as needed where the mortar is deteriorated or missing, rebuild/patch the acetylene metal door, provide a new hinge at the acetylene door, and rebuild the brick wall between the office and acetylene storage room. Replace the existing front doors with new ones to match original construction drawing. Remove hardware cloth over lower windows

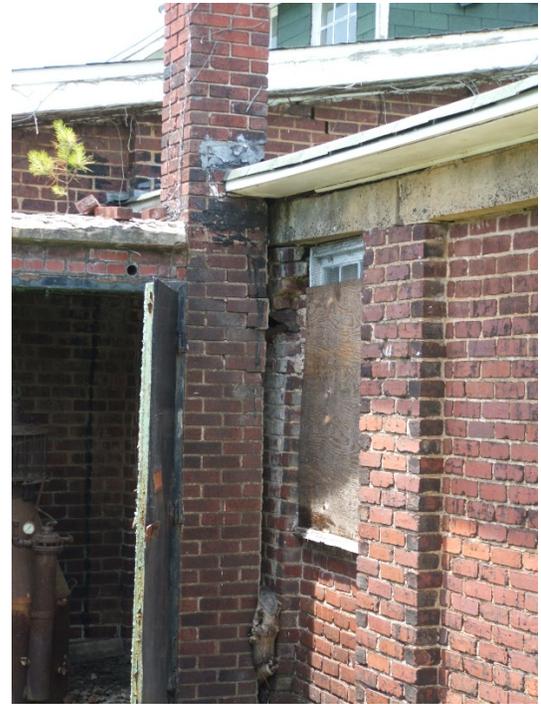
Change House – Rebuild Wall to Right of Corner Flue

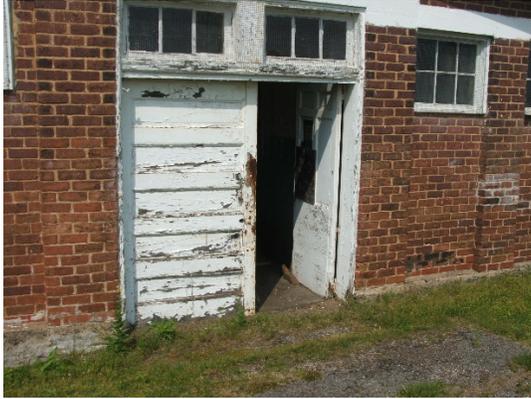
Change House – Replace Deteriorated Entry Doors – Match Left Door

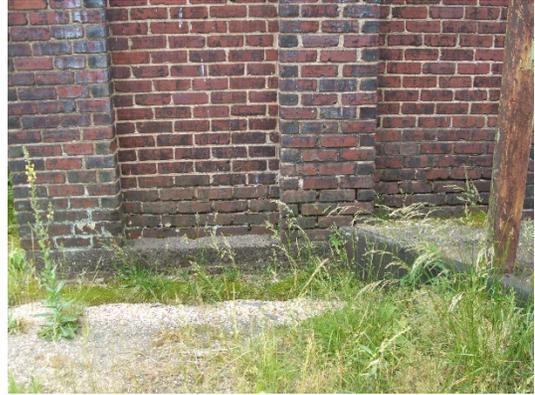
Change House – Repoint Deteriorated Mortar Joints

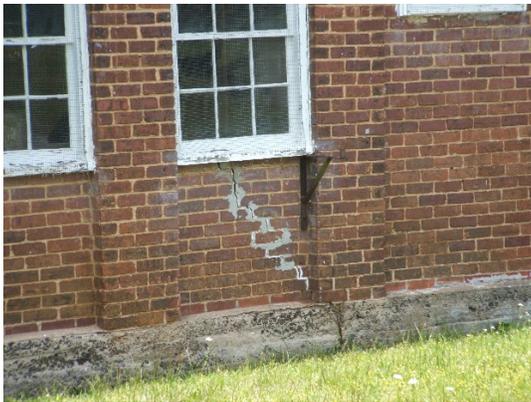
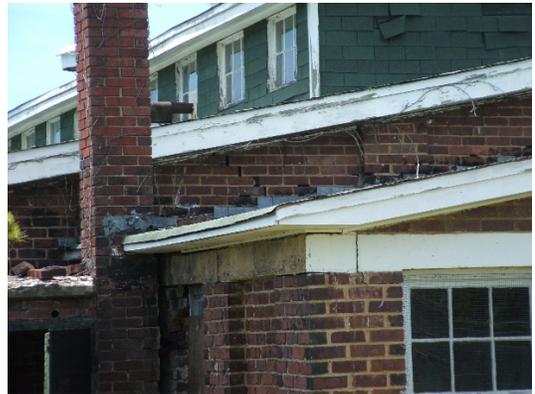
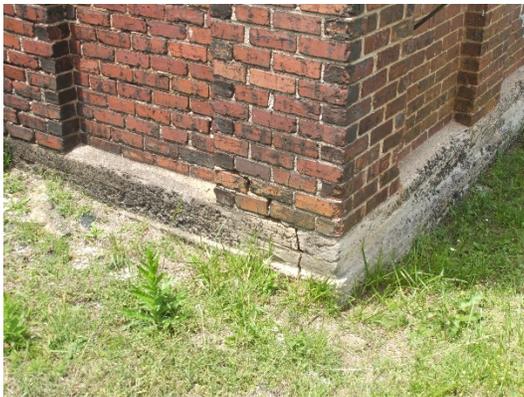
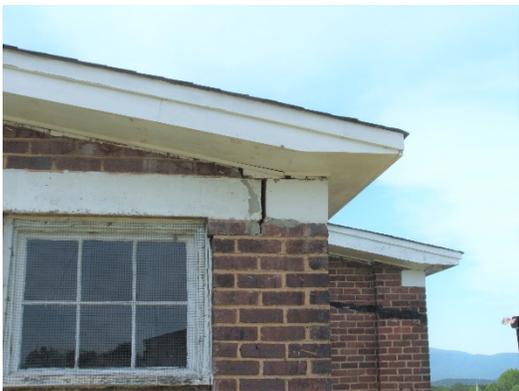
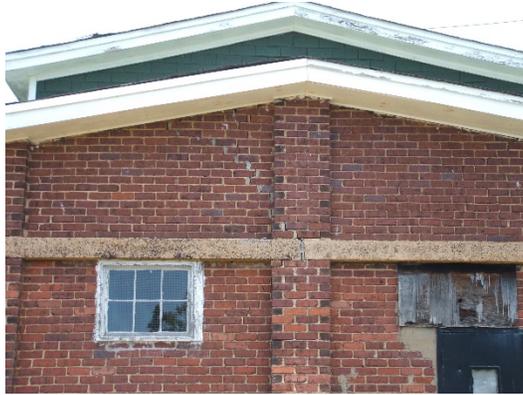
Change House – Repoint Cracks in Brick

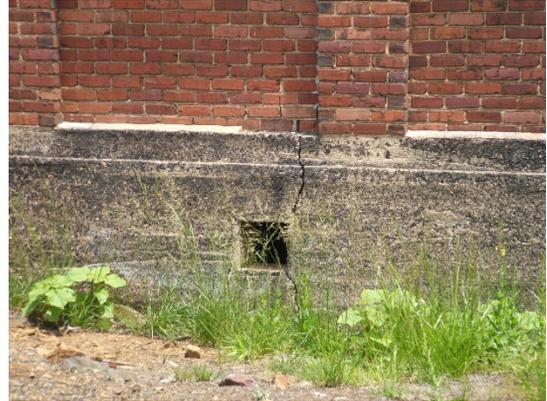
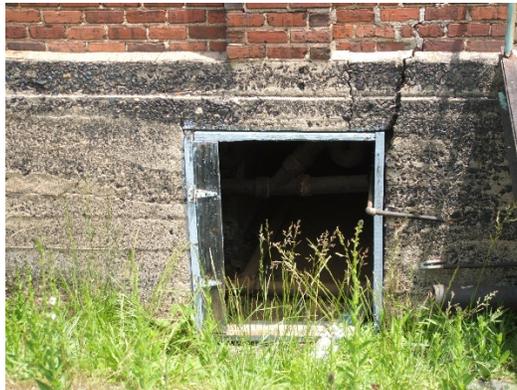
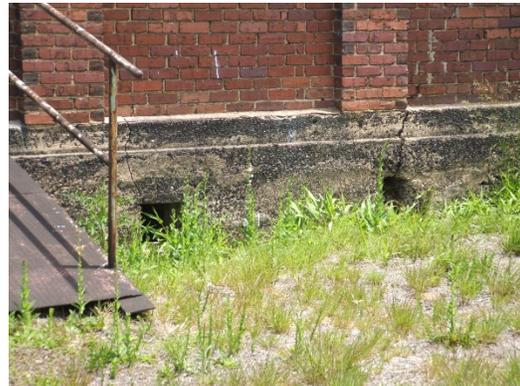
Change House – Repoint Cracks in Concrete Foundation

Change House – Repoint Cracks in Concrete Foundation and Replace Door

Exterior: replace the missing crawl space door at the west elevation, scrape the paint on the ramp and railing system, and repair the cracks in the concrete foundation at the west elevation.

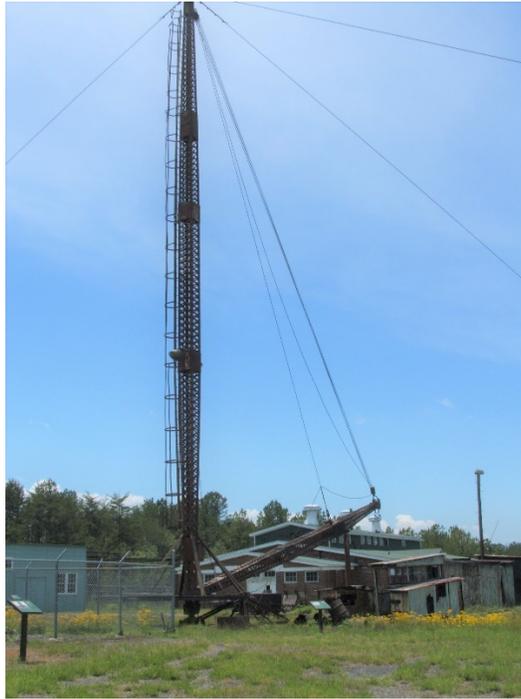
Crane Mast

Cranes of this type require periodic maintenance including painting of the structure and greasing of the guy wires in order to prevent rust. No such maintenance appears to have taken place since the mine closed down.

No attempt was made at the time of this report to determine the structural integrity of the crane. However, it is clear the only thing holding the mast upright is the guy wires, and that some buckling is present at the base of the mast. If one or more guy wires should come loose, or if the base should experience compressive failure, the structure would likely fall suddenly and unpredictably.”

Remove all rust in place, replace the rigging and guy wires, replace all deteriorated metal components and paint the crane entirely.

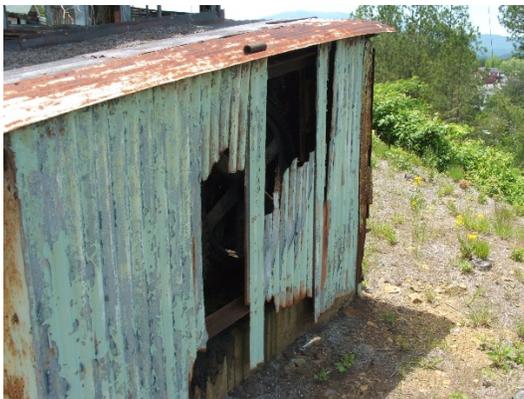
Crane Operator's Booth –
Deteriorated Siding

Replace all deteriorated wood framing, replace approximately fifty-percent of the deteriorated corrugated metal siding, replace the deteriorated/missing wood windows and paint exterior

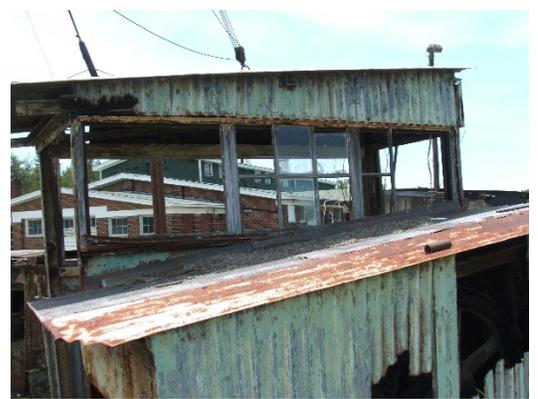
Crane Operator's Booth - Remaining
Wood Window

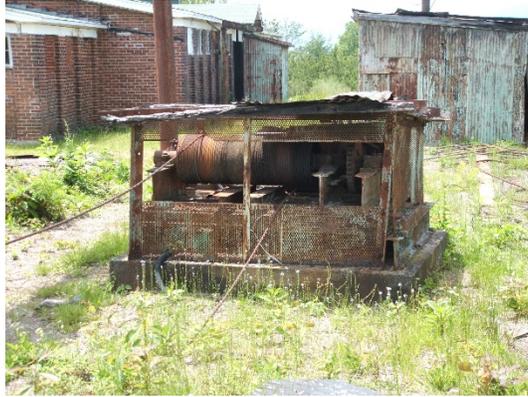
The 50 square foot Crane Winch House is a small steel frame structure resting on a concrete slab that housed the motorized winch to lift the cables on the crane arm. Wood framing members rest on top of the steel roof framing to attach the corrugated metal siding. Pierced steel plates are attached on the end of the structure facing the crane. The structure and the equipment inside are severely deteriorated.

Replace the deteriorated wood framing and corrugated metal roofing and siding, refurbish the pierced metal plates, and paint the exterior.

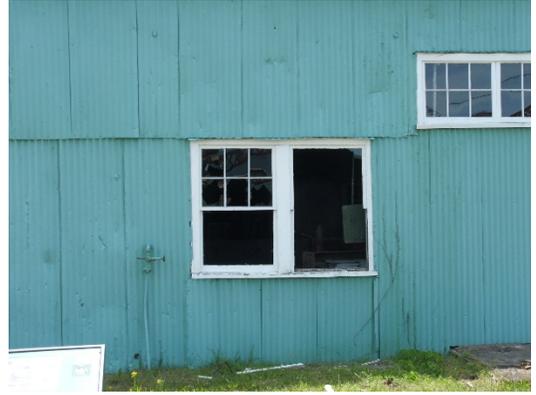
Plate Shop – Note Broken Out Windows

Exterior: replace two broken window sash, rebuild rotting window sash, remove the rust and paint the unpainted braces and small equipment shed, etc. at the west elevation, replace the deteriorated pair of wood doors and frame on the west elevation with new painted hollow metal doors and frame, install a new pipe support for rear/south porch where missing, paint the concrete block addition to match the metal siding, and reglaze the windows in the concrete block addition.

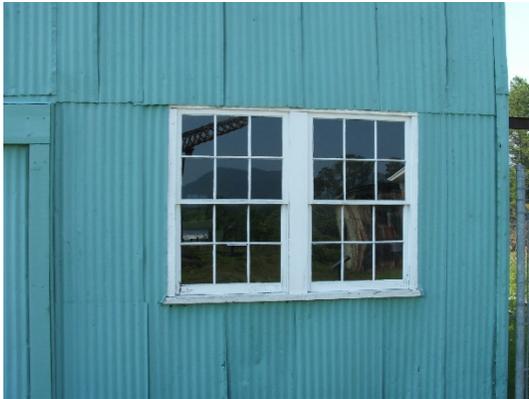
Plate Shop – Rotting Windows

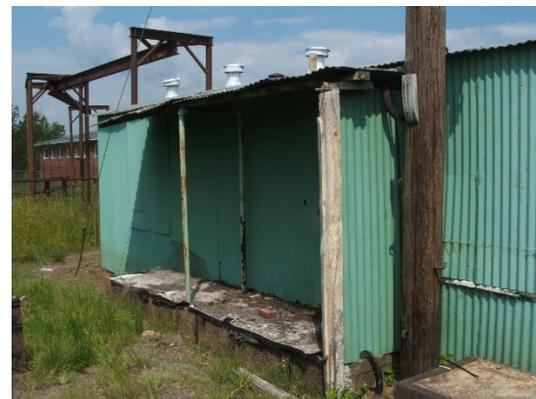
Plate Shop – Missing Porch Roof Support

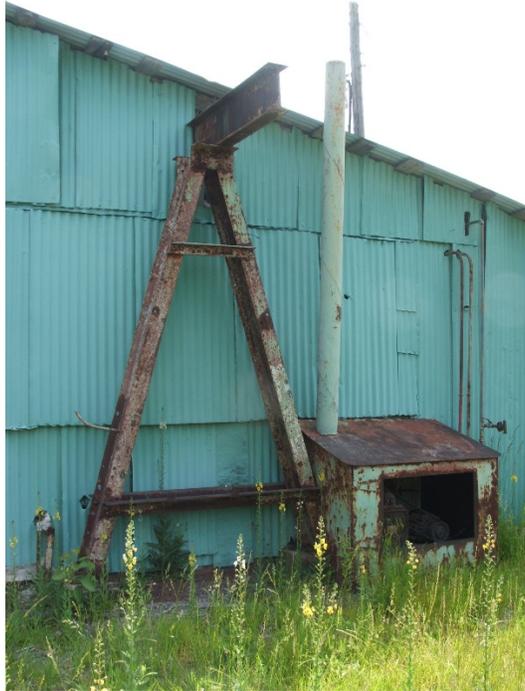
Plate Shop – Unpainted Elements

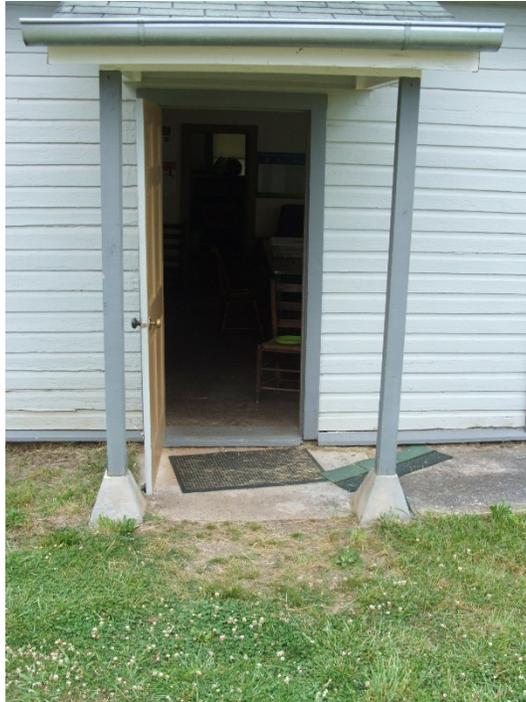
- 1) The rear door entrance does not meet ADA.

Clinic – Rear Door Entrance

Exterior: install a new “ramp” at the rear door (note: this door is inhibited by the supports for the overhang which may not be original. Alternative measures may be needed to meet the requirements of ADA), install new asphalt roof shingles, gutters and downspouts, install a new sidewalk from the adjacent parking lot to the rear door. Replace the asphalt shingle roof. Install new gutters and downspouts.

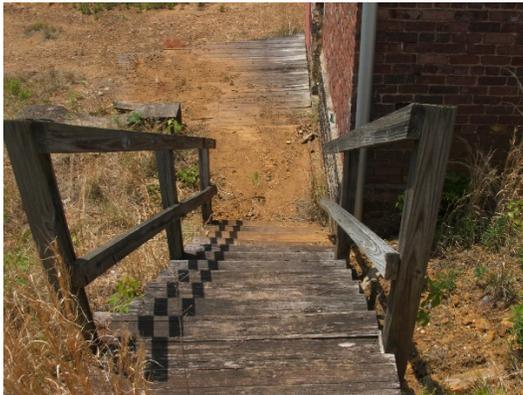
Powder House – Deteriorated Stairs and Landing

Exterior: replace the wooded stairs and landing, repoint the open and deteriorated mortar joints as needed, reopen the former window opening and install a new window frame and sash, and remove the rust on the adjacent oil tank and repaint.

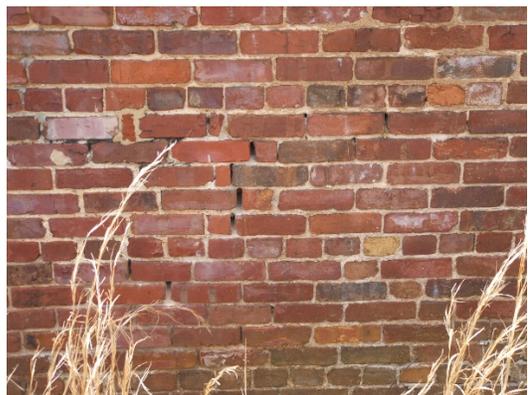
Powder House – Deteriorated Masonry

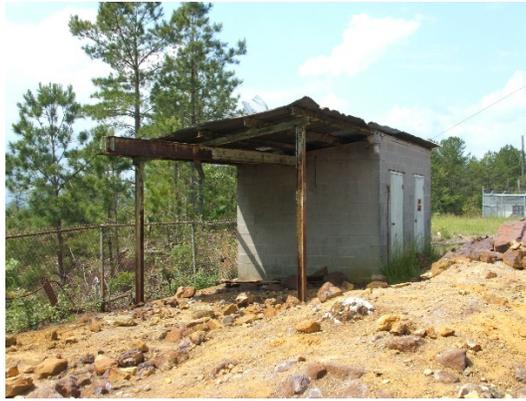
Steam Cleaner Shed

There are cracks within the masonry units.

Repoint the concrete block as needed, remove the rust and repaint the doors and frames as well as the windows, scrape the shed porch framing and repaint, and replace the old corrugated roofing to match newer roofing.

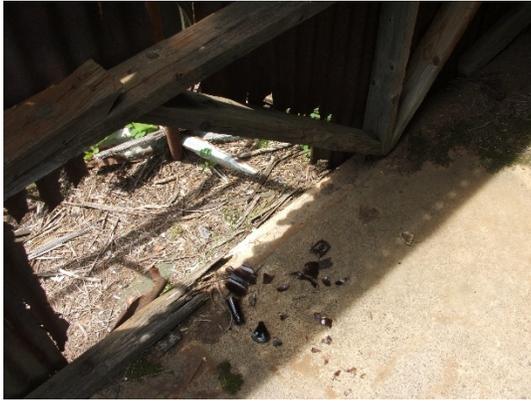
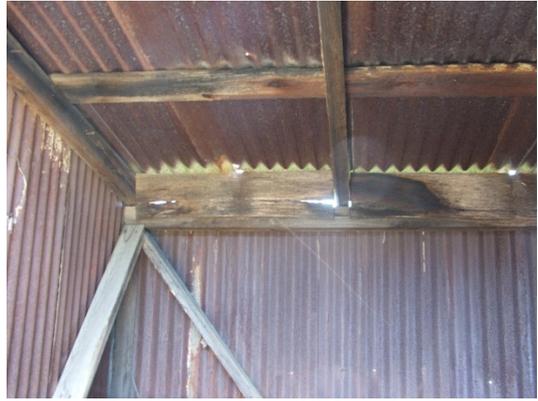
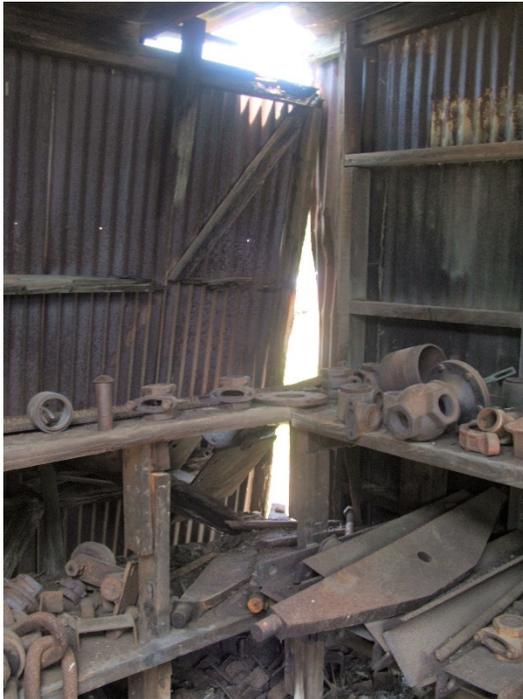
Enclosed Parts Storage Shed –
Deteriorated Framing

Enclosed Parts Storage Shed – Wood
Shelving and Deteriorated Framing

- 1) Open Parts Storage Shed: replace corrugated metal siding and roofing where deteriorated. Underpin the foundation at the corner where erosion has undercut the building. Remove the rust, scrape flaking paint and repaint.
- 2) Enclosed Parts Storage Shed: reframe the smaller wood-framed structure using pressure treated lumber. Match existing adjacent framing system in spacing and installation. Rebuild the wood shelving as needed. Replace portions of the metal siding where deteriorated or missing. Provide a new door with corrugated metal siding. Prep and paint the exterior to match historic colors.

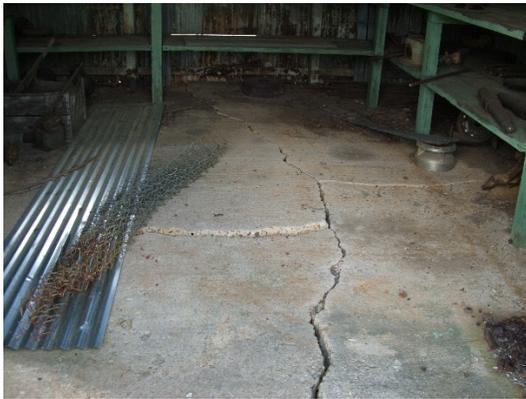
Drill Repair Shed – Broken Slab

Reinstall the bollard outside the door, remove the paint on the exterior and repaint, fill the cracks in concrete slab, replace all deteriorated metal siding where rusted through or pin holes with new siding to match, reroof the open shed porch and repaint the exterior.

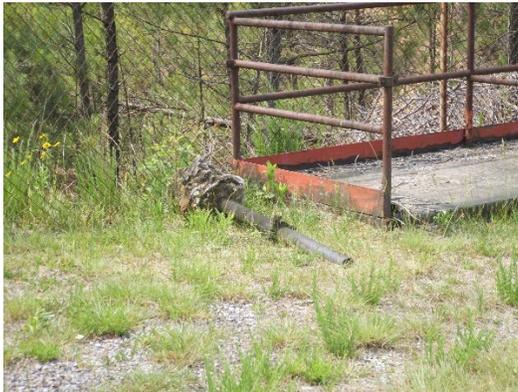
Drill Repair Shed – Reinstall Bollard

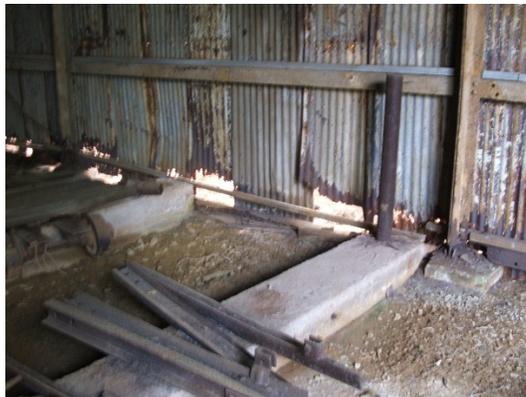
Parts and Equipment Shed – Deteriorated
Deteriorated
Ends of the Metal Siding

Remove any tree or tree limb with ten-feet of the structure, pour concrete pedestals around the connection of the steel columns and footers where rusted, replace the deteriorated and missing corrugated metal panels. Paint the exterior.

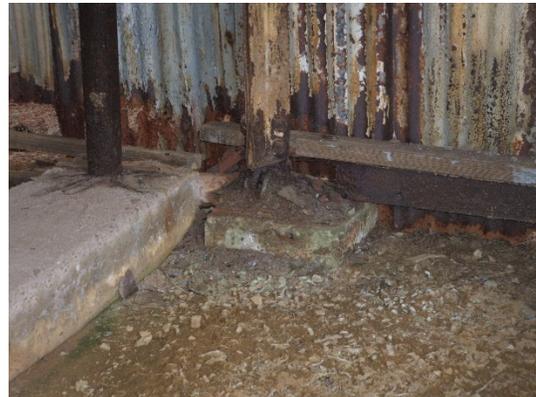
The connection of the steel columns to the concrete footers are severely deteriorated. Several panels of the metal siding are missing or deteriorated.

Parts and Equipment Shed –
Steel Column Bases

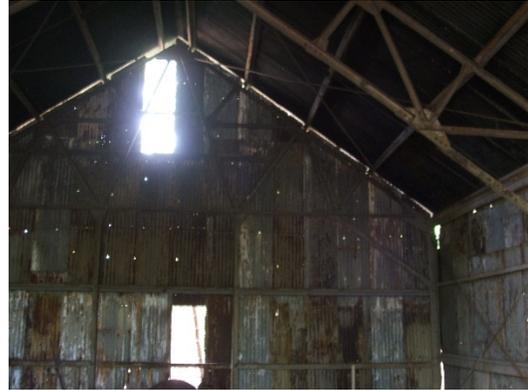
Parts and Equipment Shed – Missing and Deteriorated Metal Siding

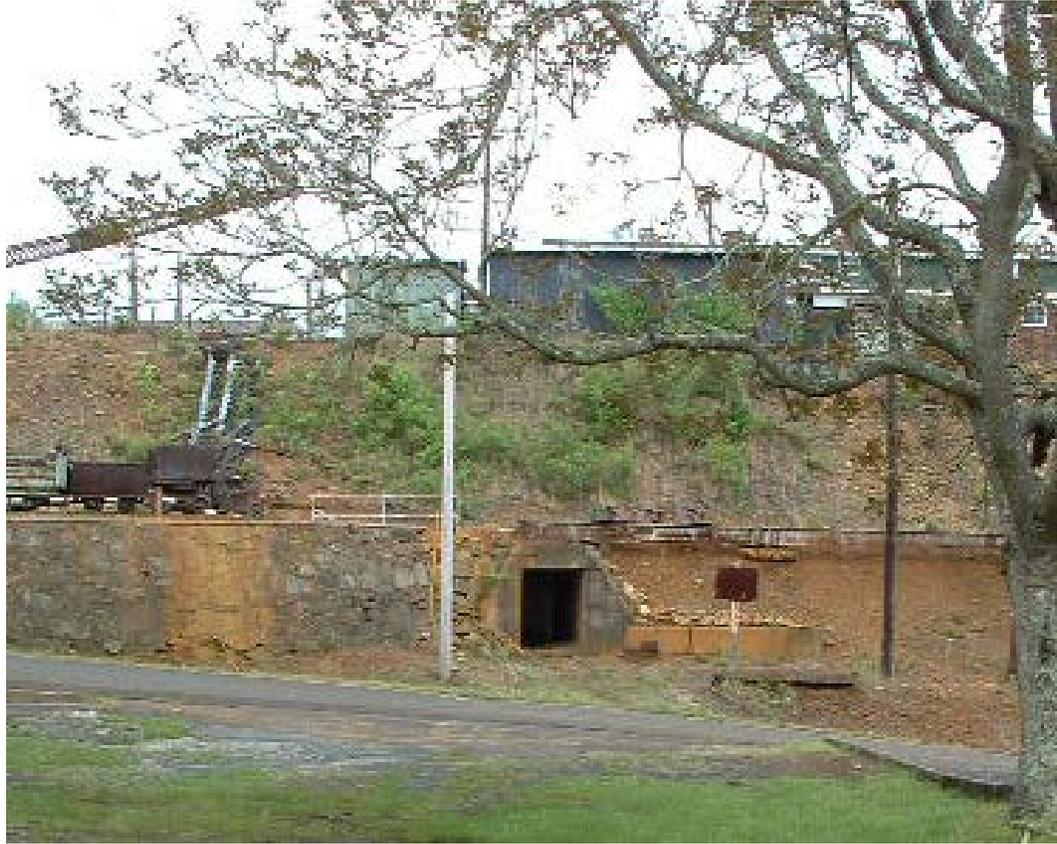
The service tunnel historically allowed workers to pass under a site train track. The structure is made of cast-in-place concrete. The adjacent stone work needs

repair and the lintel is cracked, however, the structure remains in serviceable condition.

Service Tunnel and Rock Retaining Wall

Repairs to the Service Tunnel should include repointing the entire stone wall and rebuilding the adjacent stone wall left of the tunnel where deteriorated and epoxy grouting the crack in the header so that water doesn't get in there and freeze.

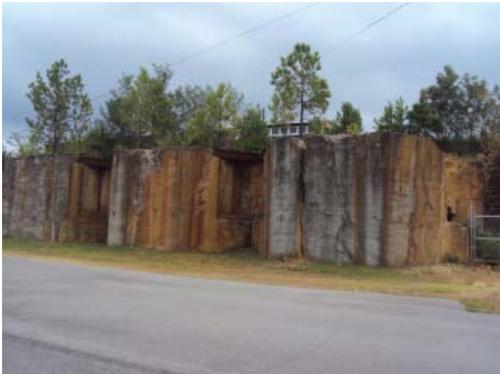
slab. Their condition is deteriorated not safe for occupancy. The associated stone and concrete wall is deteriorated.

Ore Bin Foundation – From Below

Remove the roof slab over the CMU rooms. Seal the top of the bins with new concrete slabs to prevent water getting into the foundations.

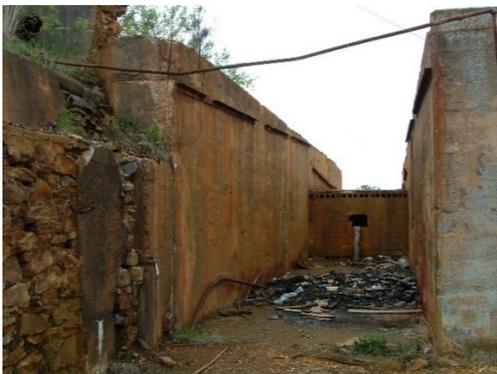
Ore Bin Foundation – Remove Roof Slab

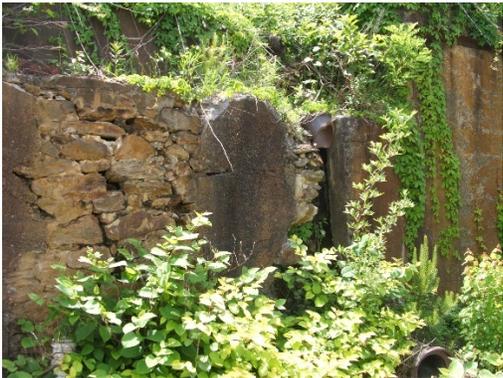
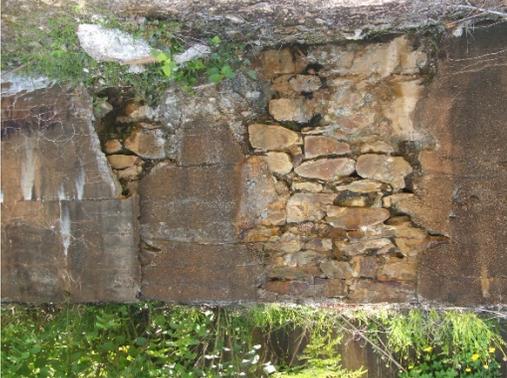
Ore Bin Foundations – Repair Retaining Wall

Repair stone/concrete retaining wall.

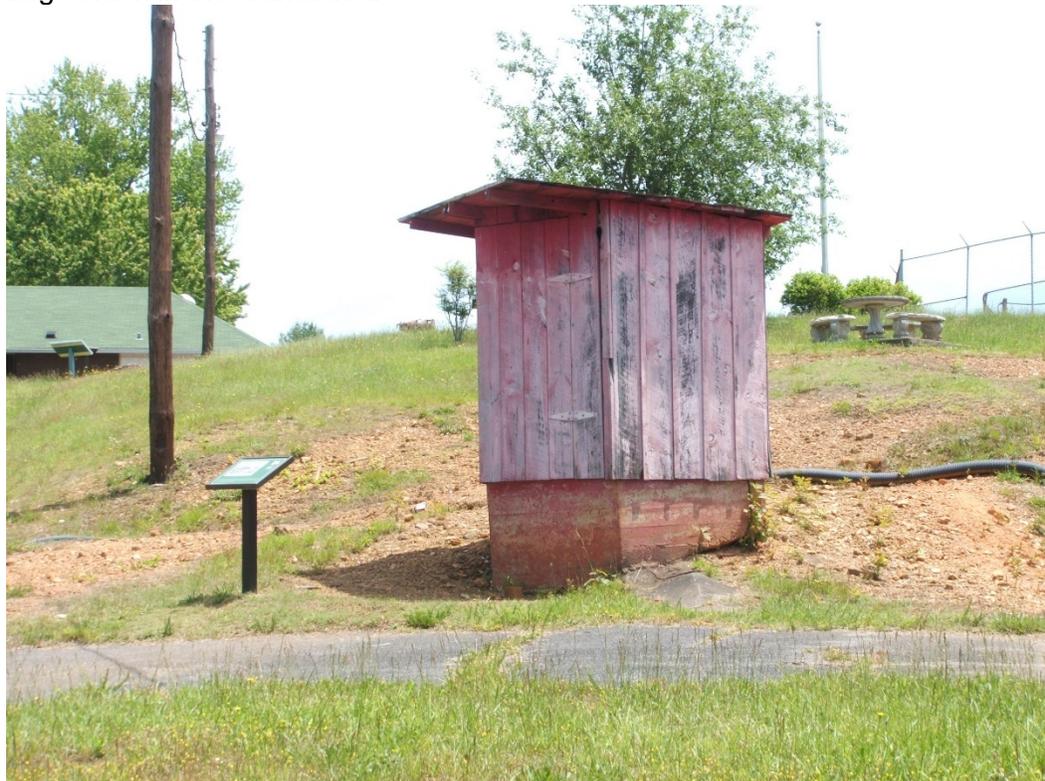
Fire Hose #1 is a 50 square foot, one-story wooden structure with board and batten siding and shed roof resting on a raised poured concrete foundation. The exterior paint and the rolled asphalt roofing are severely deteriorated. There is a large crack in the foundation.

The Fire Hose #1 structure should receive a new rolled asphalt roof and be painted. The foundation crack should be filled with grout.

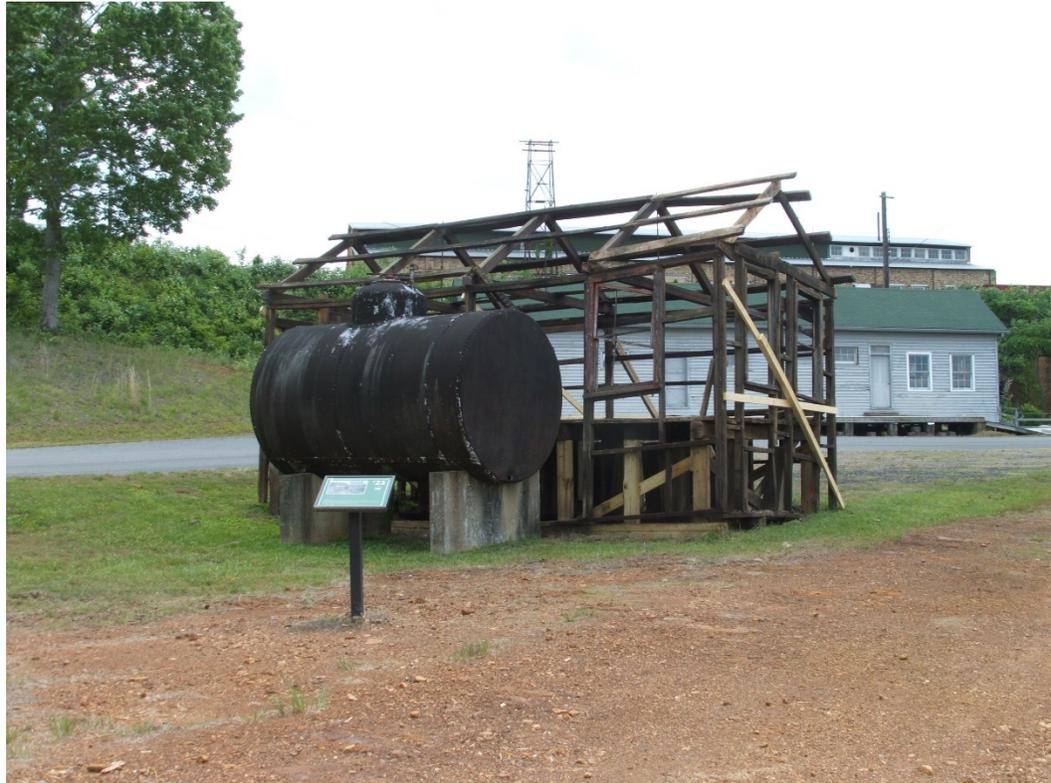
The Bit House is currently being reconstructed. However, the adjacent metal drum on concrete foundations needs to be painted and that isn't part of that work.

Metal Drum at Bit House

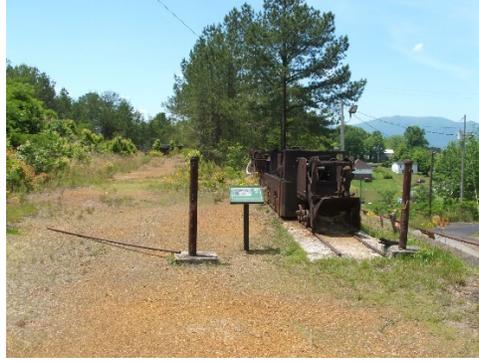
Remove Bollards and Remove Rust Off Mine Cars

Remove the rust on the steel equipment and seal, or clearcoat.

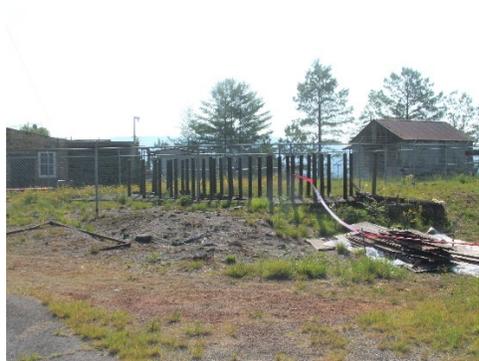
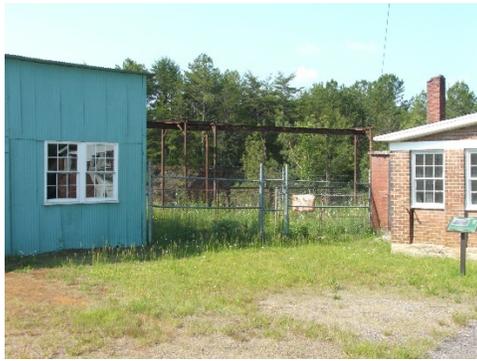
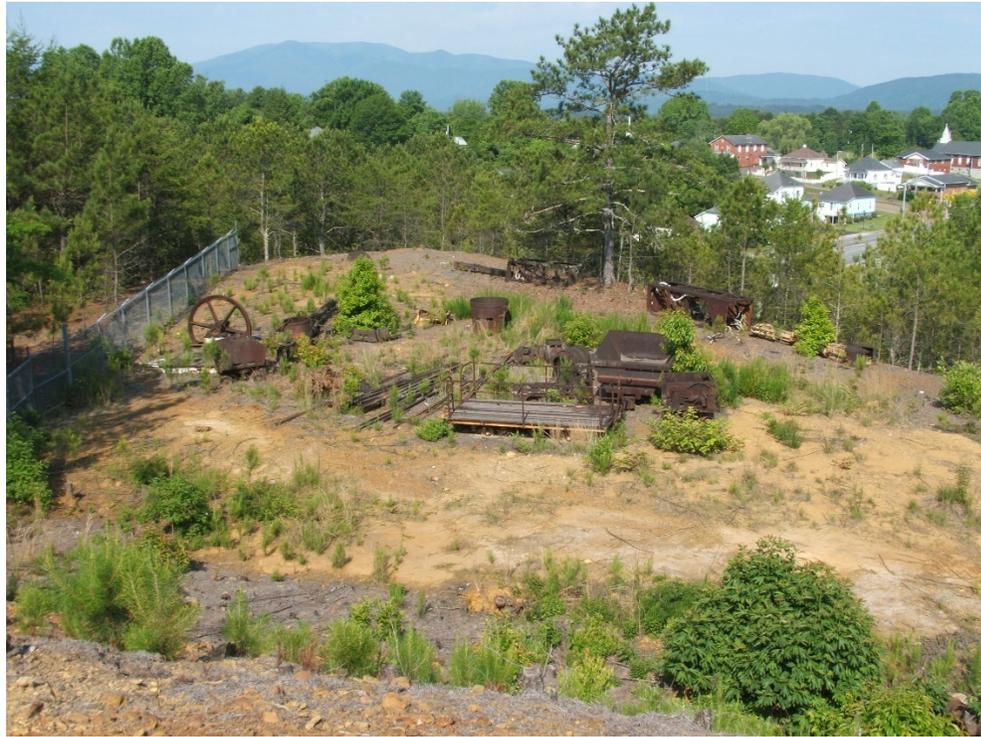
Throughout the site, there are numerous steel items used by the mining company for various activities. They are frequently sitting unprotected and are rusting.

Remove Rust Off of Exposed Equipment

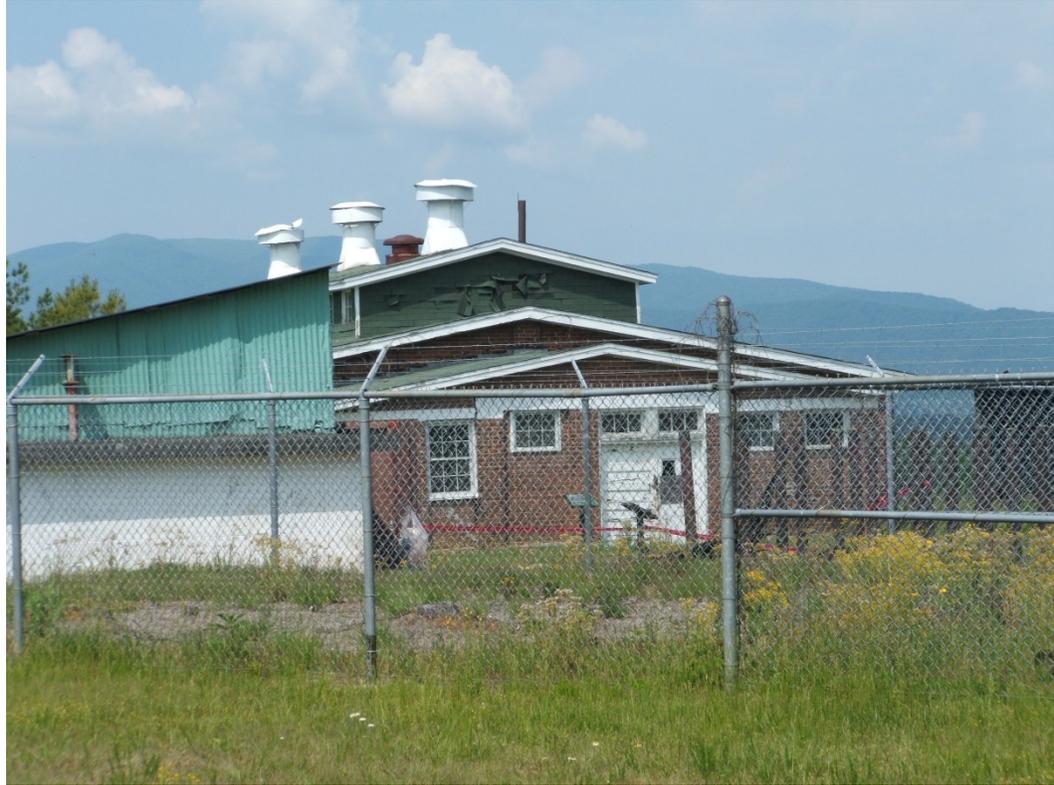
After the site was closed, the ore bin structures were removed and the structure that raised and lowered the miners was dismantled, then the entrance to the shaft was then capped using concrete. Over time, water has gotten in there and the area of the cap has dropped twelve to eighteen inches.

Concern has been raised by the Site Director, that the condition has worsened and should be address for life safety reasons.

Fence Around the Mining Shaft Area
