National Civil Rights Museum

Facility Assessment Report

SBC Project No. 529/000-16-1998

September 11, 2017

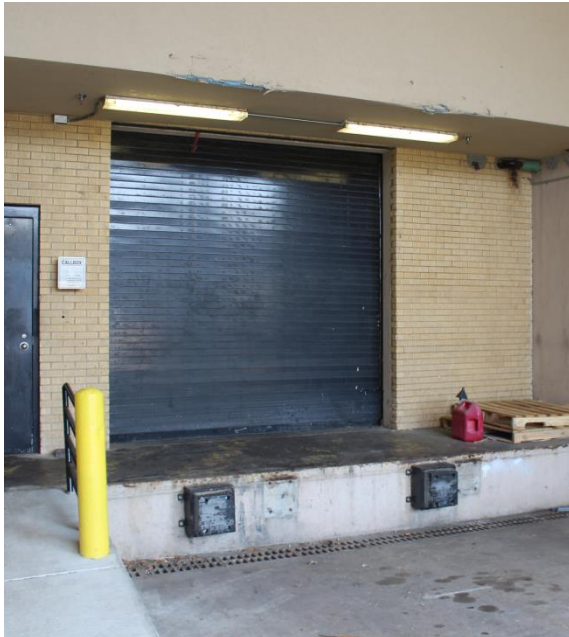
The exterior of the Museum is well maintained with some deterioration present at the truck dock due to use and overall access by large trucks. The lack of a truck dock results in damage to the soffit (Photograph 1) due the slope of the actual drive and the proximity of the top of the trucks to the buildings surfaces. Additional deterioration is present on the brick joints on the side walls of the truck dock (Photograph 2) and a brick/wall joint remains open (Photograph 3) allowing for insects and debris to be collected.

Photograph 1 –
Truck Dock Condition with
damage to exterior finish

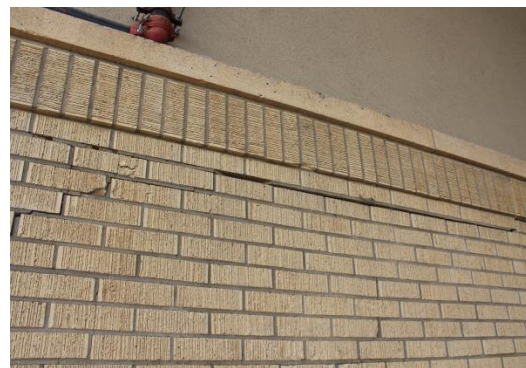
Photograph 2 –
Brick Joint Deterioration at Truck
Dock

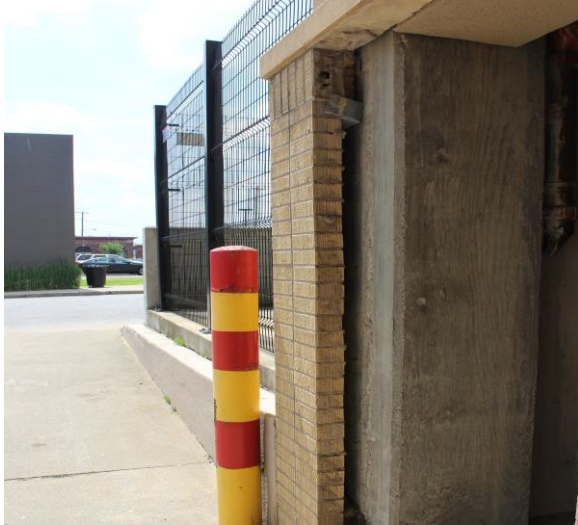
Photograph 3 –
Closure at masonry wall

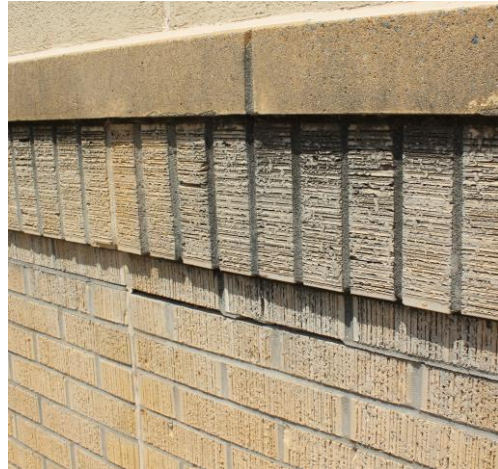
Brick joint deterioration was observed on the east wall of the Museum requiring some attention (Photograph 4) to mitigate any water intrusion and further deterioration.

Photograph 4 –
Brick/Mortar deterioration

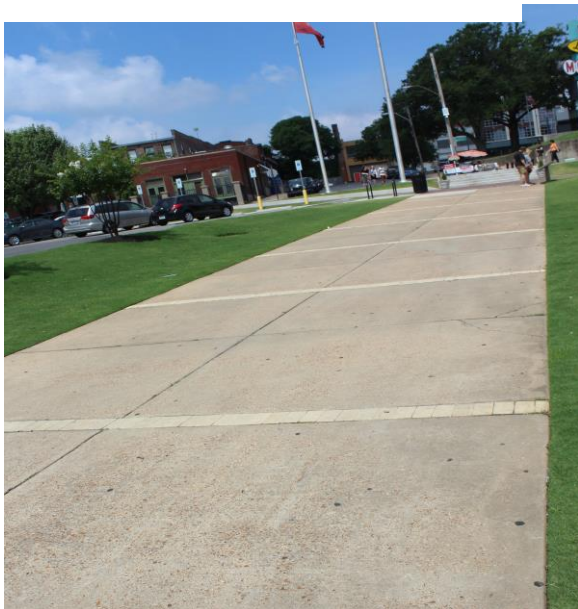
Large areas of sidewalk have been improved and maintain their presence and serve as access to the complex (Photograph 5) without creating tripping hazards.

Photograph 5 –
Sidewalk improvement

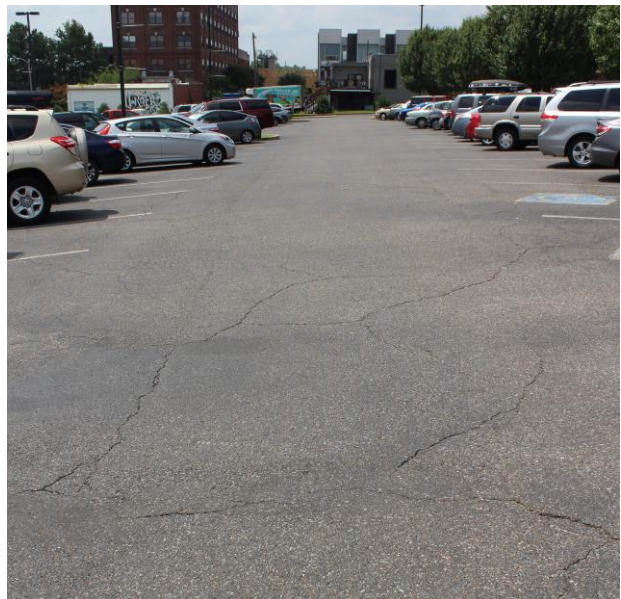
Public parking areas serving the Museum are showing early signs of deterioration (Photograph 6) that require attention to avoid further deterioration or eventual pavement failure.

Photograph 6 –
Parking lot pavement

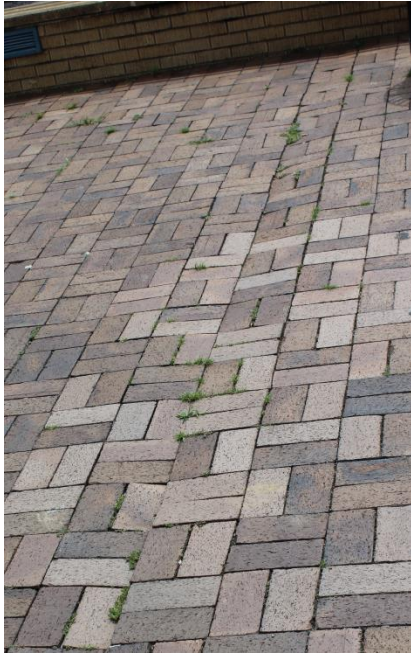
The plaza continues to be of concern since it is the walking surface for all visitors to the Museum. A specific area shows evidence of substrate failure (Photograph 7), creating an uneven surface for visitors. The remaining walkway have areas where the bricks are uneven and will require attention in the future.

Photograph 7 –
Brick paver deterioration

The plaza will require a complete removal and reinstallation of the brick pavers in order to provide a safe walking surface and to repair some substrate problems.

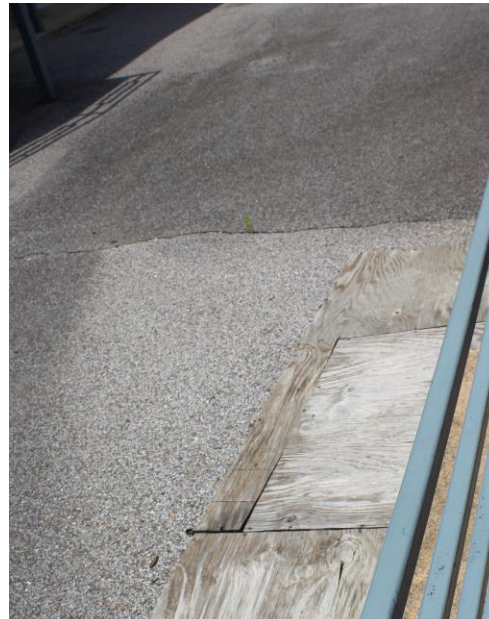
The outdoor area in front of the Lorraine Motel defined by the masonry wall and rail require access for maintenance and housekeeping. The current ramp (Photograph 8) should be replaced with a more durable material and design to accommodate maintenance equipment.

Photograph 8 –
Ramp at guard rail

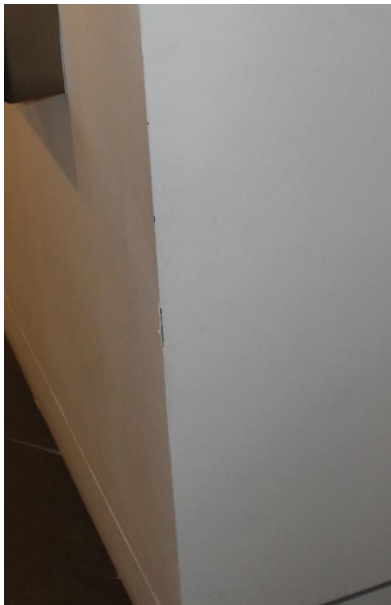
All public and exhibit areas have remained unchanged since the reopening in April 2014 and show areas of premature wear as a result of the constant visitor traffic and the lack of some surface protection measures. Interior finishes, especially corners, continue to be damaged (Photograph 9) along with panels at the front entrance (Photograph 10).

Photograph 9 –
Finish damage

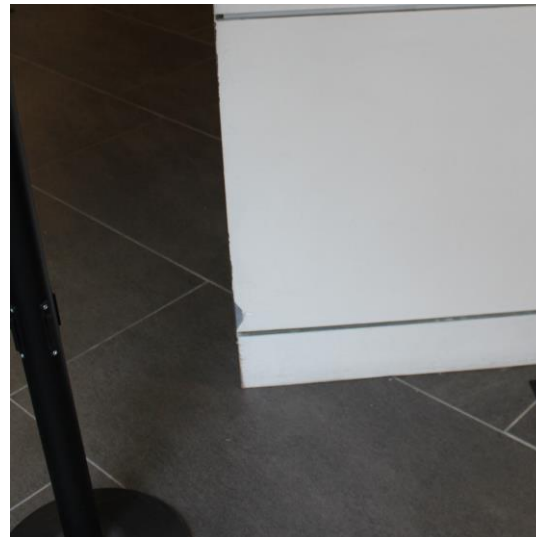
Photograph 10 –
Finish damaged

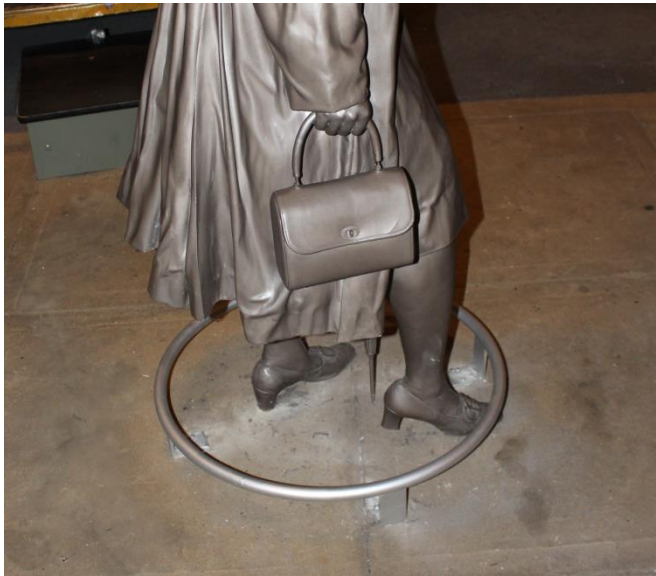
Displays continue to be improved to provide a better experience and safeguard the public. Floor guards (Photograph 11) have been installed to prevent accidental contact with displays and statues located in walkways. Physical displays incorporating vehicles and bridges enhance the visitor's experience, along with many interactive displays and research stations. Displays include life sized figures that attract visitors photograph opportunities compounding the maintenance and damage concerns

Photograph 11 –
Display guards

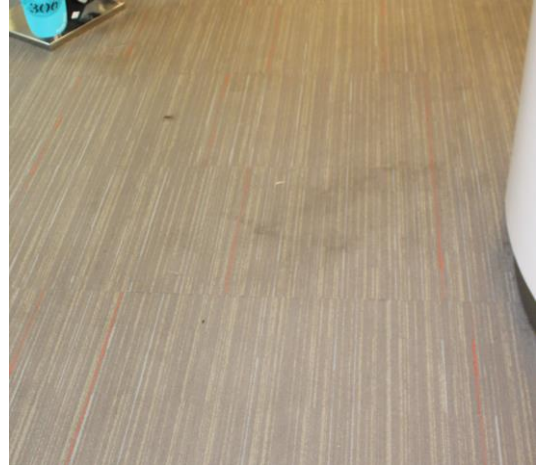
The Lobby Gift Shop continues to be an attraction as well as a revenue generator for the Museum. Discolored floor carpet tiles (Photograph 12) indicate leaks or spillages issues that have been ongoing since the reopening. Replacement of selected tiles will attract attention due to the color difference. A plan was discussed to replace tile with LVT flooring which will mitigate potential mold issues, the color difference, and has high endurance.

Photograph 12 –
Gift Shop carpet discoloration

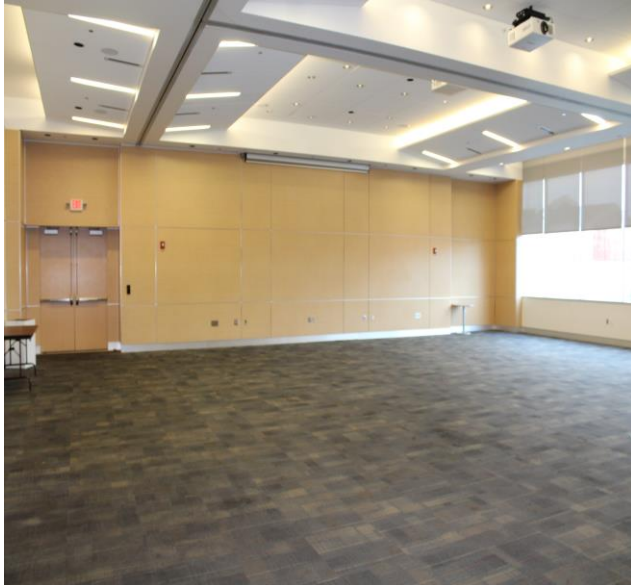
The event center continues to be an extremely popular venue for programs and presentations requiring upkeep and maintenance (Photograph 13). The use of the facility also necessitates better protection of the catering kitchen doors from food carts passing through and requires considerable maintenance to maintain the space in rentable condition..

Photograph 13 –
Public venue

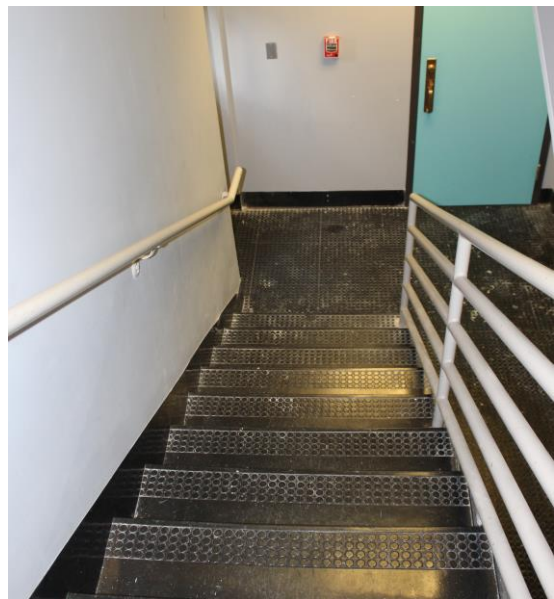
Staff spaces include the staff entrance, lockers, and restrooms, while the support spaces include two equipment basements, outdoor equipment area and truck dock serving the museum and public space/functions. A rear stair continues to be operational and unsightly (Photograph 14), however no further deterioration has been observed from the last observation report.

Photograph 14 –
Rear service stair

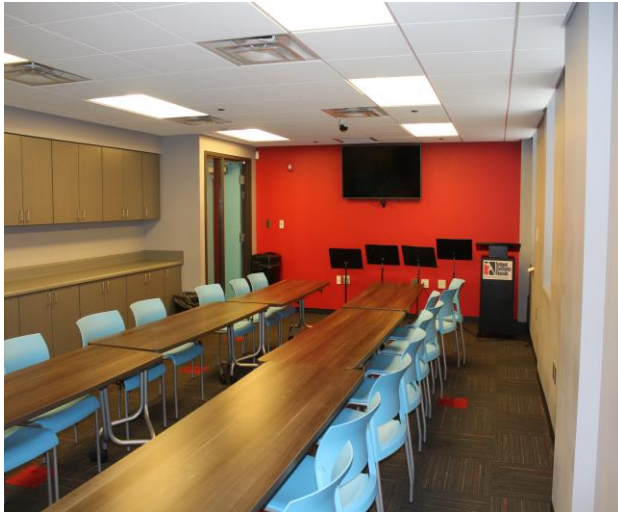
The Museum has incorporated an educational sector in the previous Lorraine Hotel students and visitors have an opportunity to learn and participate in presentations as part of the school curriculum. The Educational Center has several "classroom" spaces along with a resource library (Photograph 15).

Photograph 15 –
Classroom/Educational space

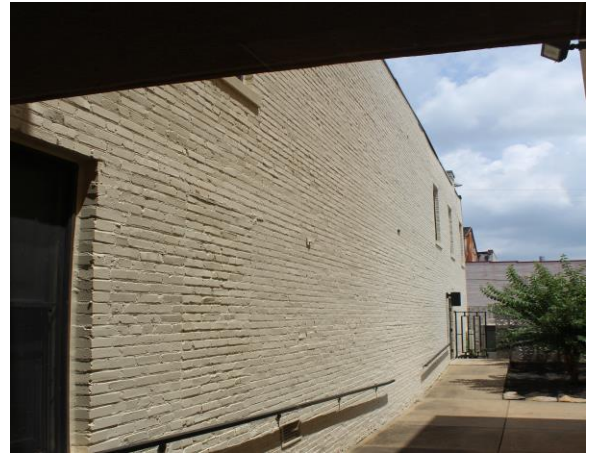
The staff entrance was recently upgraded with painting of the masonry surfaces along with the improvement of the exterior EIFS system (Photograph 16). The basement stairwell is operational and unsightly with loose and missing tiles (Photograph 17).

Photograph 16 –
Staff entrance

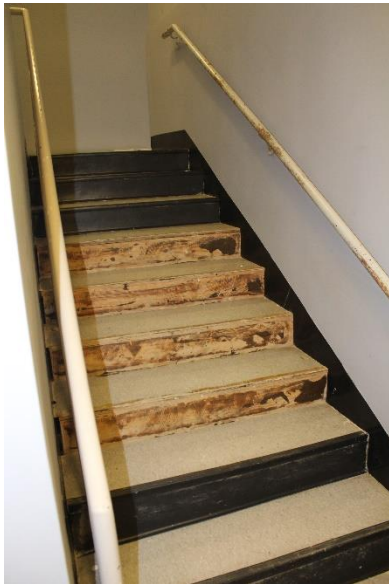
Photograph 17 –
Basement Stairs
