I-40 Crossing I40 / SR 53

Inspection Date(s): 05/22/2025 - 05/22/2025

IDENTIFICATION	
(1) State Names	47 - Tennessee
(8) Structure Number	80I00400015
(5) Inventory Route	1
(2) Highway Agency District	Region 3
(3) County Code	80 - Smith

Inspection Team's Summary

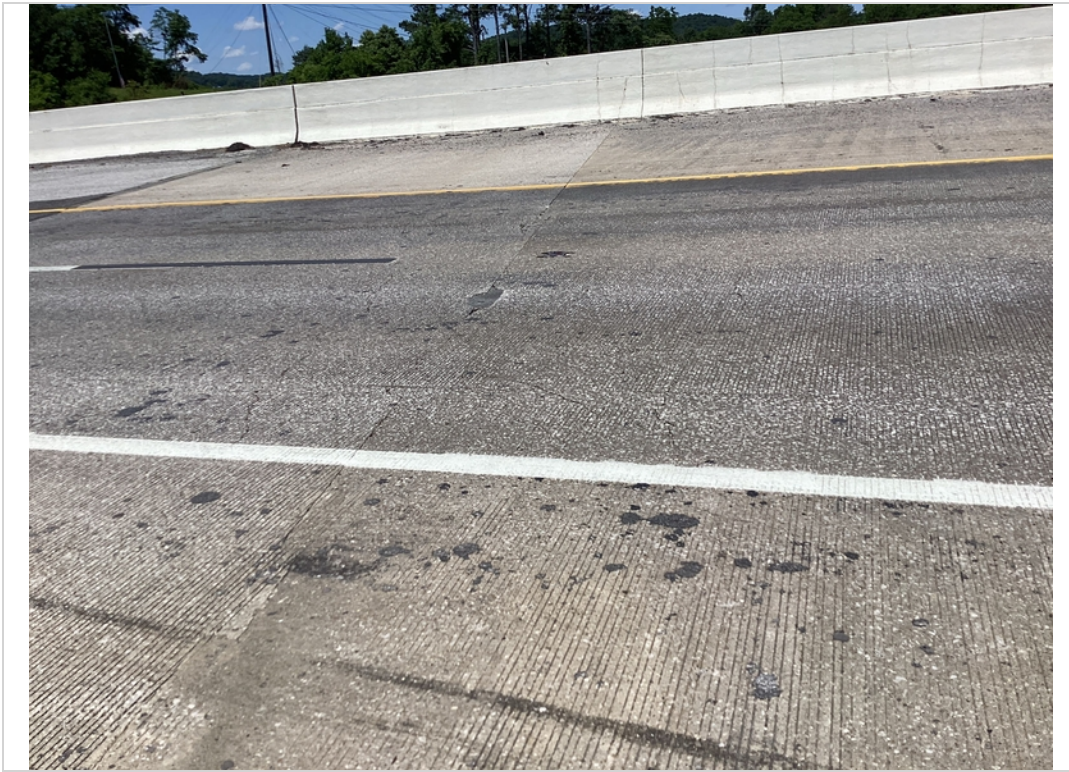
R A approach cracking on deck

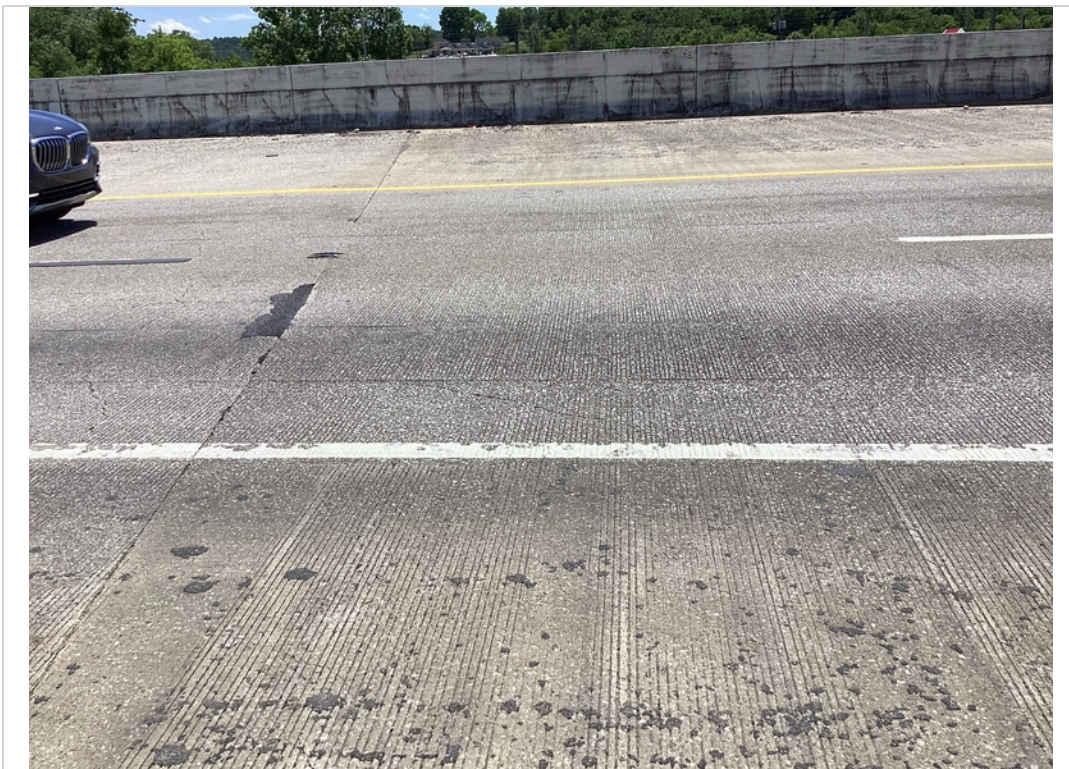
L B approach crack on deck

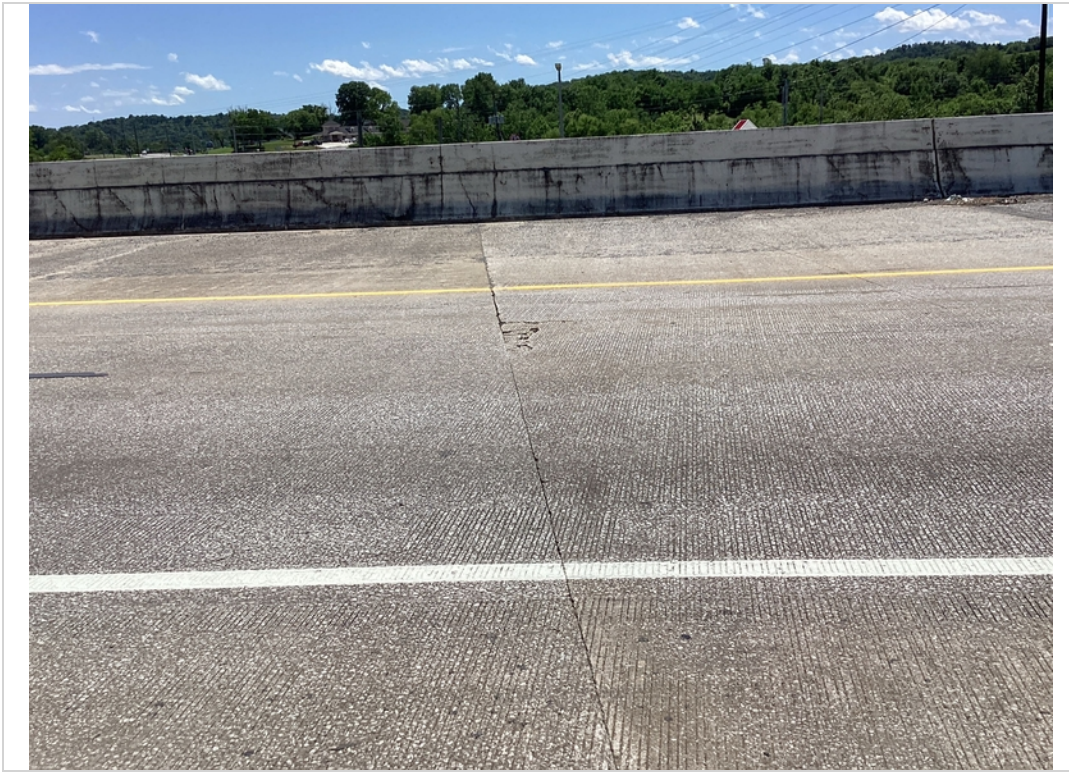
L A approach crack on deck

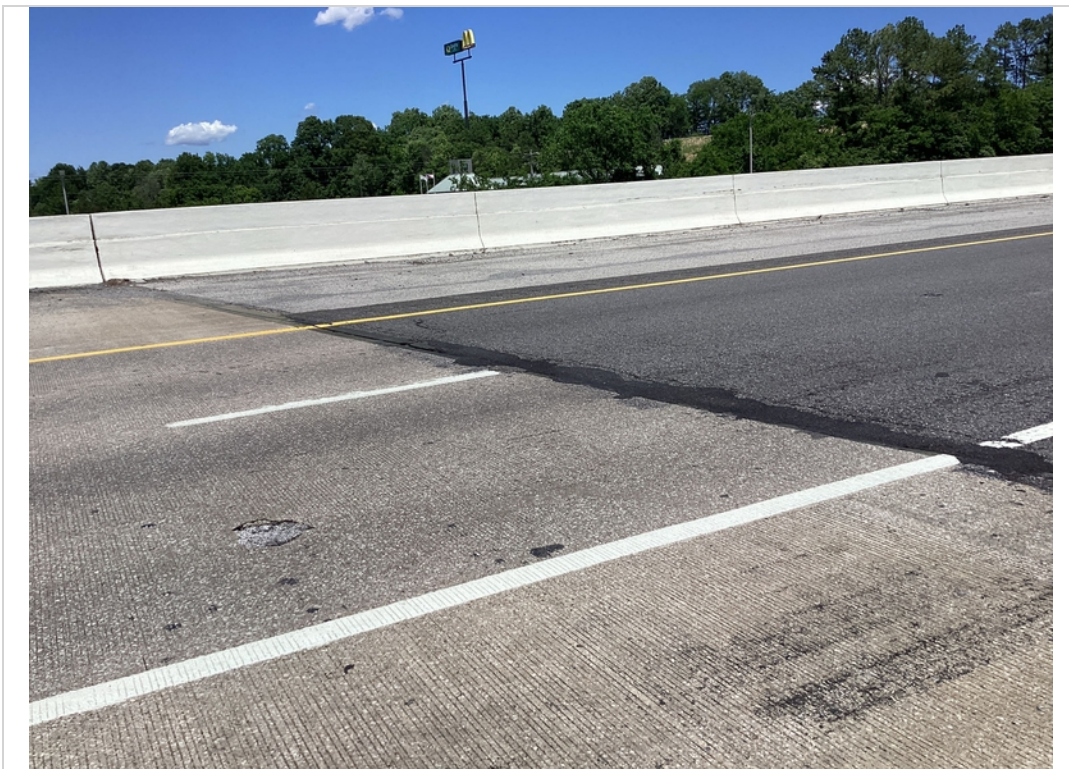
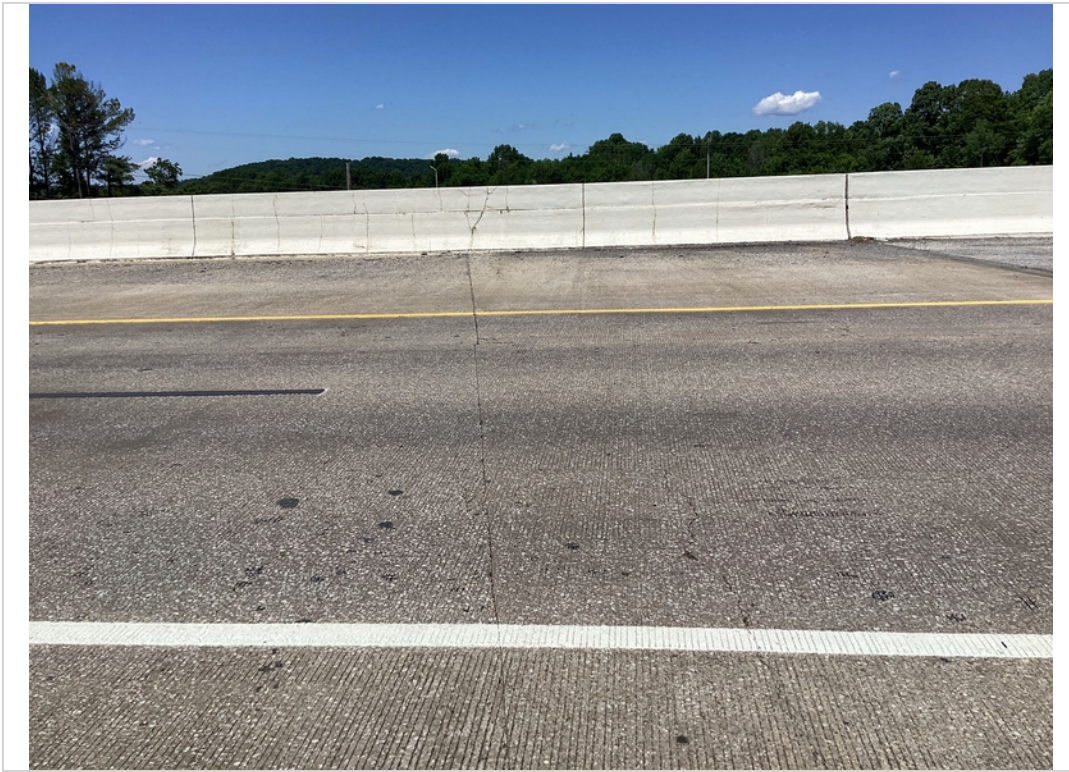
The approach alignment is good. The approach asphalt is in good condition. The approach embankment is in good condition. The approach joints are in fair condition with some moderate impact damage.

R B approach joint span 3

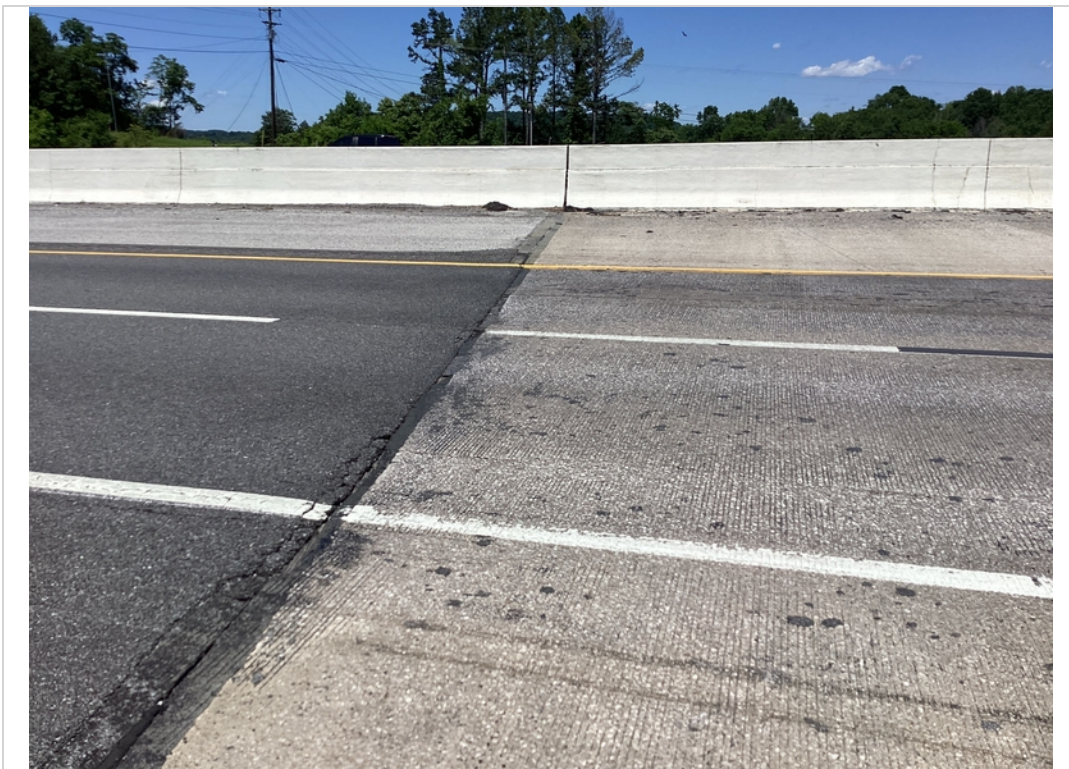
R A approach joint span 1

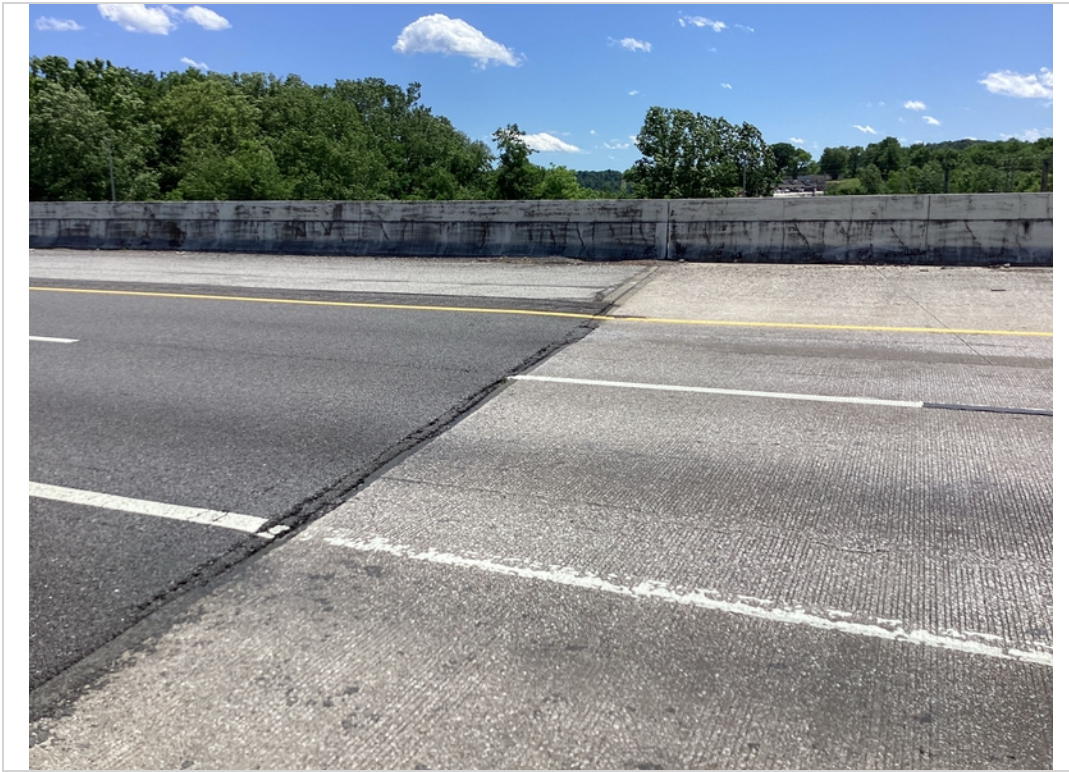
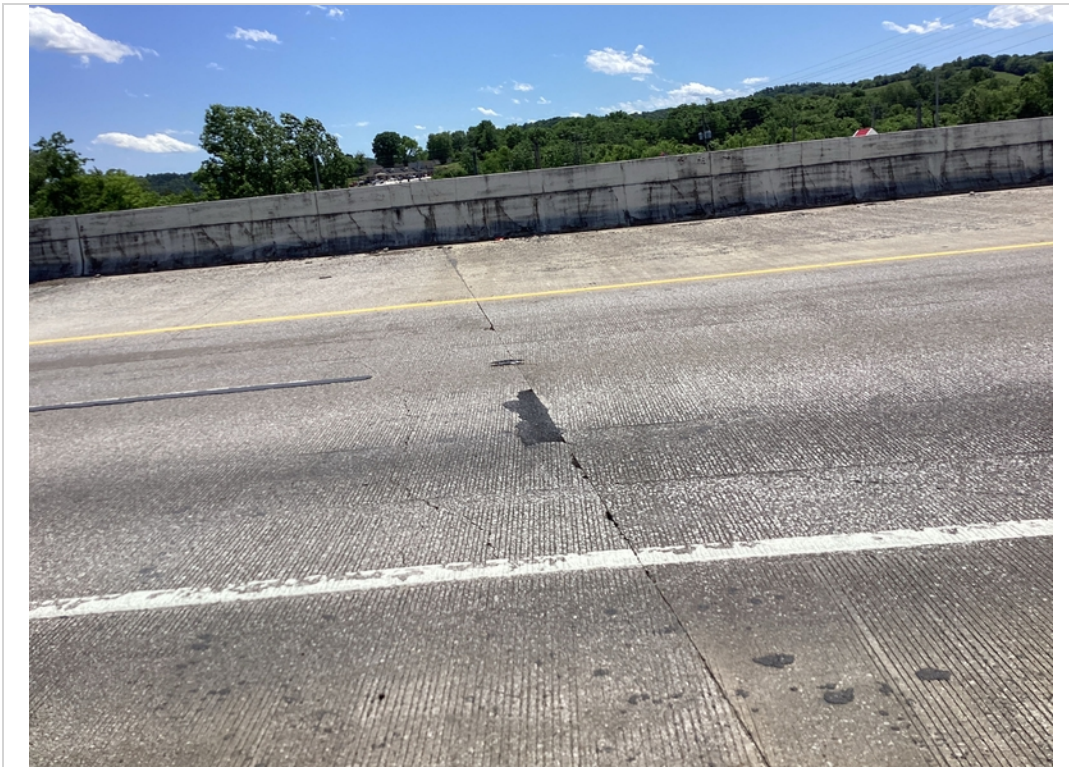
L B approach joint span 3

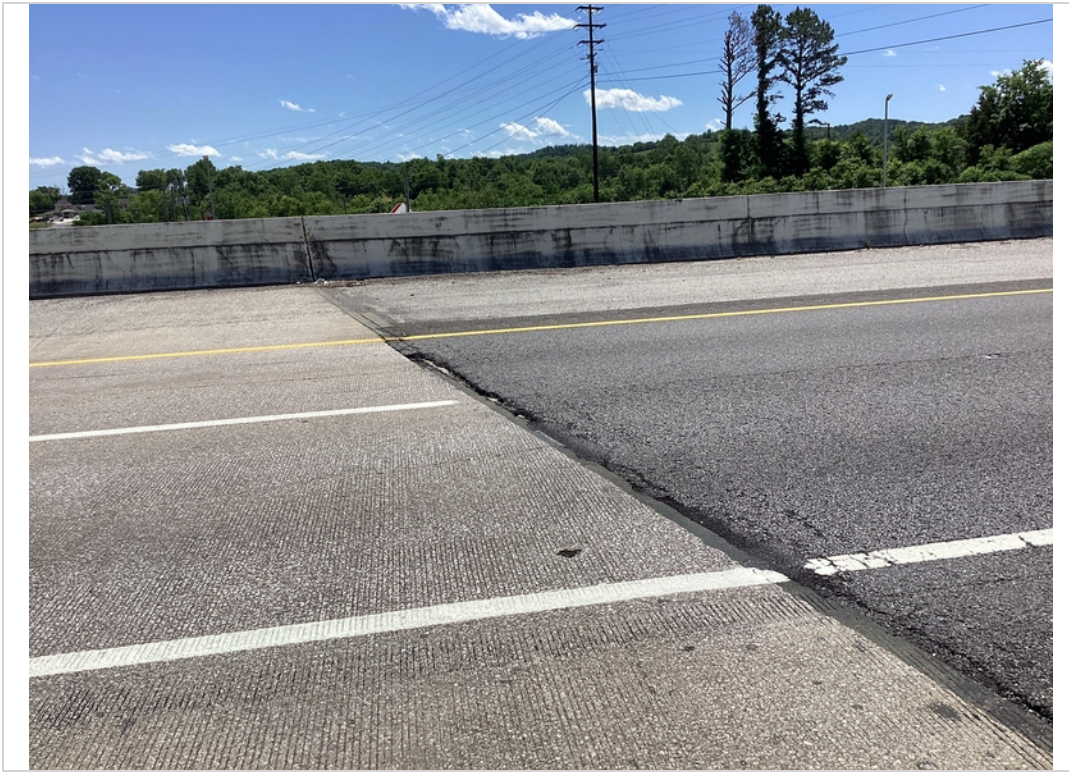
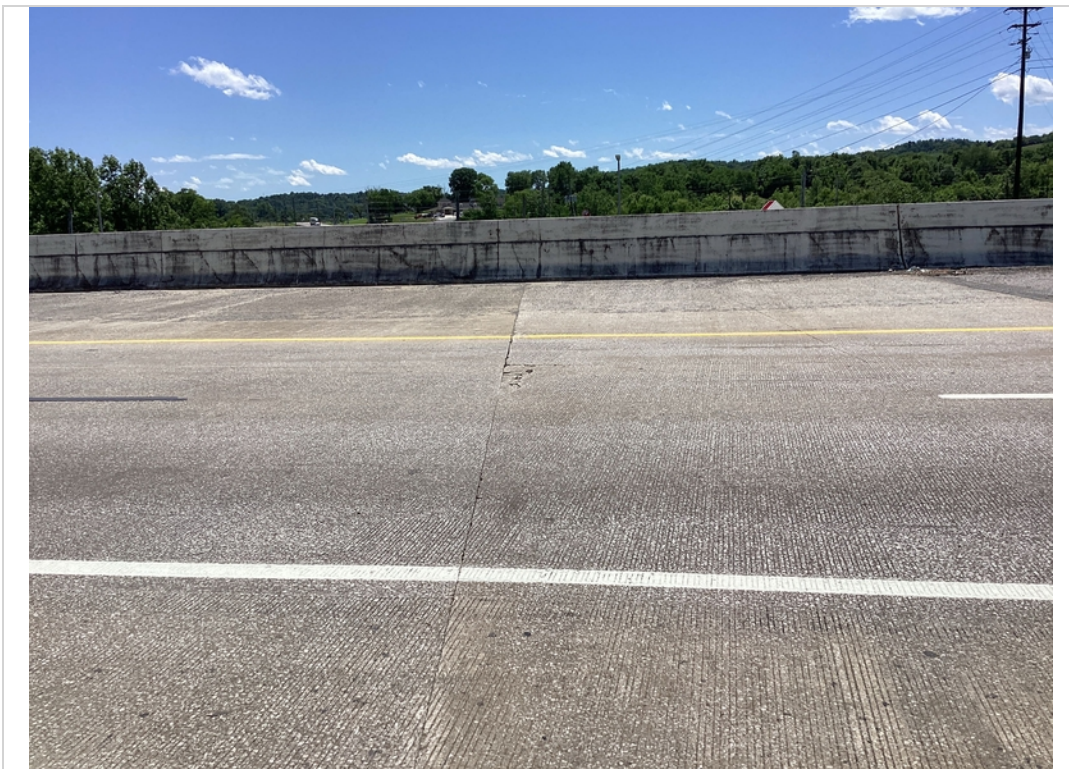
L A approach joint span 1

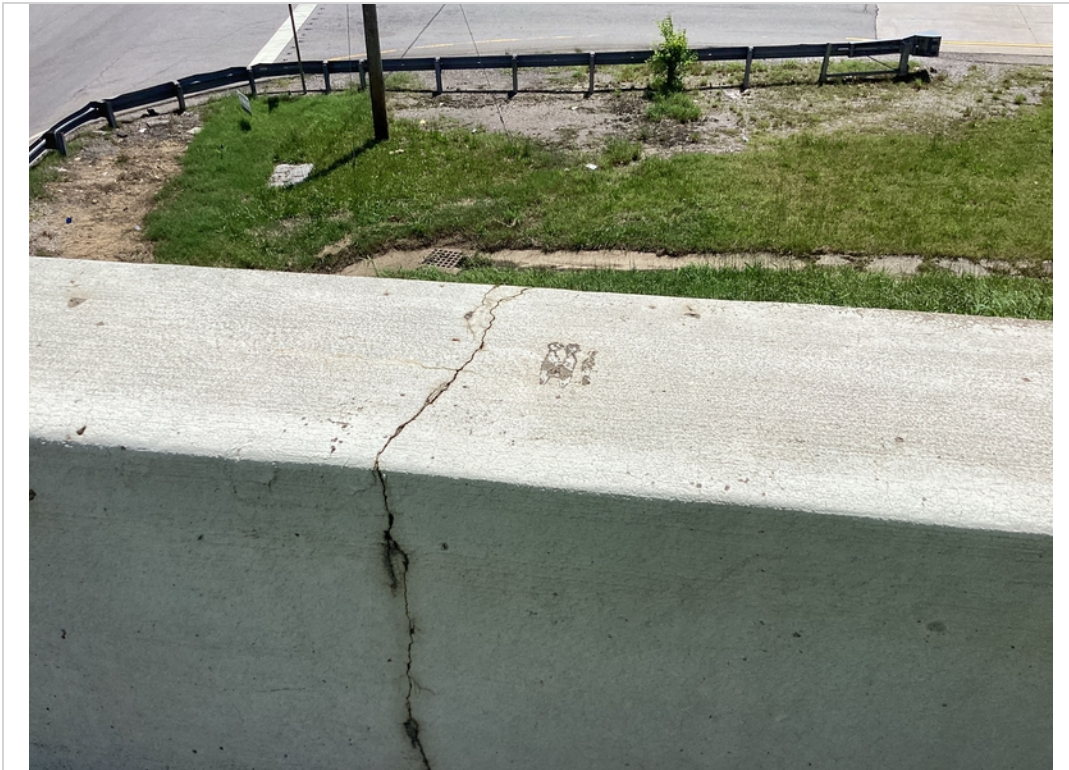
R Hairlines throughout

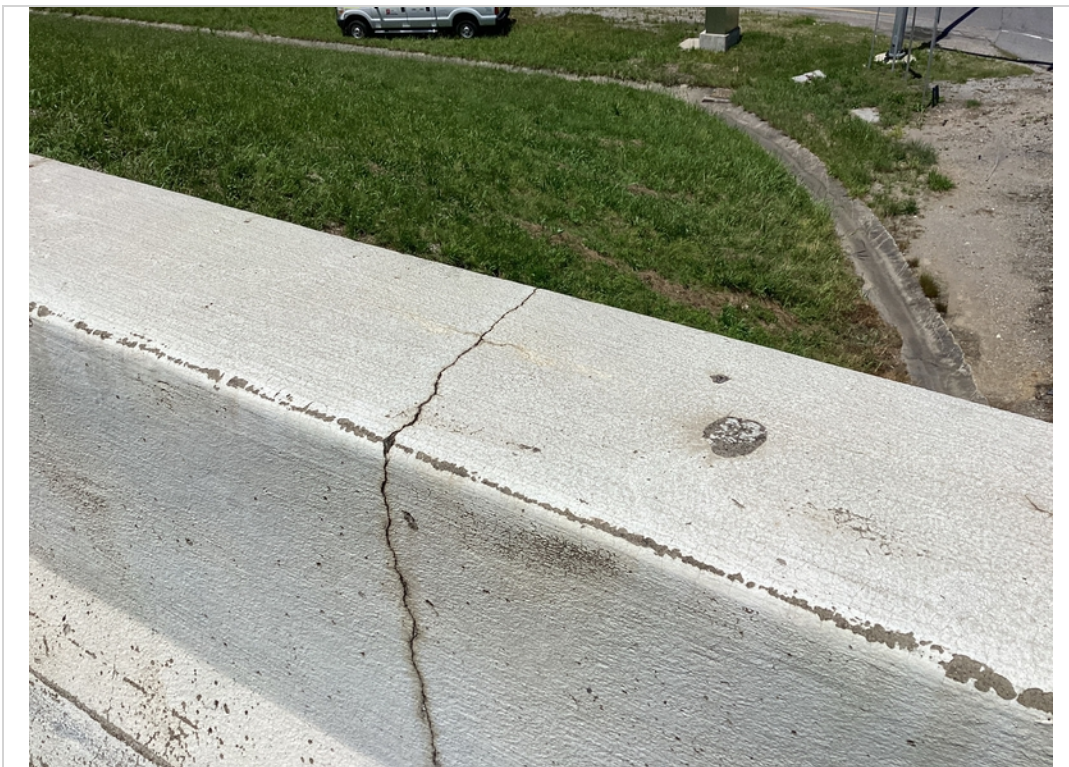
L hairlines throughout

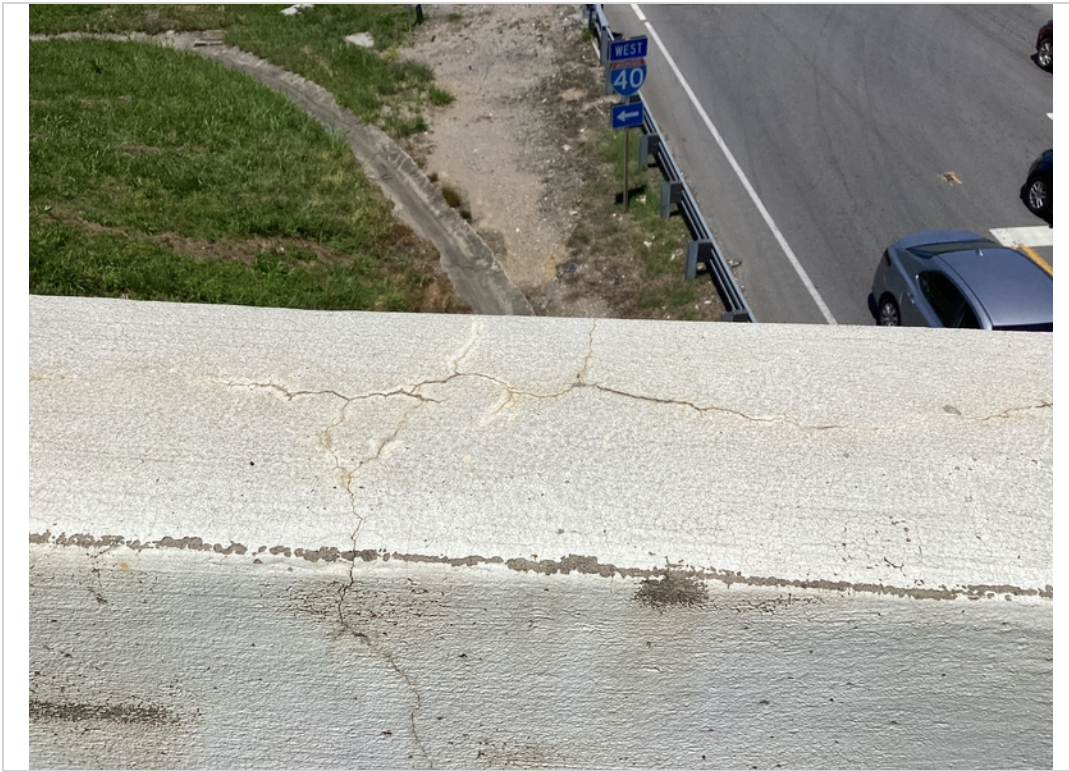
L Span 1 left side map cracking

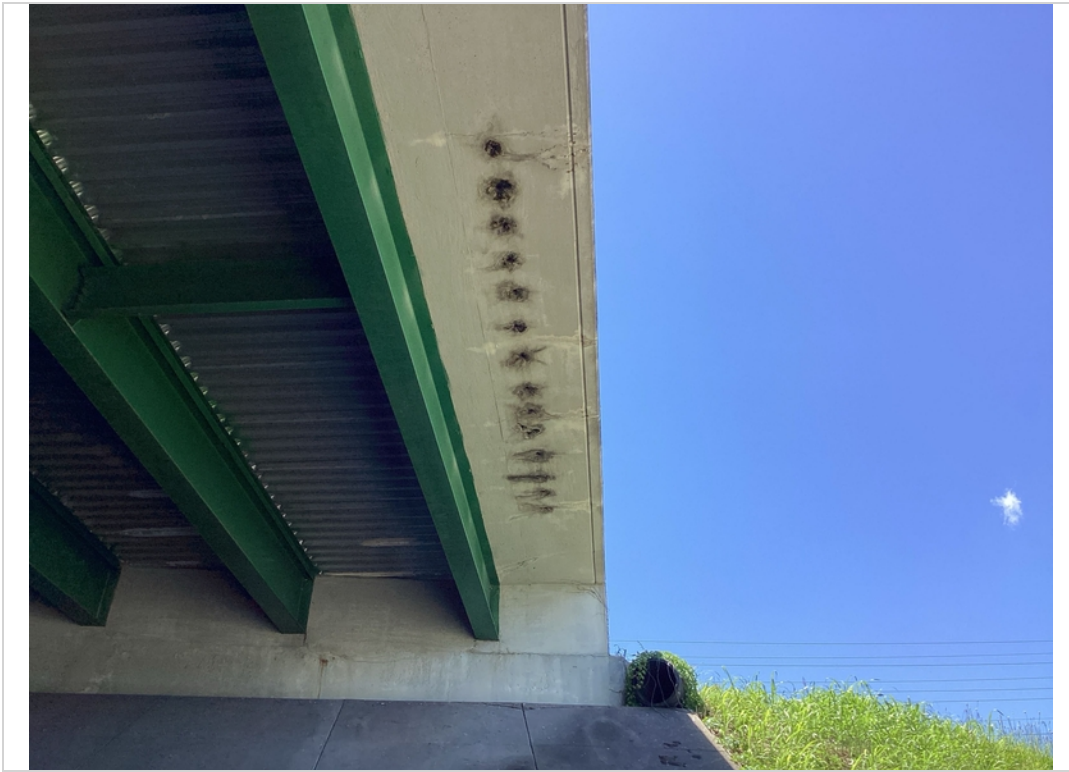
Span 1 left overhang near abutment some minor spalls with exposed steel

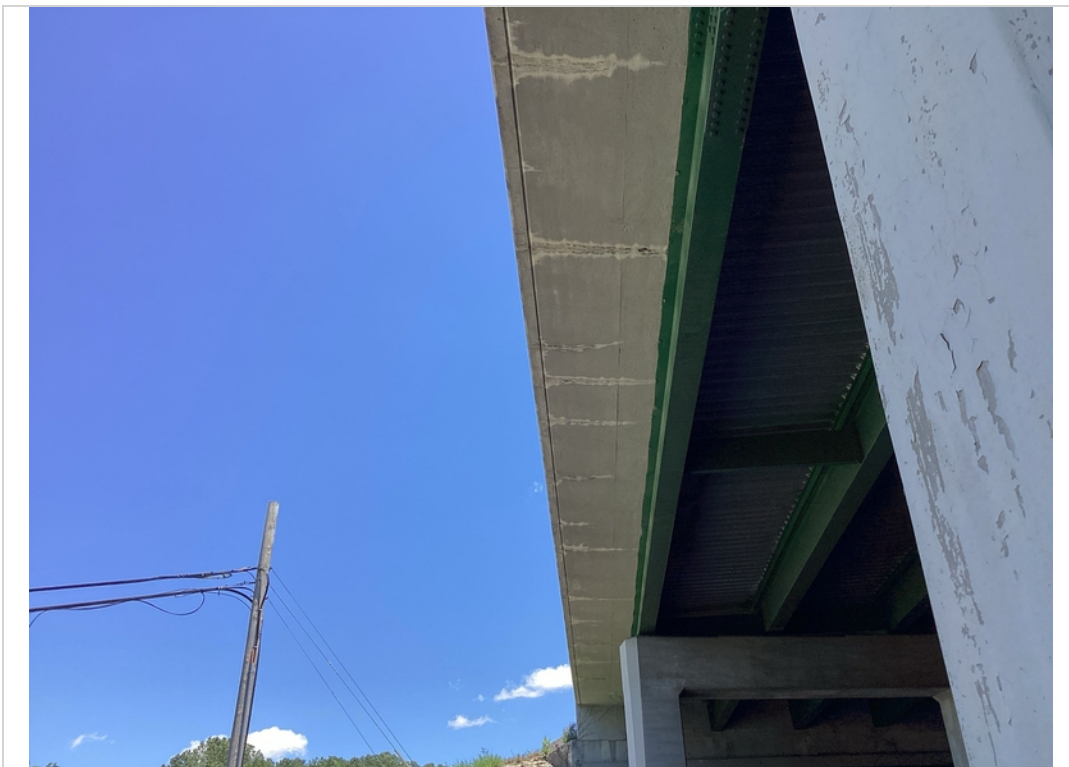
The deck is in GOOD condition. The concrete-wearing surface is in good condition with an isolated minor spall in span 1 and some minor cracks in all three spans. The underside of the deck is in good condition with isolated minor cracks with efflorescence in the overhang areas. Two isolated areas on both sides of span 1 are holding water. The current deck condition rating is good (7).

All spans transverse cracks with efflorescence left overhang

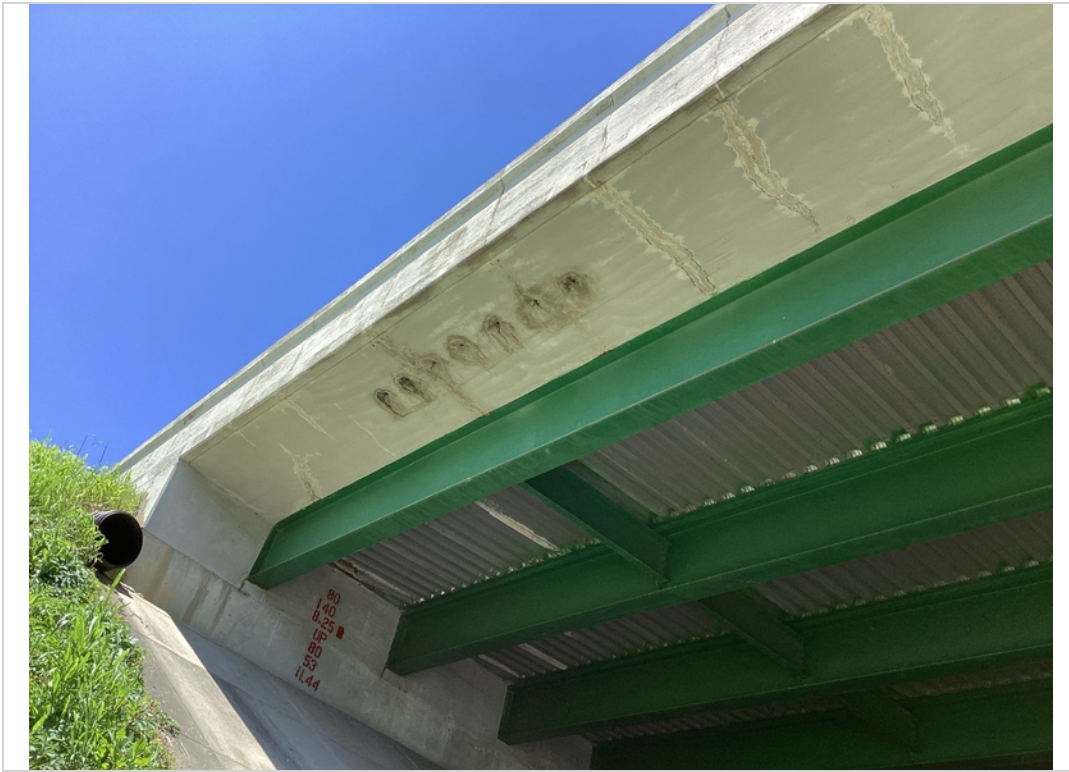
Span 1 right overhang near abutment some minor spalls with exposed steel

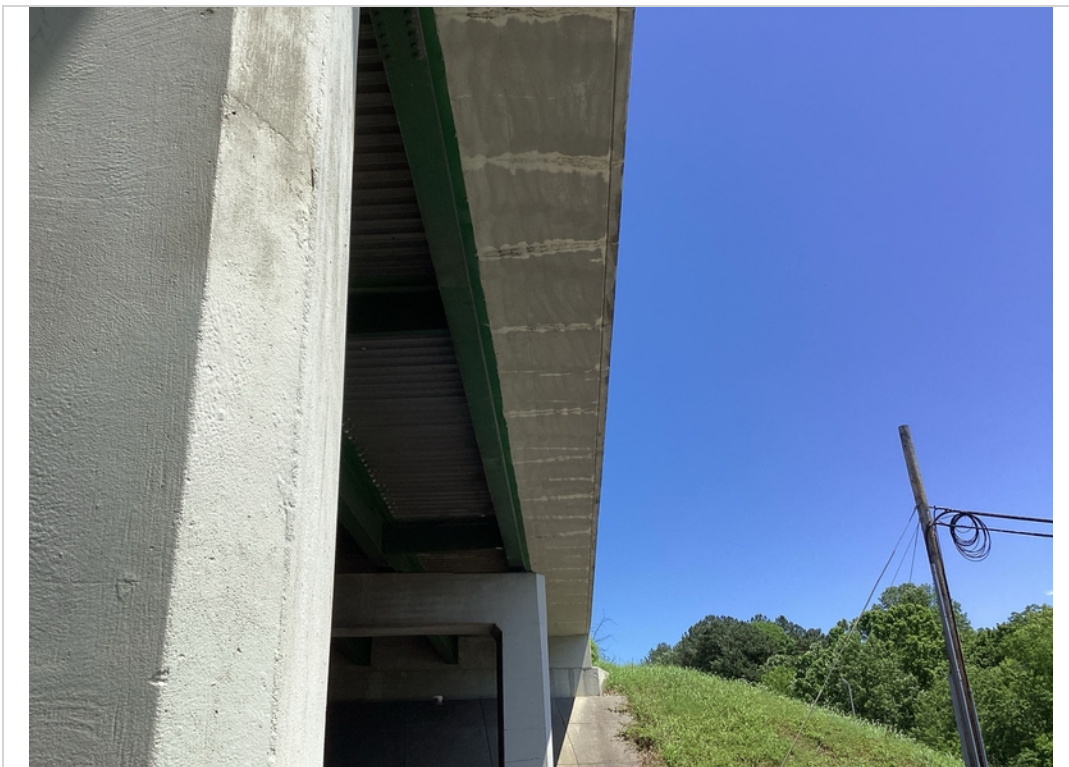
All spans transverse cracks with efflorescence right overhang

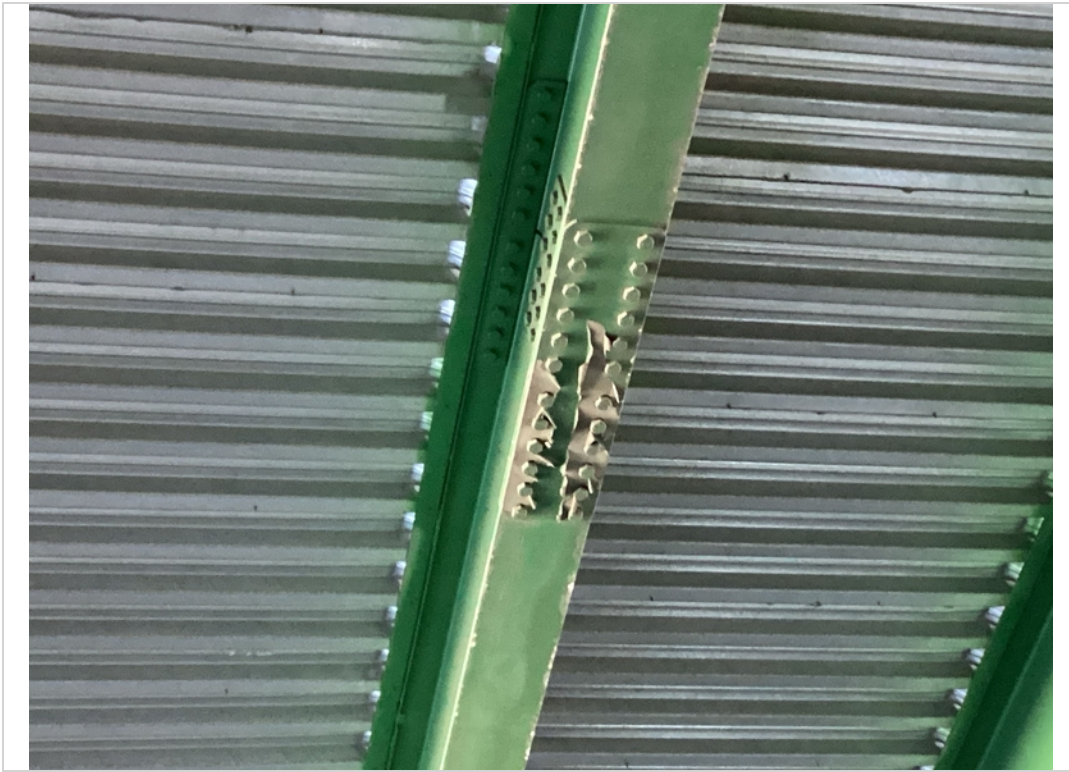
The superstructure is in GOOD condition. The beams are in good condition with an isolated minor paint defect at span 2 on beam H at the bottom splice plate.. The diaphragms are in good condition. The bearings are in good condition. The current superstructure condition rating is good (8).

Bearing Devices	(Good)	
Beams	(Good)	Isolated area of paint scaling at span 2 beam H on the bottom splice plate
Diaphragms	(Good)	
Superstructure Paint	(Good)	
Alignment of Members	(Good)	
Texture Coat Condition Rating-1	(Good)

Span 2 beam H at splice plate-flaking paint

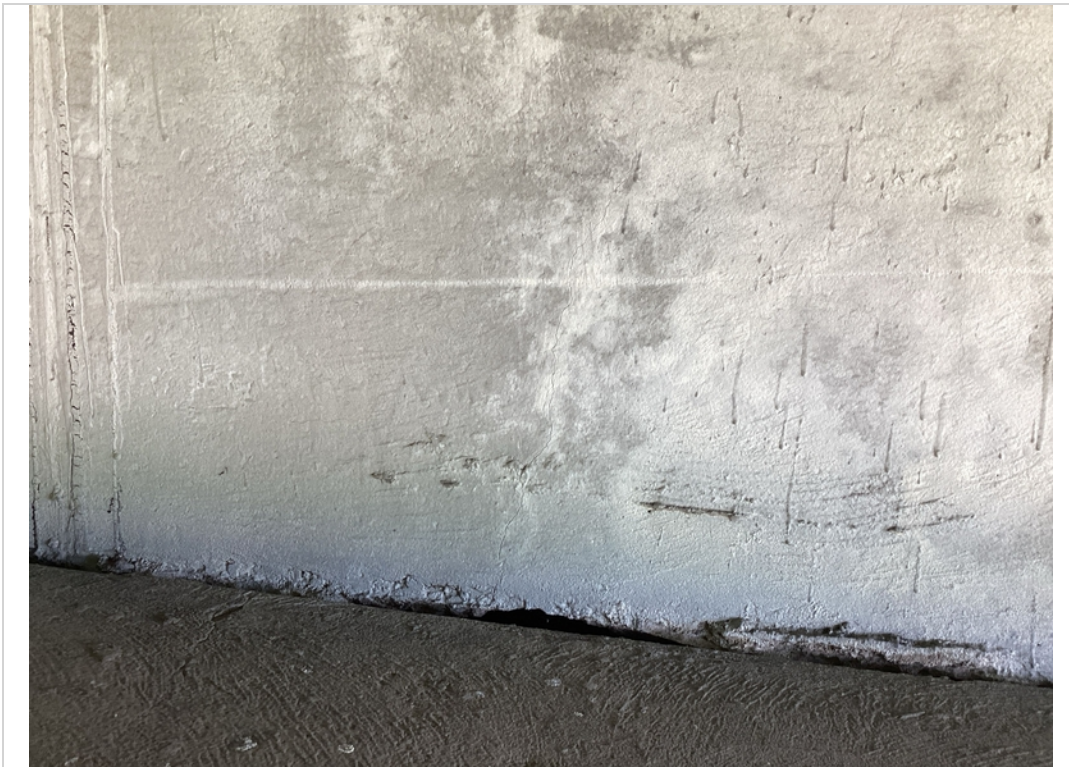
Abutment 2 random hc's

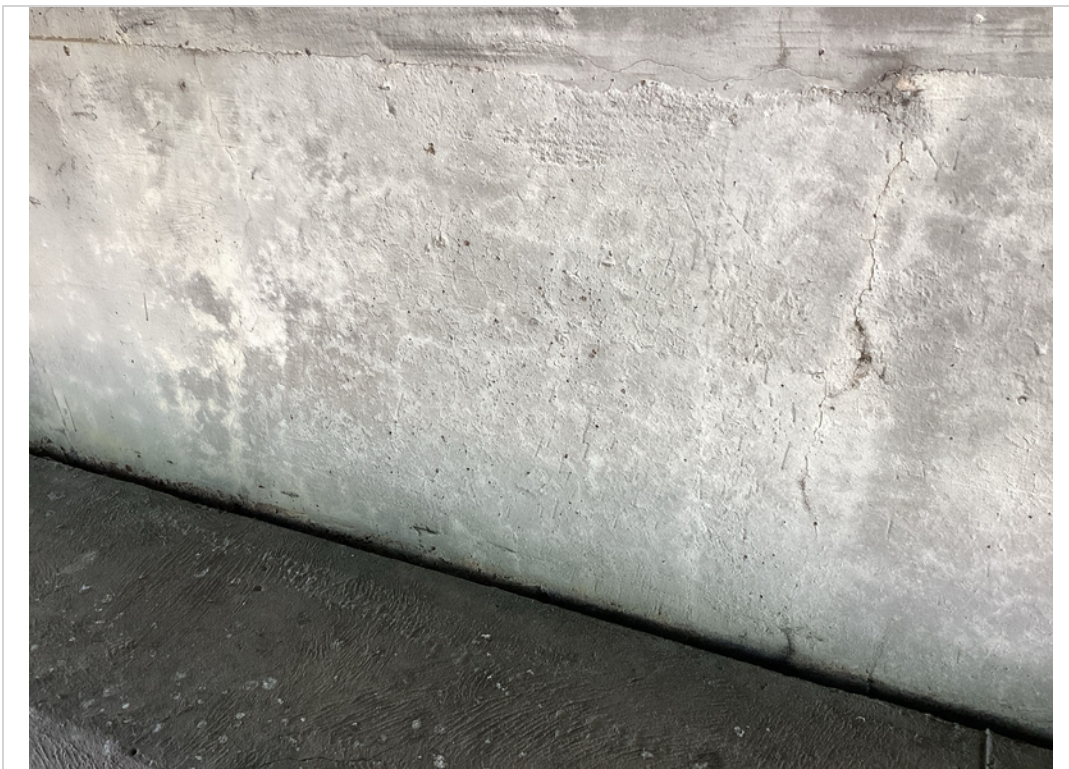
Abutment 1 random hc's w/ eff

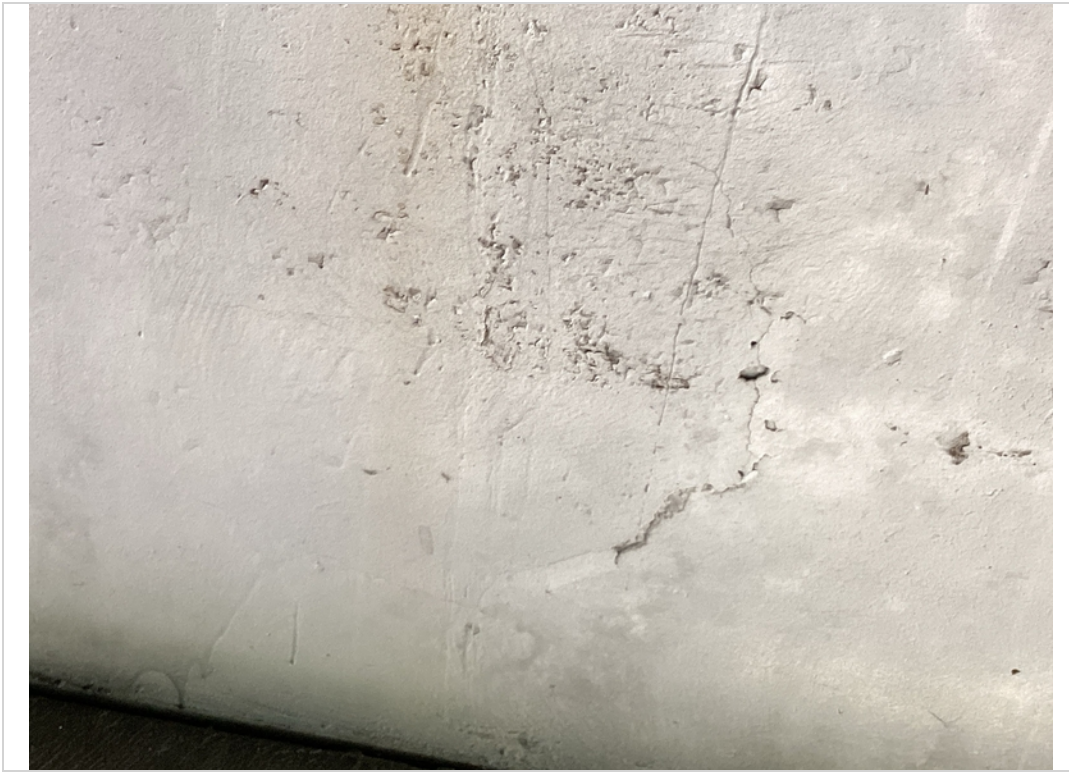
Abutment Caps	(Good)	Some minor cracks Isolated minor delamination Isolated minor area of honeycomb
Abutment Breastwall	(NA)	
Abutment Wings	(Good)	
Abutment Backwall	(Good)	
Abutment Plumb	(Good)	
Abutment Piles	(Not Visible)	
Abutment Embankment	(Good)	
Abutment Bearing Surface	(Good)	
Abutment Slope Paving	(Good)

Abutment 1 cap area of Delam under beam F

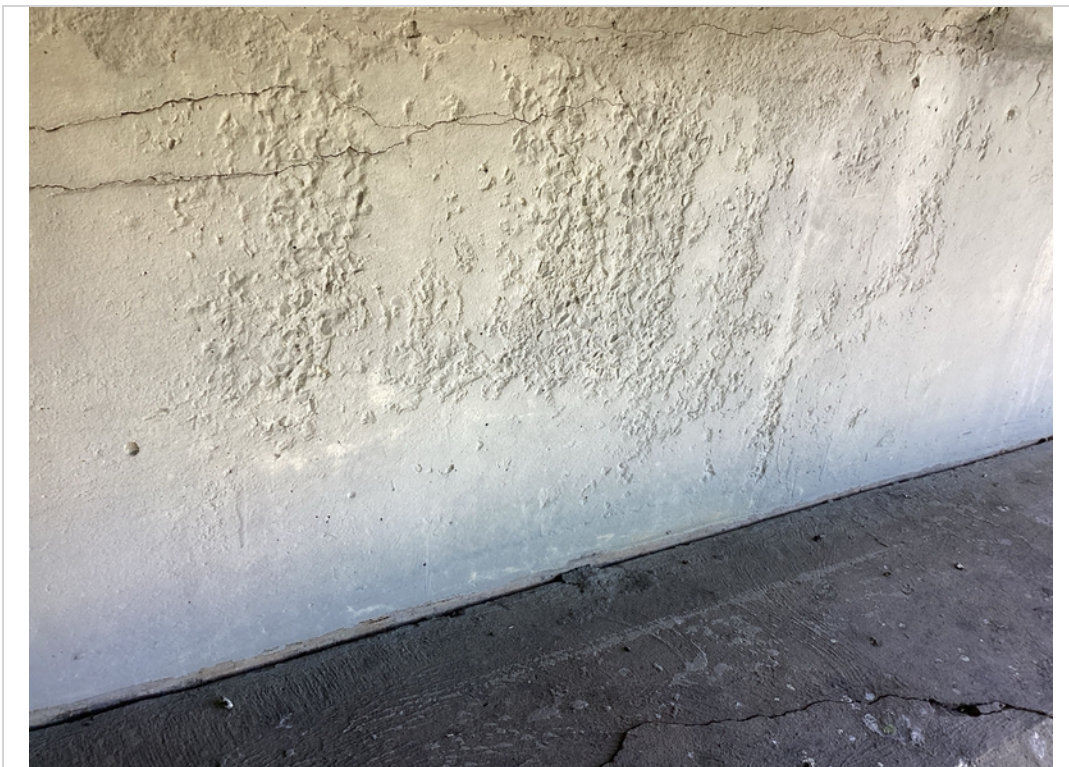
Abutment 1 Lt honey combing

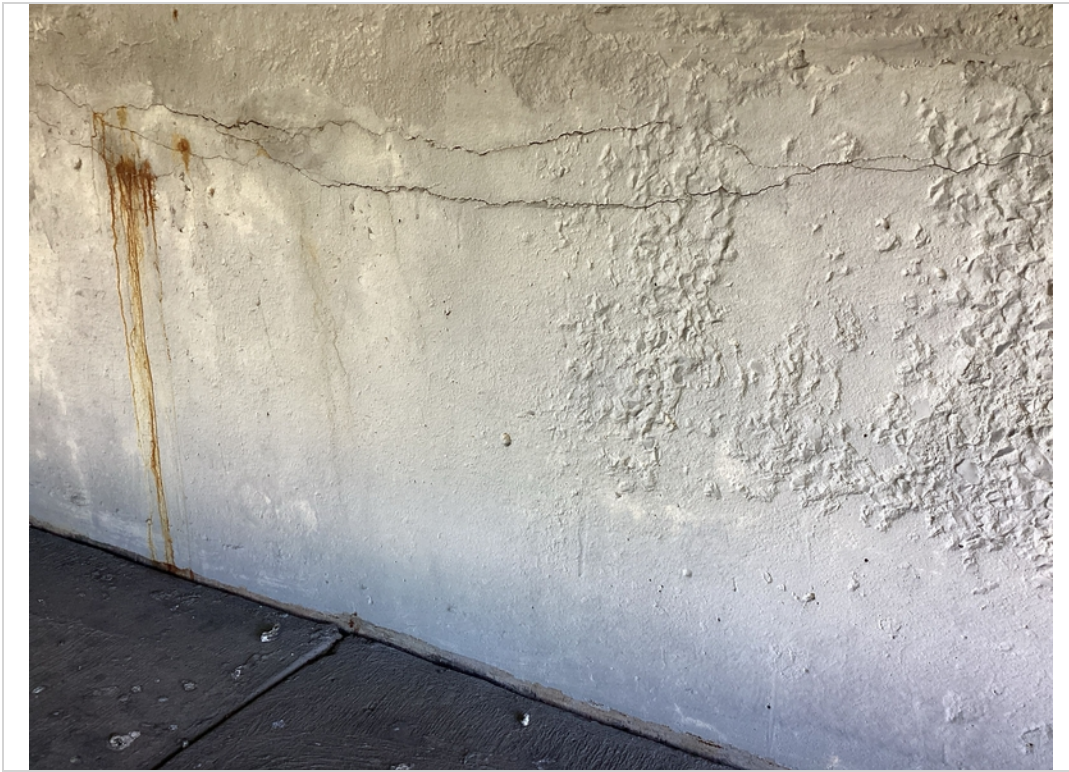
Abutment 1 LT horizontal cracks w/ rust staining

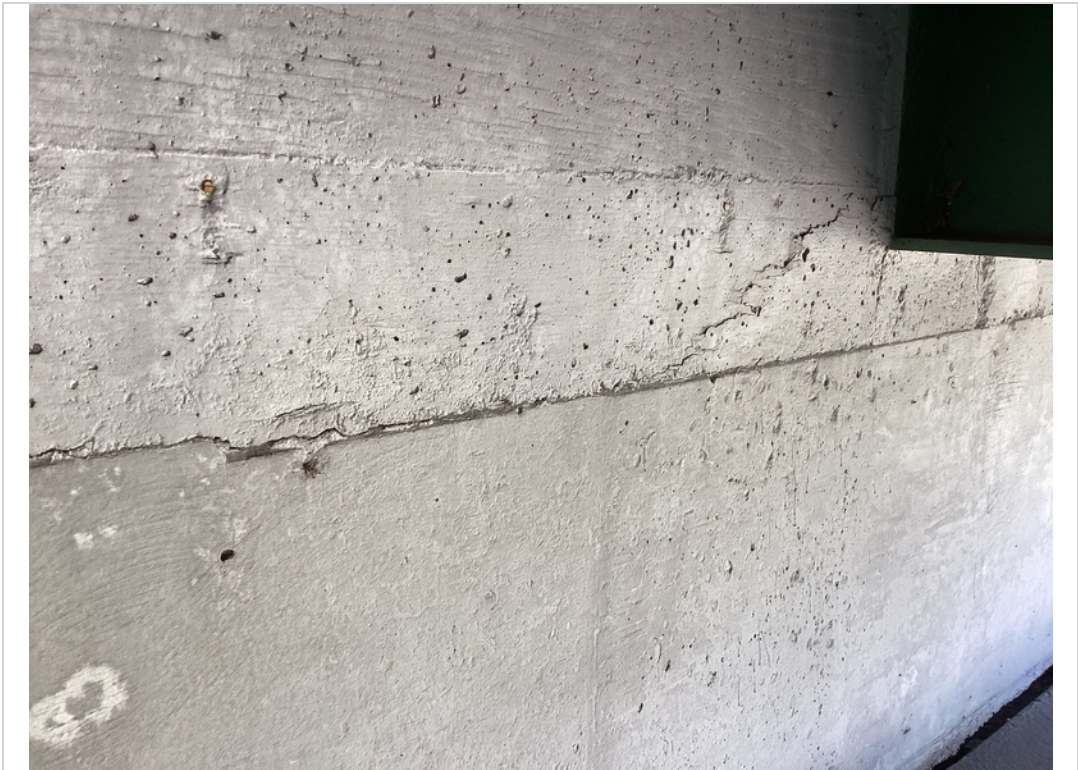
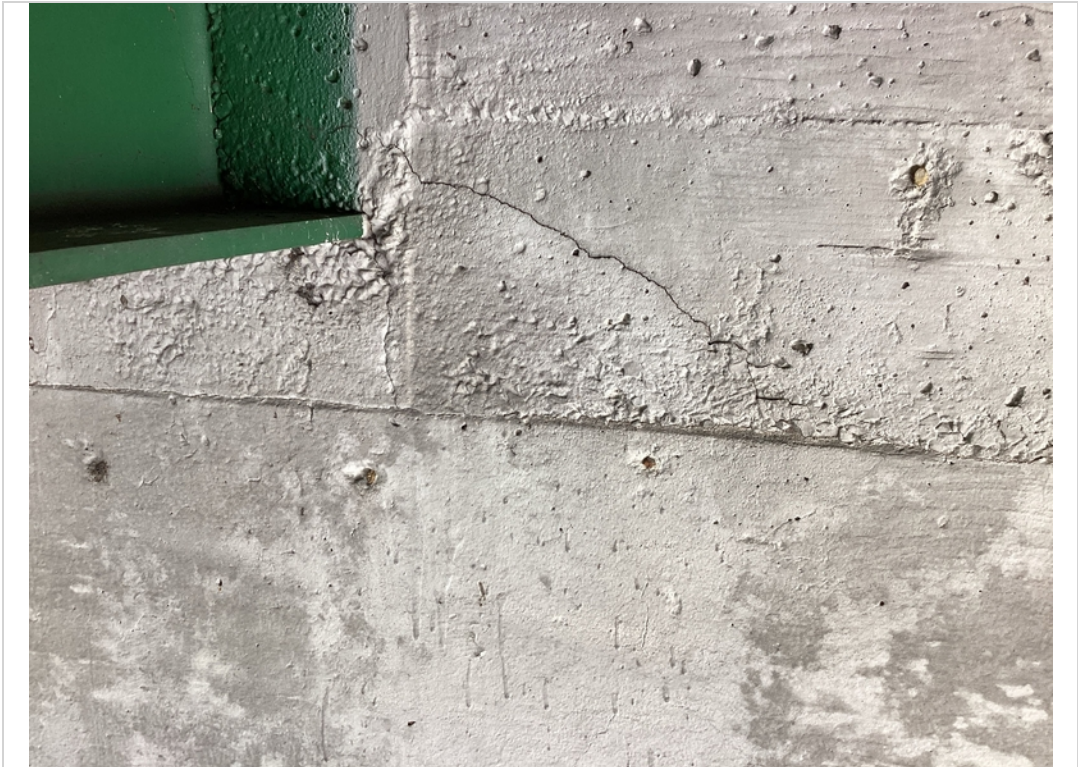
Abutment 2 backwall bay 17 Hc

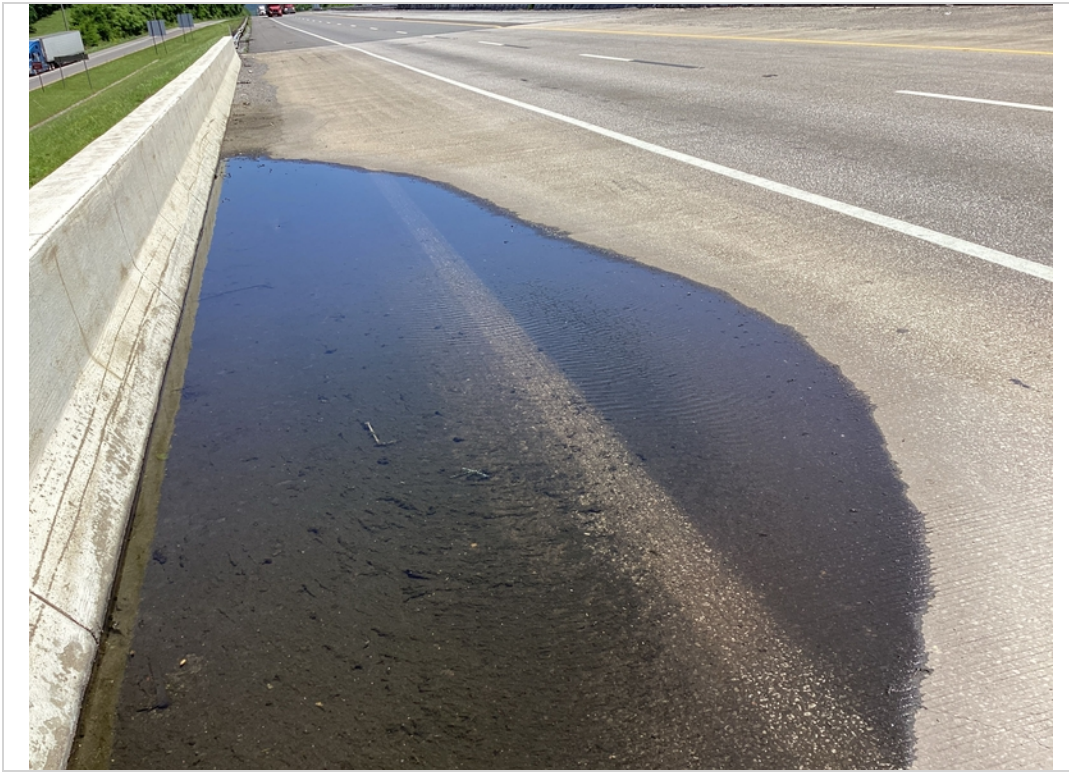
L A approach left side pooling water on deck

Date Added	Recommendation	Priority
05/22/2025	Water ponding in span 1 at both sides

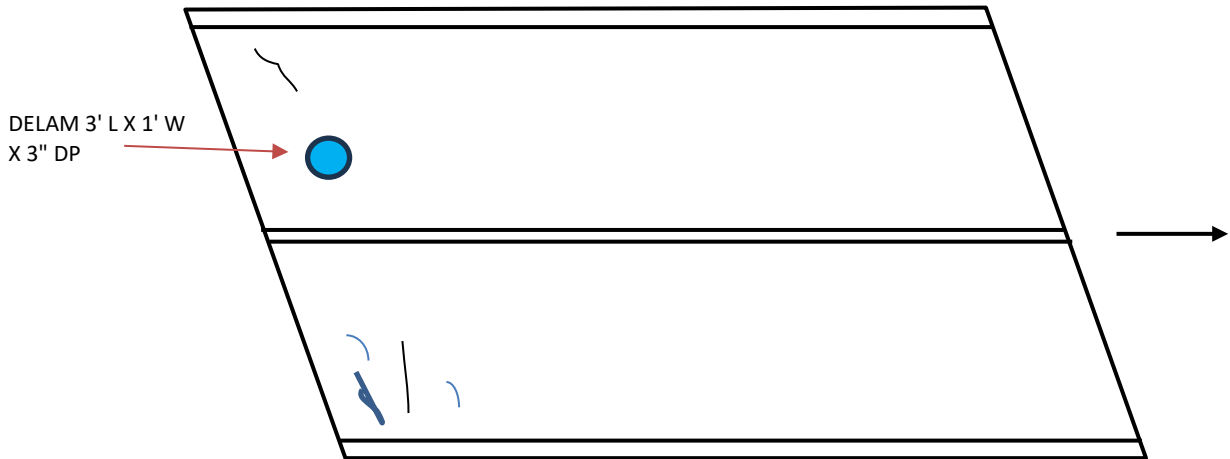
Top of Deck Span No. 1

DECK	GOOD	SOME MINOR CRACKS
		DELAM
MEDIAN	GOOD	SOME MINOR CRACKS
JOINTS	GOOD	
DRAINS	GOOD	
RAIL	GOOD	SOME MINOR CRACKS

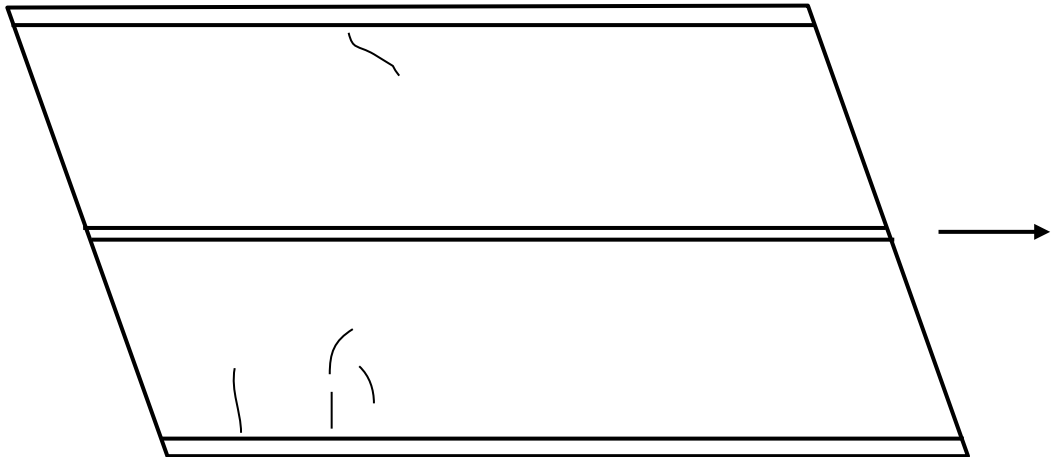
Top of Deck Span No. 2

DECK	GOOD	SOME MINOR CRACKS
MEDIAN	GOOD	SOME MINOR CRACKS
JOINTS	GOOD	
DRAINS	GOOD	
RAIL	GOOD	SOME MINOR CRACKS
