I-40 Crossing I40 / SR 53

Inspection Date(s): 05/22/2025 - 05/22/2025

IDENTIFICATION	
(1) State Names	47 - Tennessee
(8) Structure Number	80I00400015
(5) Inventory Route	1
(2) Highway Agency District	Region 3
(3) County Code	80 - Smith

Inspection Team's Summary

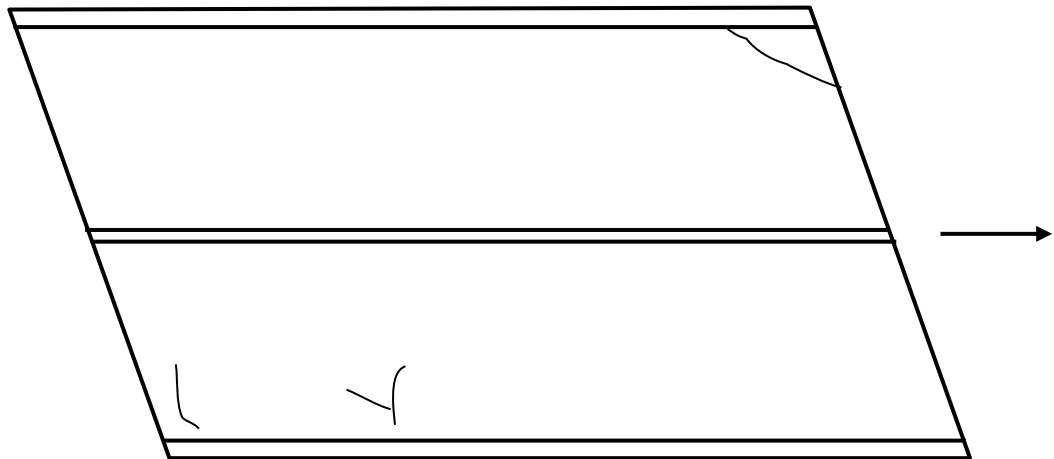
Top of Deck Span No. 3

DECK	GOOD	SOME MINOR CRACKS
MEDIAN	GOOD	SOME MINOR CRACKS
JOINTS	GOOD	
DRAINS	GOOD	
RAIL	GOOD	SOME MINOR CRACKS

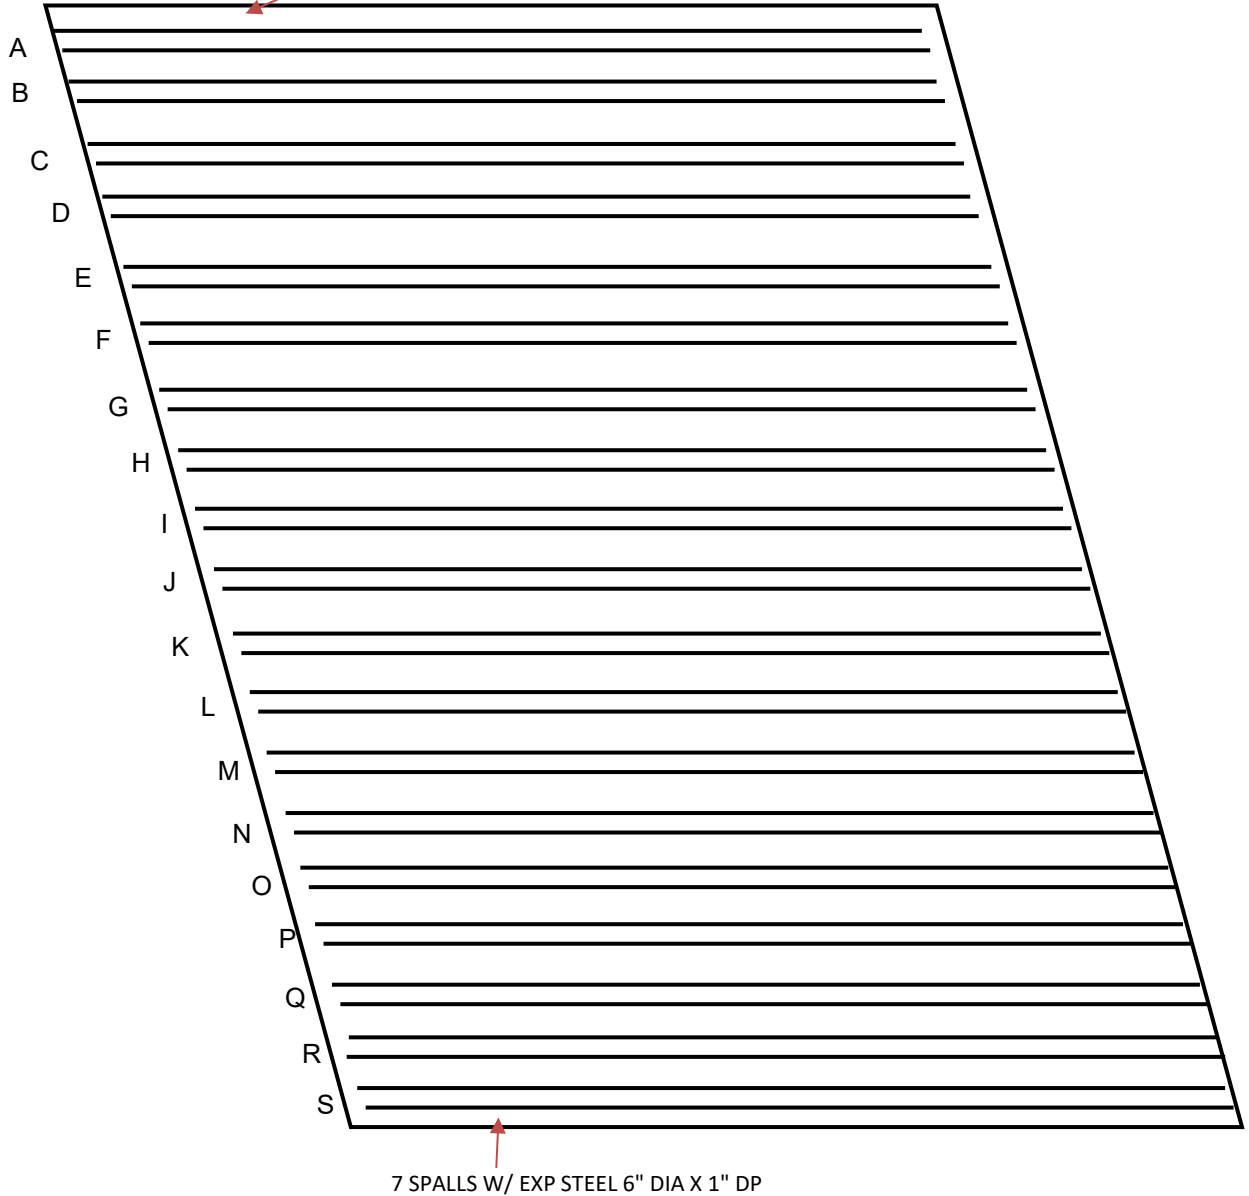
Bottom of Slab Span No. 1

14 SPALLS W/ EXP STEEL 6" DIA X 1" DP

DECK	N/V	CORUGATED METAL FORMS, SPALLS W/ EXP STEEL
		SOME MINOR CRACKS WITH EFF IN OVERHANGS
DIAPHRAGMS	GOOD	
BEAMS	GOOD

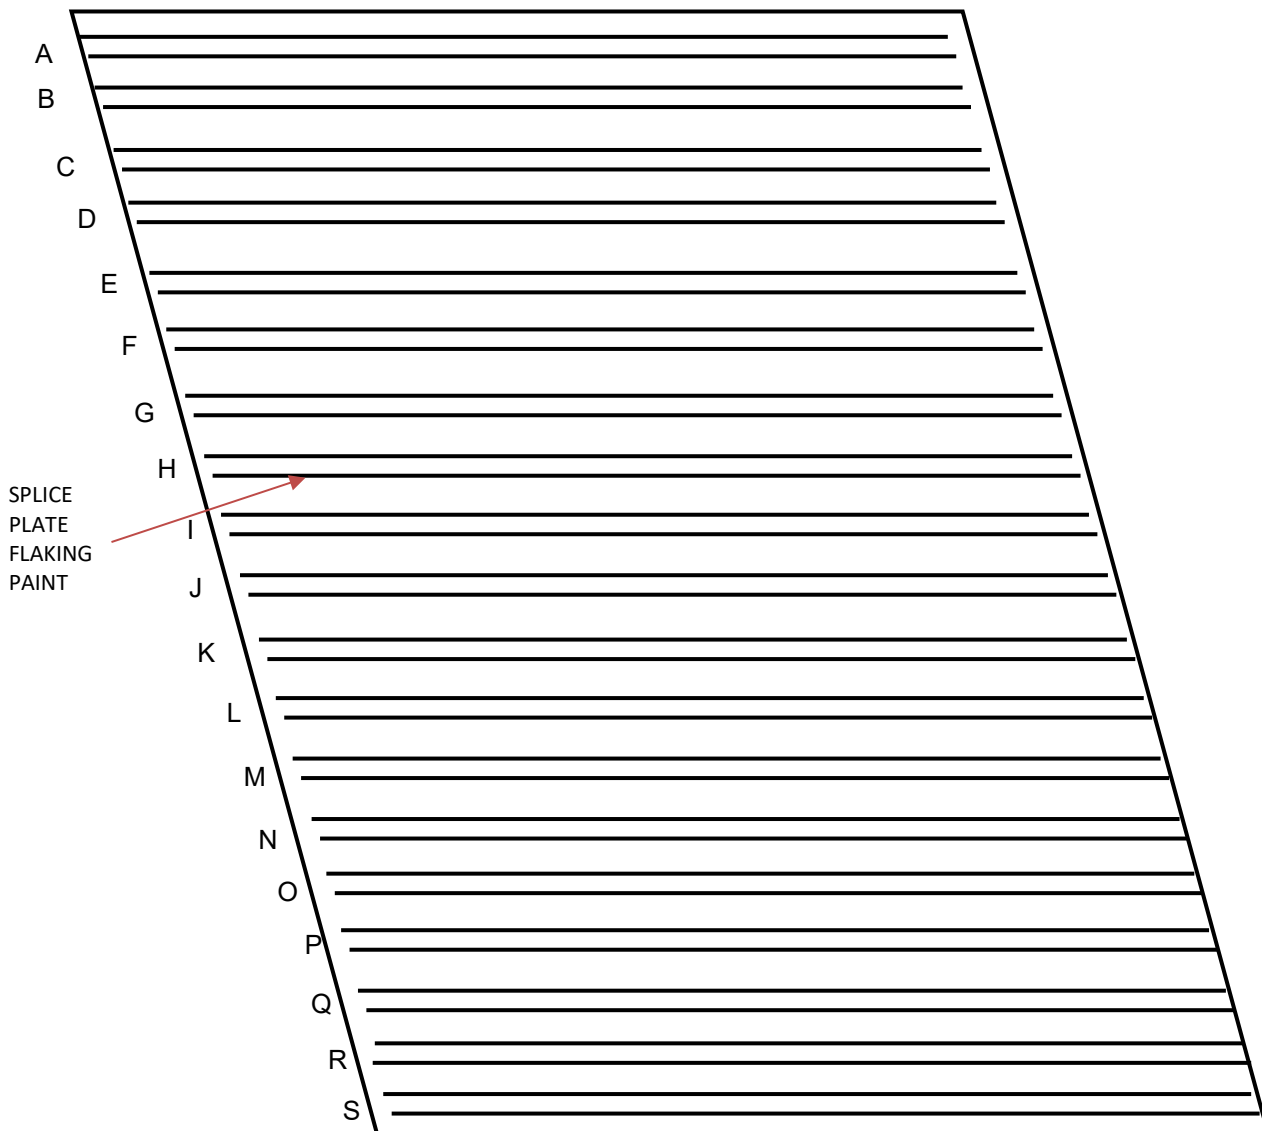
Bottom of Slab Span No. 2

DECK	N/V	CORUGATED METAL FORMS, OVERHANGS ARE GOOD
		SOME MINOR CRACKS WITH EFF IN OVERHANGS
DIAPHRAGMS	GOOD	
BEAMS	GOOD	BEAM H PAINT FLAKING NEAR BENT 1 AT SPLICE PLATE

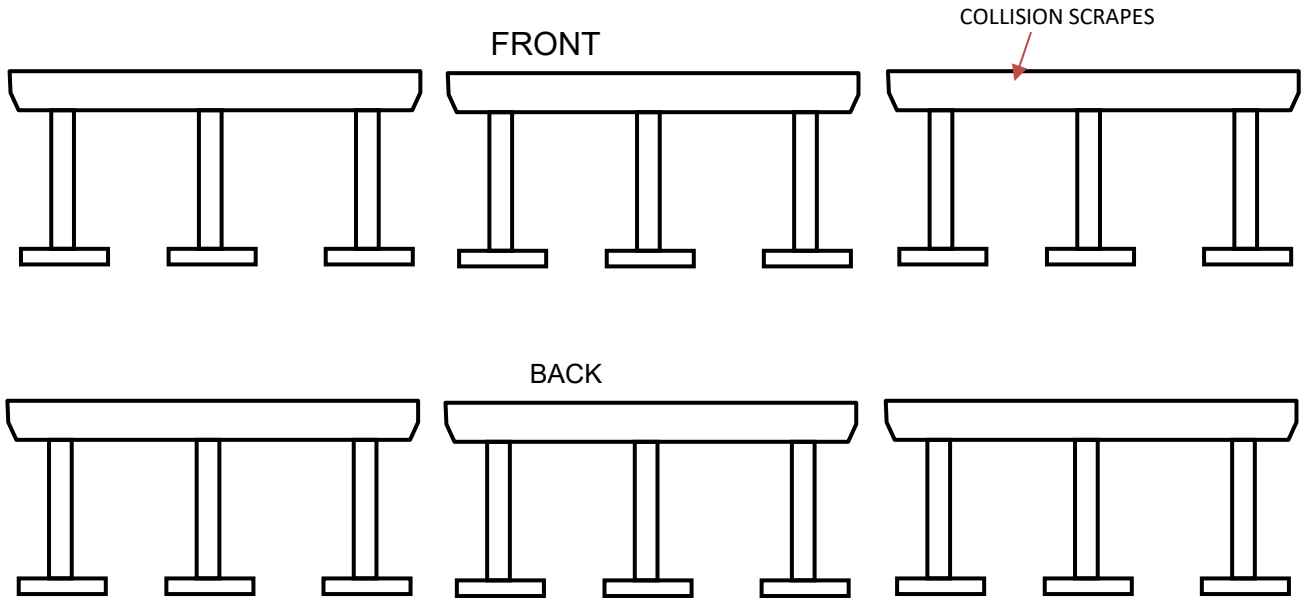
BENT # 2

CAP	GOOD	ISO MINOR COLLISION SCRAPES
COLUMNS	GOOD	
FOOTING	N/V	
BEARINGS	GOOD
