#3: Struck By – Inspection #317585800

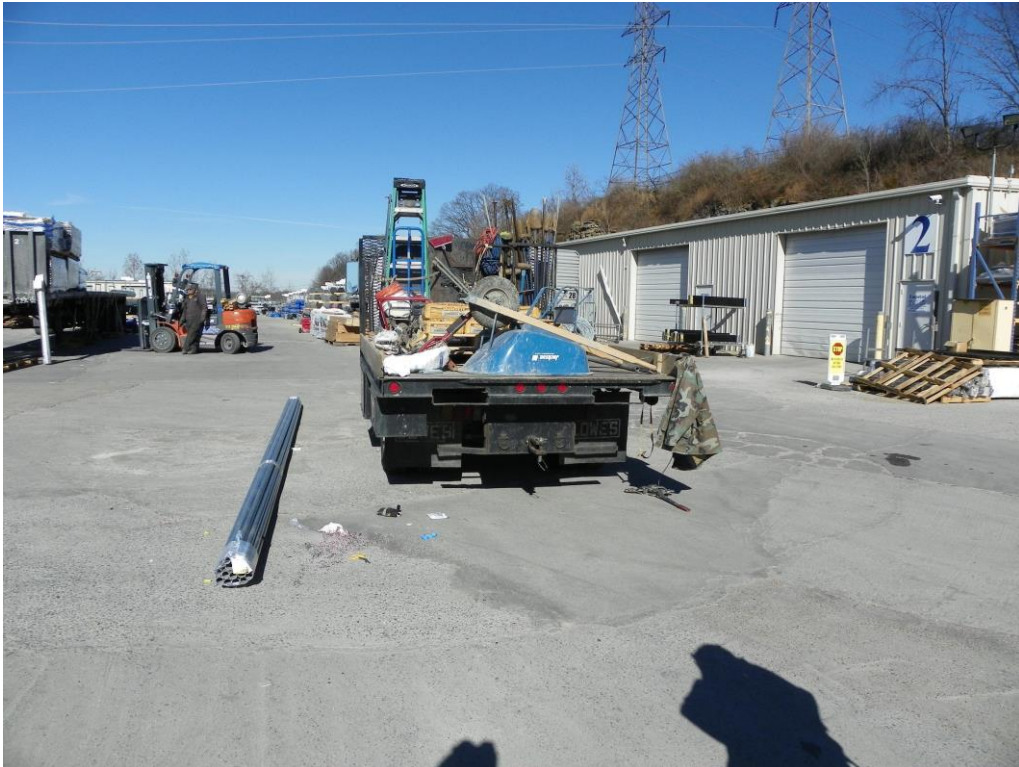
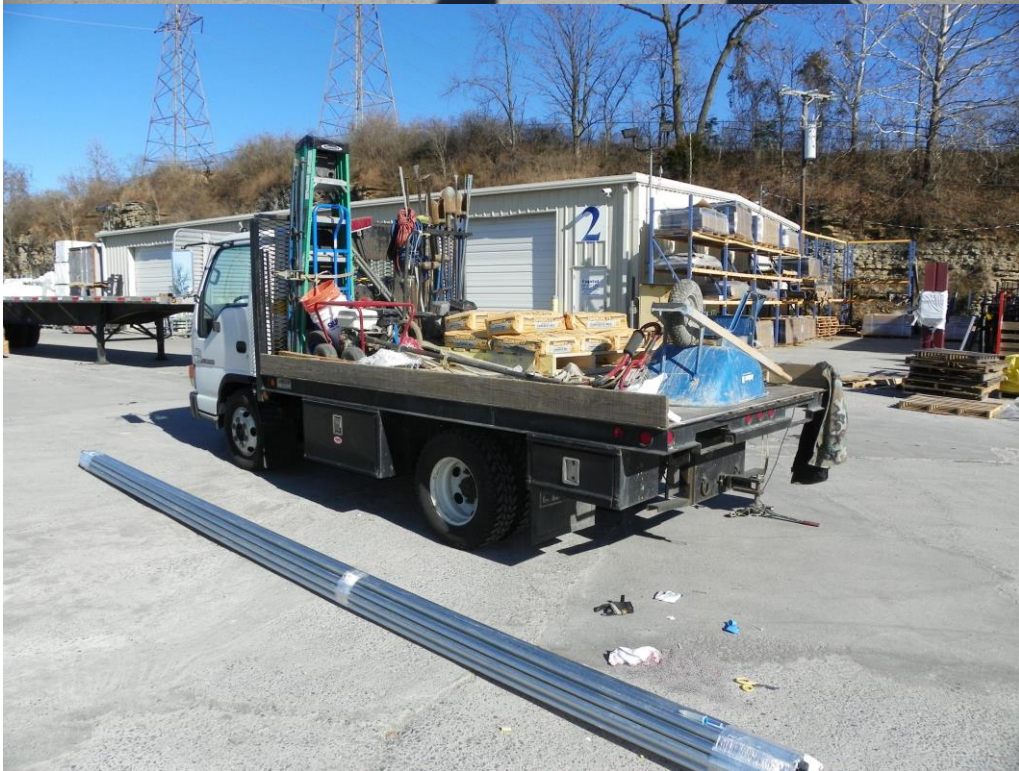
A **36 year old male** employee was struck by a shifting load of bundled top-rails for wire fences. A fencing company had purchased material for a fence installation from a wholesaler. The victim was standing next to the company work truck as the wholesaler employee was loading the fencing supplies onto a company work truck at the wholesaler’s work site. The wholesaler employee was using a forklift to place a bundle of sixteen 20 foot long 1 5/8 inch pipe used for top-rails on wire fences. The bundle weighted approximately 500 pounds. As directed by the company employees, the wholesaler employee placed the bundle of pipe at a 20 degree angle in the 14 foot long company truck bed. The victim was strapping the bundle at the tail section while his co-worker was hooking up a come-along to slide the bundle in to a safe position for transport. The Wholesaler employee took the forklift around to the rear of the truck and had one of the forks supporting the bundle to prevent sliding. The bundle slid off the truck and struck the victim in the head. The fence company had another work truck that was equipped with front and rear pipe racks that allowed the long pipe to be transported in a horizontal position and also had vertical members that would have prevented the pipe from sliding off to either side of the truck.

The victim was struck in the head by shifting fence rails while loading the work truck

Item 1 T.C.A. 50-3-105(1)	The employer did not furnish employment and a place of employment which were free from recognized hazards that were causing or likely to cause death or serious physical harm to employees in that employees were exposed to a struck-by hazard due to failure to prohibit employees from working close to loadings being handled on forklifts, which could shift and fall onto employees.
---------------------------	--
