#10: Equipment Roll Over – Inspection #317752905

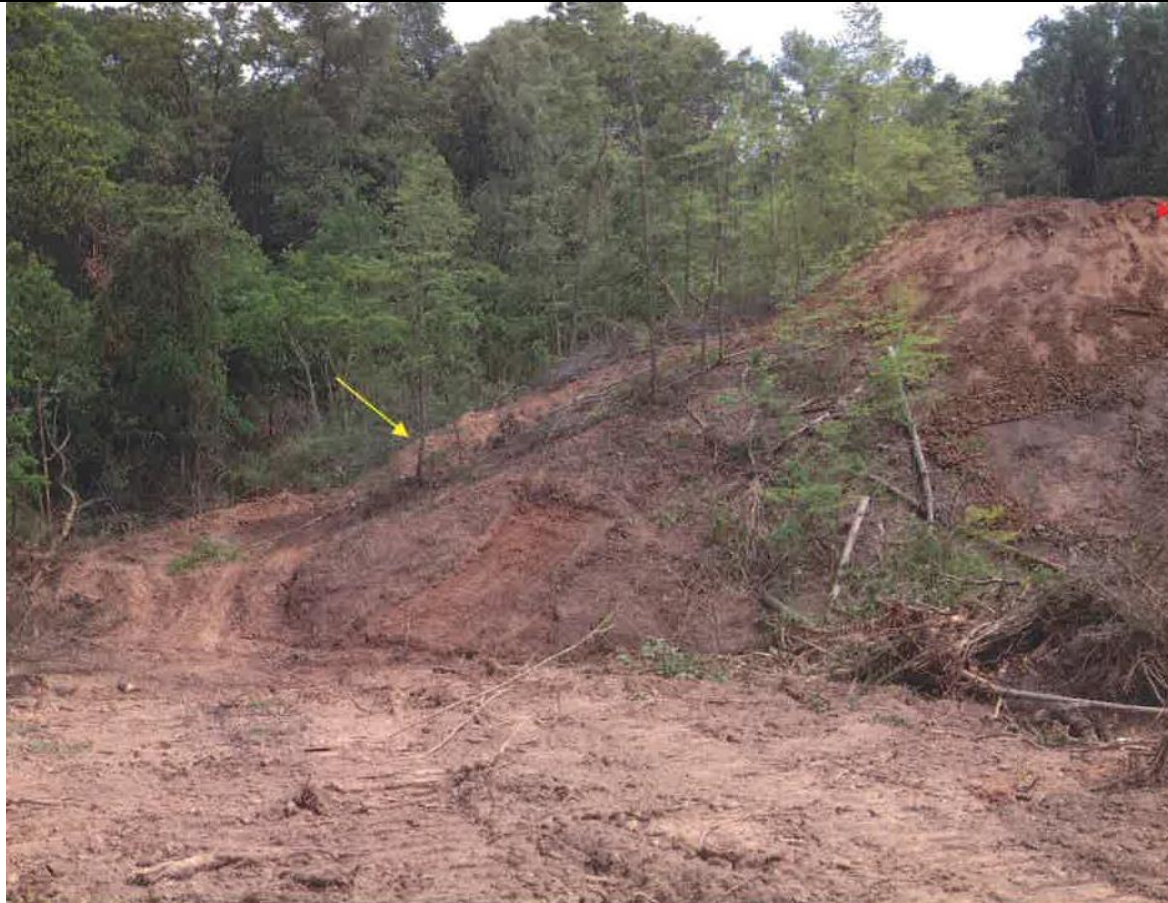
A **49 year old male** employee was injured when the dump truck he was operating rolled over. The victim had been operating a Volvo articulated hauler (dump truck) on the day of the incident. The victim backed up a steep embankment, 12-20 degrees, to dump a load of dirt and the truck rolled down the embankment approximately 100 feet. An employee operating a hauler nearby noticed the victim and hauler was gone. The employee looked down the embankment and saw the dump truck with the cab upright and the dump bed turned over. He ran down to the truck and saw the victim was slumped between the back of the seat and the door with his back facing the windshield. He stated that the victim was not wearing his seatbelt and he observed that the victim was bleeding from the right side of his head and was unresponsive. During interviews, employees stated that the truck bed was not raised and the cylinders were not extended on the bed. The victim was life flighted and passed away the next day. Upon arriving on the site, the CSHO climbed up in the cab and tested the seatbelt and found it to be operable. Management demonstrated that the brakes and parking brake were working. The victim was hired 3 days prior to this event. Management stated that the day of the incident was the first day for the victim to operate the dump truck on the steep terrain and during his hands on training he only operated the dump truck on the flat side of the jobsite. During interviews, operators stated the use of the seat belt was required. Other haulers on site were inspected for defective seat belts, side mirrors, brakes, and damaged steps.

Photo 1 of 1 – The embankment the dump truck rolled down.
