#14: Fall – Inspection #317797496

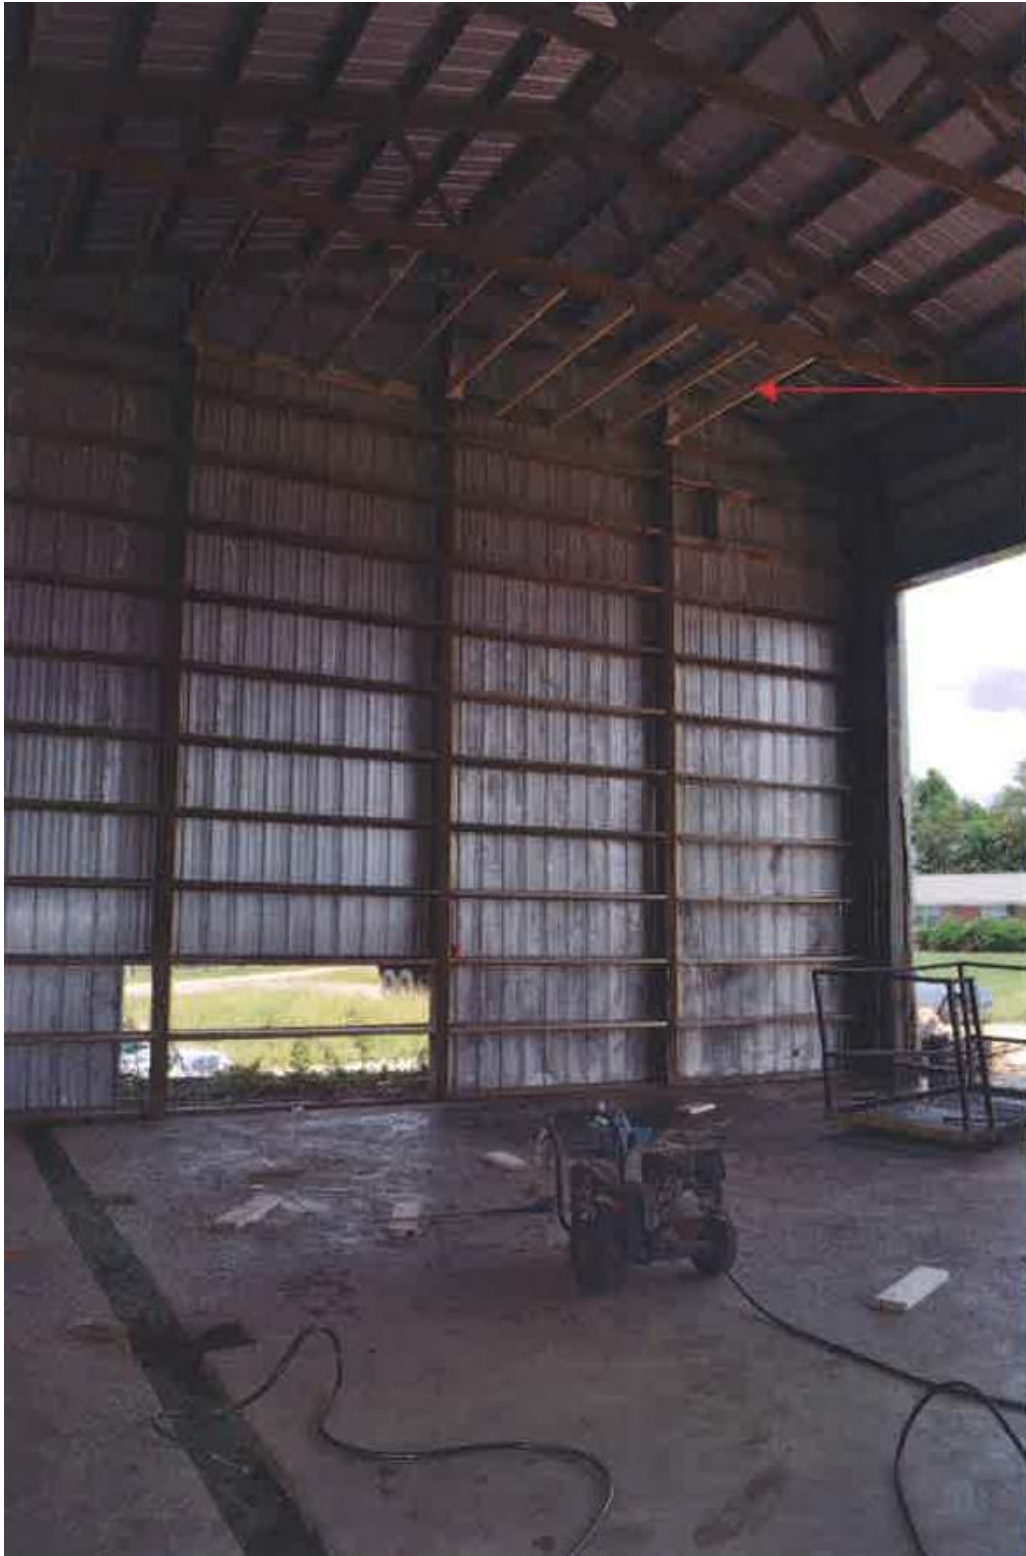
Photo 1 of 3: Ceiling to be erected by the contractor.

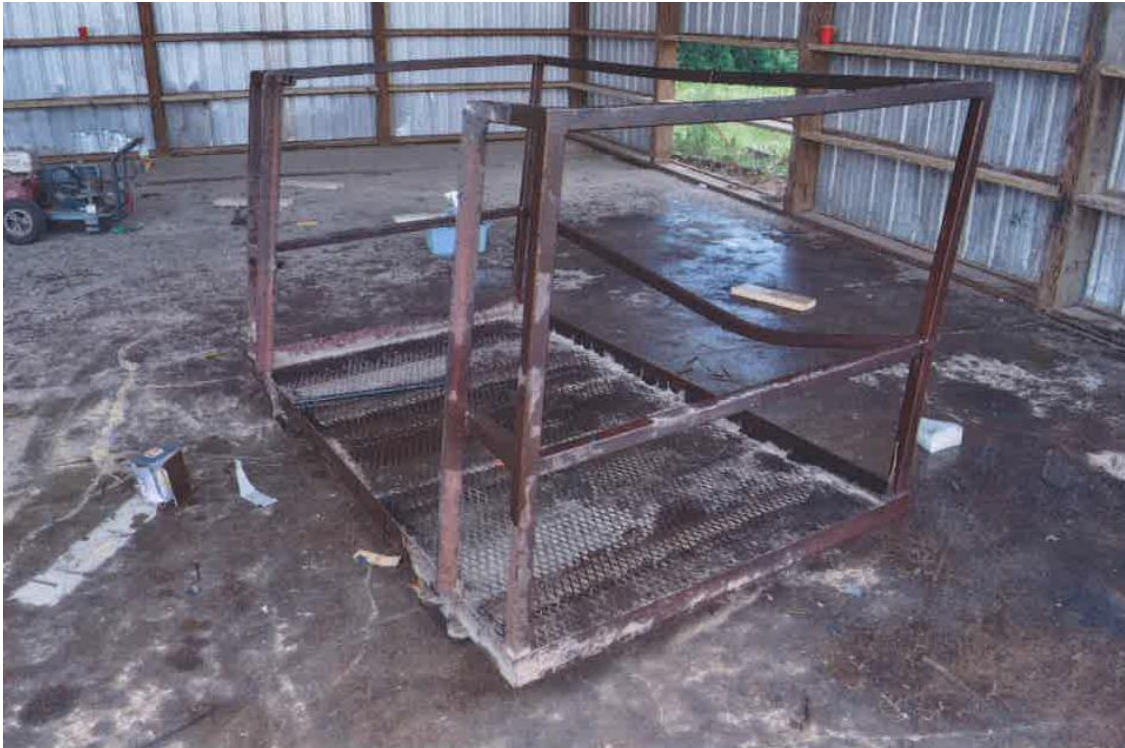
A **59 year old male** sole owner and employee (son) were working from a personnel platform, elevated approximately 16 to 18 feet by a Skytrak lift, when the forks failed and the platform, with the owner and employee in it, fell off the forks to the concrete floor below. The company was contracted to install a ceiling in a building on the client’s business site. The Skytrak was being operated by the part-time employee (grandson) of the contractor, who had only recently been trained on operation of the lift. The platform being used belonged to the client and the Skytrak lift belonged to the contractor. The platform measured 4 feet wide and 7 feet long and was not secured to the lift during this incident. During the TOSHA inspection it was observed that the threaded hydraulic line fitting on the right side fork tilt cylinder was broken. Hydraulic fluid was reported to be present on the lift and ground following the accident. The CSHO observed a warning label to the left of the steering wheel that read “this machine is designed to handle material only; lifting or lowering personnel could result in injury or be hazardous to life”. The CSHO inquired of the dealer, if the threaded hydraulic fitting would fail solely due to pressure or would it have to strike something to break off. The dealer stated that the fitting could have been struck at some other point and then the pressure of lifting the load could have caused the fitting to fail. An employee of the client moved the Skytrak away from the building after the accident and stated that the parking brake was engaged when he got on the lift and the service brakes were working. The construction company is no longer in existence due to the death of the sole owner and citations with penalties were not issued.

Item 1 1926.451(c)(2)(iv)	In that the Skytrak, Model# 6034-4, at the jobsite was used to elevate the employee in a personnel platform when the lift was not designed by the manufacturer to be used as a manlift, exposing the employee to a fall of approximately 16-18 foot. .
Item 1 1910.451(c)(2)(v)	Forklifts shall not be used to support scaffold platforms unless the entire platform is attached to the fork in that the personnel platform, for which the employee was working, was not secured to the Skytrak lift when used at the jobsite to elevate the employee, exposing the employee to a fall of approximately 16-18 foot.

Photo 2 of 3: Personnel platform used during incident.

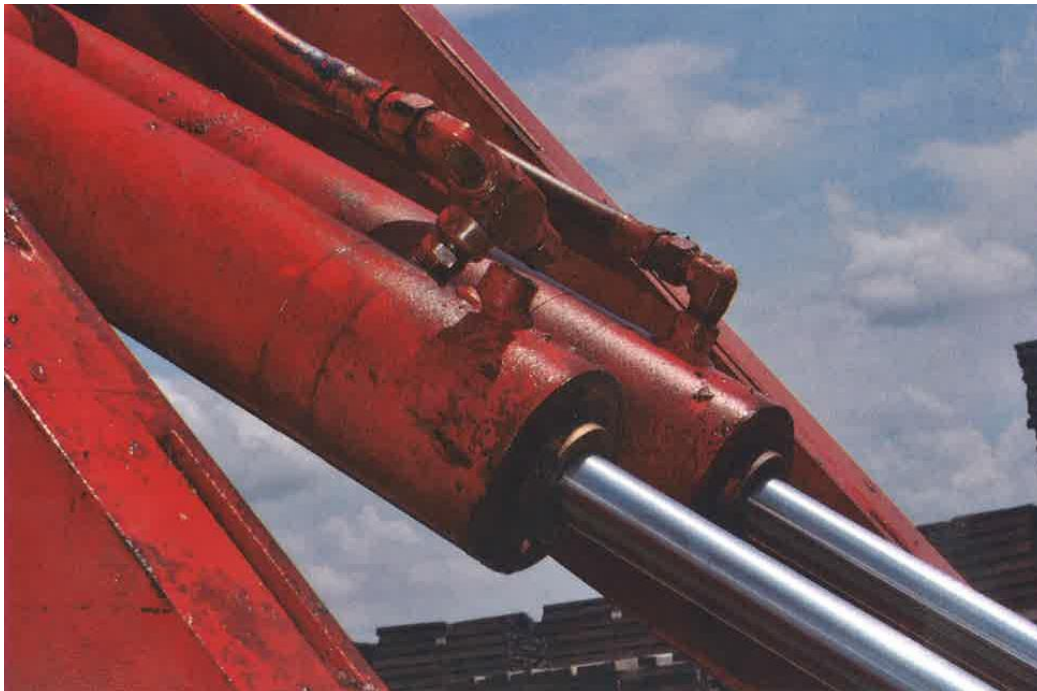
Photo 3 of 3: Broken threaded hydraulic fitting on the right side fork tilt cylinder.
