## **11 Crushed between scissor lift & mezzanine support beam – Inspection #1159893**

A **27 year old male** employee was fatally injured when he was crushed between the railing of a scissor lift and a mezzanine outer support beam while installing insulation on duct work. On the day of the incident, the victim was working alone installing insulation around duct work using a Dyna-Mite Work Platform scissor lift. The duct work could only be accessed through a small opening approximately eighteen inches high by thirty one inches wide under the mezzanine deck between the vertical beams, an electrical junction box, and piping. In efforts to reach the area, the victim positioned himself leaning backwards out of the scissor lift with his back resting across the lift upper guard rails. At some point while installing the insulation the victim became pinned between the scissor lift upper guard rail and the bottom of the mezzanine outer support beam. During the investigation, it was determined that the control console on the scissor lift was missing the guard that prevents the inadvertent activation of the lowering and rising of the work platform. The control console was found hanging on the

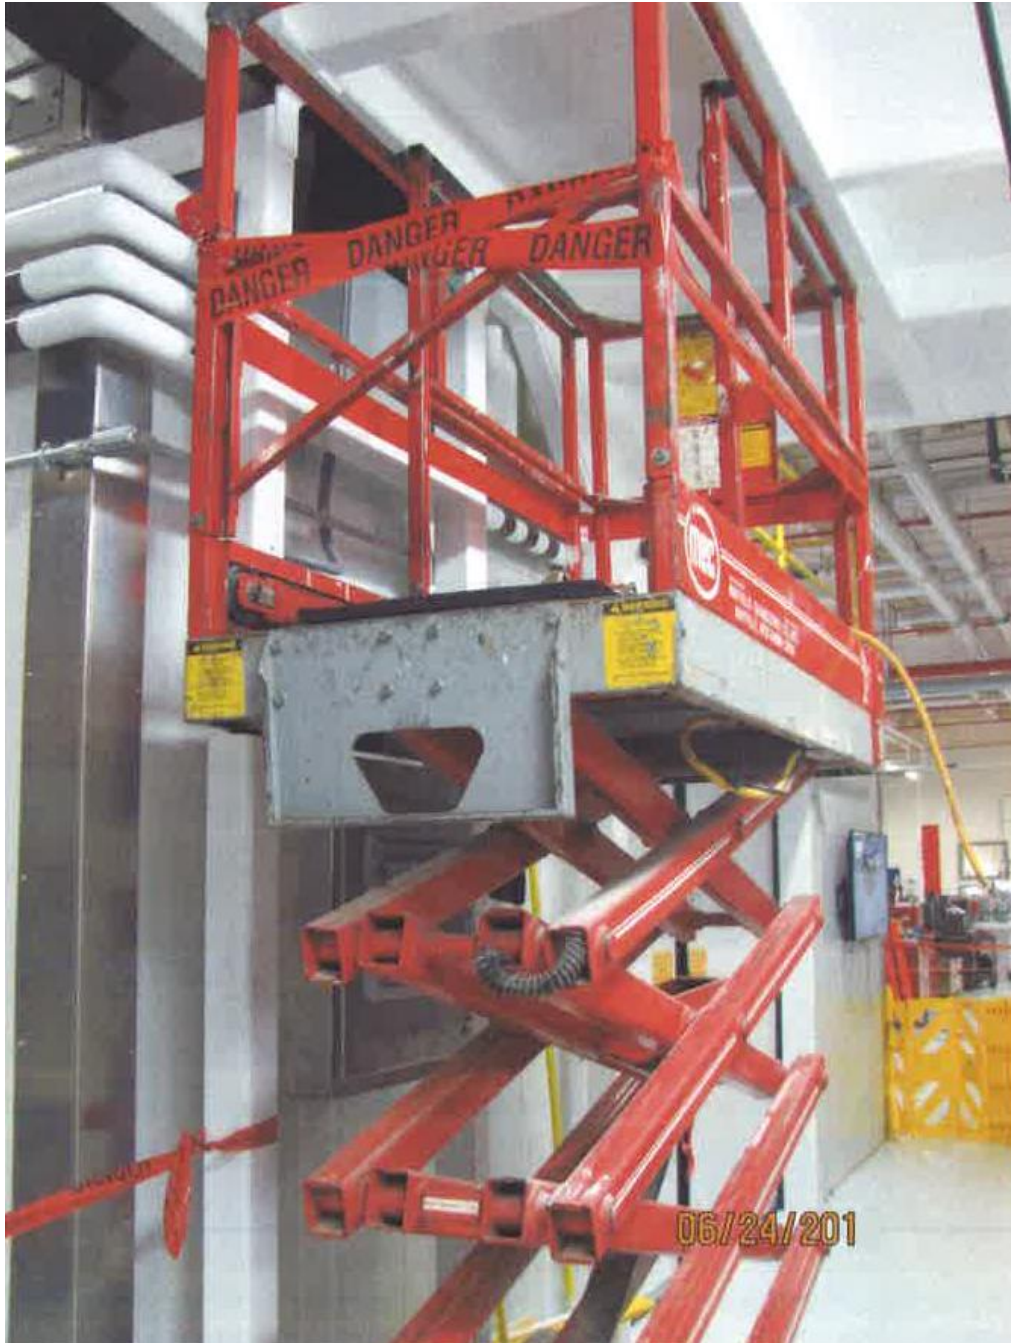
Photo 1 of 1 – Position of lift at the time of the incident.
