2 Struck by falling wood floor joist – Inspection #1121856

A **35 year old male** employee was fatally injured when he was struck in the head from a falling 12 foot long, 2x6 wood floor joist. The company was contracted to preform demolition and asbestos removal for a thirteen story building approximately one hundred years old. The victim was working as part of a demolition crew, on the 9th floor, removing a section of concrete floor on the southern side of the building to make room for a new staircase. On the day of the accident, several crews were working in the building. One crew was cutting the wood floor joists from the 13th floor, and lowering them to the 12th floor. Due to prior floor removal on the 12th floor a temporary plywood floor was built to cover the opening. The 12th floor crew was standing on the temporary platform to receive the joists from the 13th floor before cutting them into smaller pieces for placement in a chute. Another crew, including the victim, was operating a jackhammer and saw on the ninth floor to remove a section of the concrete flooring for the staircase. When the 12th floor crew was unavailable to continue receiving floor joists the 13th floor cr

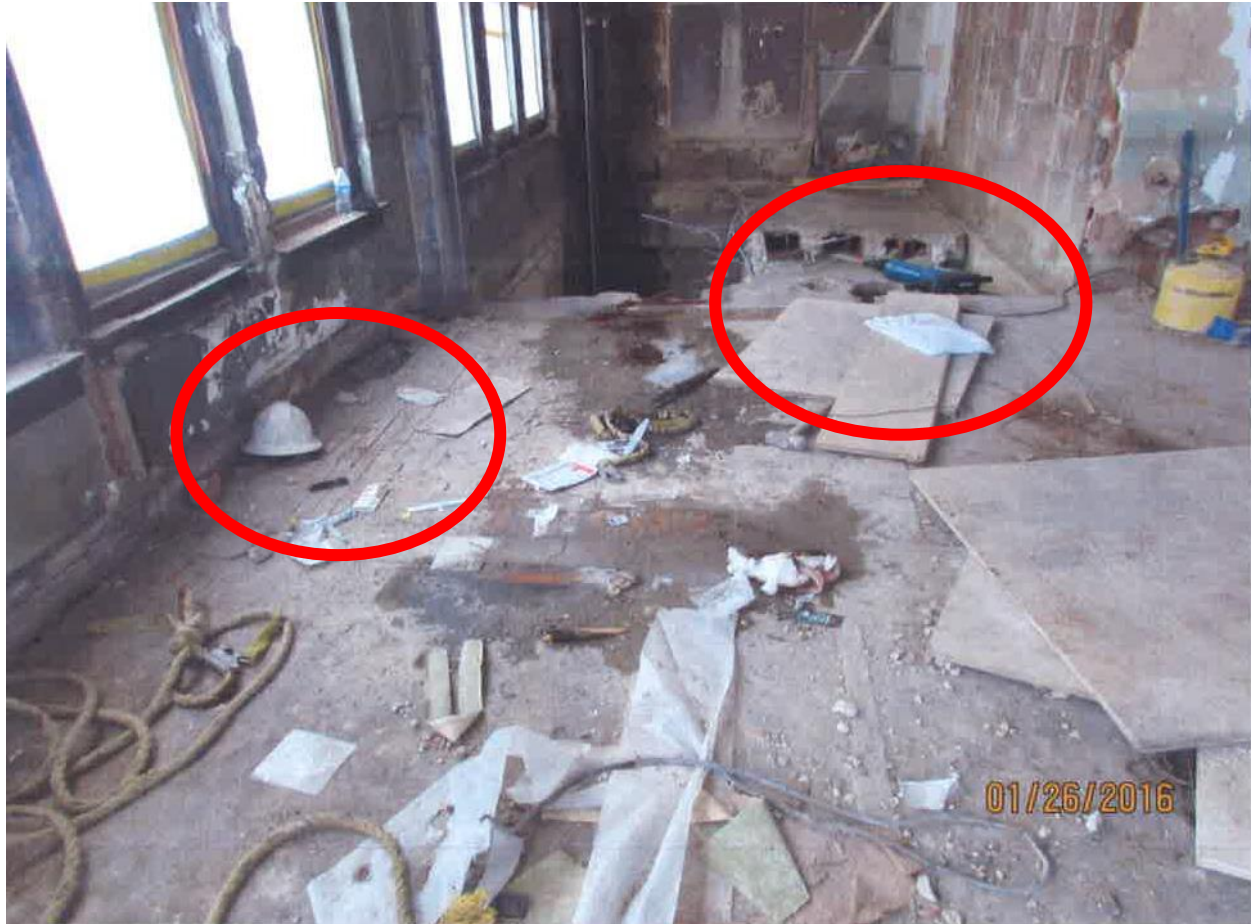
29 CFR 1926.100(a)	Employees working in areas where there was a possible danger of head injury from impact, or falling or flying objects, from electrical shock and burns, where not protected by protective helmets: In that the employee working on the 9 th floor was not wearing his hardhat at the time of the accident and was struck by a falling 2/6 floor joist.
--------------------	-------------------------------------------------------------------------------------------------------------------------------------------------------------------------------------------------------------------------------------------------------------------------------------------------------------------------------------------------------------------

Photo 1 of 1 – Photo shows the location of the jackhammer and hardhat
