30 Struck by block wall – Inspection #1192351

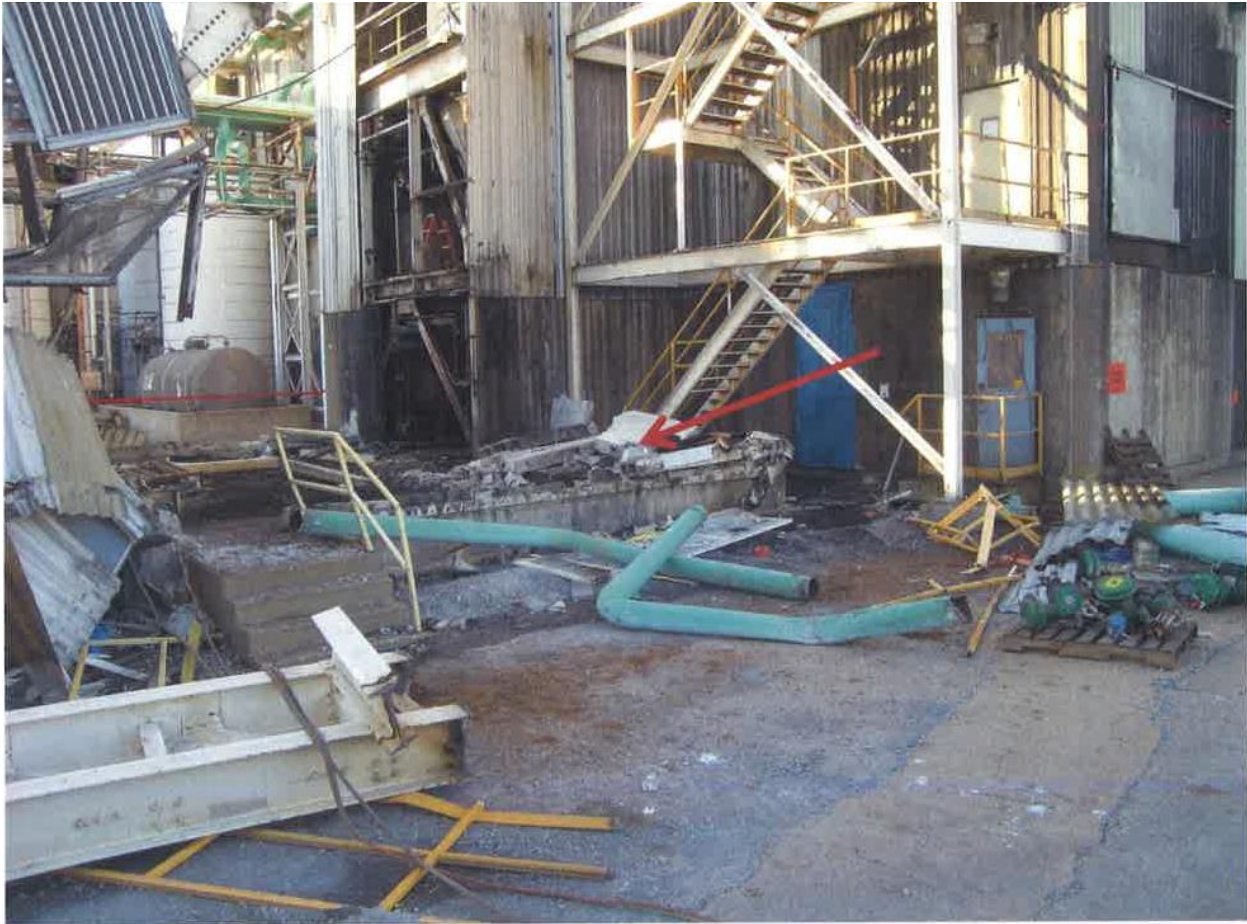
A **59 year old male** employee was fatally injured when he was struck by a falling cement masonry wall. On the day of the incident, the victim, a Superintendent/Equipment Operator, and three other employees, were working inside a Dextrose/Fructose Refinery building conducting demolition activities. The crew was cutting notches in a steel I-beam within the Carbon Column Area when it collapsed unexpectedly, along with a nine foot high cement masonry wall which struck the victim, and injured another employee as they were trying to escape the area. During the investigation it was determined, that the company had conducted an engineering survey and developed work procedures for the demolition. However, the employer did not effectively ensure implementation of the demolition plan. The actual work conducted was inconsistent regarding timing of the sequence of cuts. Employees performed cuts on structural steel columns, and diagonal cross braces of the Carbon Column Area structure in a sequence which differed from outlined procedures, causing the structure to become unstable and prematurely collapse, carrying the cement masonry wall along with it.

Photo 1 of 1: Southeast side of the Fructose Building after the Carbon Column Area collapsed. The cement masonry wall that struck the victim is designated by the red arrow.
