### 33 Struck by cargo loader – Inspection 1279827

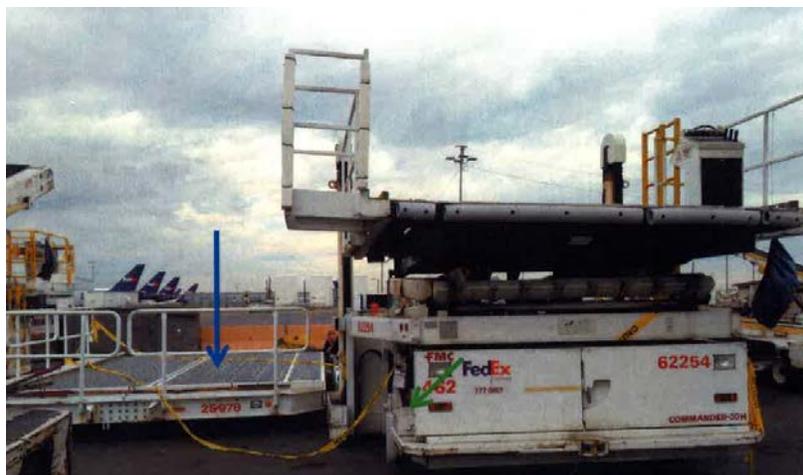
A **60 year old female** employee was fatally injured when she was struck by the auxiliary deck that was attached to a cargo loader. The victim was defined as the E-Stop Controller who along with a Guide Person and Loader Operator was responsible for moving the cargo loader with attached auxiliary deck into position for unloading cargo inside a Boeing 777 aircraft. The B777 aircraft is unique from other aircraft used by FedEx in that the main cargo door is located aft of the wing whereas all other aircraft cargo doors are in front of the wings. Due to the position of the cargo door the auxiliary deck is attached to right side of the loader so that the loader, cargo containers, and tugs maintain a safe distance from the aircraft's wing. This set-up along with the placement of the e-stop pendent box required the victim to be in front of the auxiliary deck. The e-stop controller is responsible for obtaining the e-stop pendent when the loader is approximately 50 feet from the aircraft. The e-stop controller is responsible for ensuring that the cargo loader does not make contact with the aircraft. The left-hand drive Commander 30H Cargo Loader is the only loader used on the B777 aircrafts. While operating this type of loader, the operator positioned at their controls cannot see the e-stop controller when they attempt to retrieve the e-stop pendent. As the loader operator moved the cargo loader slowly toward the aircraft, the guide person noticed the e-stop pendent dragging on the ground and noticed the victim had been run over by the wheels of the auxiliary deck.

Photo 1 of 1 – Photos shows a view of the Commander 30H Cargo Loader with auxiliary deck attached. The blue arrow is indicating the auxiliary deck that struck the victim. The e-stop pendent box is indicated by the green arrow. The operator controls are located in the upper right side of the photo.

TCA 50-3-105(1)	<p><b>The employer did not furnish employment and a place of employment which were free from recognized hazards that were causing or likely to cause death or serious physical harm to employees.</b></p> <p>In that employees were not protected from struck-by hazards while performing activities associated with unloading cargo from a Boeing 777 aircraft with Commander 30H Cargo Loader.</p>
-----------------	--
