2 Caught in ditch witch – Inspection #1290603

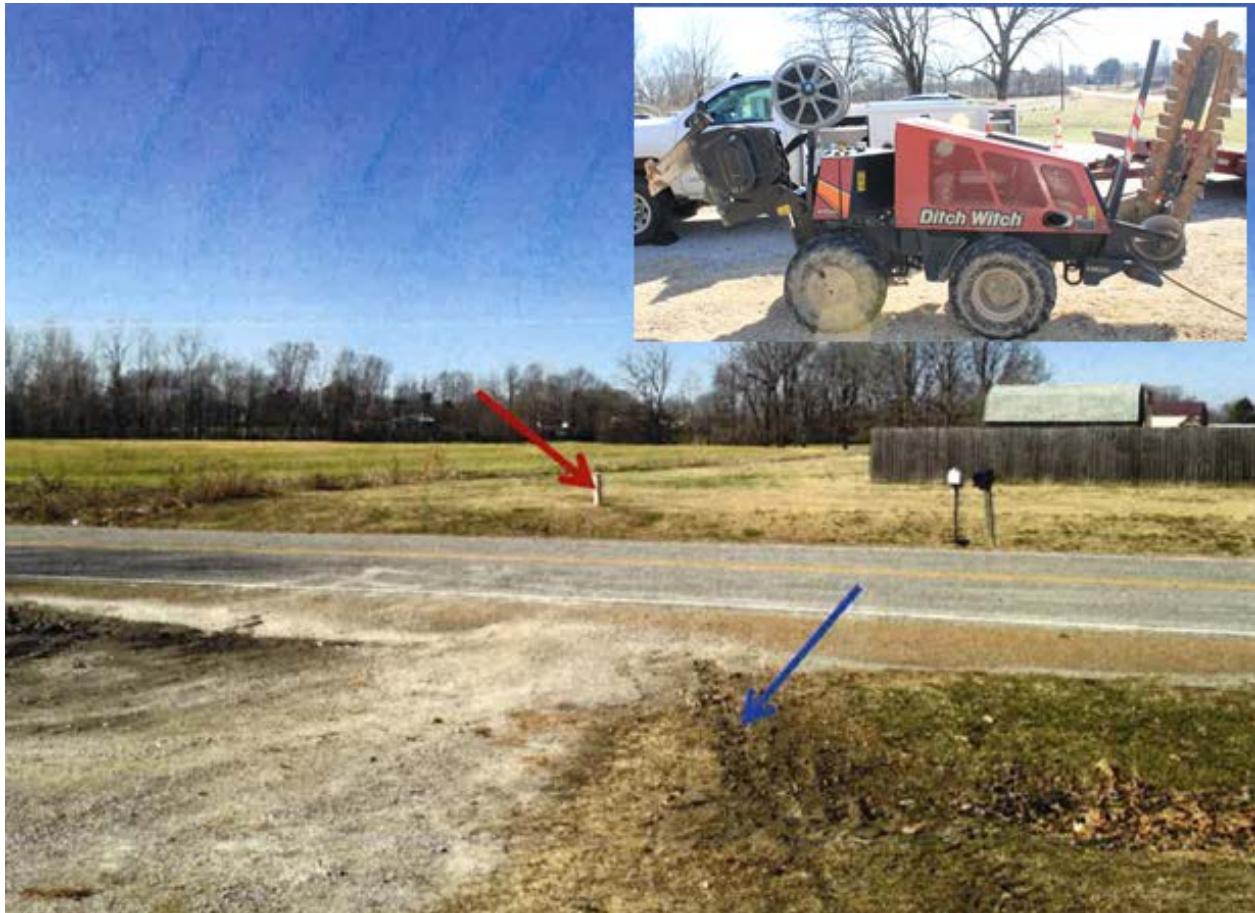
The employee was an experienced machine operator with 20 years of experience conducting bores. The investigation concluded that the victim did not call for help on a bore greater than 20 feet, did not dig an approach trench of adequate length, connected four drill rods prior to starting the bore, used pliers to override the safety feature of the ditch witch drill attachment controls, and approached the drill bit while the drill string was rotating.

Photo 1 of 1 – View of the pedestal across the road, indicated by red arrow, and the approach trench filled in with dirt, indicated by blue arrow. View of the ditch witch used to dig the trench.

1. Develop a tracking system to ensure policies and procedures are enforced and discipline employees if procedures and/or policies are violated.
2. Provide Installation Technicians with additional training and tools to make better site assessments so that two Machine Operators should be assigned before the crew leaves to go to a job site that, according to policy, would require a helper.
3. Develop and implement a program that provides employees with clear, consistent training on bore policy and procedures especially with regards to 1-man vs. 2-man bore operations.
