### **33 Electrocution---Inspection #1343126 David H Elliot Construction**

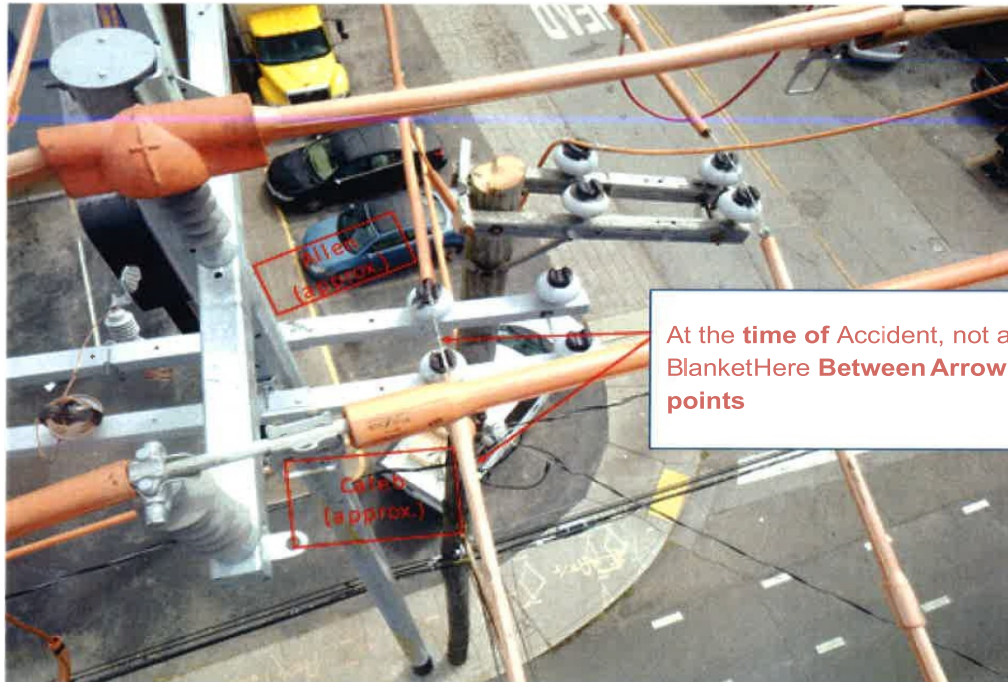
**Description:** This photo shows the insulator where point of contact was made. Not visible from the photo, but the aluminum wire was burned in two at the (blue arrow)
