Citation(s) as Originally Issued

23 struck by tug door—Inspection # 1518385 Fed Ex Express

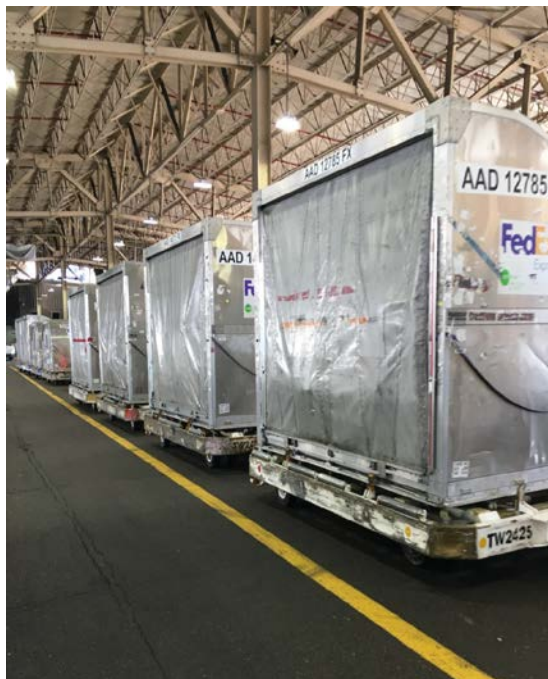
A 23 year old male employee was struck by an unsecured vinyl roll up door of a container as it was being transported by tug along the input line. Containers are offloaded from aircraft, placed onto a dolly, and transported via a motorized tug to the Courtyard Input Area.

It was revealed that once a dolly string at the front of the line is empty, the remaining dolly strings will move forward even if containers are not fully unloaded. Just prior to the incident, two dolly strings at the front of Line #2 were empty; therefore, moved off of the line in preparation to move the third dolly string forward. There was freight remaining in the containers of the third dolly string when the Line Call "Standby" was given. Container AAD 21050 FX, involved in the incident, was the fourth and last container in the third dolly string.

An employee was unloading this container when "Standby" was communicated; therefore, he put the vinyl roll-up door down; however, did not engage the door bar flap in order to secure the door in the closed position. Upon receiving the "Go" signal, the Tug Operator moved the dolly string forward. Prior to the tug operator moving the dolly string, eight (8) employees, including the Team Leader, began walking to the front of the line (backs to the moving dolly string) instead of standing with their backs again the conveyor.

Because they started walking prior to the tug moving, the employees were in view of the Tug Operator; the victim was the last in line of employees walking. It was learned from video footage that the first 3 containers of the dolly string moving past the employees showed packages shifting and falling out of container AAD 21050 FX which caused the roll-up vinyl door to swing out over the grating. The aluminum bar of the vinyl roll-up door struck the victim on the back of his leg as he walked causing him to fall against the metal railing of the 3-input belt conveyor system.

- a. Develop and implement procedures to ensure vinyl roll-up doors are secured while on the input line and during dolly string movement. Also include a work rule to prohibit vinyl roll-up doors in a partially opened/closed position.
- b. Develop and implement additional signals to communicate when packages are shifting and/or have the potential to fall out of the container during dolly string movement.
- c. Develop and implement procedures to ensure employees are out of the danger zone when tugs are moving dolly strings.
