A 60 year old male was **crushed by a concrete wall panel** that weighed approximately 4,560 lbs. The employer was contracted to cut out and re-caulk the joints between architectural precast concrete panels, as well as joints between other surfaces located on the exterior of the building, at ground level, along the sidewalk, and in the area leading to the underground parking garage and loading dock.

21 Crushed by Concrete Panel—Insp#1486686 Architectural Glass & Metal

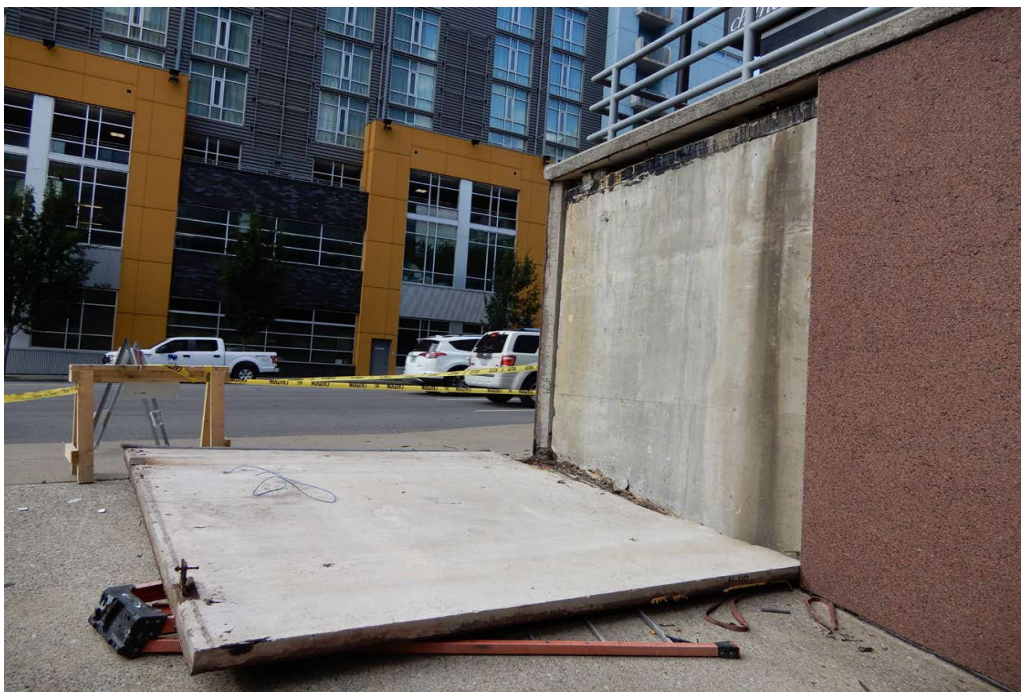
**29 CFR 1926.1053(b)(4):** A ladder was used for purposes other than the purpose for which it was designed:

In that an 8 foot Werner step ladder was being used incorrectly by an employee who was straddling the top of the ladder and using both the steps on the front and the cross bracing on the rear section of the ladder while cutting out and removing caulk from joints around an architectural precast concrete.

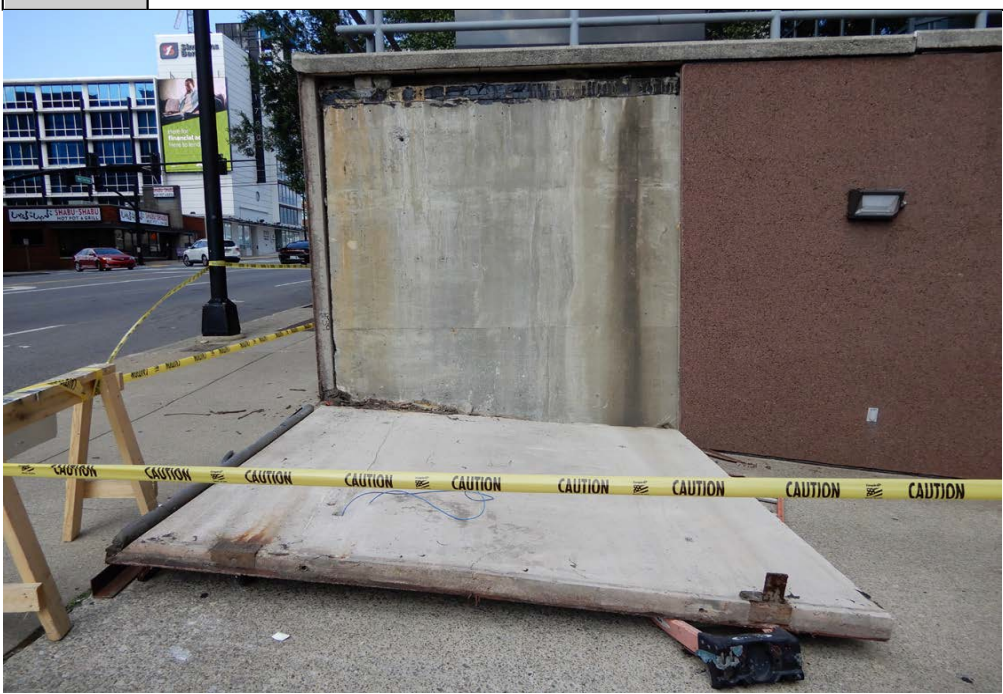
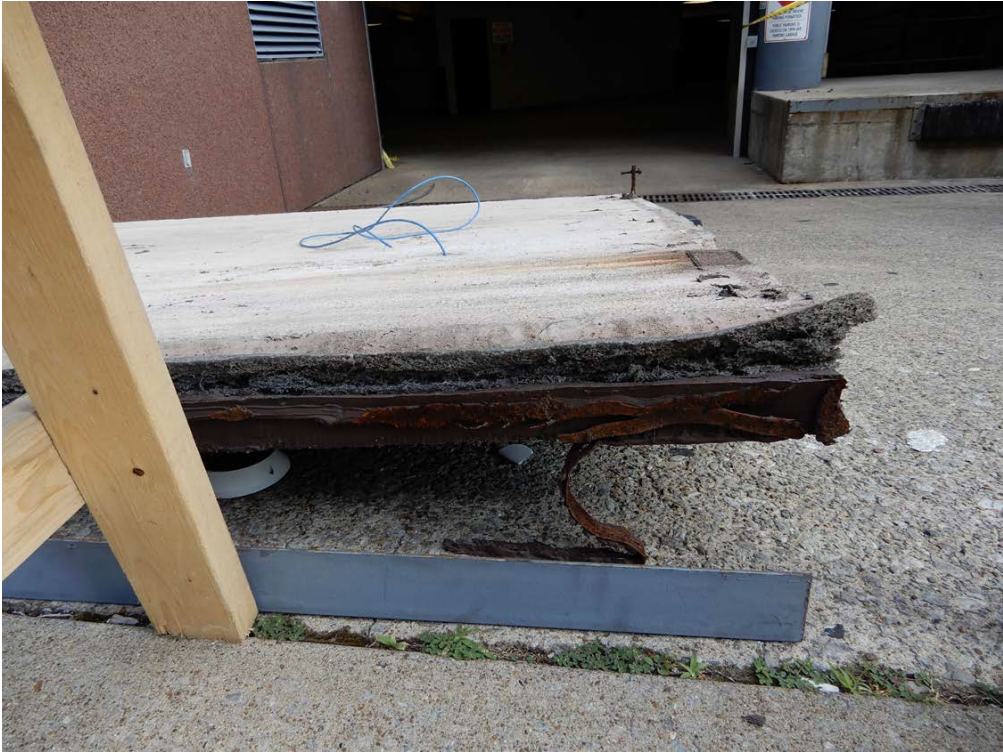
The ground leading to underground parking in the loading dock was sloped approximately 8.5 degrees, and the heights of the architectural panels varied as a result, but ranged between approximately 109 inches and 144 inches tall. The victim removed the caulking from the perimeter joints around the 3 sections of architectural precast panels closest to the underground garage area, before beginning the process of removing the caulking from the joints around the architectural precast panel closest to the road. He worked at ground level and then used an 8ft Werner stepladder to cutout the caulking that could not be reached from the ground. He set the ladder up at the left side of the architectural precast panel and removed caulking within reach above the panel from the ladder. He worked towards the top right side of the panel and repositioned the ladder once. During the process, he straddled the stepladder and used the cross-bracing on the rear of the ladder to extend and reach additional caulking. Shortly after removing most of the remaining caulking and while straddling the stepladder, the architectural precast concrete panel became unstable and started to move. He noticed the movement and tried to dismount the ladder. The architectural precast panel detached from the underlying cast in place concrete structure, falling on and crushing him as he attempted to get out of the way.

It was determined that the architectural precast panel had originally been attached in 2 places; however, issues were identified with both connection points. A corroded metal bracket was observed above the concrete and beneath the capstone on the left side. Differences were also observed on the panel where connecting components had been installed. The top edge of the panel had 2 pieces of 90-degree metal angle embedded in it. The top right side of the precast panel had a metal bracket with a wedge anchor attached to the embedded metal angle; however, the top left side of the panel did not have any additional items connected to the metal angle.
