A **26 year old male** was **electrocuted** when he contacted a conveyor while attempting to remove a broken band saw blade at a sawmill that manufactured pallets.

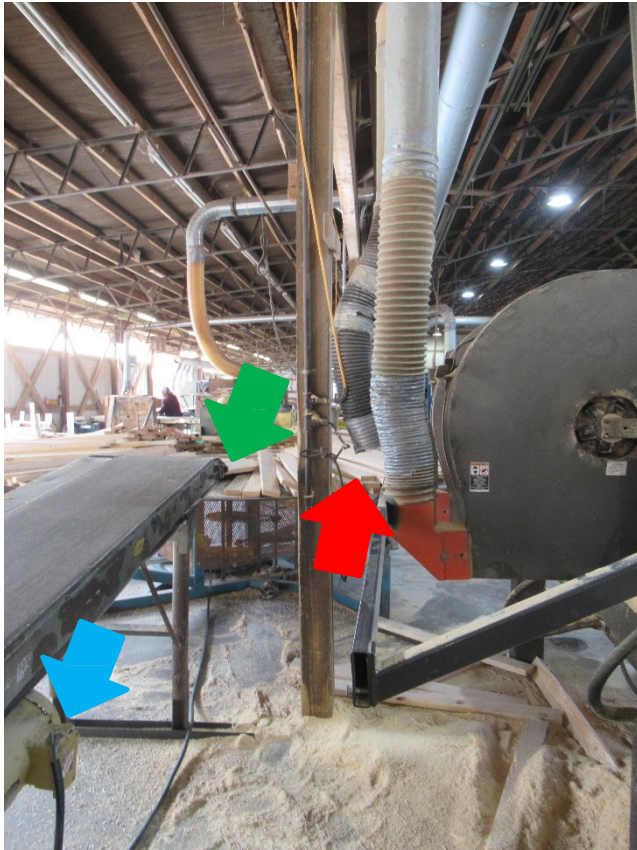
During the inspection, several electrical hazards were identified on the Newman KM-16 trimming saw. The Plant Manager stated that the incident occurred because the Hytrol conveyor was a stand-alone machine and the green ground wire became disconnected. He stated that the ground screw came undone and would not allow the circuit breaker to trip, therefore, energizing the frame of the Hytrol conveyor. During the inspection, there were multiple electrical hazards identified on the Newman KM-16 that could have contributed to the energized equipment which resulted in a fatality. It was determined that the operator of the Newman KM-16 trimming saw and the acting supervisor on the second shift was shocked by the Hytrol conveyor earlier in the shift but did not report it or fix it.

Photograph shows: The area where the incident occurred. The red arrow indicates where the blade was lodged, and the victim was trying to dislodge it. The green arrow indicates where the victim contacted the Hytrol conveyor that was energized. The blue arrow indicates the electrical box on the Baldor Super-E Premium Efficient Industrial motor that powered the Hytrol conveyor. The electrical box cover was only secured with one screw, did not have a bushing, and the ground wire was not connected inside the box. The plant manager stated that he believed the conveyor lost ground which energized the conveyor.

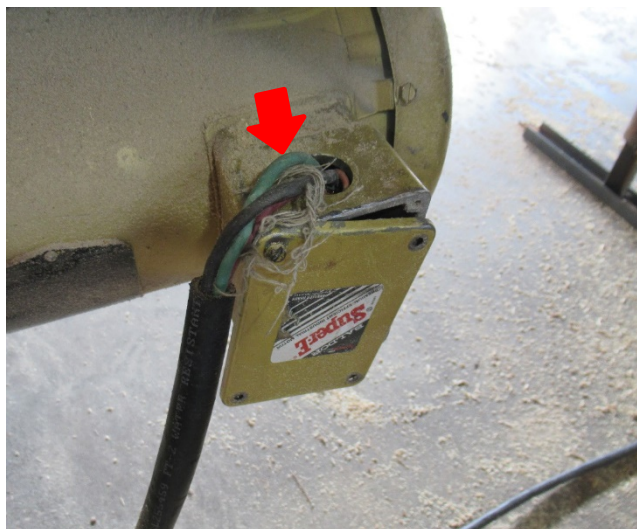
29 CFR 1910.304(g)(5): The path to ground from circuits, equipment, and enclosures was not permanent, continuous, and effective.

In that the ground wire powering the Hytrol conveyor was not connected which resulted in the frame of the conveyor to be energized.

Photograph shows: The red arrow indicates the green ground wire that was not connected inside the box. The plant manager pulled the wire out during the inspection, and the wire was only inside the box approximately ½ an inch.

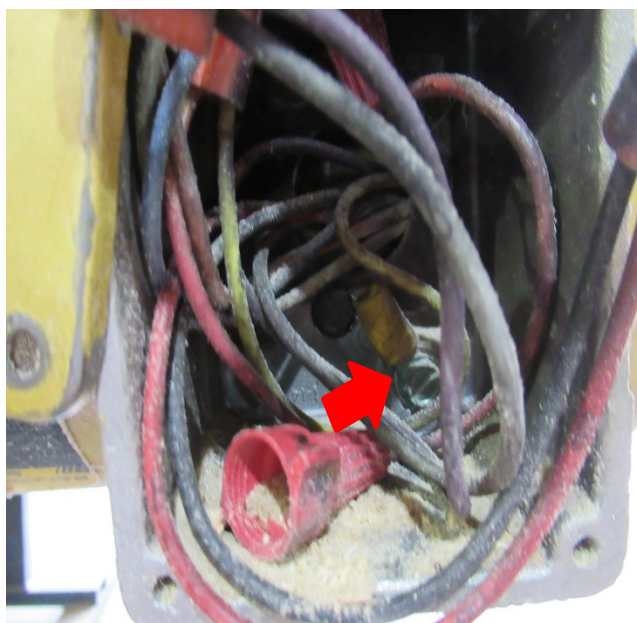
Photograph shows: The red arrow indicates where the green wire was supposed to be connected according to the plant manager.
