Crushed—Insp #1545152 Packaging Corporation of America

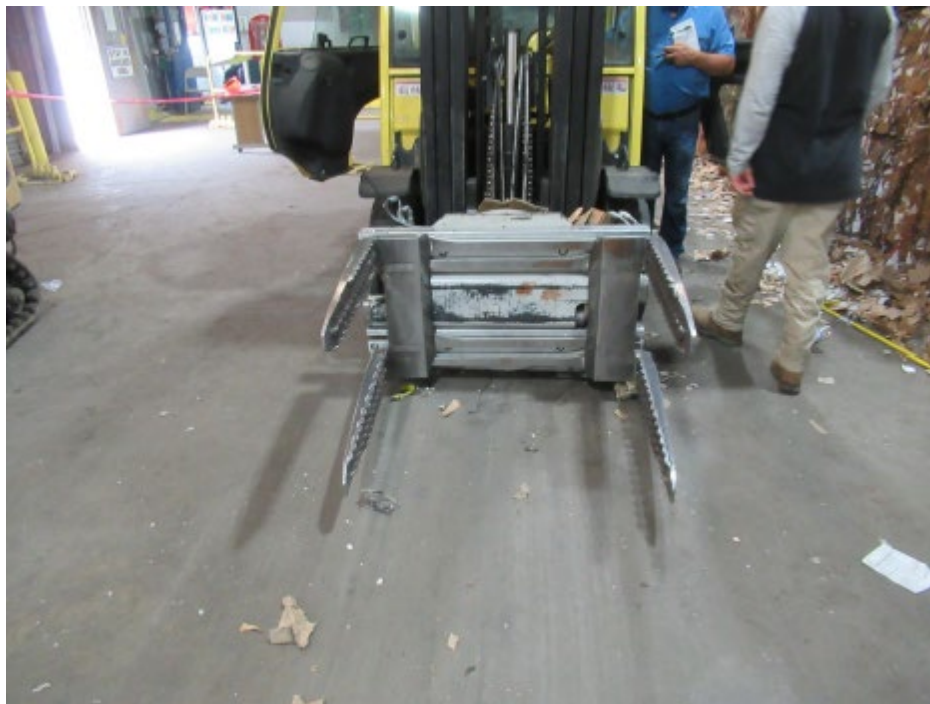
During the inspection, it was observed that the pin and head assembly which is intended to sit on the top of the first mast section hydraulic cylinder was not in place. This pin and head assembly were found to have been removed from the top of the cylinder and were sitting between the forklift mast and cab, hanging by 2 hydraulic hoses and chains. A broken bolt was also observed to be on the floor inside the clamp assembly near the right-side clamp. This bolt was discovered to have been sheared/ broken. This broken bolt was one of four bolts that hold the clamp assembly to the block that is placed on the forklift mast. A yellow prybar was found on the floor approximately 4.5 feet away from the forklift's left side lying on the floor.

It was determined the most likely cause of the pin and head assembly to be removed from the mast cylinder was that the employee placed a bale of recycled material on top of other bale(s) and while attempting to maneuver his clamps/ mast, a piece of wire, from one of the bales, hung in the pin and head assembly pulling it out. If this were the case, it would prevent the first stage mast assembly from lowering all the way to the ground. It is believed the victim could not lower the mast to the floor; it is estimated to have stopped at about 5-6' off the ground. The victim may have been using the crowbar in attempt to reinstall the pin and head assembly when the clamp assembly fell on top of him, crushing him.

29 CFR 1910.147(c)(4)(i): Procedures were not developed, documented and utilized for the control of hazardous energy when employees were engaged in activities such as servicing and/ or maintenance of equipment.

- a. employees do not utilize lockout/ tagout on forklifts and were not required to utilize lockout/tagout when completing service/maintenance work on forklifts.
- b. There was no machine specific procedure documented for use when performing servicing/ maintenance related work on forklifts at the site.
