A **36 year old male** employee **fell** approximately 55' through the roof to the 3<sup>rd</sup> floor decking of the building. This contractor was hired to remove rotted wood beams, columns, joists, and decking at an existing 7 story cold-storage building which was being remodeled into an apartment complex.

Fall--Insp # 1516301 Gray's Framing, LLC

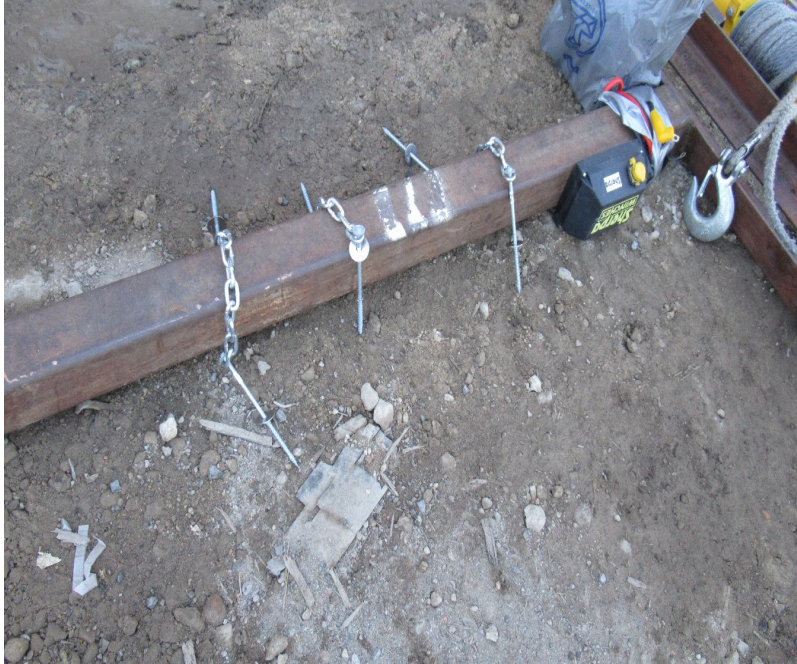
The crew each grabbed the 'T'-shaped base and started maneuvering the winch and base from the hoist area opening towards the west section of the roof. They stayed on the plywood walkway. At a point where the crew was approximately 20-25 feet away from the hoist area opening, the victim fell through the roof, and landed on the 3rd floor decking approximately 55 feet below. The victim fell through a section of rotted roof decking.

In that while on the roof moving a winch, the work crew, consisting of a supervisor and three carpenters, was not utilizing fall protection. One employee was fatally injured when he fell through the roof approximately 55 feet. The employee was wearing a personal fall arrest system (PFAS) full body harness and lanyard but was not tied off to an anchor point.

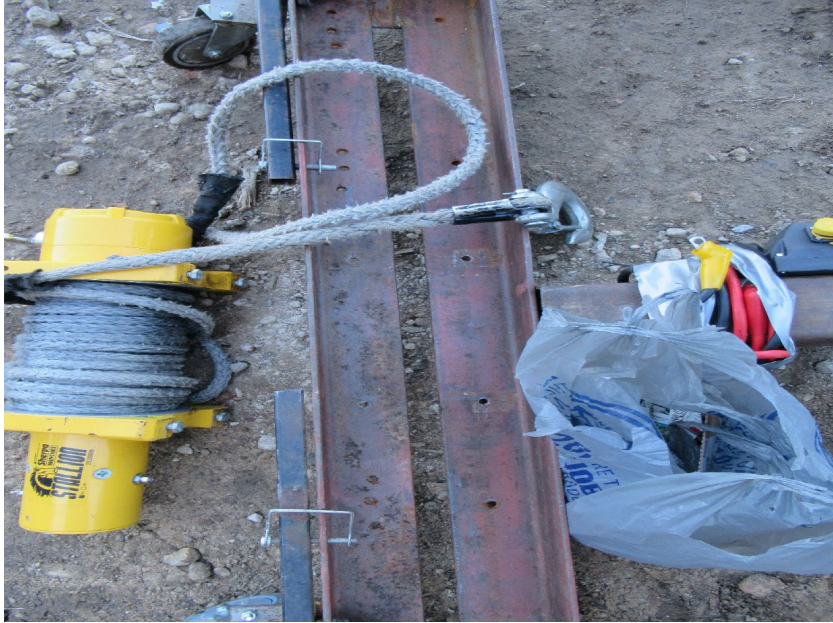
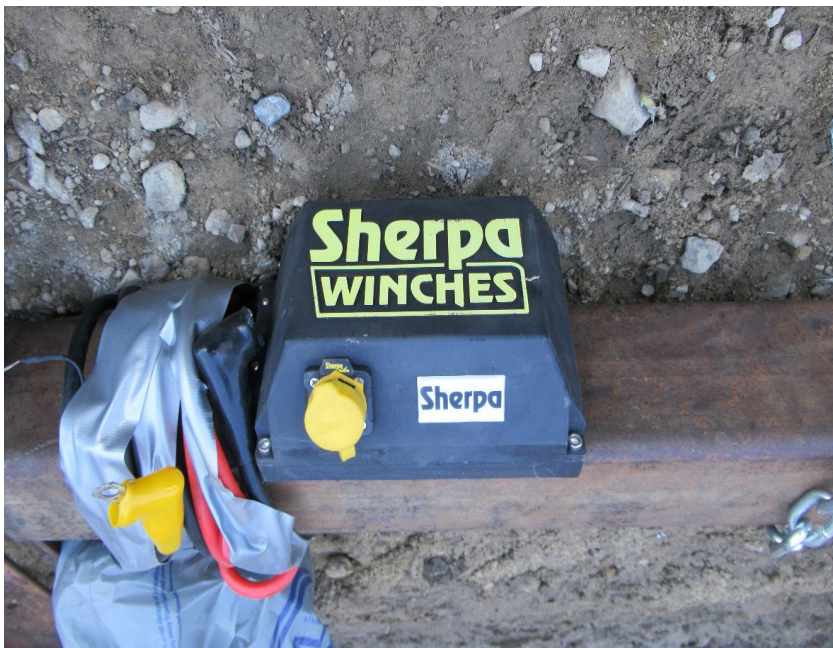
On the roof, the crew were each wearing their personal fall arrest system (PFAS) full body harnesses and lanyards, but no one was tied off to an anchor. The crew walked on the plywood walkway to the hoist area opening in the roof where the Sherpa Winch was located. Sheets of plywood were laid on the existing wood roof decking and followed a path of existing sound wooden beams that supported the existing wood roof decking.
