A **42 year old male** employee was **struck by** falling product while operating an AGV (automated guided vehicle). This employer produces block, sliced, and shredded cheese products.

Struck by--Insp # 1550303 Bongards' South LLC

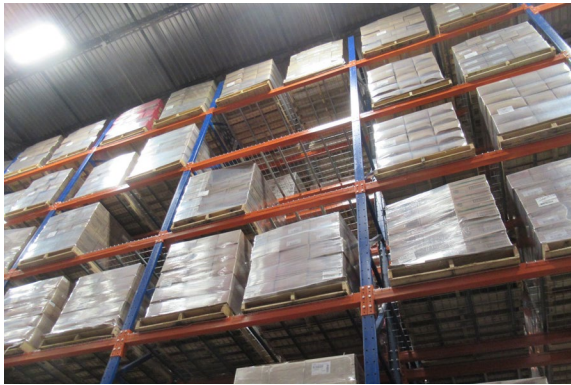
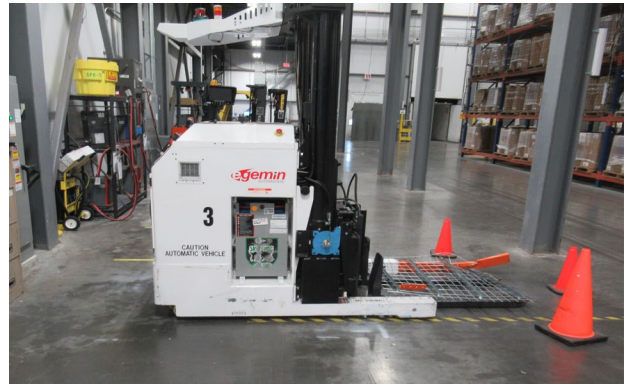
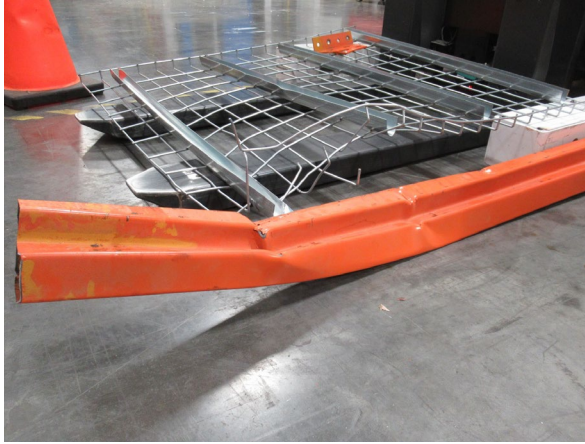
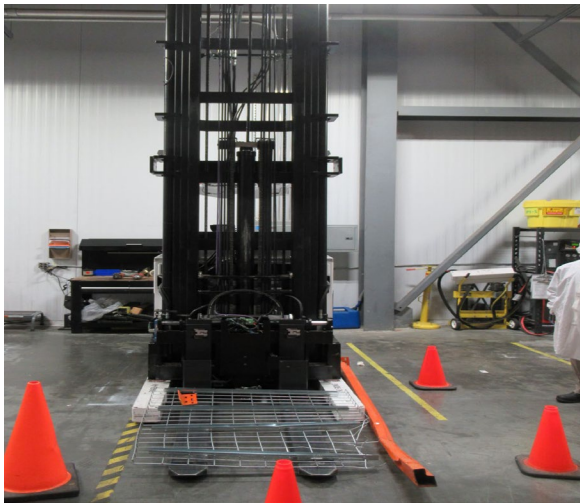
On August 24, 2021, the victim was injured as he attempted to reset a fault on AGV #3 that had stopped in row 9, bay 58, level 4 of the DC warehouse. It was explained that when an AGV shows a fault, the machine stops where it is and what it is doing until the fault is reset. According to fault codes pulled from AGV #3 at the time of the incident, the fault code stopping AGV #3 appeared as a "TC Hold Sec". The code showed because the pallet being raised by AGV #3 did not clear a portion of the racking system and one of the AGV sensors thought something was blocking the pallet's progress into the racking system.

When the victim arrived at AGV #3, it appears he placed the machine in the manual mode and proceeded to manually place the pallet in the racking system. It was stated that manual mode is normally used when a fault or code occurs and the operator needs to move the fork assembly to clear the fault or code.

There is a monitor in place on the front side of the interface control panel of the AGV. This camera system allows an operator to see the location of forks and/ or product when the unit is placed in manual mode. When the AGV is placed into the manual mode, a portion of the sensors on the lift are overridden giving the operator full control of the system. Some of the sensors that are overridden are the ones that sense when the path of the forks and/ or product on the forks are blocked. The main reason the camera and screen were installed on the lift is to allow the operator to see more clearly when working the forks at elevated heights. This camera only shows in real time and does not save a record of what is shown.

These the "black box" was pulled from AGV #3. The "black box" provided codes and sensor readings from the AGV, along with times in which each code appeared. It is assumed that sometime during the task of placing the pallet into the racking system, contact was made between the AGV and the racking system on level 5 damaging the cross brace which caused approximately 23 cases of cheese to fall on the victim.
