A **32 year old female** employee was pinned beneath a **forklift when it overturned** while loading palletized freight onto a trailer in the trucking area. She had to access a yard ramp to enter the truck trailer.

Overturned Vehicle—Insp # 1579237 Federal Express Corporation dba FedEx Express

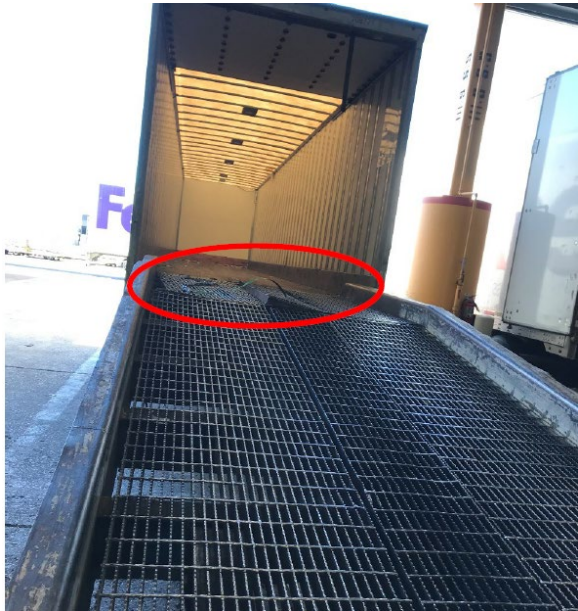
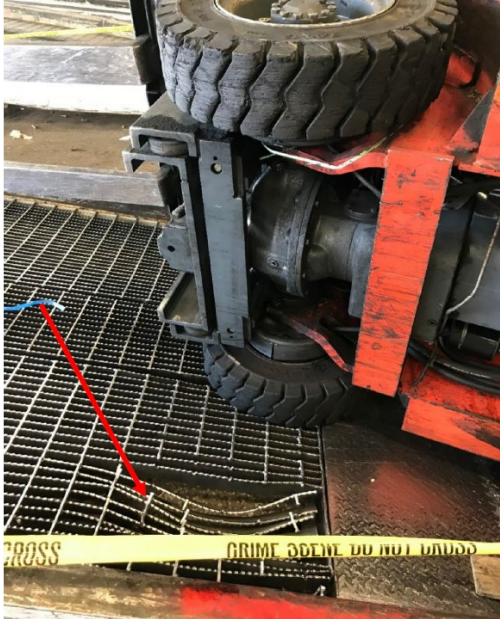
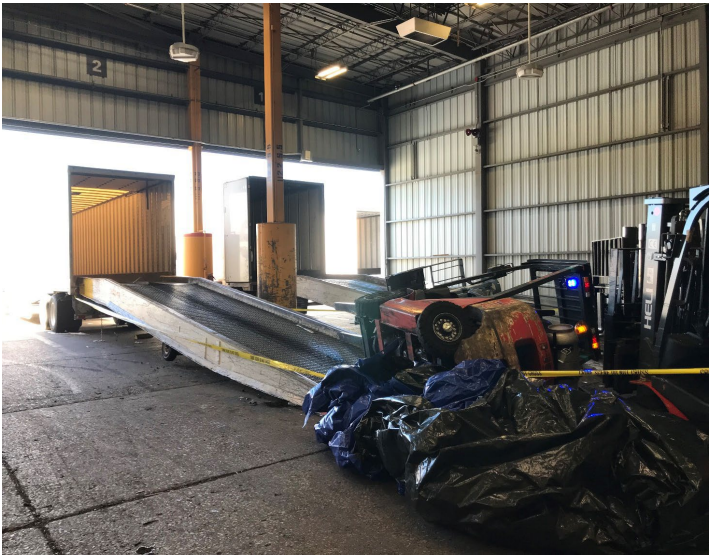
The yard ramp measured approximately 36 feet in length, approximately 6 feet, 4 inches in width, and was approximately 49 inches above ground level at the trailer end. The yard ramp curb measured approximately 5 ½ inches in height and ran the length of the yard ramp on both sides. Two of the three grating panels near the Front Tread Plate at the “trailer” end of the yard ramp were out of position with the middle grating panel sticking up and not lying flat. In addition, damage including an approximately 15-inch by 23-inch concave section was observed in a grating panel near the rear tread plate at the “ground level” end of the ramp where the forklift was overturned. Also, the running gear of the yard ramp was missing one of two wheels. The yard ramp was not secured to the trailer via the safety chains provided and a chock was not placed behind the ramp’s wheel.

The employer’s video surveillance footage showed that approximately 13 minutes prior to the incident, the victim stopped the forklift that she was operating approximately ¾ of the way up the yard ramp to reposition grating panels that had become displaced near the Front Tread Plate at the “trailer” end of the yard ramp. She dismounted, mounted, and maneuvered the forklift two times while attempting to reposition the grating panels. Once the grating panels were set back into position, she got back on the forklift and began operating the vehicle in reverse. The forklift quickly veered to the “right” side of the ramp, struck the curb, and then quickly veered to the “left” side of the ramp, and struck the “left” side curb with enough force to cause the left rear wheel to go over the curb and off the ramp resulting in the forklift being stuck at the approximate halfway point of the yard ramp. The victim remained on the forklift and attempted to maneuver the forklift wheel back onto the ramp for approximately 30 seconds prior to another Forklift Operator responded to assist her. Upon arrival of the second forklift, the victim dismounted the “stuck” forklift and both Forklift Operators attempted to get her forklift unstuck for approximately 8 minutes. The attempts were unsuccessful in getting the left rear wheel back onto the yard ramp; however, did result in the forklift being repositioned on the yard ramp to where the forklift was approximately 1 vehicle length from the approach plate at the ground level. Video surveillance showed the victim getting back onto the “stuck” forklift and putting the vehicle into reverse. As the vehicle rolled back, the right rear wheel appeared to drive into a depression in the yard ramp grating resulting in the forklift becoming unstable which caused the victim to be ejected from the vehicle and the forklift subsequently overturning on top of her.

The location of the approximately 15-inch by 23-inch concave, damaged section in the grating panel observed by the CSHO during the walkaround inspection coincided with the location of the “depression” that the right rear wheel drove into as seen on the video footage just prior to the victim being ejected from the forklift. The victim was not wearing a seat belt at the time of the incident.
