A **48 year old male** employee was **electrocuted** when he contacted 23Kv powerline while making a repair to the line.

Electrocution—Insp # 1641355 Memphis Light Gas & Water

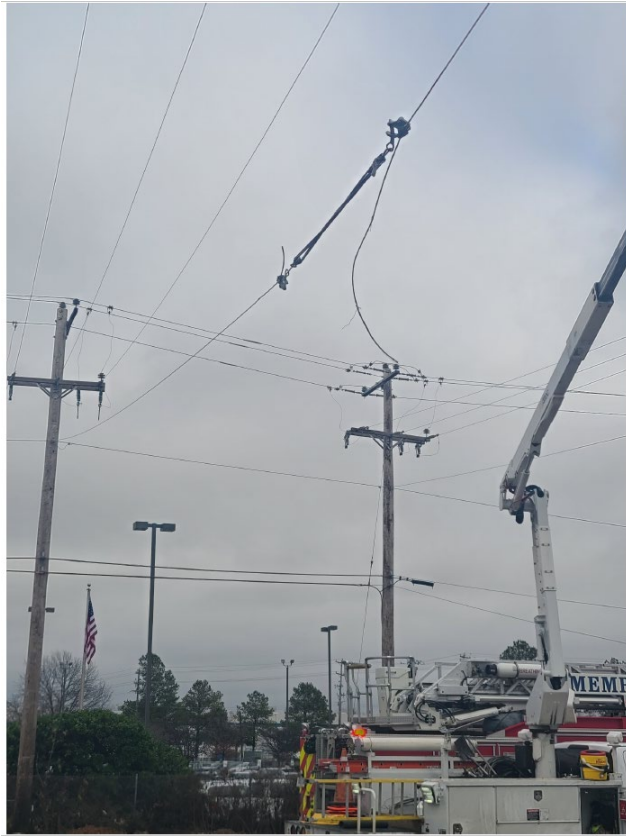
It was determined during the investigation that the victim was in the bucket but did not isolate, test, and ground the wires before he began working on them. Although the B & C phase lines that he was working on had the fuses blown open, with the A phase line still closed, it could back feed the B & C lines. The victim was also not wearing the insulated gloves to work on energized lines; he only was wearing leather gloves. Although it did not cause the fatality, it was determined that the victim was not wearing fall protection while he was working in the bucket at an approximate height of 20 feet.

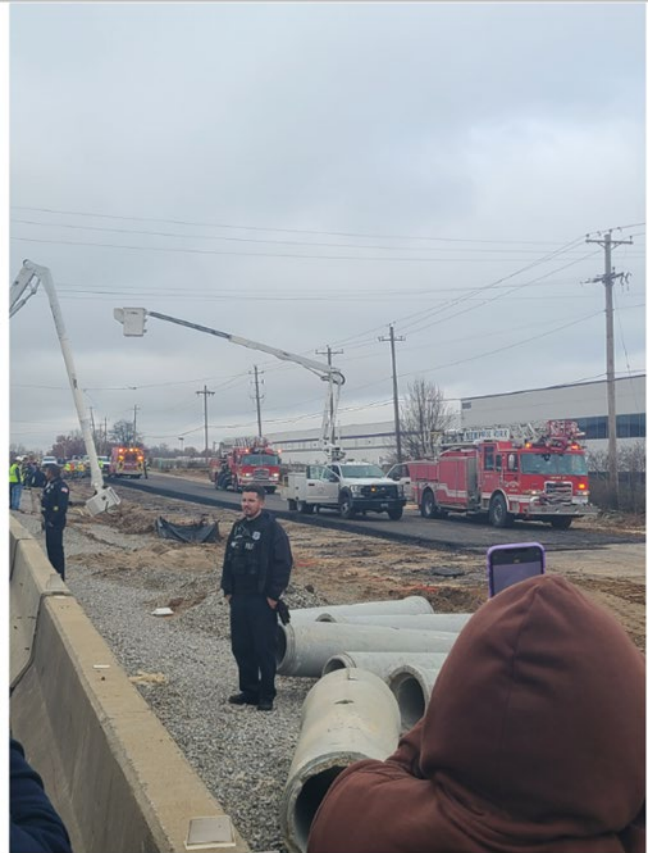
On 12/9/22, it was determined that all three phases of overhead power lines in the vicinity of work being done at 5215 Lamar Avenue, Memphis, TN, were not isolated and tagged as required. An employee was electrocuted while attempting to separate the B & C phases of power from the neutral, but the A phase in the vicinity was still energized.
