A 30 year old male employee was struck by a dumpster that was being lifted into a garbage truck with a winch.

Struck By Dumpster—Insp # 1668340 Bass Waste Removal and Recycling

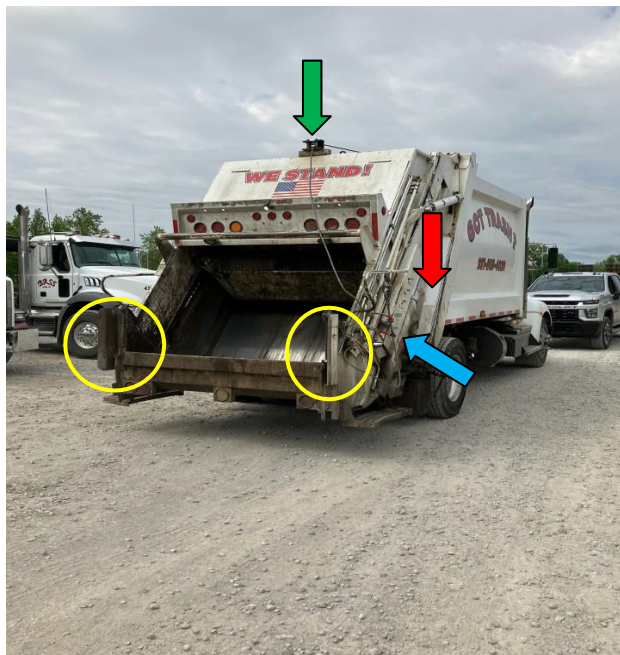
The photo shows the Kenworth #22, rear loading garbage truck involved in the accident. The red arrow indicates the approximate area where the victim was struck and pinned by the dumpster. The green arrow shows the cable/winch system that was used to lift and empty the dumpster. The yellow circles show the location of the locking mechanisms that lock the dumpster in place before the lifting process is performed. The blue arrow shows the location of the manual controls.
