Crushed by landscaping blocks—Insp # 1670069 **Frerichs Sawmill**

In that a 44 year old male employee was crushed by several 3500 pound concrete landscaping blocks when a retaining wall collapsed. The wall was approximately 40' long x 8' tall x 2' wide and comprised of interlocking concrete V-Lock Blocks that were approximately 2' high x 2' deep x 6' long and stacked 4 high.

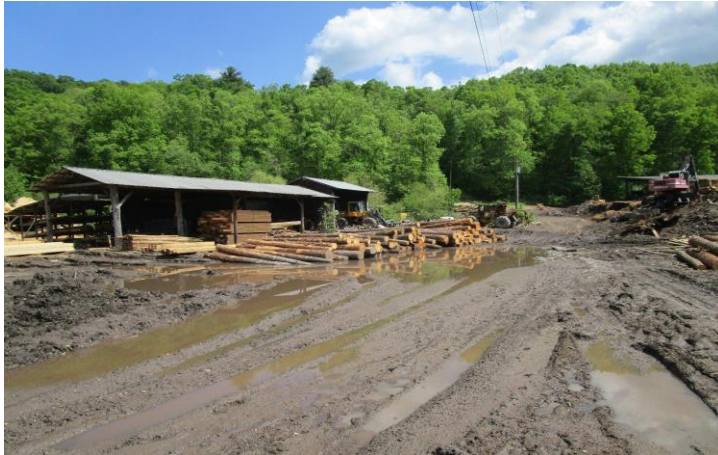
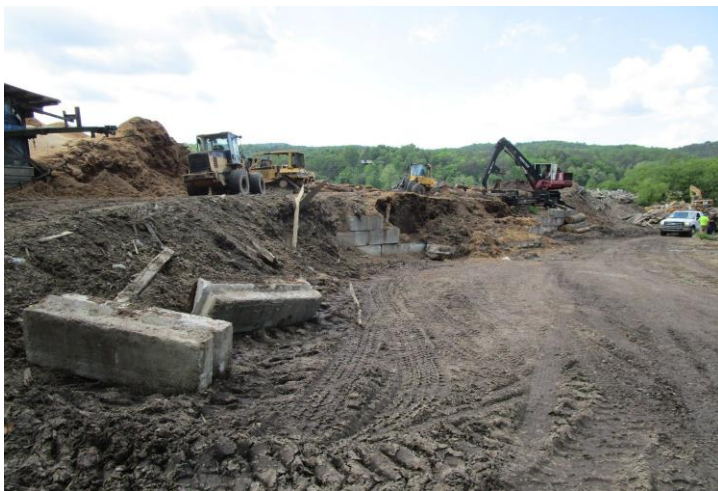
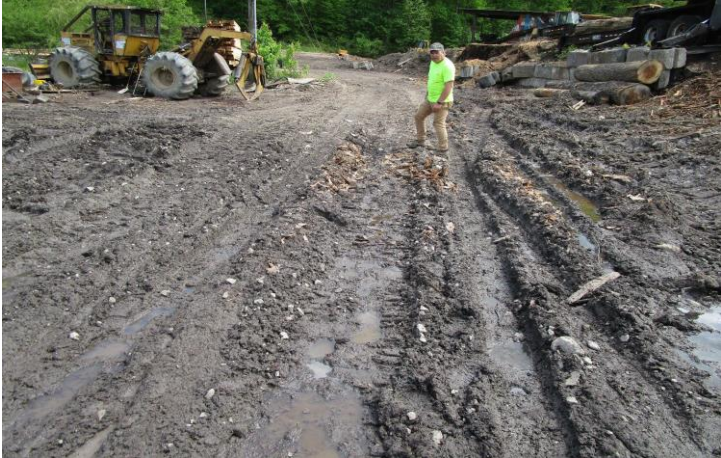
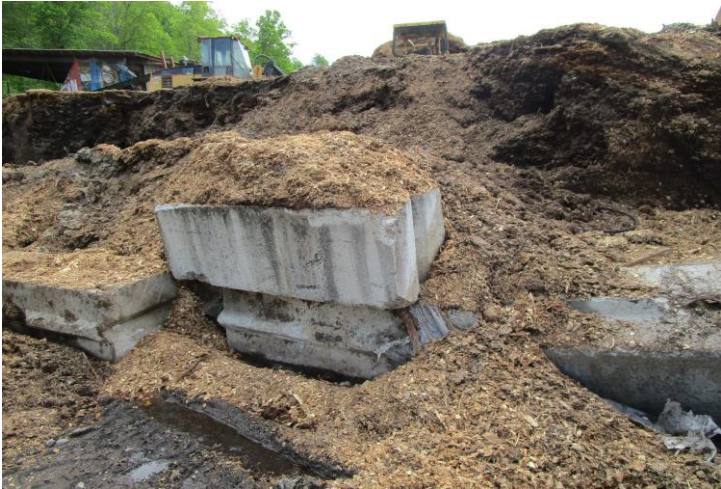
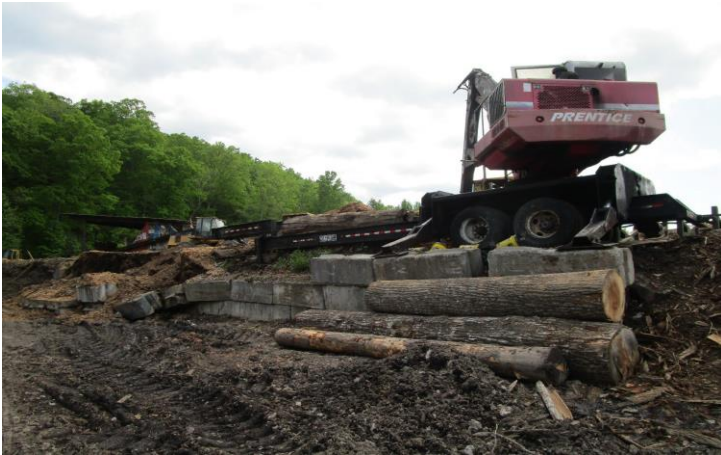
The victim and the truck driver were standing on the ground close to the south end of the retaining wall near the trailer's end while another employee operating a skidder, used the skidder's blade to push the corner of the trailer towards the wall. The victim was giving ground guidance so the skidder operator would know how far to push the trailer. As the trailer was being pushed closer to the wall, a Wheel Loader operator, began to load the trailer with bark from top part of the retaining wall. As he approached the trailer with a scoop of bark, the block right in front of the loader's wheels completely dislodged from the wall and tumbled to the ground below.

The company owner was standing outside near the office at this time; he stated that he saw the loader operator abruptly apply the brakes prior to the block tumbling. The blocks on both sides of the dislodged block began to fall like dominos. The wall partially collapsed, striking the victim, and narrowly missing the truck driver.

Retaining walls can fail when the opposite is true, when the force required to hold the soil is greater than the weight of the blocks. This wall had additional, transient loads on the fill side of the wall exerted by the weight of the Wheel Loader and Knuckle boom Log Loader.

During the inspection, it was noted that there were copious amounts of mud and standing water scattered about the site. Evidence of moisture on the blocks themselves were also observed. Extra moisture in the fill materials behind the retaining wall adds additional weight, which could further degrade the wall's stability. Also, the fill materials behind the wall are not a typical fill material like clay, sand, or loam. It is a mixture of sawdust, bark, and wood chips; it absorbs water readily and can become saturated after a significant rain event. These wood byproducts do not compact well, they absorb moisture, and overall degrades the stability of the retaining wall. Soil compaction is critical to the stability of structure like retaining walls and foundations.
