DATE: 15 September 2021 **DRAFT**

TO: Lanette M. Phillips  
Development Manager  
STREAM  
Tennessee Tower, 24<sup>th</sup> Floor  
312 Rosa L Parks Avenue  
Nashville, Tennessee 37243

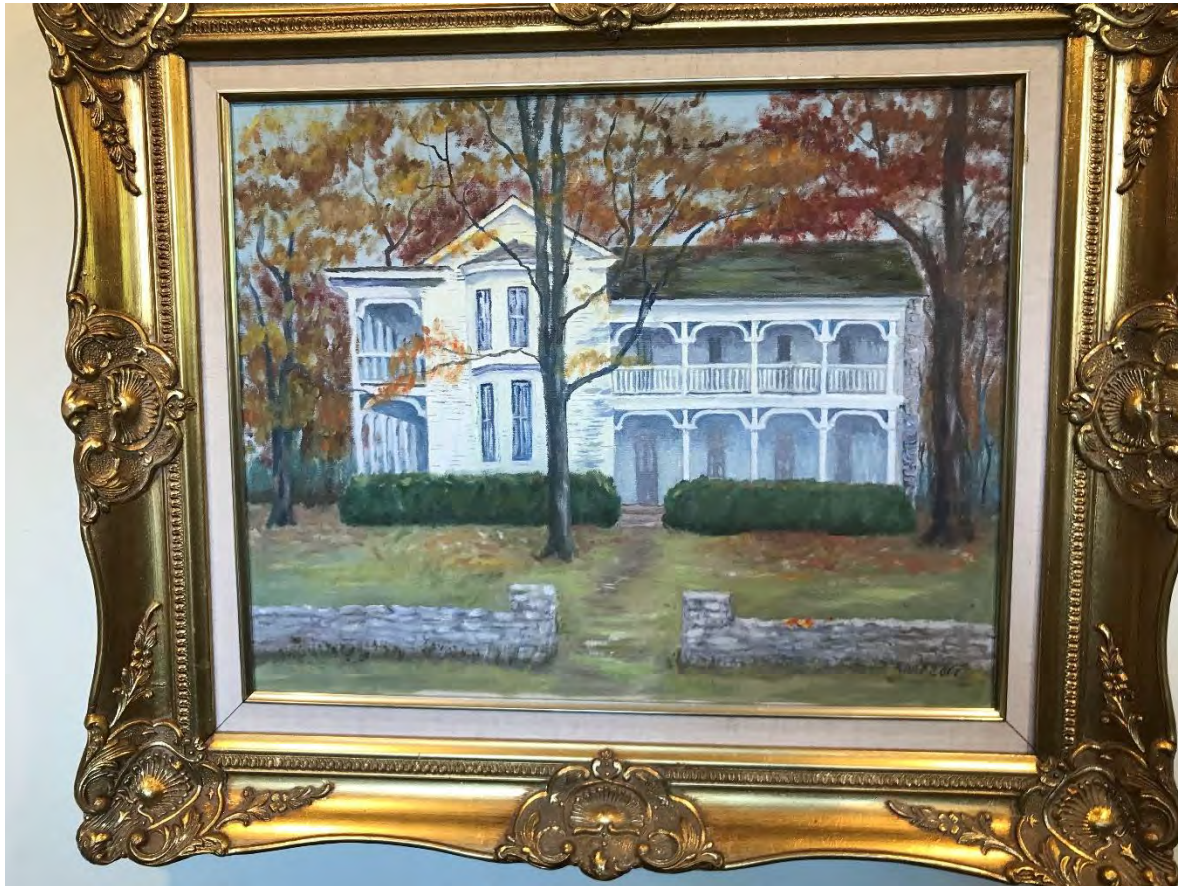
**Motor Court** - The single-story motor court was built in 1961. (12 Guest Rooms)

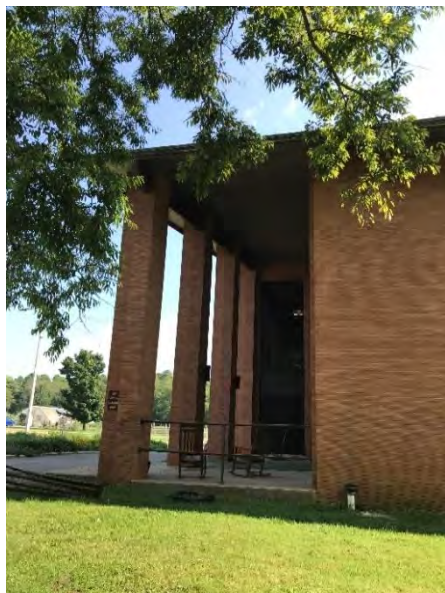
**4) Lodge Exterior** – View of the north façade at the lobby and fireplace chimney. Note masonry staining and efflorescence below eave line.

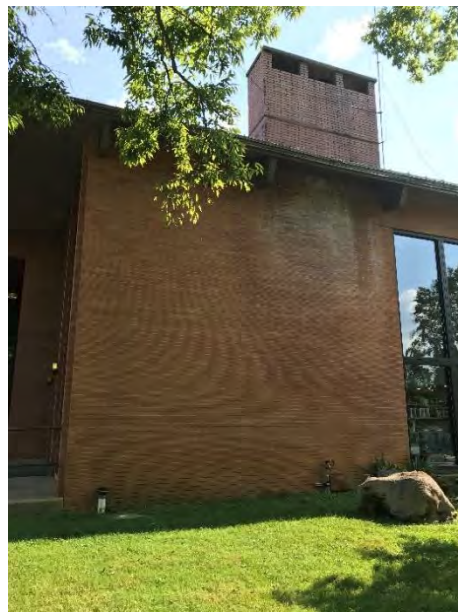
**5) Lodge Exterior** - View of the north façade and sidewalk leading to the side entry to the lobby.

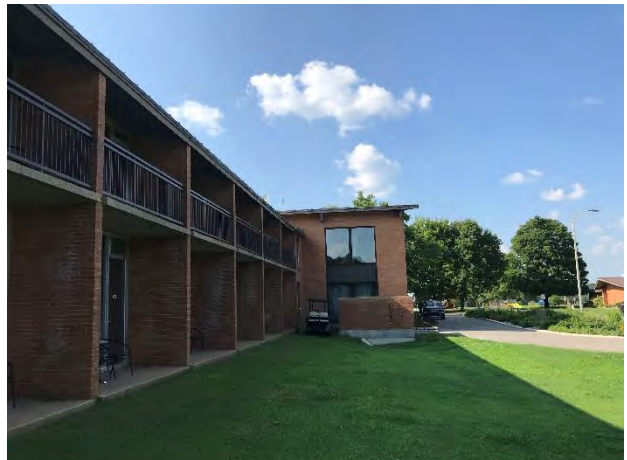
**17) Lodge Exterior** – View of guestrooms facing east. Note masonry staining and efflorescence.

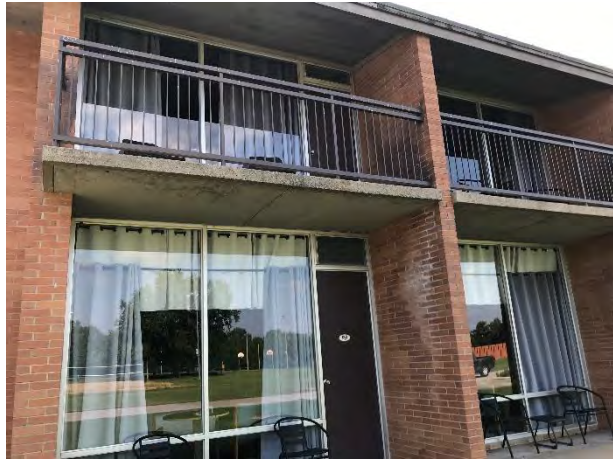
**18) Lodge Exterior** – View along the southeast façade looking north.

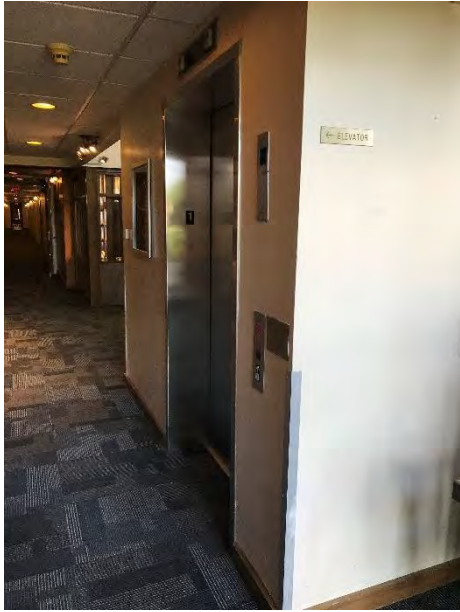
**36) Elevator** – Carpet tile floor finish and stainless steel hand rail'

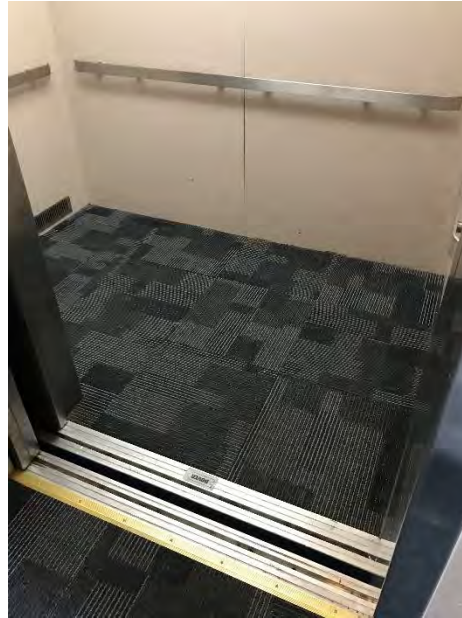
**37) Elevator** - Floor indicator and 2,500 lbs weigh capacity.

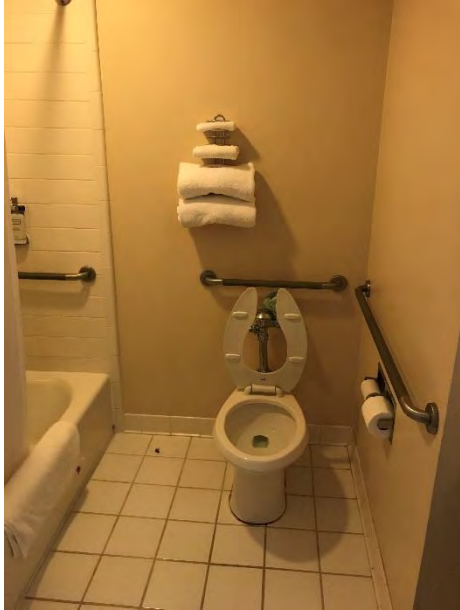
**75) MGuest Room 102 – View of bathroom showing signs of leaks on ceiling tiles.**

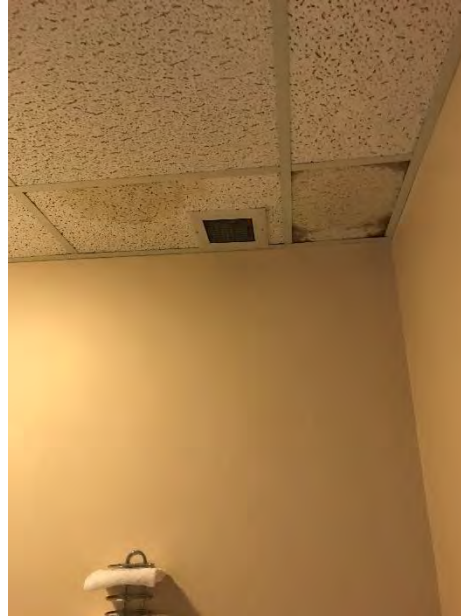
**76) Guest Room 102 - View of tub and shower controls.**

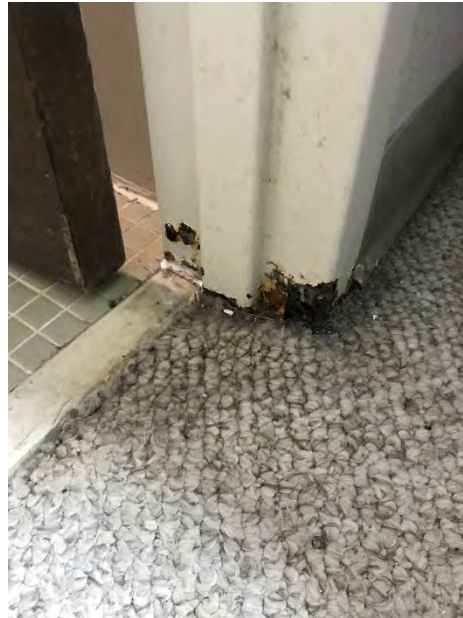
**86) Guest Room 107 – View of deteriorating wall substrate at control valve.**

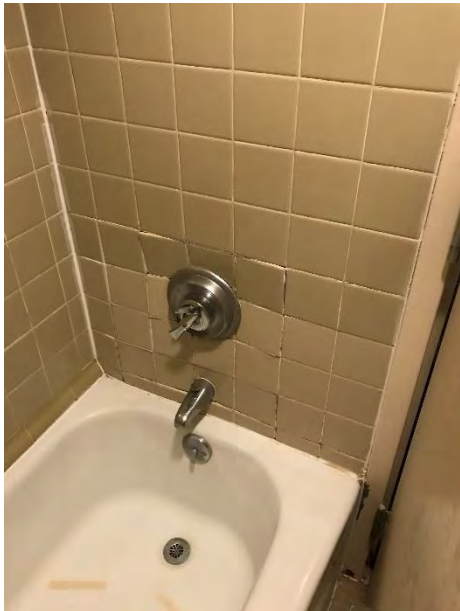
**87) Guest Room 107 – Miss-matched tile color from previous repairs.**

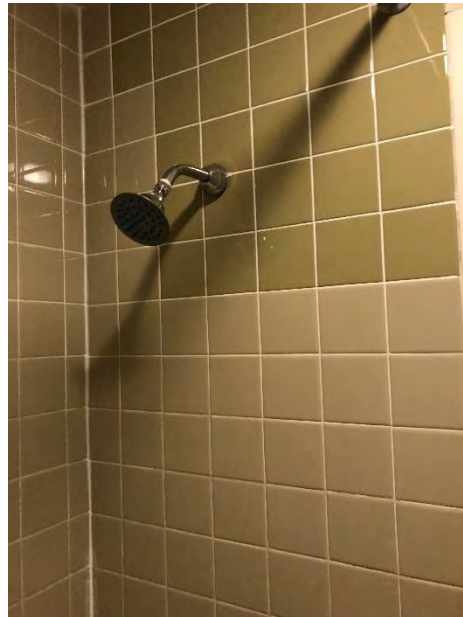
**Guest Room 118 – (Office)**

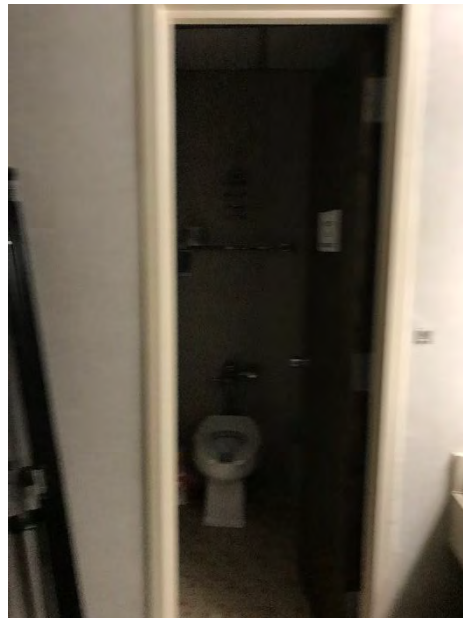
## First Floor Housekeeping

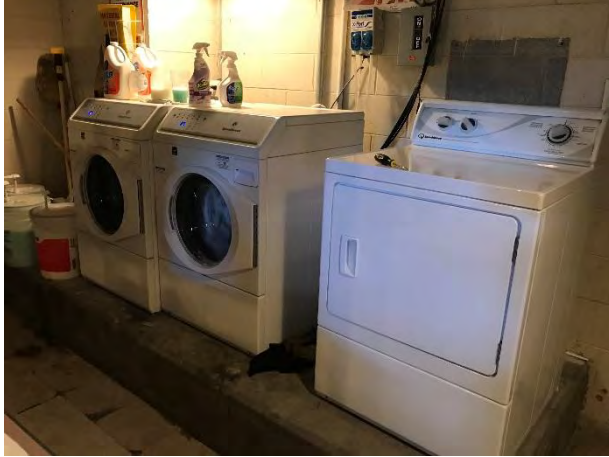
93) First Floor Housekeeping –

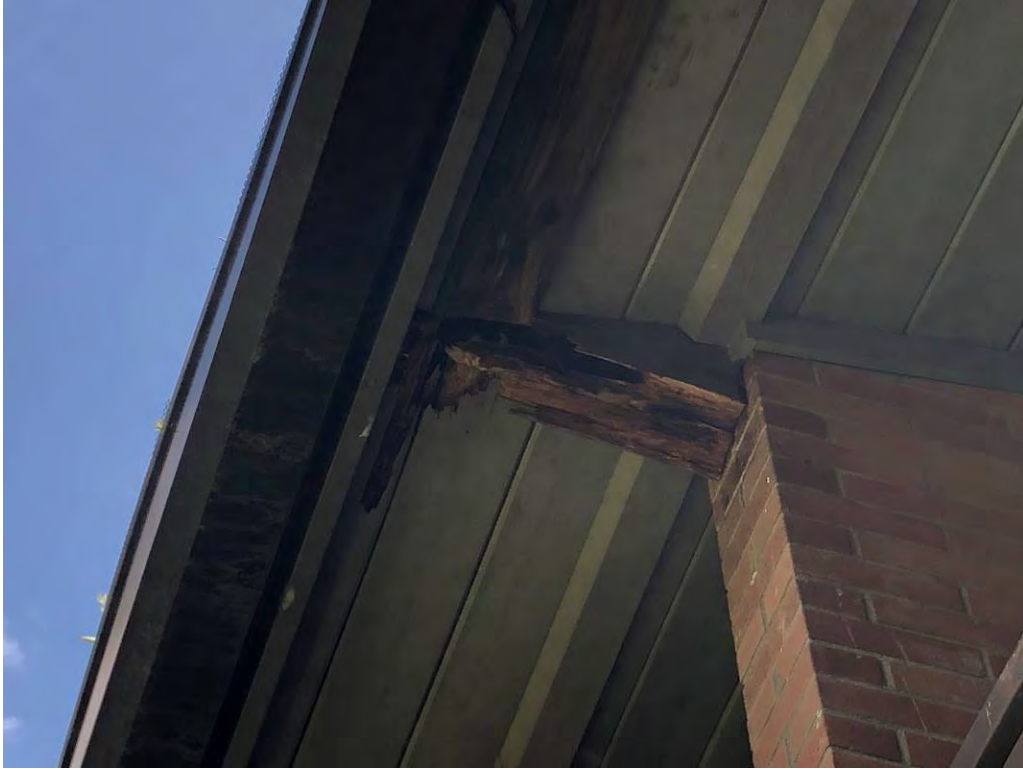
**Photograph 5 – Decay at wood beam at lodge roof eave.**

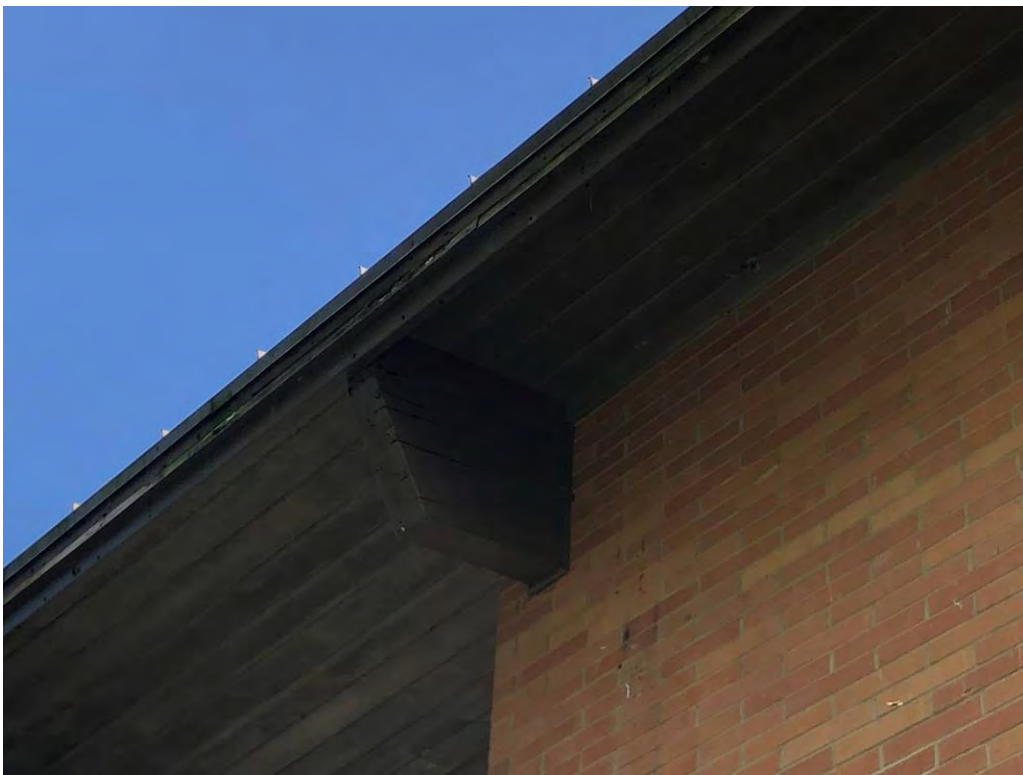
**Photograph 6 – Decay at end of wood beam at lodge near fireplace.**

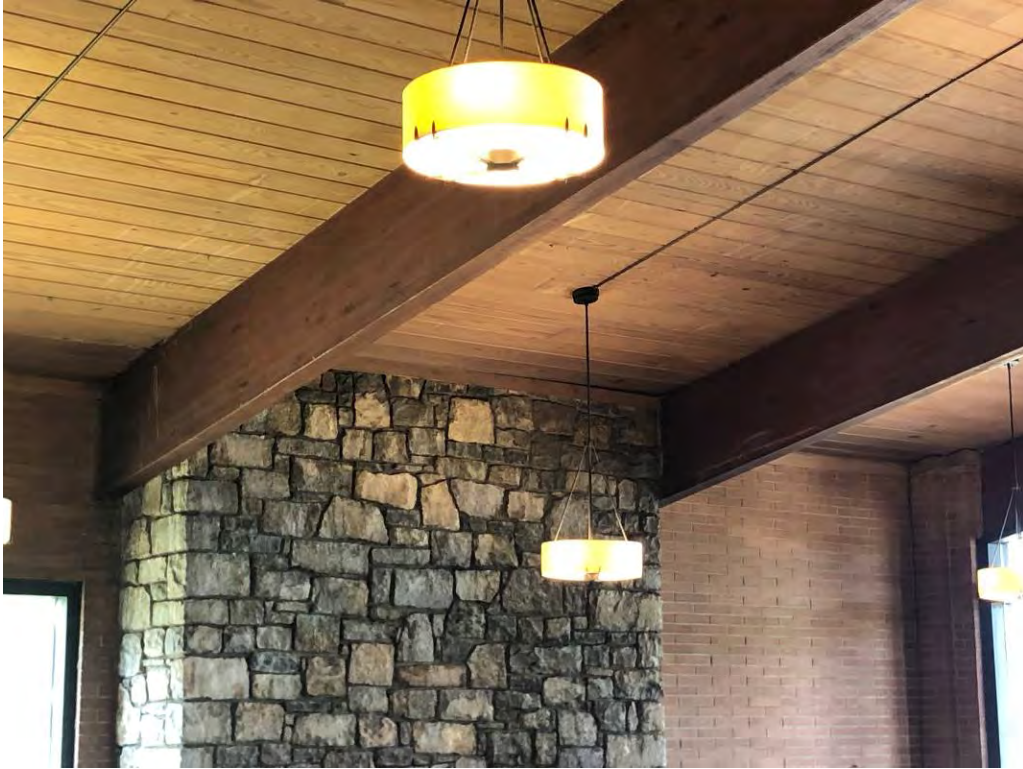
**Photograph 7 – Roof framing at fireplace in lodge lobby. Potential water damage at roof decking and wood beams.**

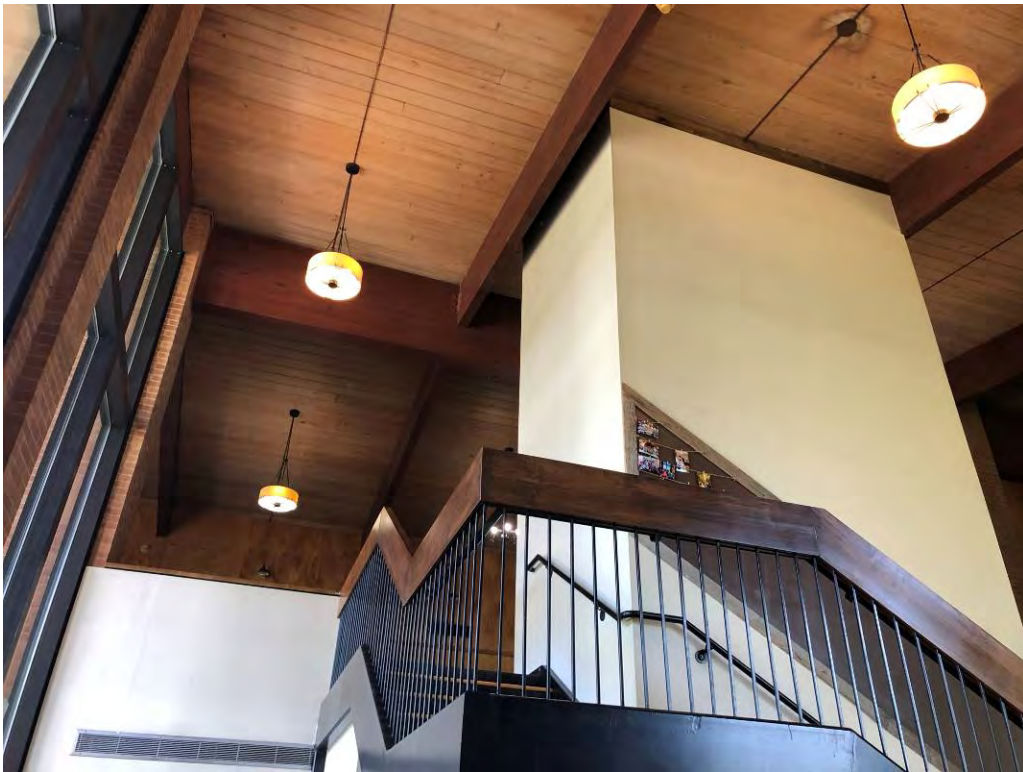
**Photograph 8 – Stair and elevator beyond at lodge lobby.**

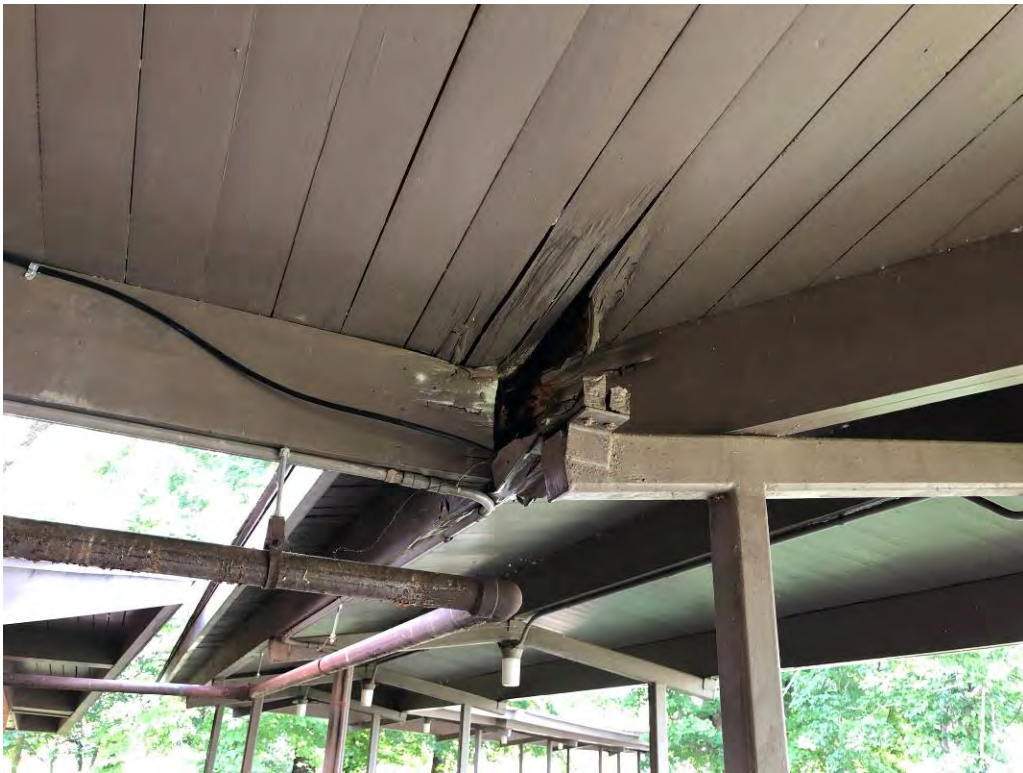
**Photograph 18 – Wood decay at covered walkway between lodge and motel.**
