# National Civil Rights Museum

Facility Assessment Report  
SBC Project No. 529/000-16-1998

July 23, 2014

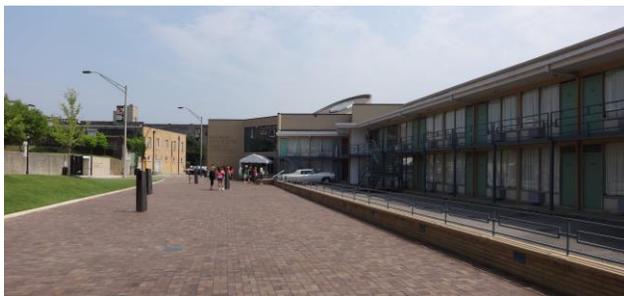
Photo 3 – Main Entrance Plaza

The plaza was modified to accommodate informational kiosks and the new entrance configuration. The kiosks have received very positive feedback since they provide pertinent information about the Museum and the surrounding structures and significant elements around the events associated with the Museum.

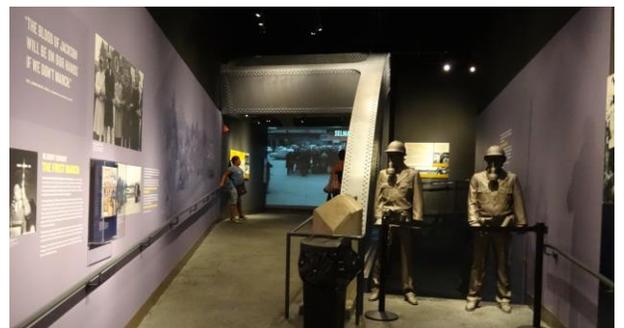
Photo 4 – Interior Display

Visitors presently are greeted at the entrance lobby and directed through a well-organized museum experience that takes visitors through all the phases of the Civil Rights Movement. Interactive and passive displays provide information and visuals at critical points of the tour. Physical displays incorporating vehicles and bridges enhance the visitor's experience.

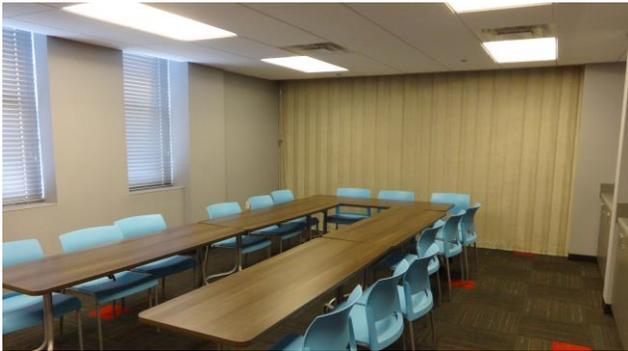
Photo 7 - Education Center

The Museum has incorporated an educational section in the previous Lorraine Hotel where school students have an opportunity to learn and participate in presentations as part of the school curriculum. The Educational Center has several "classroom" spaces along with a resource library

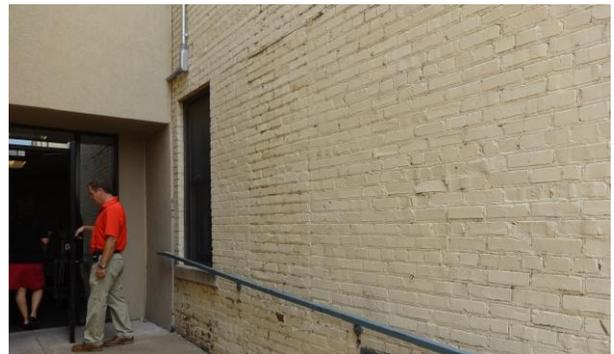
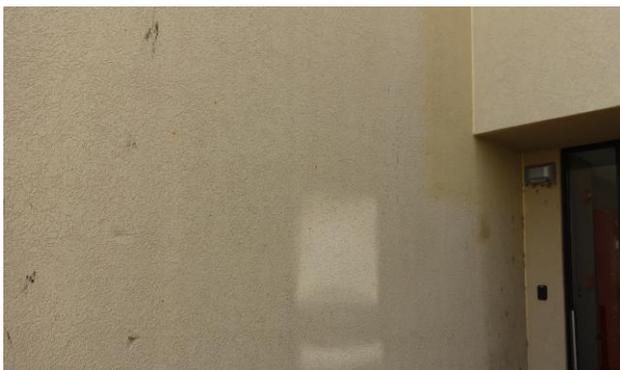
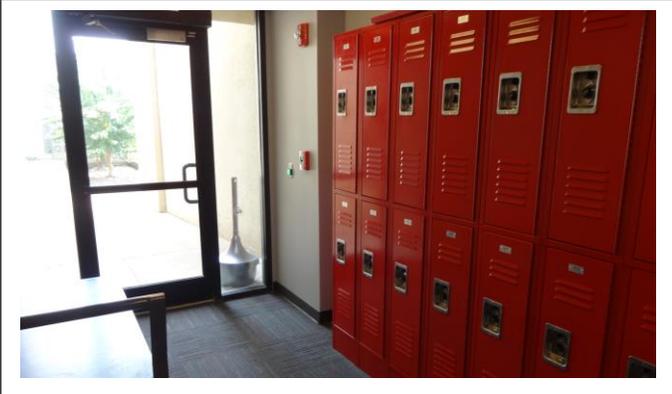
Photo 8 - Staff Entrance

The staff entrance was not upgraded as a part of the most recent renovation and requires attention since the EIFS is showing deterioration and water intrusion. The staff entrance exterior finishes show accumulation of surface dust creating discoloration and darkens areas.

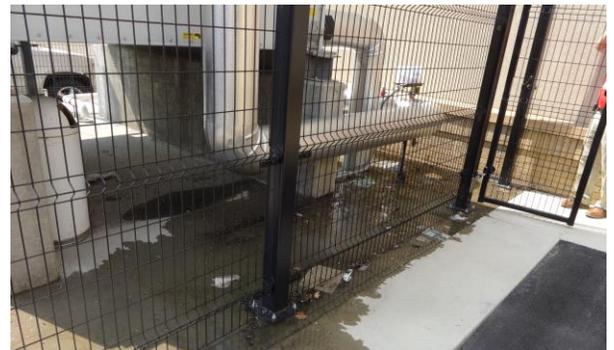
Photo 13 – Cooling Tower

The new cooling tower had considerable leaking during operations generating large areas of puddles which in turn hold debris creating an unsightly condition in the rear of the building and next to the staff entrance.

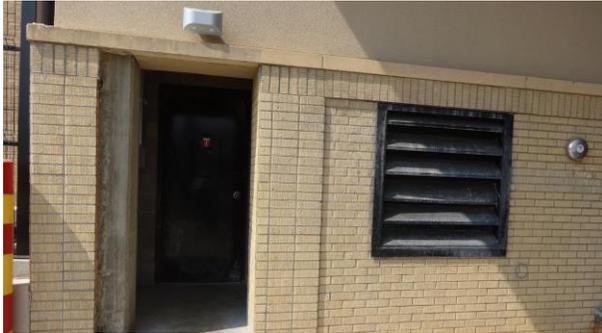
Photo 15 – Truck Dock Area

The truck dock was improved under the most recent renovation and shows signs of use which will eventually require painting and surface repairs.

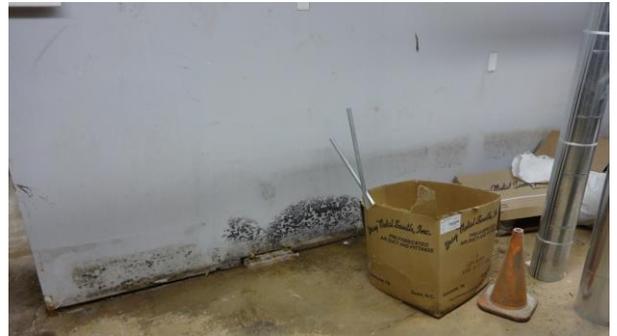
Photo 16 – Basement Area

Environmental issues, such as mold, have been created due to lack of ventilation in areas and the presence of moisture and un-conditioned air. Maintenance, in the basement area, will be needed to mitigate the effects of the mold and to clean-up the area.

Service basement for the Lorraine Motel lacks ventilation and conditioned air creating an environment for mold propagation and eventual environmental issue with wall finishes and painted surfaces. Several non-operating systems remained (sump pump and coal chute) in the area compounding the ability for moisture to migrate into the basement and propagate the humid condition.

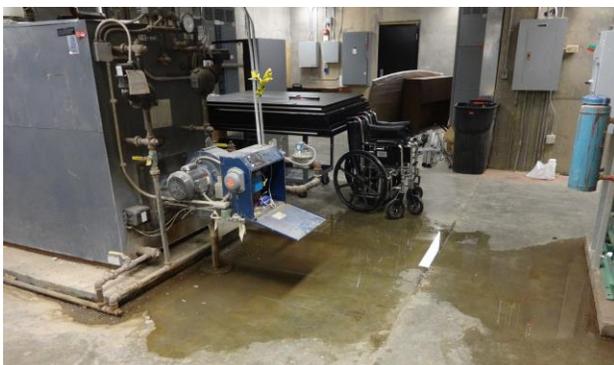
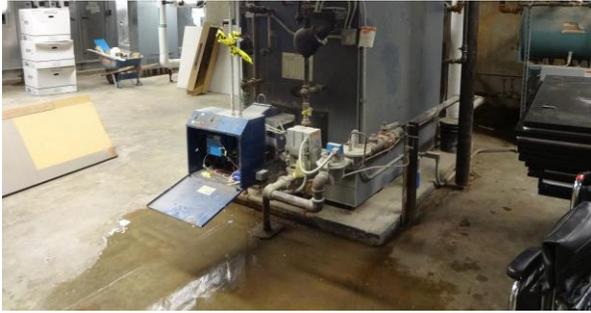
Photo 19 – Basement Area Blow Down Water

The service basement under the Hotel Lorraine houses all the mechanical equipment that supports all the National civil Rights Museum. The space is well ventilated, with full access to all equipment for servicing. A blow-down valve discharges water across the floor to a near-by drain creating puddles across an access/working aisle.

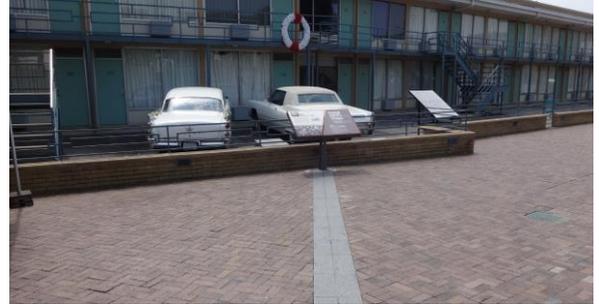
Photo 21 – Plaza Surface

The plaza continues to deteriorate due to water intrusion under the paver bricks along with slight shift in the supporting substrate creating tripping hazards. The sidewalks and curbs also show

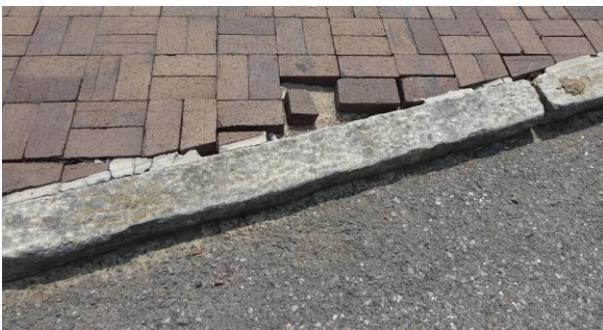
Photo 24 – Plaza and curb Damage

signs of deterioration along Mulberry Street which is part of the overall visitor experience. The parking light poles show deterioration and are very evident since visitors use that parking lot and walk towards the Museum.

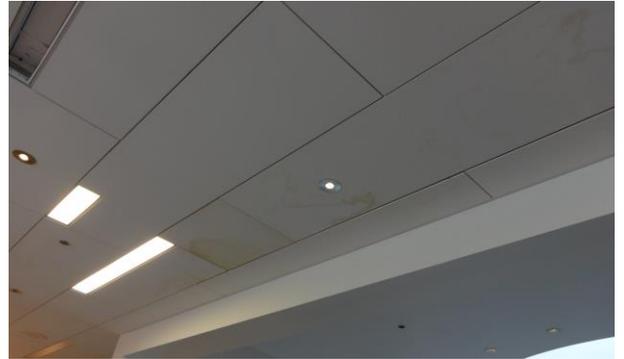
Photo 26 – Gift Shop Ceiling Damage

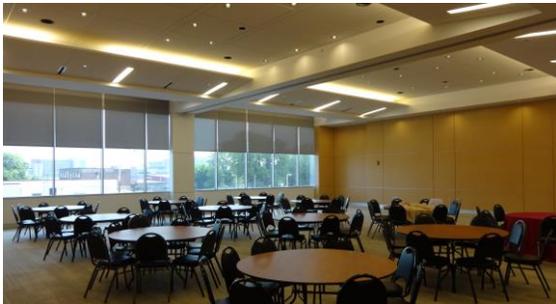
Photo 27 – Multi-Purpose room

The Museum is further complimented by the public meeting space and catering kitchen where program are scheduled and provide museum exposure beyond the customary museum hours and visitors.
