# **Crooked Fork Watershed Restoration Plan**

*This document was developed cooperatively by Tennessee Valley Authority, Natural Resources Conservation District, Morgan County Soil Conservation District and the Emory River Watershed Association to guide our efforts to restore Crooked Fork and its tributaries to fully support all of their designated uses, and protect public health and well being. This restoration plan follows Fiscal Year 2004 EPA Section 319 watershed plan guidelines and addresses each of the nine required components.*

**November, 2006**

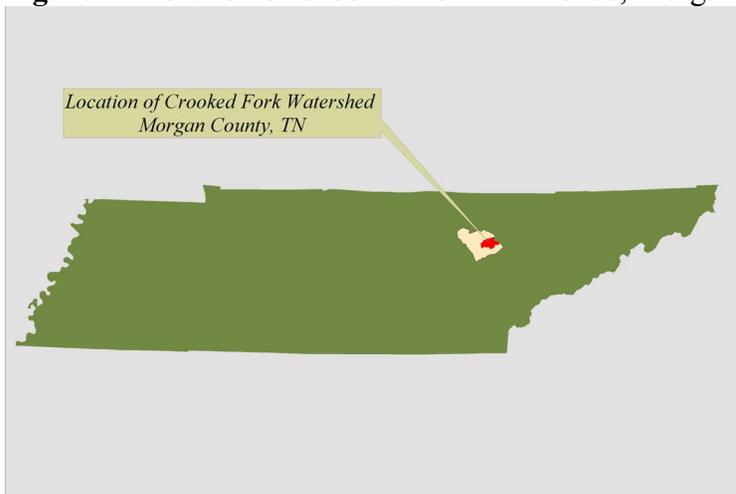
**Figure 1.** Location of Crooked Fork Watershed, Morgan County, Tennessee.

Crooked Fork, a tributary to the Emory River (TN06010208) in upper east Tennessee (Figure 1), drains a 62 square mile area in Morgan County. The headwaters of Crooked Fork are located above the town of Petros, Tennessee in an area of past and active strip mining and logging operations. The stream then flows through the town of Petros, which is without a central sewage facility, and through an area of pasture and hay land. The historic Brushy Mountain State Prison, which does have a sewage facility, is also located in Petros. Flat Fork, the main tributary to Crooked Fork, has its headwaters in Frozen Head State Park, where it is a high quality reference stream while in the park. Its condition quickly degrades as it passes through an area of pastureland and the State of Tennessee operated Honor Farm and Morgan County Correctional Facility, which is currently under expansion. Downstream from the confluence of Crooked Fork and Flat Fork is the Plateau Utility District drinking water supply facility and the Wartburg Sewage Treatment Facility. Below these facilities are the popular swimming areas of Potters Falls and Laymance Falls. These sites are of considerable interest and concern to the citizens of Morgan County for their recreational and scenic significance.
