NATURAL RESOURCE ASSESSMENT FOR THE PROPOSED ENVIRONMENTAL MANAGEMENT DISPOSAL FACILITY (EMDF), OAK RIDGE, TENNESSEE

**NATURAL RESOURCE ASSESSMENT FOR THE PROPOSED
ENVIRONMENTAL MANAGEMENT DISPOSAL FACILITY (EMDF),
OAK RIDGE, TENNESSEE**

Date Published: June 2018

Prepared by
OAK RIDGE NATIONAL LABORATORY
Oak Ridge, TN 37831-6283
managed by
UT-BATTELLE, LLC
for the
US DEPARTMENT OF ENERGY
under contract DE-AC05-00OR22725

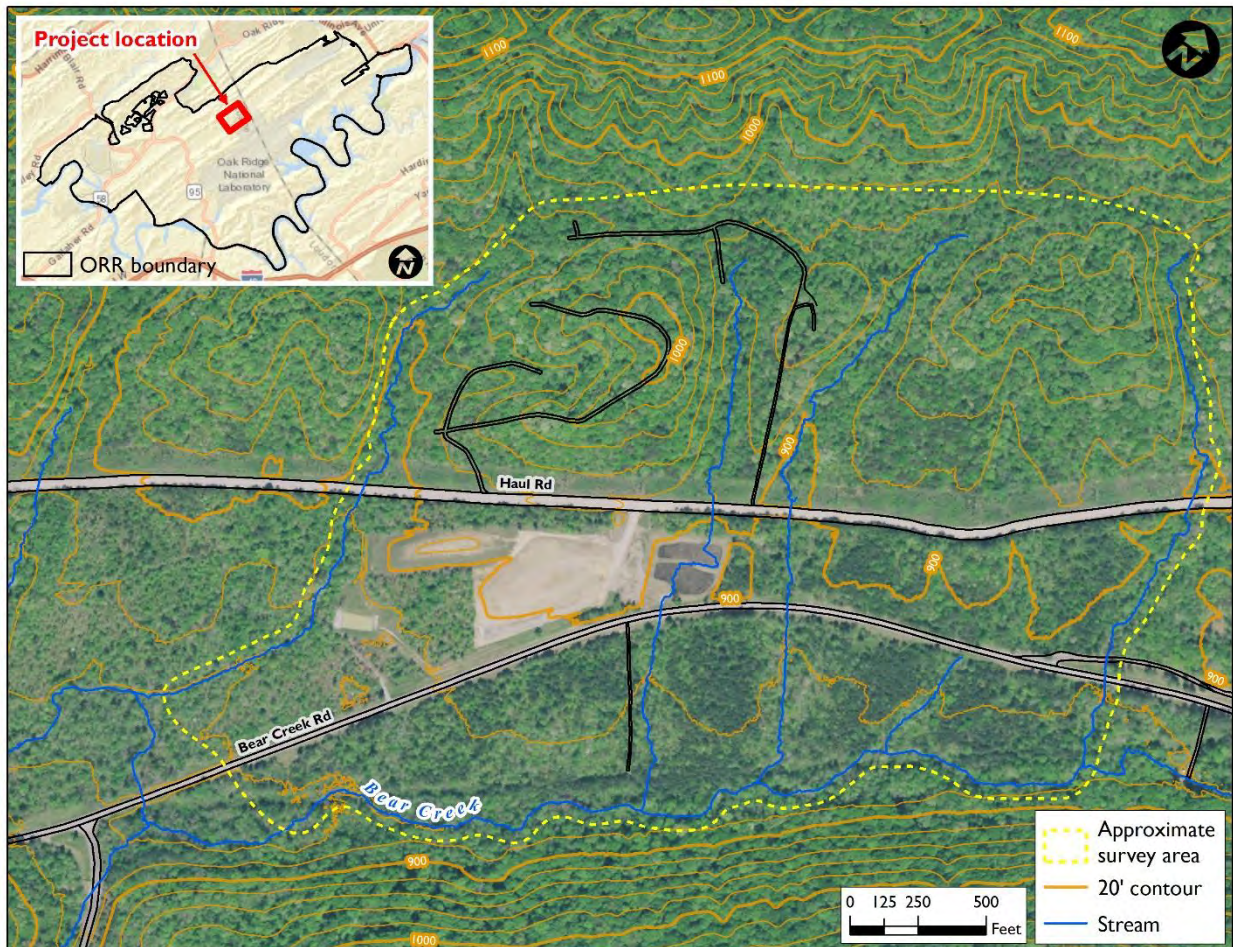
Figure 1. Map showing the proposed EMDF project area with the boundaries of the area to be surveyed for natural resources in yellow.

Because of the large size of the site, the natural resource team conducted walkovers of the study area to identify specific zones for follow-up evaluation (Figure 1). Specific survey methods for wetland delineations, stream surveys, timber assessments, and rare species surveys are described in the subsections below.

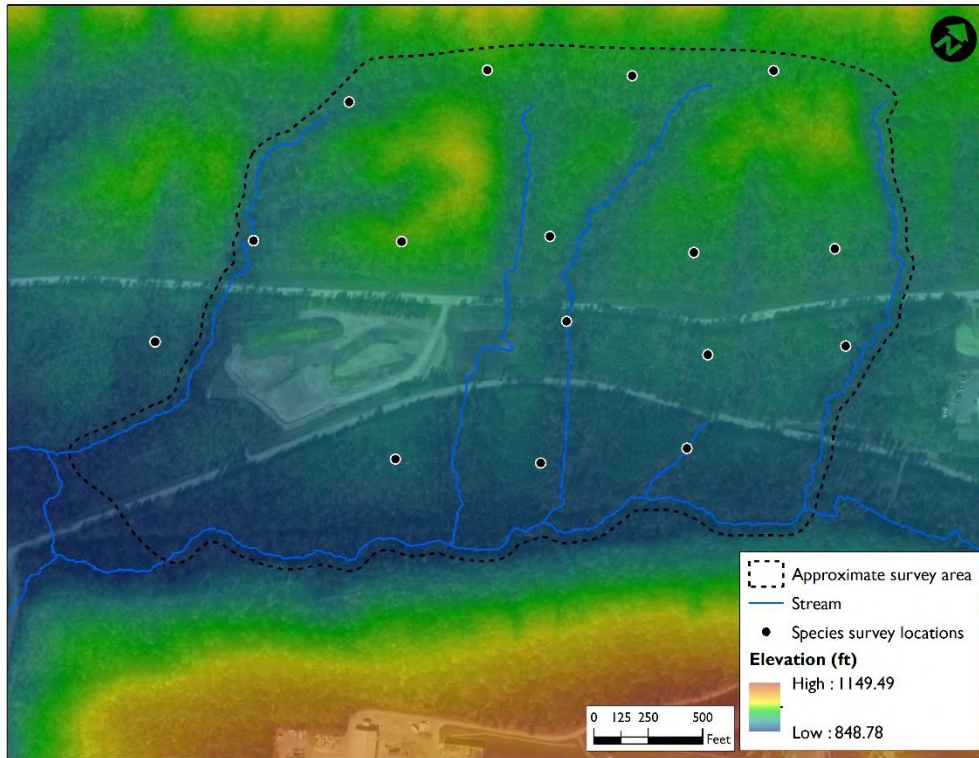
Figure 2. Map of rare species survey points.

Sixteen survey points were established approximately 200 meters apart across the site (Figure 2). Coordinates for each point are provided on Appendix A. At these survey points information on birds, small terrestrial mammals, reptiles and amphibians were recorded. All birds seen or heard at each point were recorded using methods established under the international Partners In Flight program, similar to breeding surveys already conducted on the ORR. Birds seen or heard while traveling between survey points and those incidentally observed in the course of surveying other resources on the site were also recorded. Also conducted were site listening surveys to capture information on nocturnal species (e.g., owls). Three Sherman live-traps were set in strategic locations at each point to gather information on small mammal populations frequenting the area. Visual encounter surveys (VES) were also conducted at each point to gain information on reptiles and amphibians. Cover board sampling and direct searches under logs, rocks, bark, leaf litter, and other debris were also performed. Drainages and wetlands on the site were surveyed for presence of amphibian species, including evening anuran (frog) call surveys.

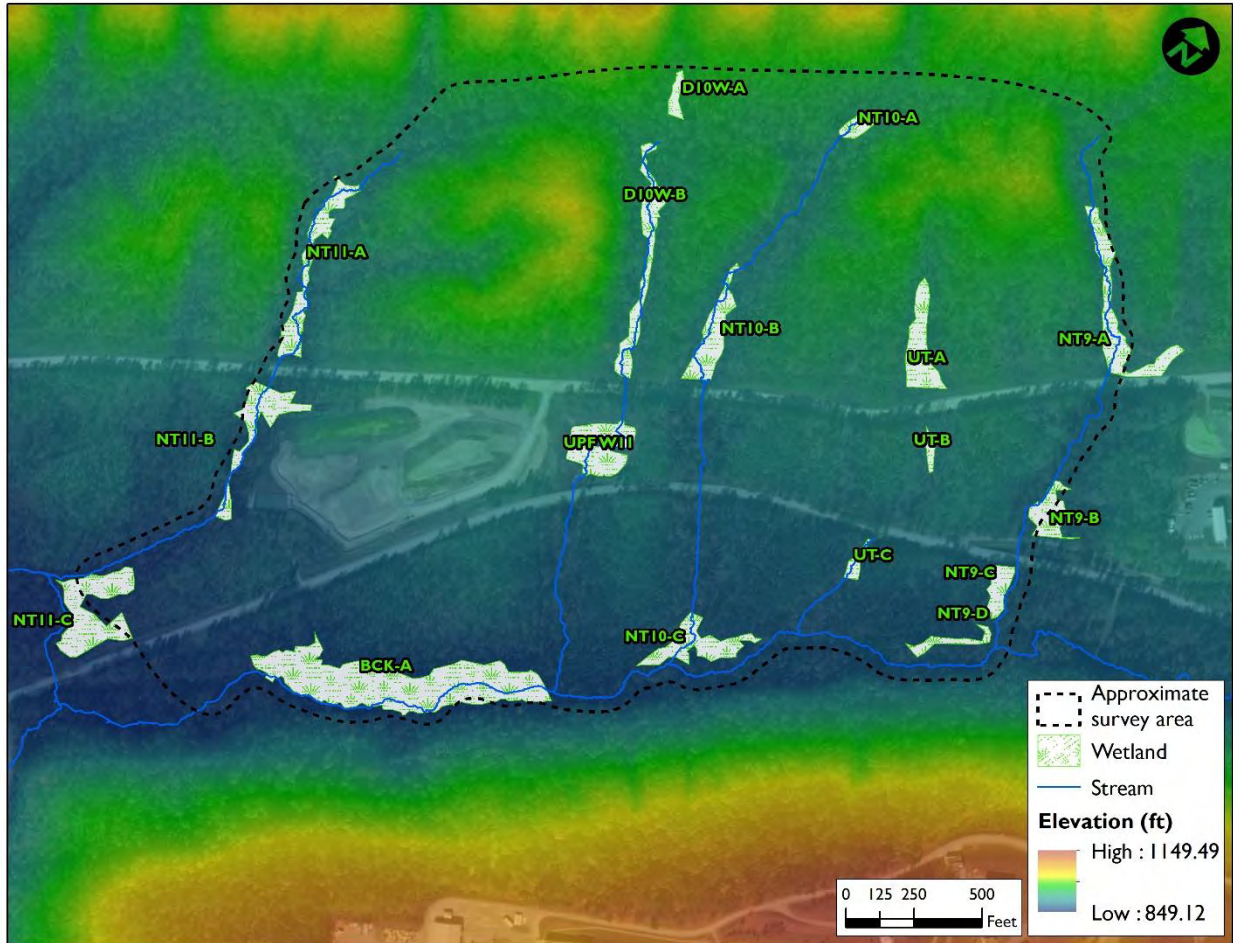
Figure 3. Map of wetlands within and adjacent to the study area.

Seventeen wetlands are located within or partially within the study area (Figure 3). A total of 11.81 acres of wetland were surveyed (Table 1). Wetlands are named based on their associated tributary or creek. Detailed information about hydrology, vegetation and soil for each wetland can be found on the data forms in Appendix B. GPS coordinates for each wetland can be found in Appendix C.

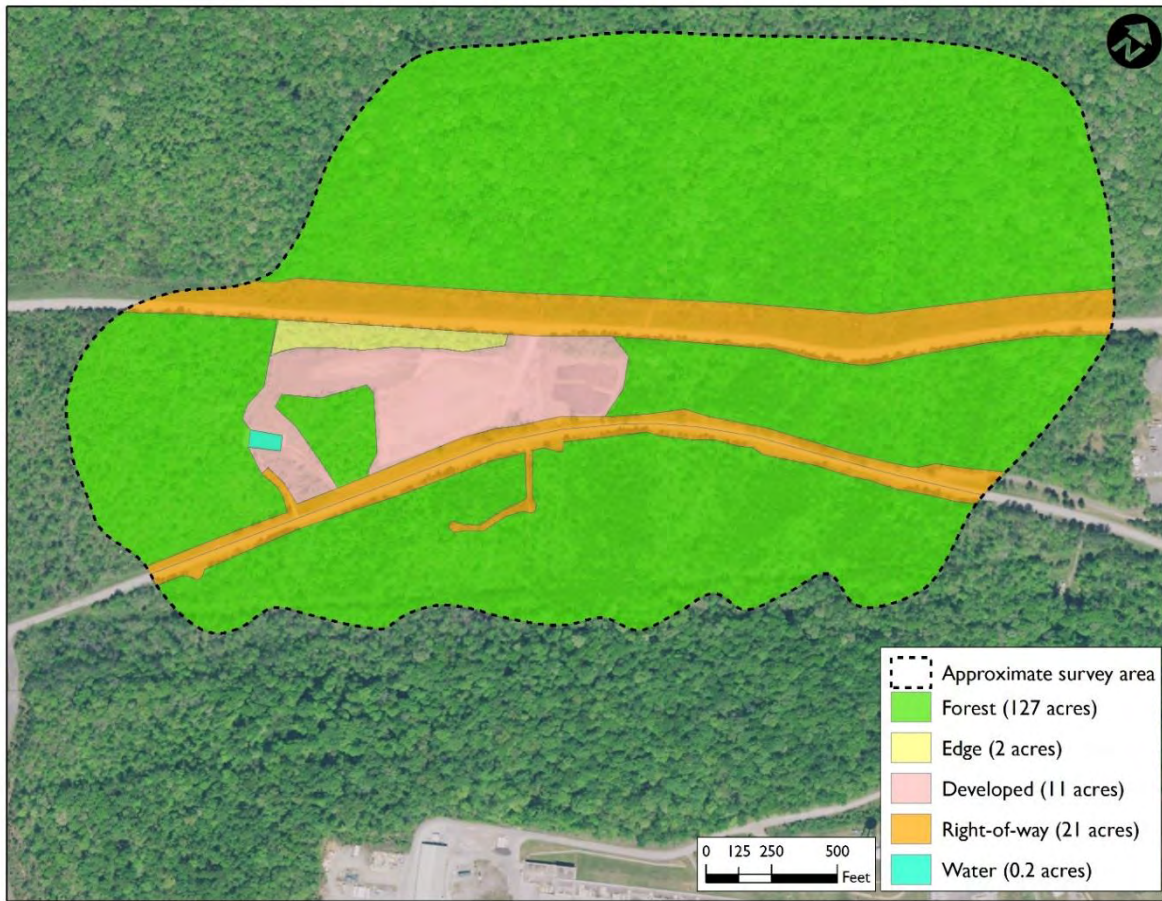
Figure 6. Spatial distribution of land use types for the proposed EMDF site.

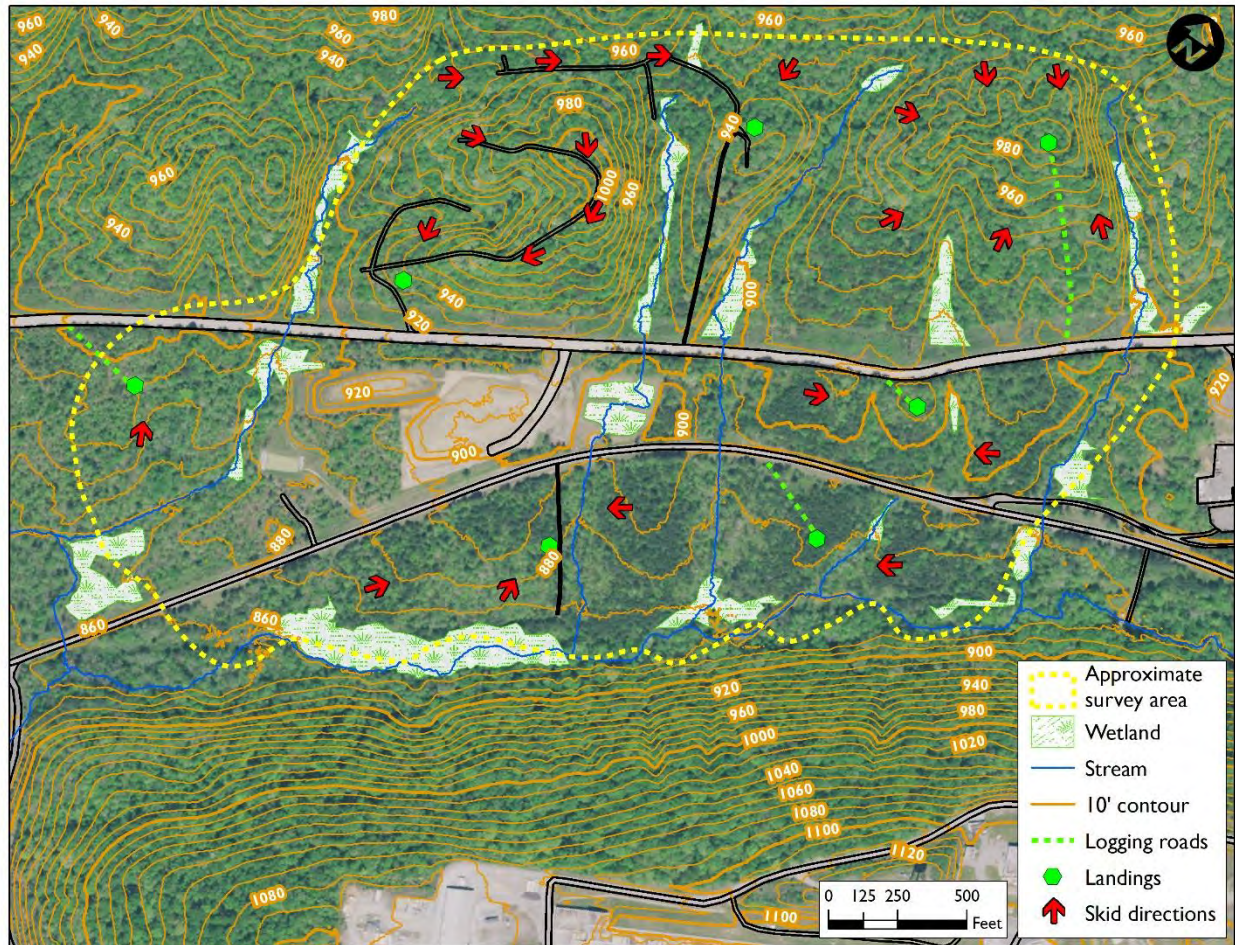
Figure 7. EMDF site topography, developed access, and forest.

Figure 7 depicts the EMDF site topography, developed access and forest. Potential log landings and additional access to them are shown in green. Generally, these are on the accessible high ground spacious enough to maneuver vehicles. In some instances, particularly off Bear Creek Road, these would be located at the sites of previous log landings. As much as possible, these will need to be away from streams and wetlands such that logs are moved away from them and taken to the landing points (potential

skidding directions shown in red). Actual locations may vary depending on weather, additional avoidance concerns, and the particular apparatus utilized by the logging crew.
