# **Health Consultation**

**FOREST VIEW PARCEL**

**ANTIOCH, DAVIDSON COUNTY, TENNESSEE**

May 8, 2017

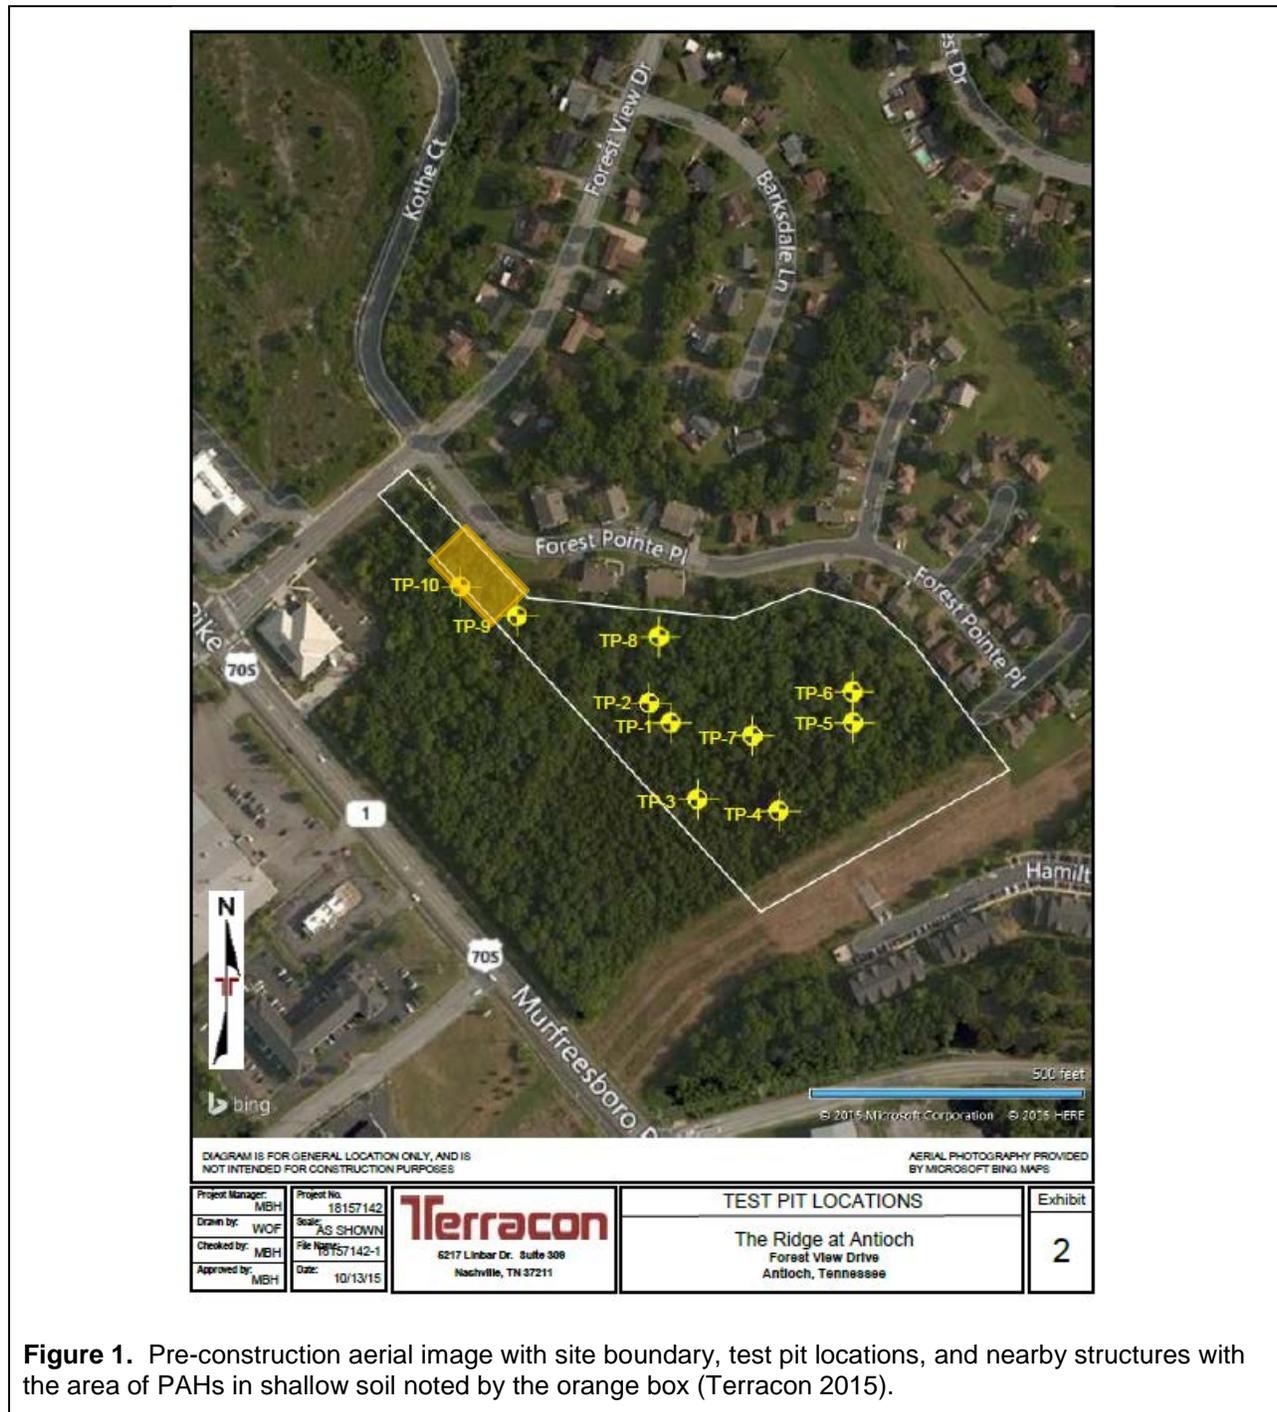
**Figure 1.** Pre-construction aerial image with site boundary, test pit locations, and nearby structures with the area of PAHs in shallow soil noted by the orange box (Terracon 2015).

A *Limited Site Investigation* was performed by Terracon Consultants, Inc. This report dated November 24, 2015, represented site work done around October 2015. The report indicated historic dumping on the site appeared to be household waste (Figure 3). Ten test pits were excavated from one to five feet below ground surface to characterize the site as shown on the aerial image in Figure 1. Seventeen hand auger soil borings were also dug. No buried wastes

A *Site Management Plan* was completed by Terracon on January 19, 2016. This document guided construction excavation including what to do with environmentally impacted site soils. The plan described testing and proper disposal methods for various potential impacts in site soils. It recommended removal of impacted soils. The plan included a short paragraph about site worker health and safety. The report indicated the area around test pit TP-10, where PAHs in soils were detected, was further sampled and delineated (Figure 1).

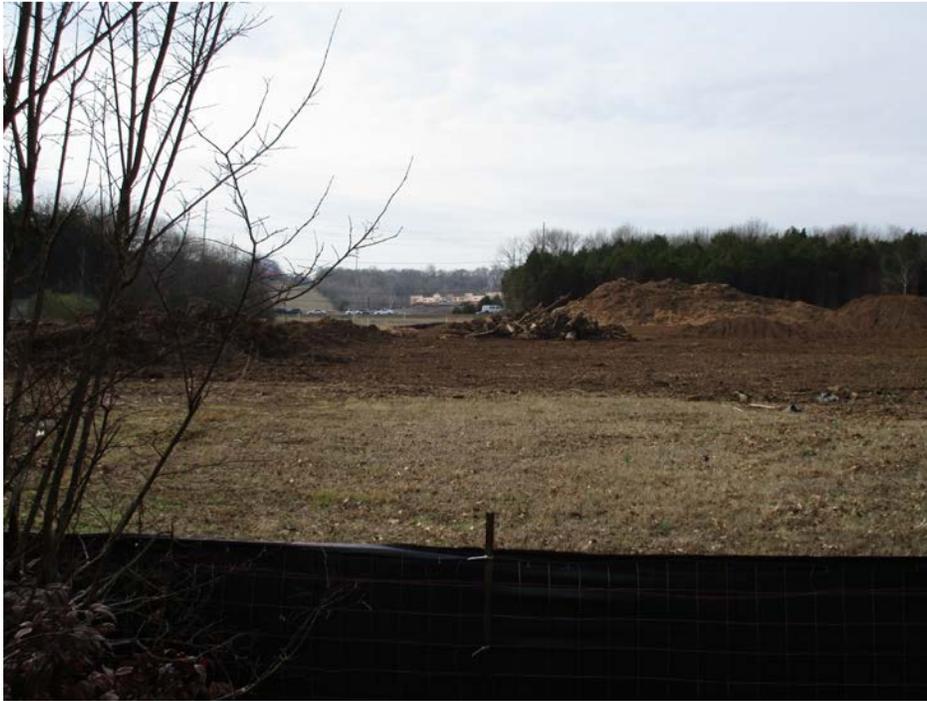
**Figure 2.** TDH photograph of the site taken January 16, 2017, after initial construction that shows piles of chipped materials after much of the woods and undergrowth was removed. The photograph was taken from Forest Pointe Place dead end looking west to Murfreesboro Road in the distance.

When TDH EEP's, David Borowski, drove by the site on January 16, 2017, much of the woods and undergrowth had been cleared (Figure 2). The site appeared to have been graded with piles of chipped material and top soil visible. An erosion control fence surrounded the worksite and created a boundary.

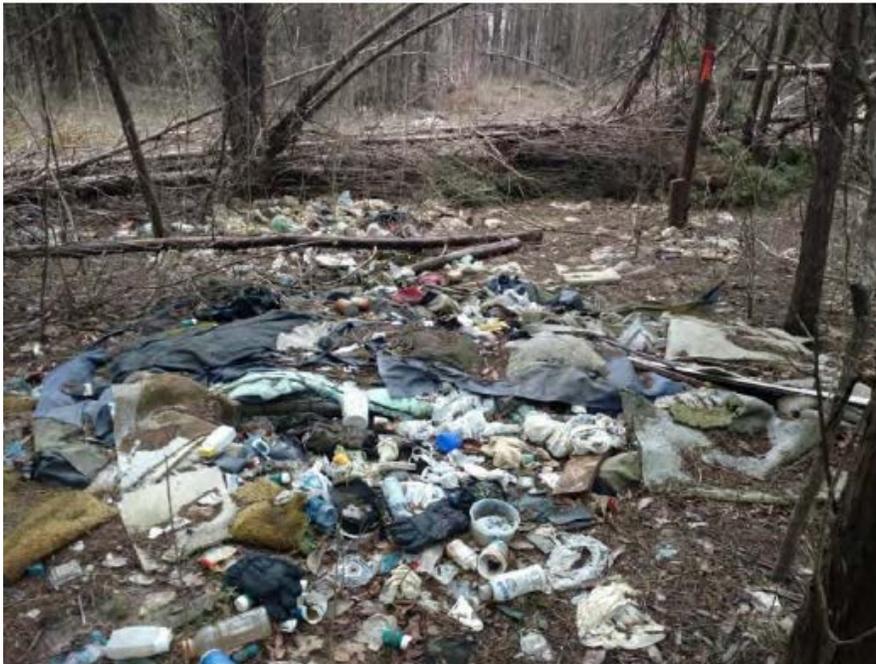
**Figure 3.** Pre-construction “view of dumped waste materials” taken February 23, 2016, as depicted in the Phase I Environmental Assessment Update (Impact Environmental).

As the far as the narrow, panhandle portion of the site, the area where small amounts of benzo[a]pyrene and benzo[b]flouranthene were found in soil was to be left undeveloped. The physical hazard of the dumped household waste materials (Figure 3) has been removed. While it may have been ideal to permanently remove these soils from the site, the area of former trash dumping was small. Leaving this small area wooded with trees and brush provides vegetative cover to both hold soils in place and act as a barrier to people coming in contact with the soils. Perhaps more importantly the small area is disconnected from the proposed apartment complex (Figure 7). Considering the proposed site plan, after construction of the buildings, pavement, and landscaping the places where people are likely to be are different from the small area near TP-10. People would not be expected to wander through the wooded area on a frequent basis making any residual chemical concerns in the small area of very low health risk.

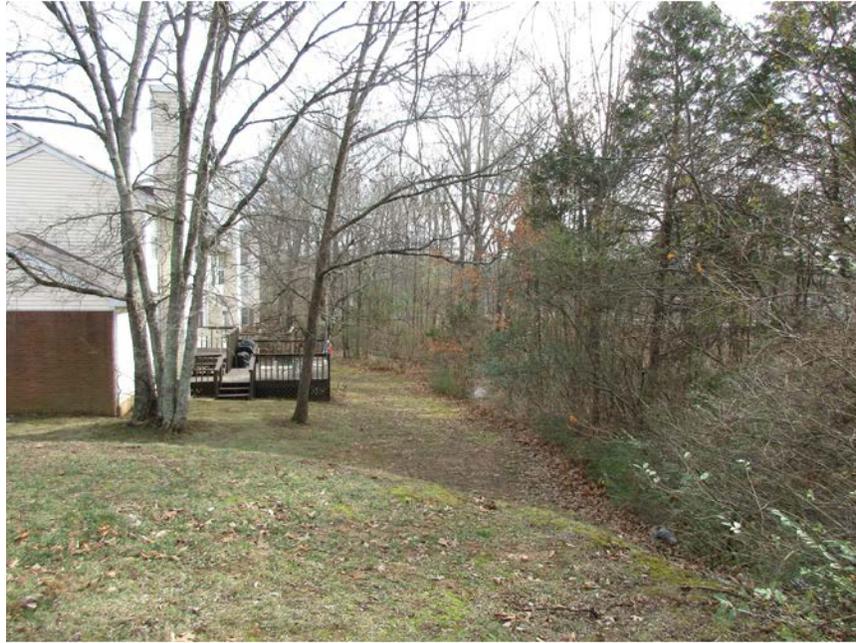
**Figure 4.** TDH photograph of the general wooded boundary of the existing neighborhood and the new development showing the appearance of some backyards during the initial construction and land clearing. The photo was taken by TDH on January 16, 2017, from the mailbox area of the Forest View neighborhood on Forest Pointe Place looking east southeast. The tree and brush on the right-hand side is near test pit TP-10 and representative of the ground cover that remains undeveloped in that area.

Two ways impacted soils could migrate off the site are as soil or as fugitive dust. The developer used and has since appeared to maintain an erosion control fence around the perimeter of the site to prevent soil from leaving the site. Figures 4 and 5 show the eastern boundary of the site near a neighborhood with typical winter season vegetative cover. Figure 6 shows the western boundary with the grassy, underground utility easement and existing apartment complex in the background. There was no indication of soils leaving the site going to nearby residential yards.

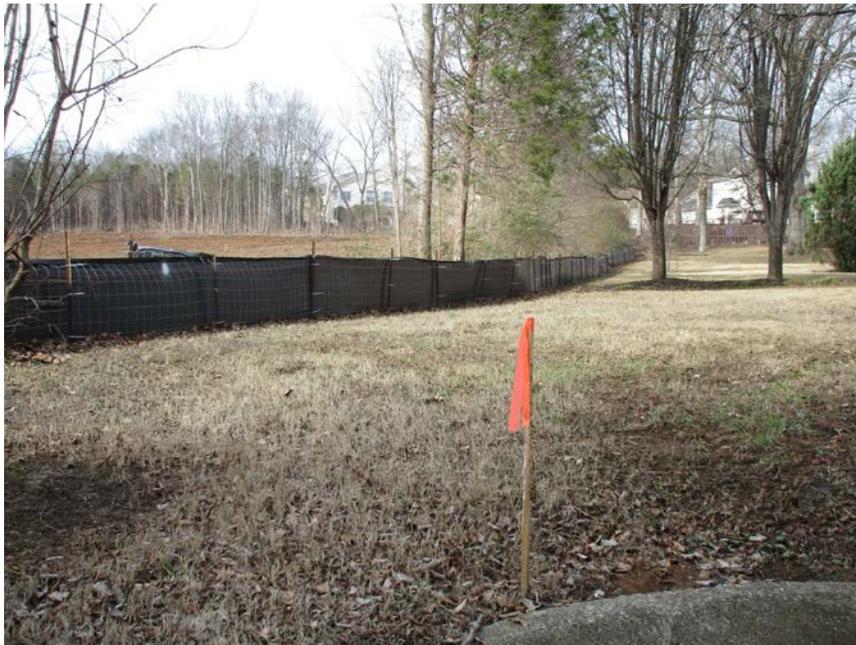
**Figure 5.** TDH photograph of a survey flag at the concrete curb of the dead end of Forest Pointe Place showing conditions of the cleared site, erosion control fencing, and backyard areas of several homes along the southwest side of Forest Pointe Place taken January 16, 2017. Survey flag was assumed to be the eastern property line that runs southeast to northwest.

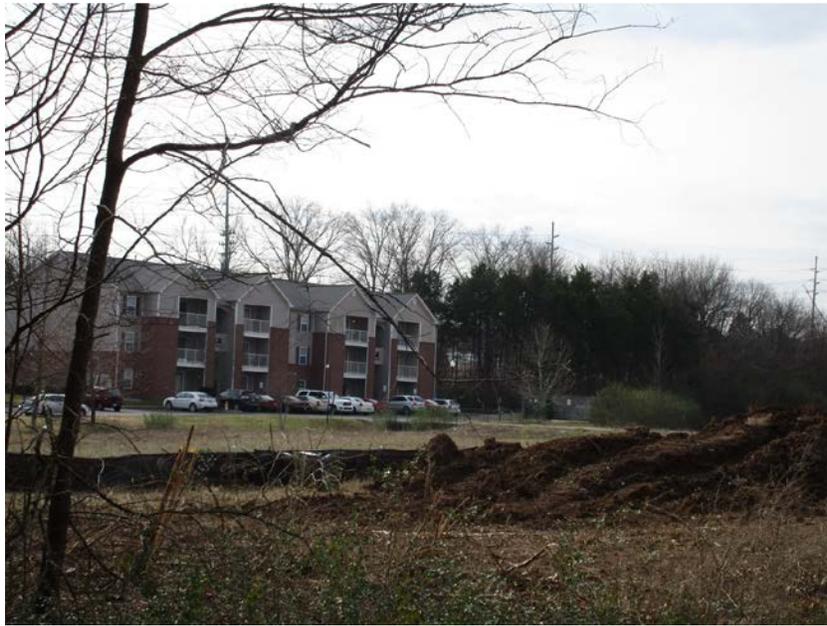
**Figure 6.** TDH photograph of the site boundary on the south side with the erosional control fence, grassy utility easement, and the Hamilton Creek Apartments taken January 16, 2017. The photo was taken from the dead end of Forest Pointe Place looking south.
