NATIONAL REGISTER OF HISTORIC PLACES NOMINATION FILE  
Tennessee State Historic Preservation Office

Listing Name: Dunlop House  
Address: 517 Madison Street  
City: Clarksville  
County: Montgomery  
Associated MPS: Clarksville MPS

# National Register of Historic Places Registration Form

**Dunlop House, ca. 1916 – Contributing Building**

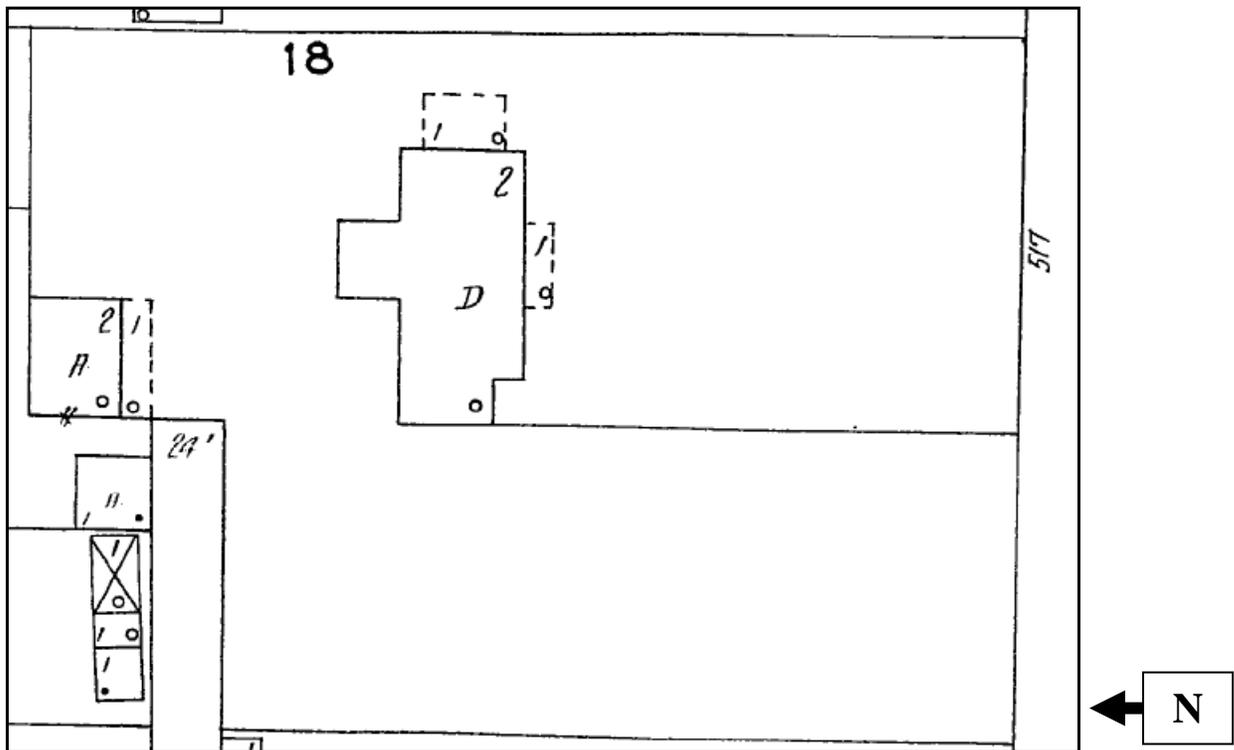
Figure 1: Dunlop House as shown on the 1927 Sanborn Map for Clarksville, Tennessee. From ProQuest Digital Sanborn Database.

At first glance, the house appears to have a symmetrical fenestration pattern due to the prominence of the south façade, particularly from the lower street level, but the house’s form is actually complex, due to a recessed side (west) wing, a side (east) porch, and a rear (north) wing (see Figure 1 and Plans).

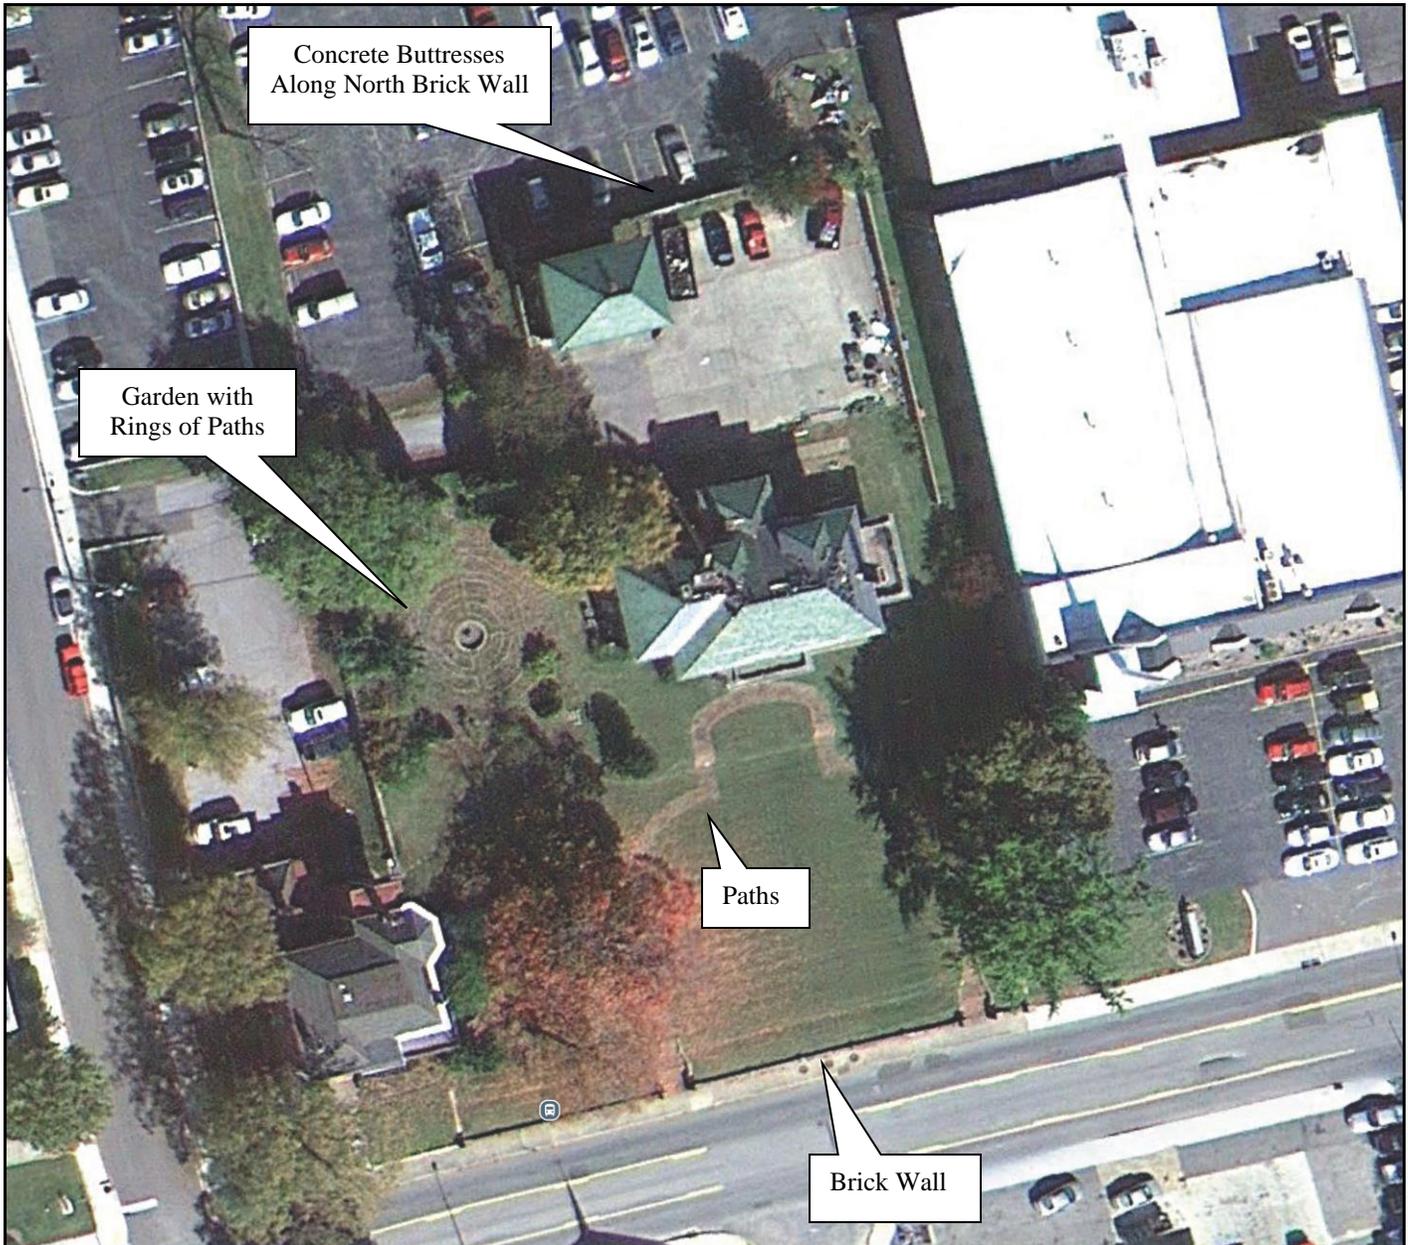
Figure 2: Oct 2011 Aerial View of the Dunlop House Property with added annotations noting important landscape features. The image is still representative of conditions today. Image courtesy of Google Earth.

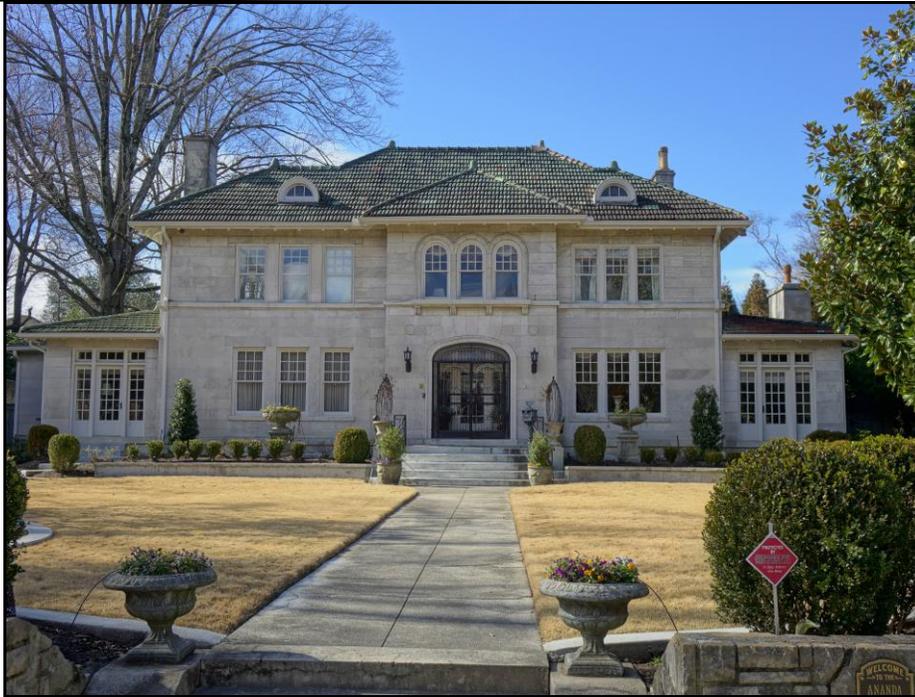
Figure 3: Typical Example of Italian Renaissance Revival Style in Tennessee, as seen at 543 S. Belvedere Blvd., Memphis, Tennessee, 2021. Photo from the Tennessee Historical Commission.

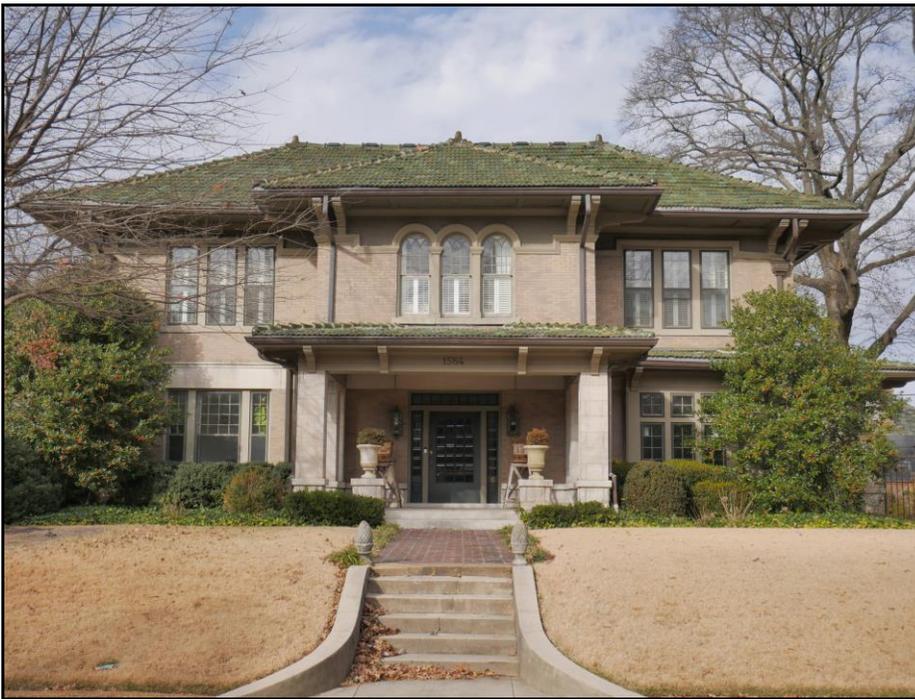
Figure 4: Typical Example of Italian Renaissance Revival Style in Tennessee, as seen at 1584 Carr Avenue, Memphis, Tennessee, 2021. Photo from the Tennessee Historical Commission.

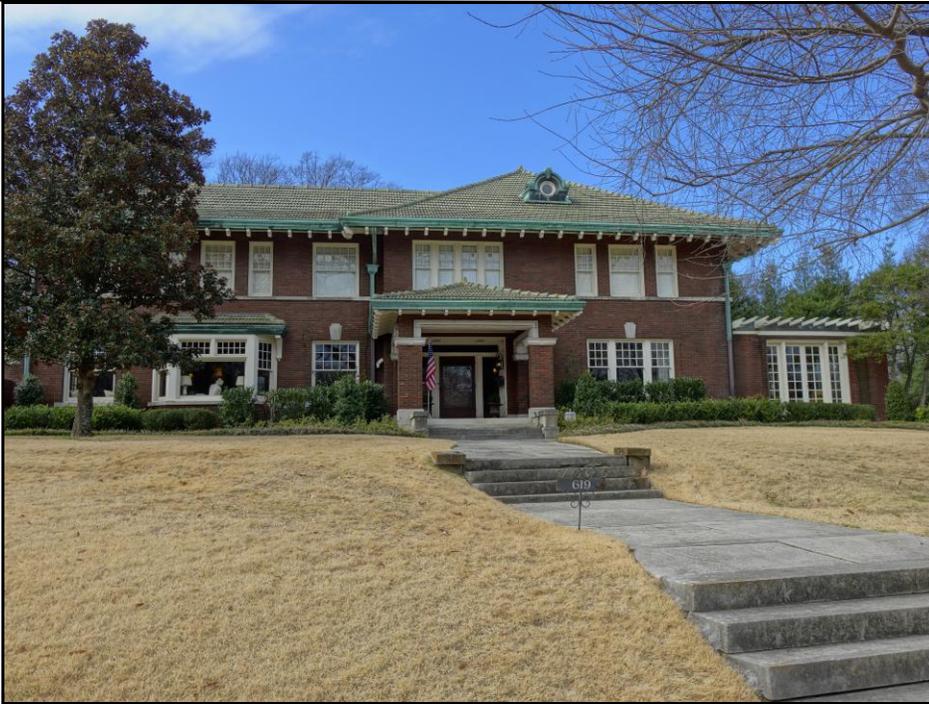
Figure 5: Asymmetrical Example of Italian Renaissance Revival style, as seen on 619 S. Belvedere Blvd in Memphis, Tennessee, 2021. Photo from the Tennessee Historical Commission.

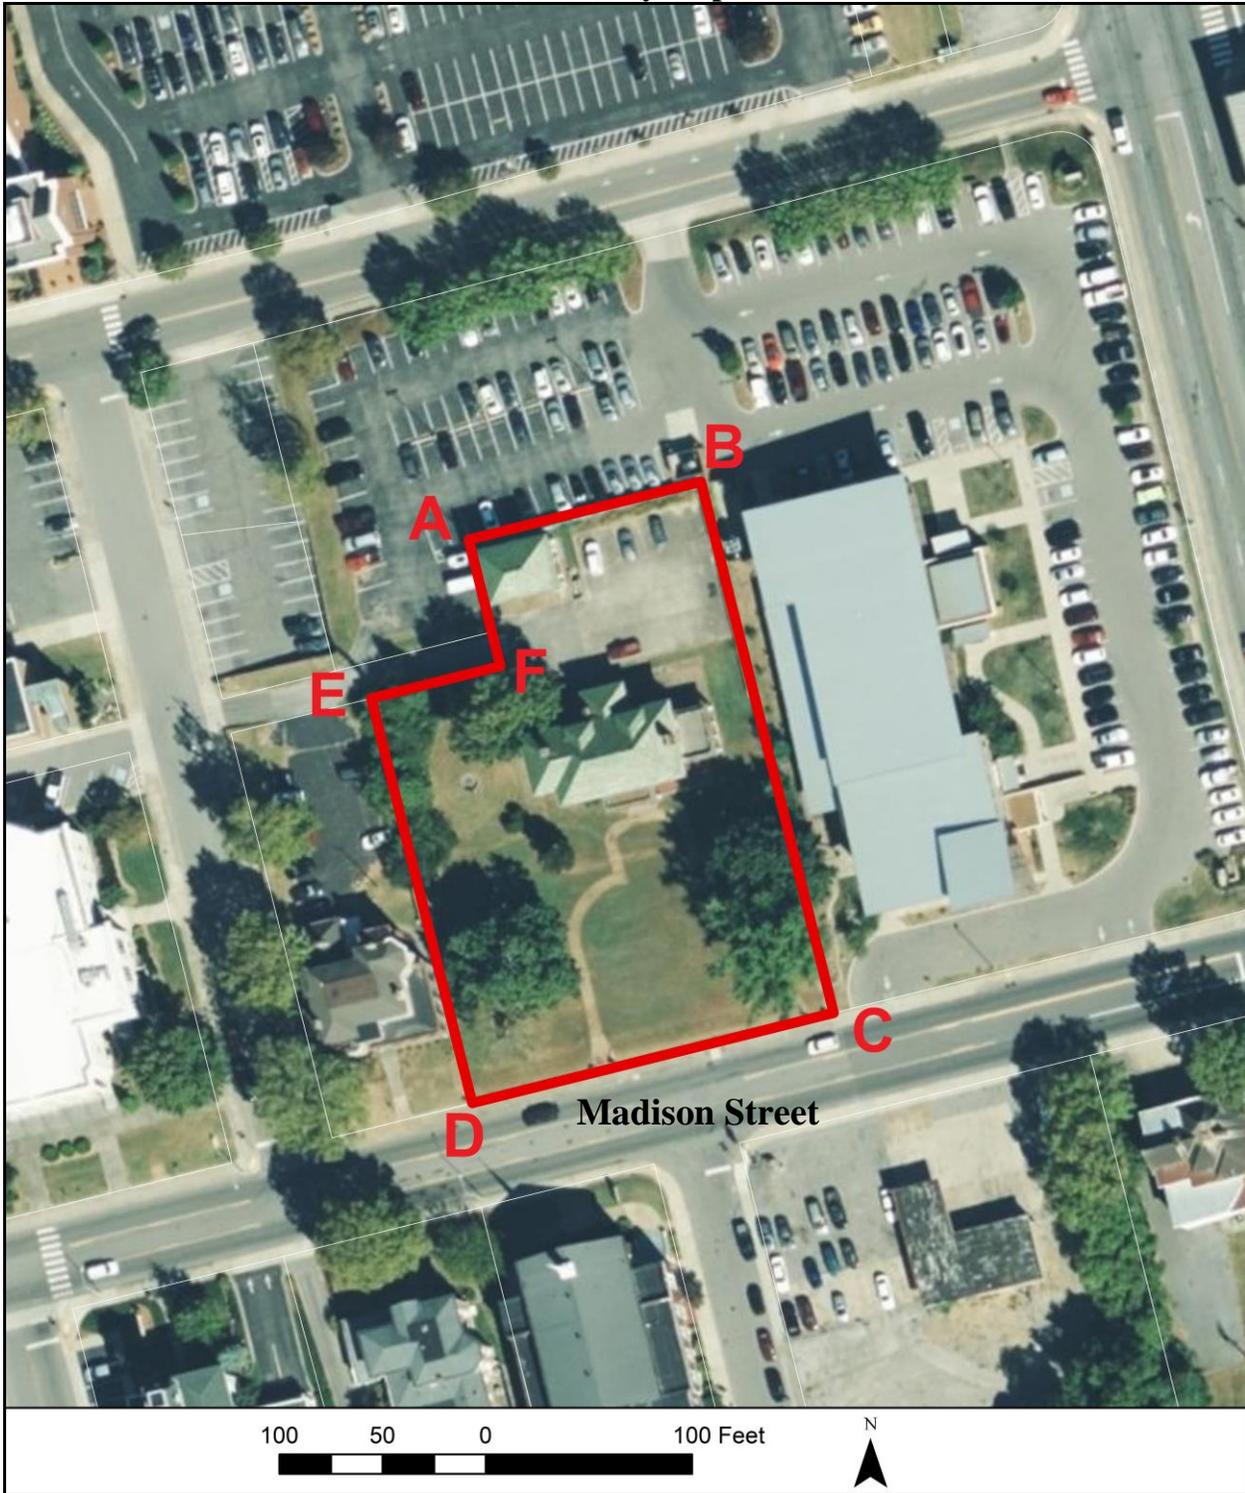
**Boundary Map**

The National Register boundary is depicted by the bold red polygon, overlaid on ca. 2020 aerial imagery and parcel lines (thin white lines). Also included are references to the Latitude/Longitude coordinates noted in Section 10.

The National Register Boundary corresponds to the legal parcel boundaries of Montgomery County Parcel 066K B 01900 000. The boundaries are depicted on the enclosed boundary map. The coordinates noted above correspond to the approximate corners of the boundary.

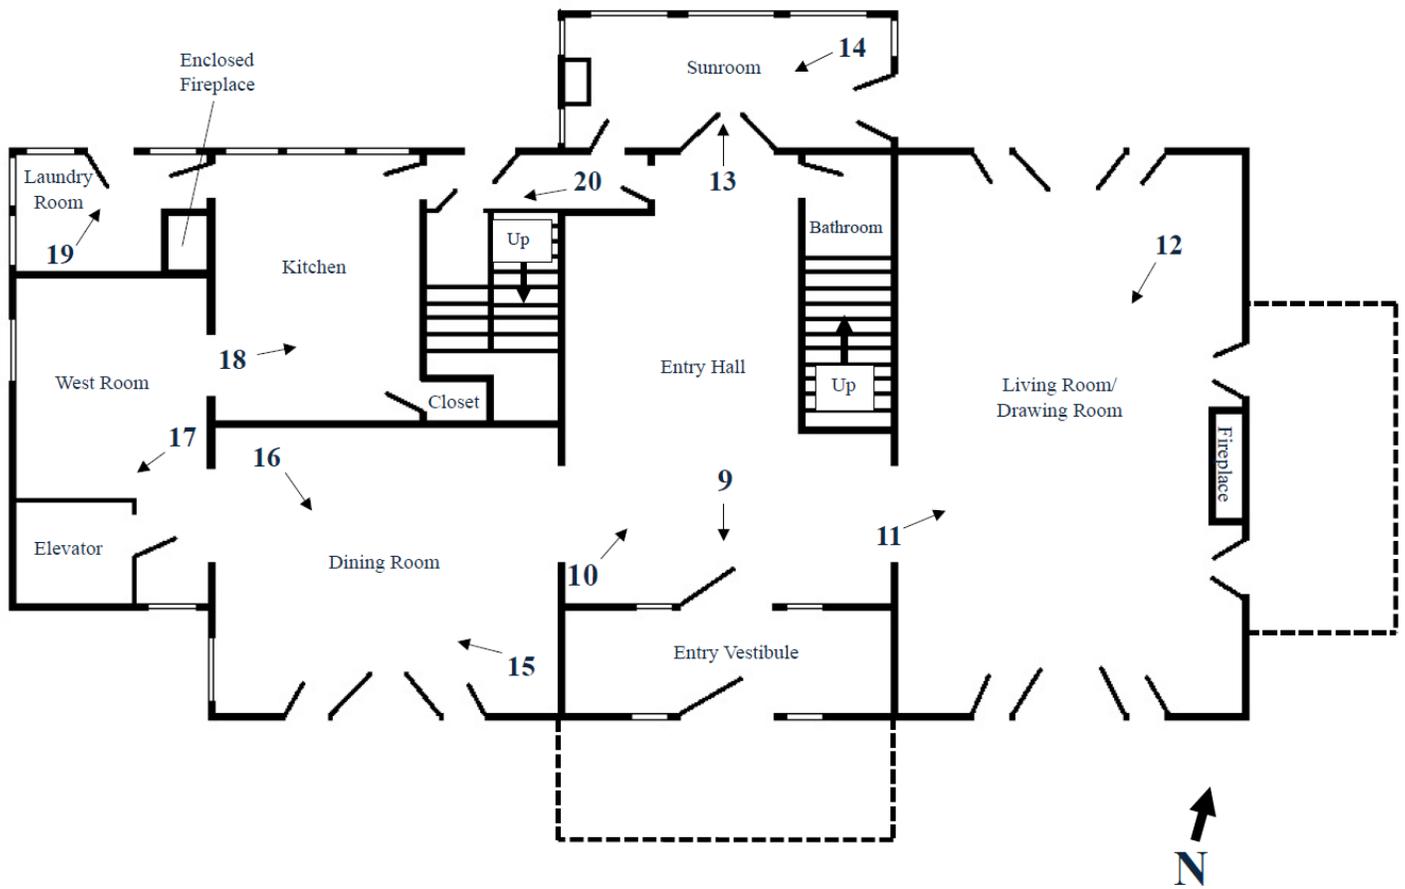
### Dunlop House – First Floor

### Floor Plans with Photos Keyed All Plans Not to Scale
