SR-66 Natural Resources  
Technical Memorandum

From State Route 34 (US-11E, Andrew Johnson Highway) in Bulls Gap to  
Near Speedwell Road/Old Highway 66, Hawkins County, Tennessee  
PIN 107579.00, Federal Project #: STP-66(38)

Appendix H: SR-66 Natural Resources Technical Memorandum  
April 2025

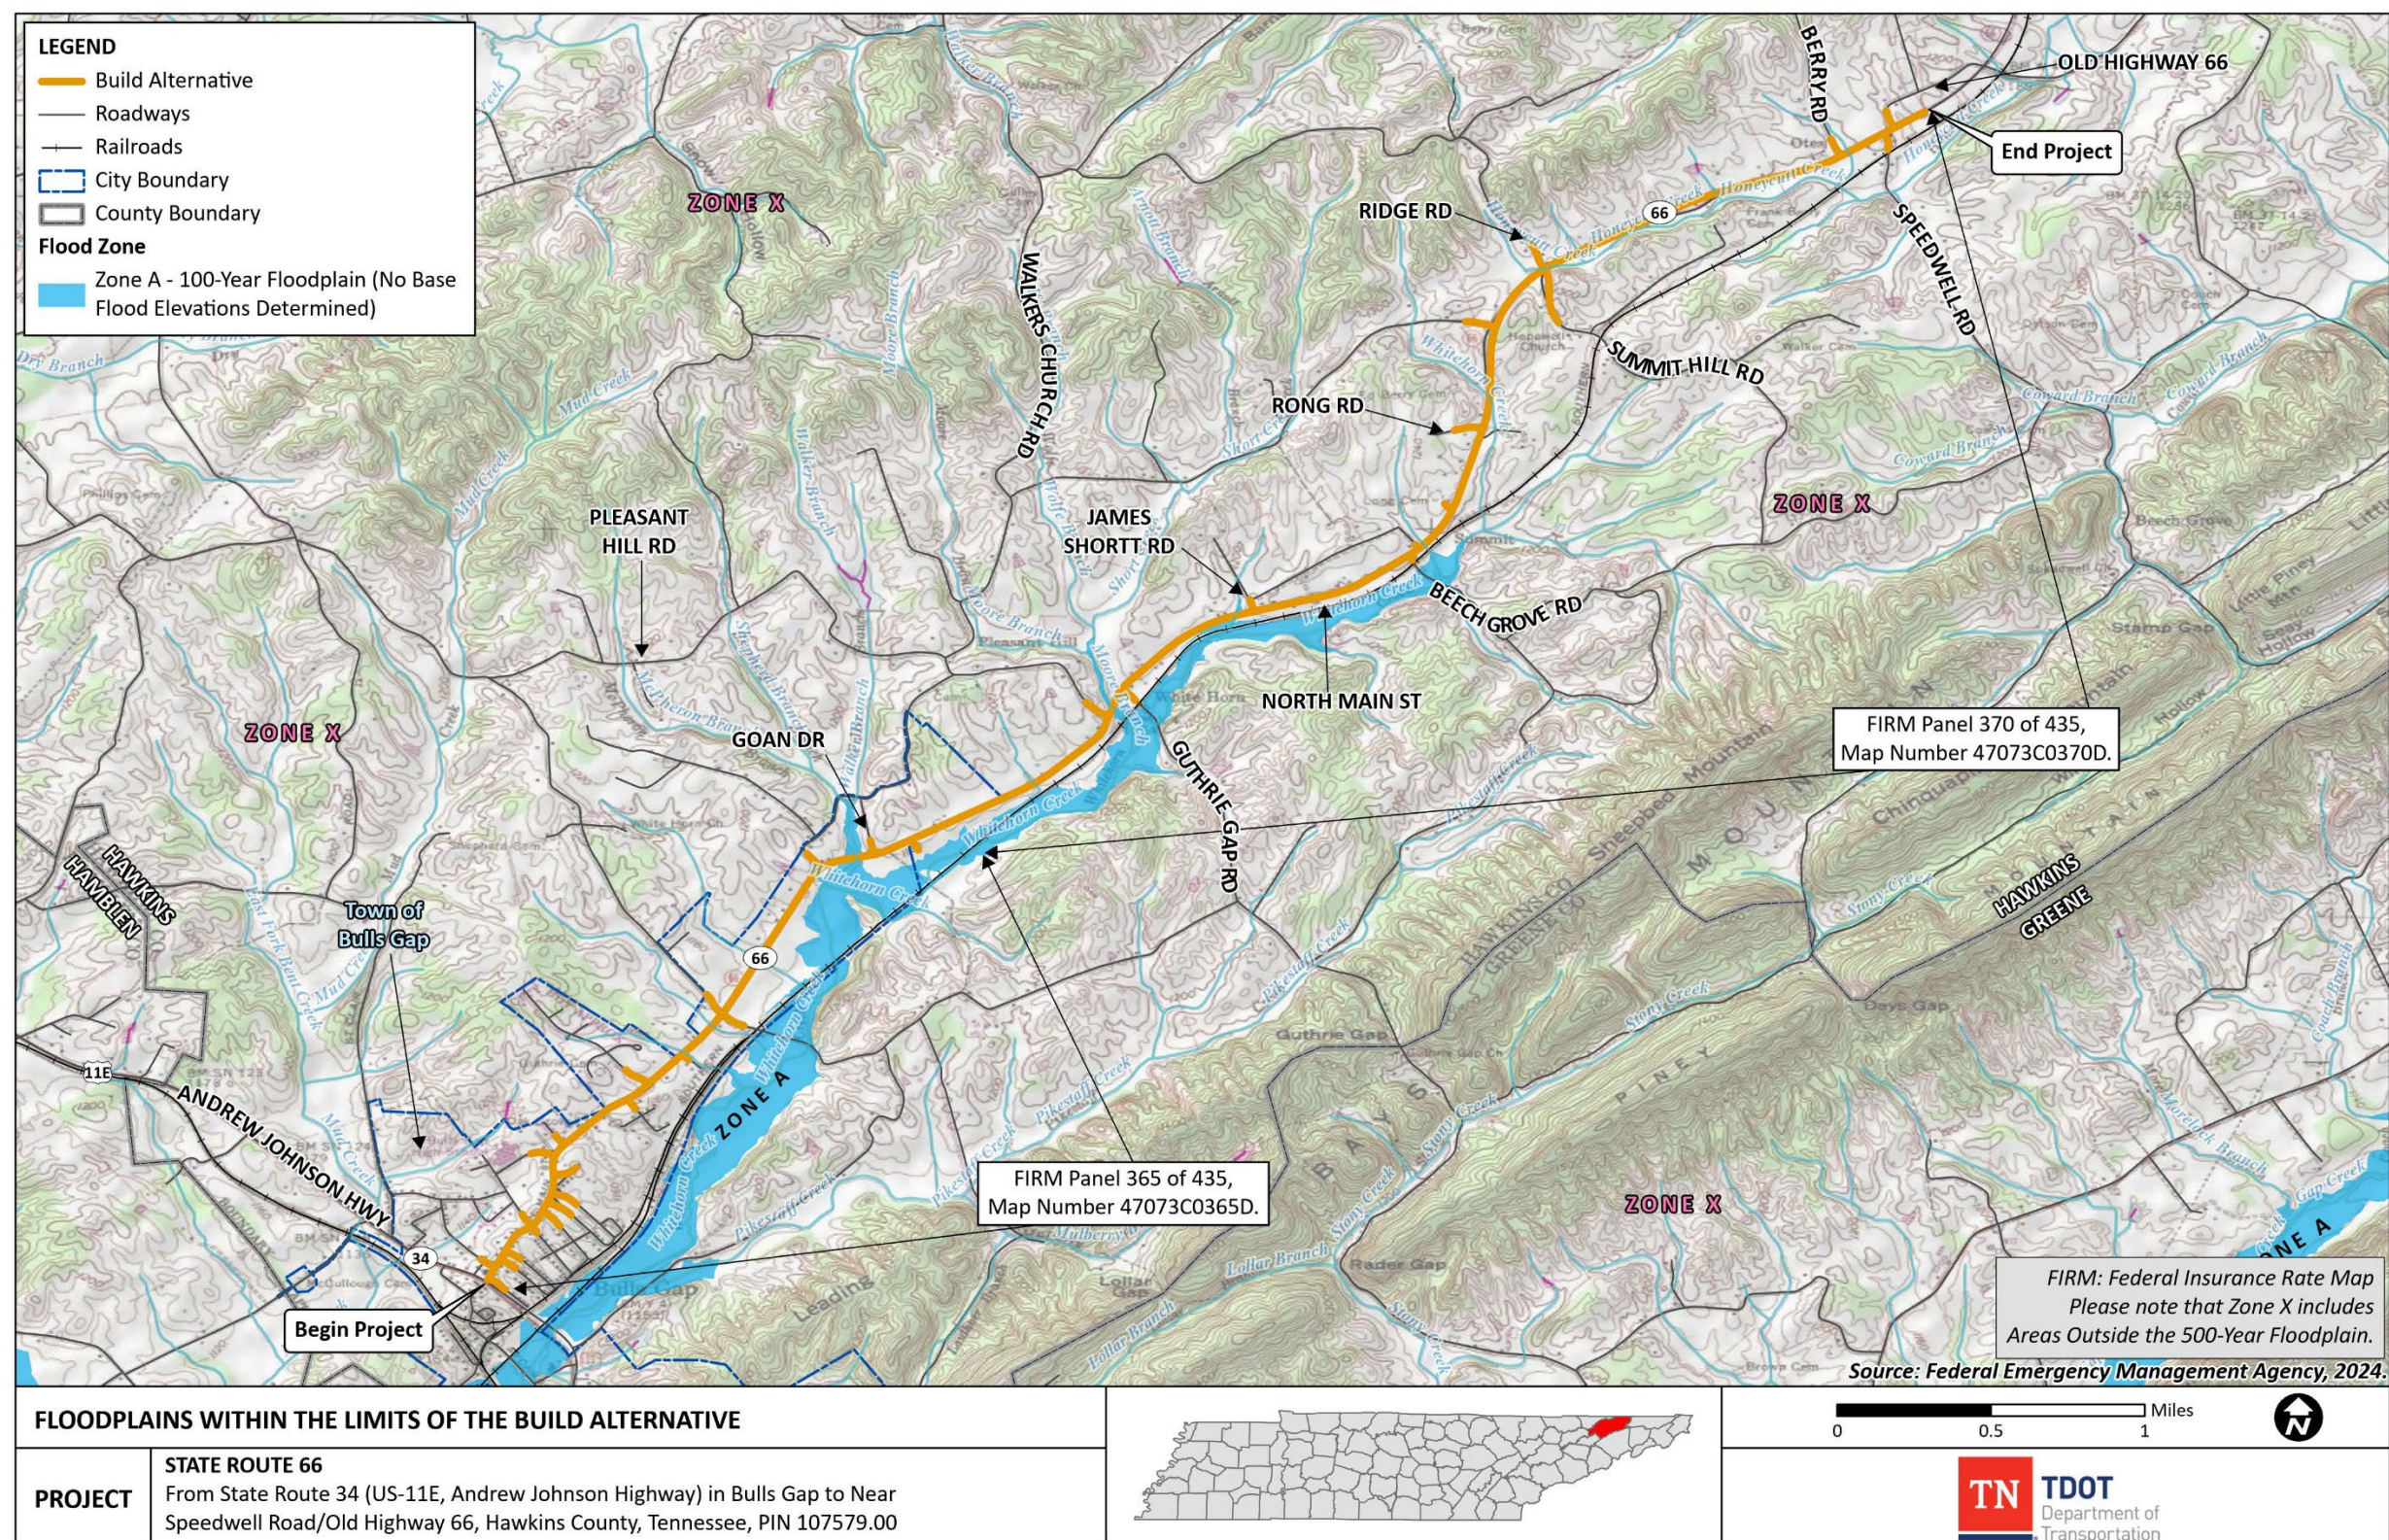
### Figure 2: Floodplains Within the Limits of the Build Alternative

Refer to **Figure 2** below for a map of the floodplains found within the limits of the Build Alternative. Copies of each individual FIRM can be found below in **Appendix C**.

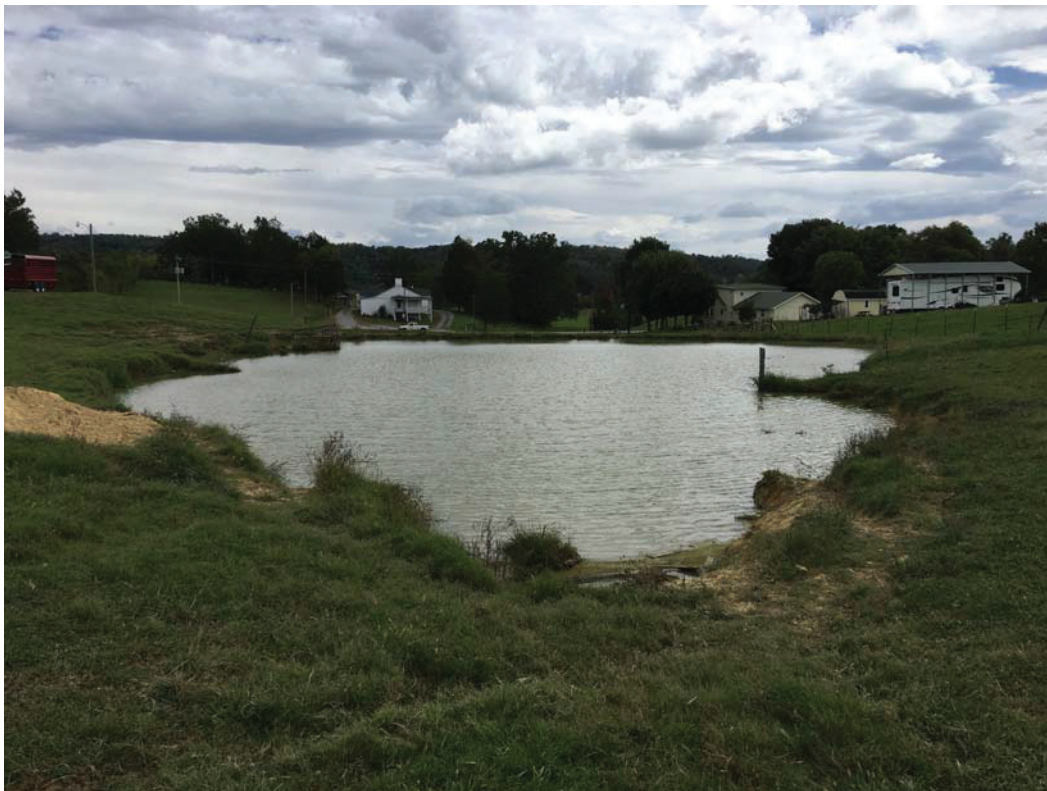
**Photo 1:** Southeast view of PND-1 at Sta. 132+00L.

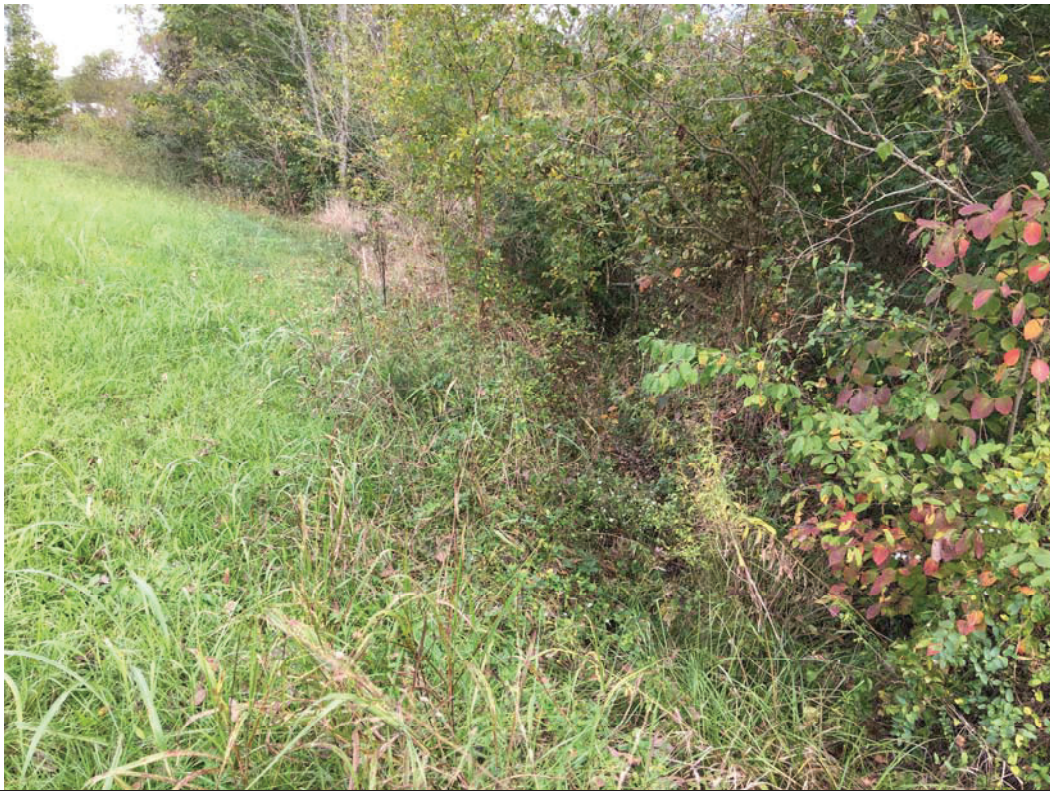
**Photo 3:** Downgradient view of WWC-1 / EPH-1 at Sta. 143+00R.

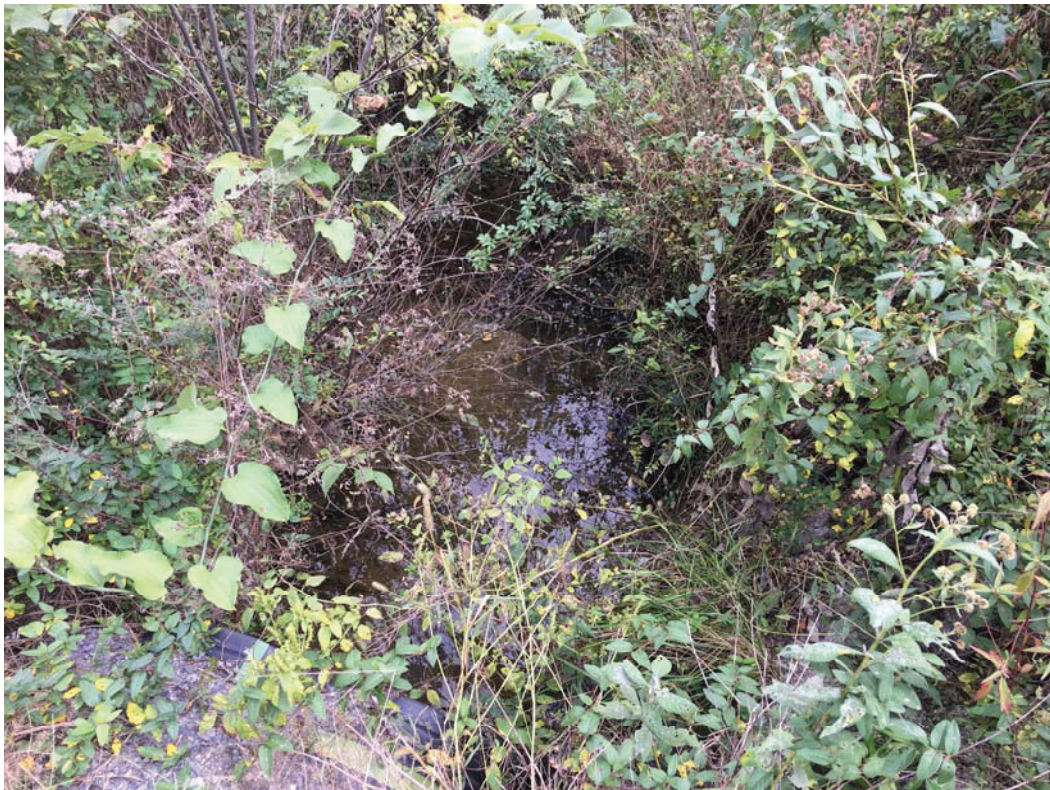
**Photo 4:** Downstream view of STR-1 at Sta. 149+60.

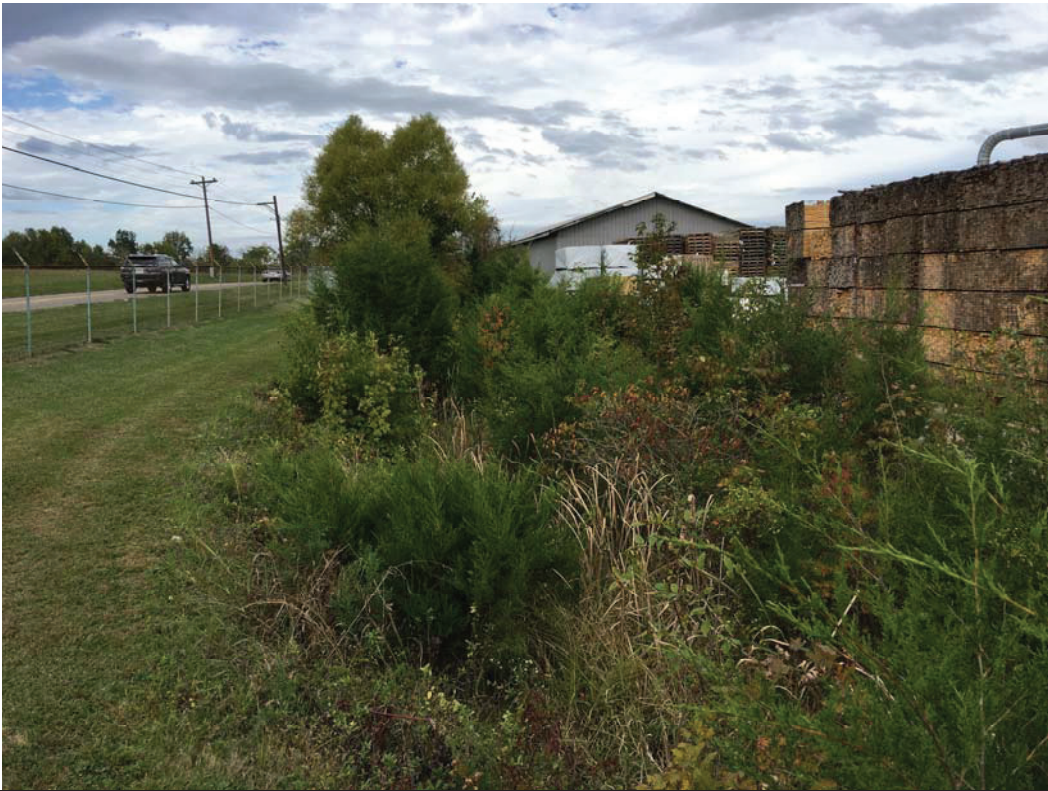
**Photo 7:** Upstream (north) view of STR-3 and WTL-3 at Sta. 158+00R.

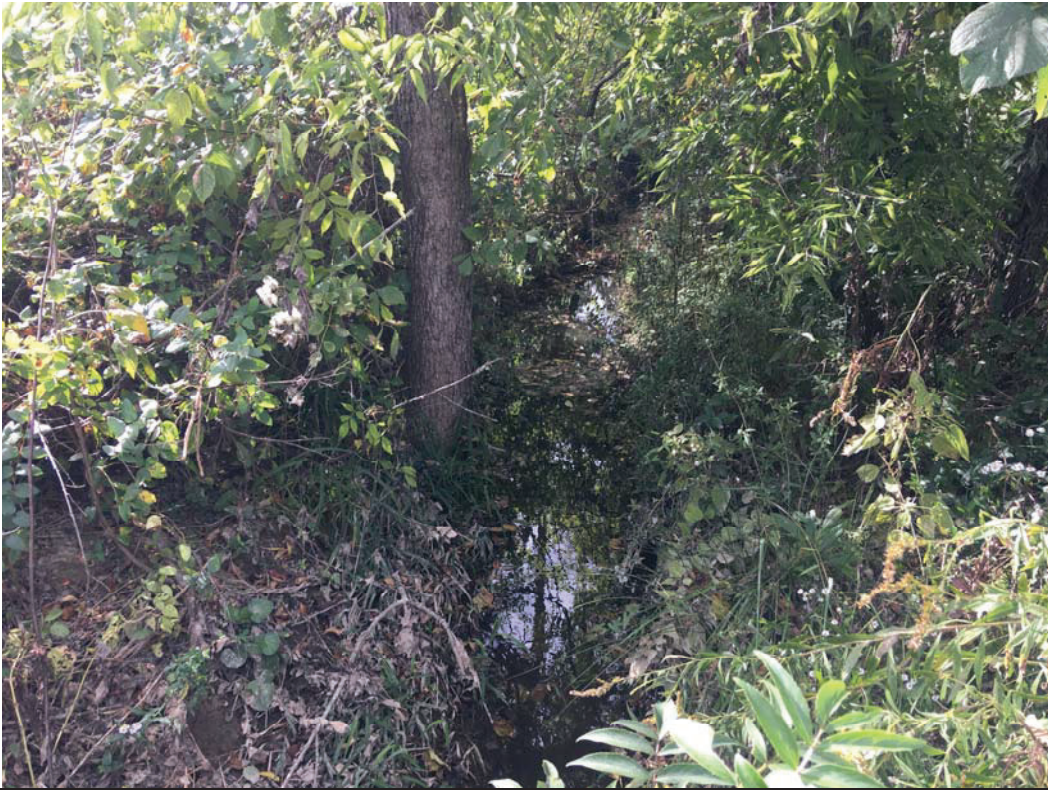
**Photo 9:** Upstream view of STR-4 at Sta. 168+60.

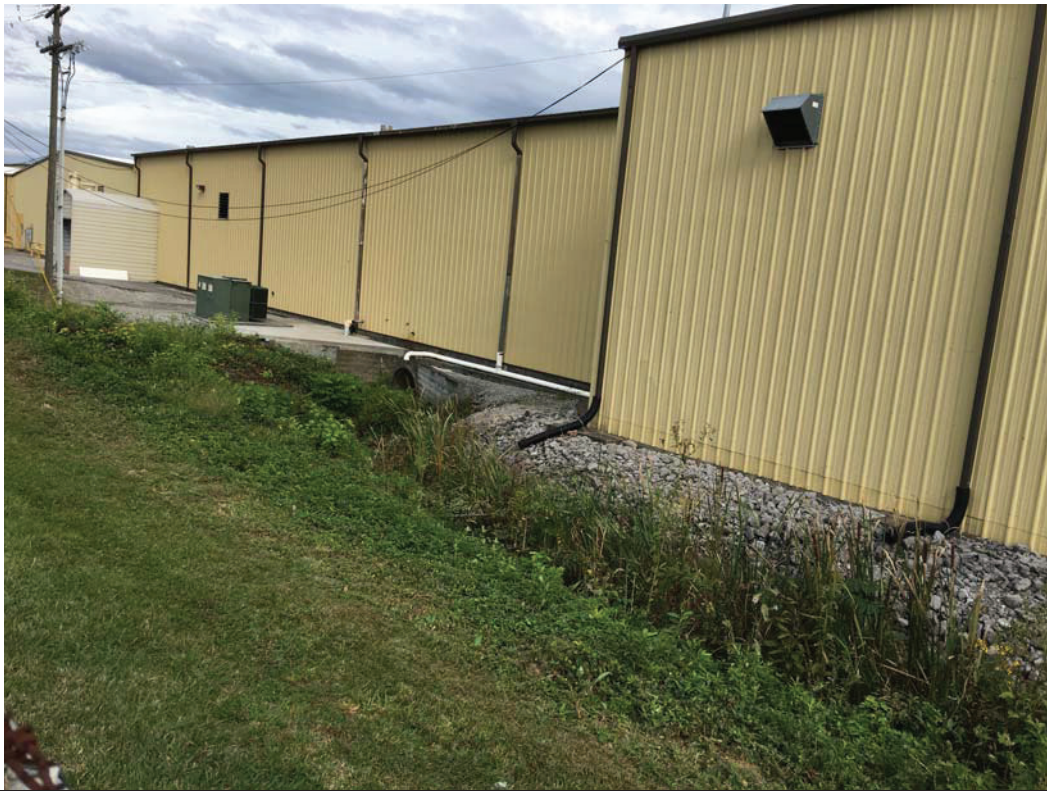
**Photo 11:** Downstream view of STR-4 where it flows under warehouse at Sta. 172+50R.

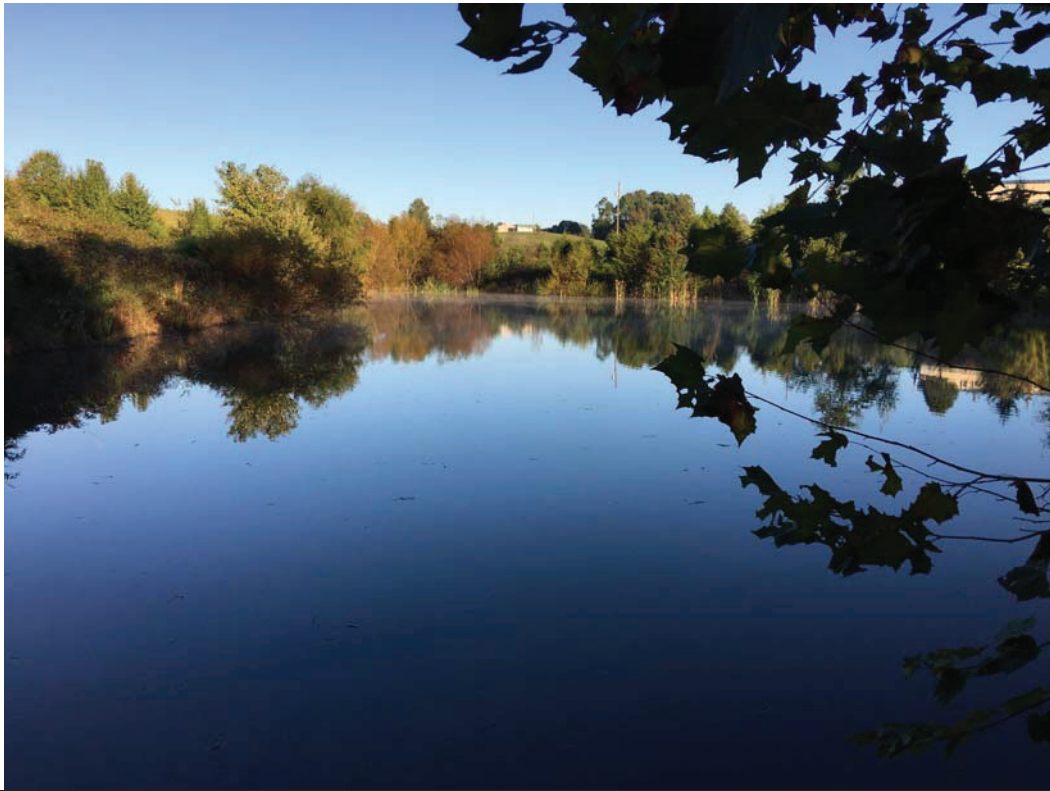
**Photo 13:** Northwest view of PND-2 at Sta. 184+25L. PND-2 provides hydrology for STR-5 and WTL-4.

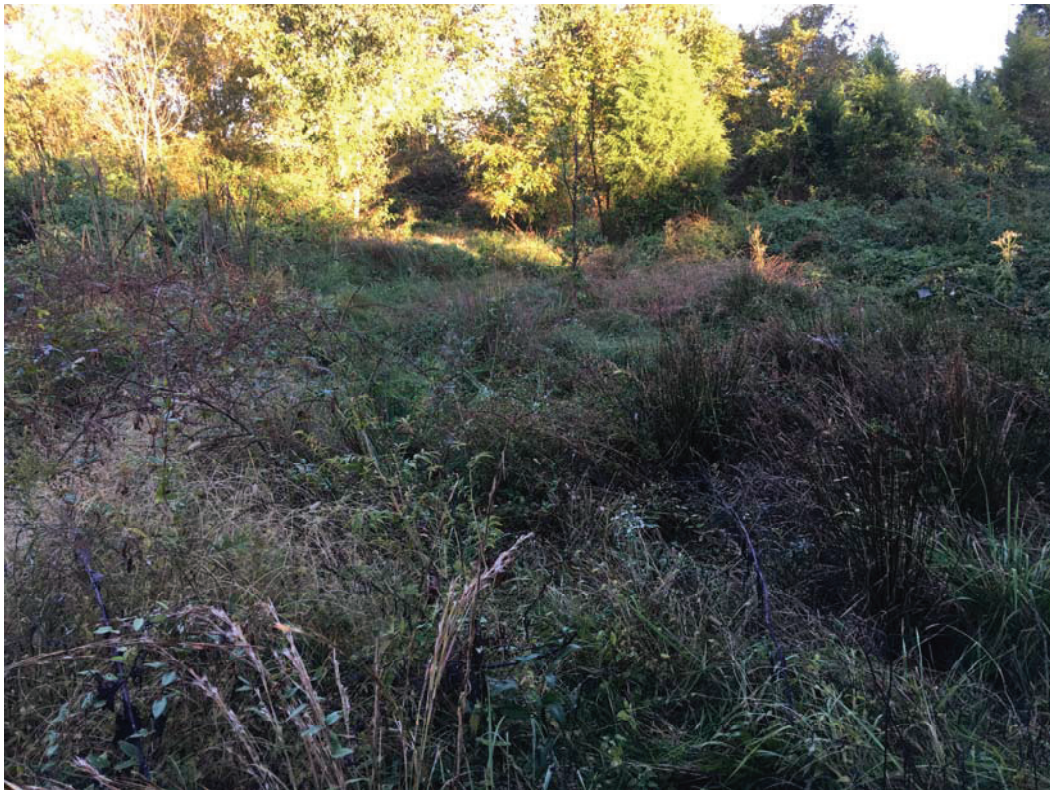
**Photo 14.** Northwest view of WTL-4 at Sta. 184+50L.

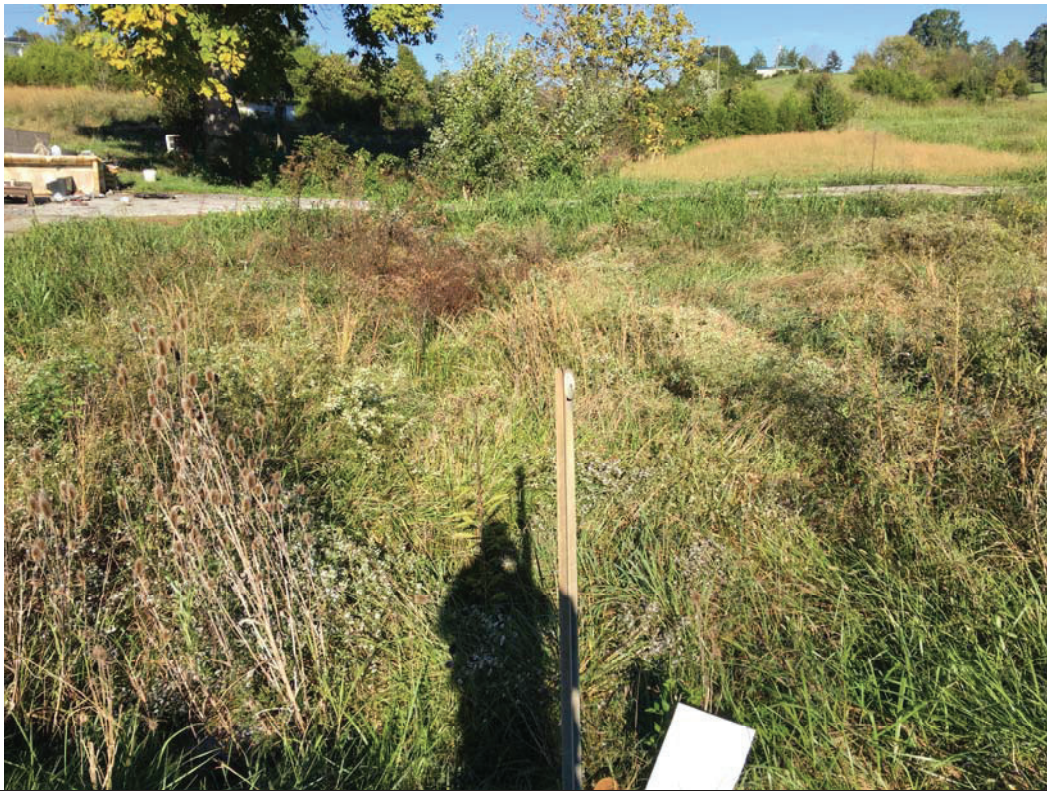
**Photo 17:** Upgradient view of WWC-2 / EPH-2 at Sta. 204+90.

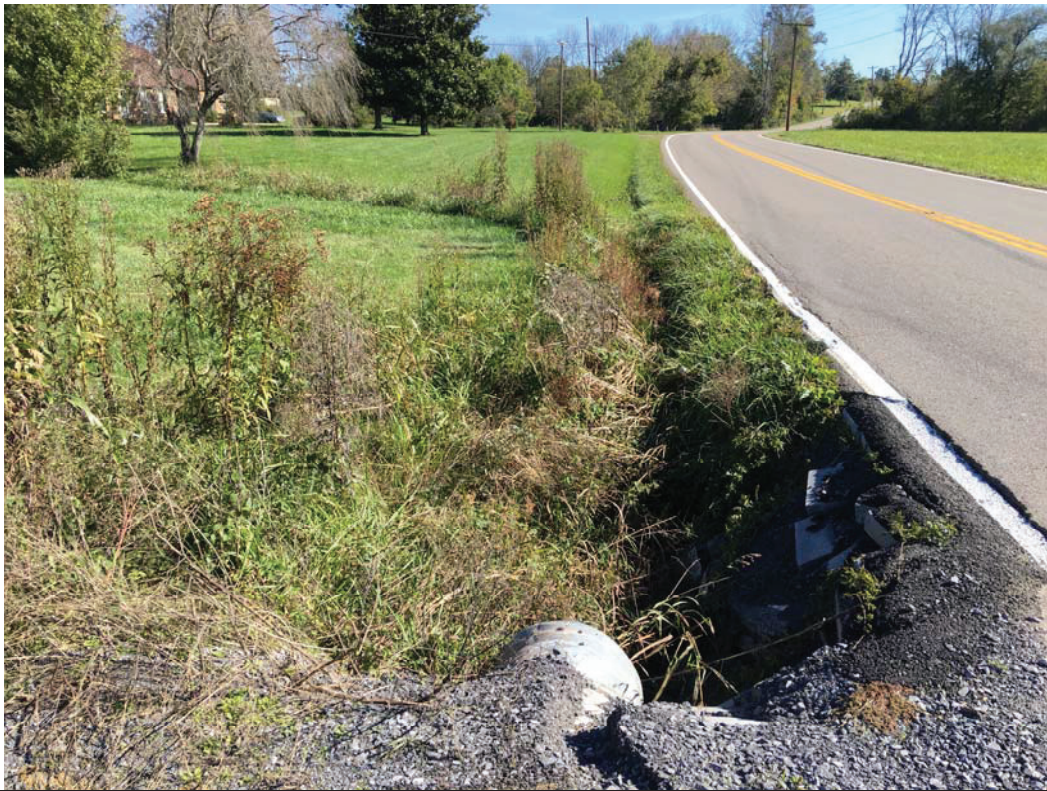
**Photo 23:** Upstream view of STR-12 at Sta. 256+00 flowing out of yard on left and into ditch line of SR-66.

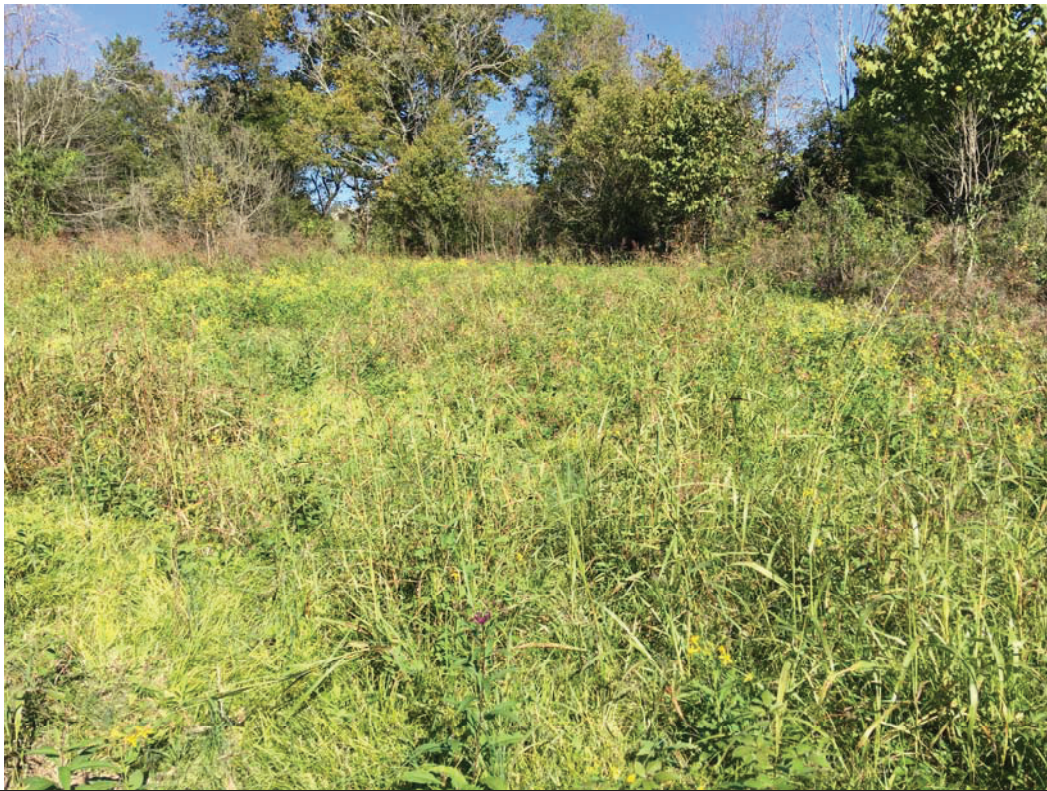
**Photo 29:** Northwest view of WTL-7 at Sta. 290+00L. Feature is outside the project limits.

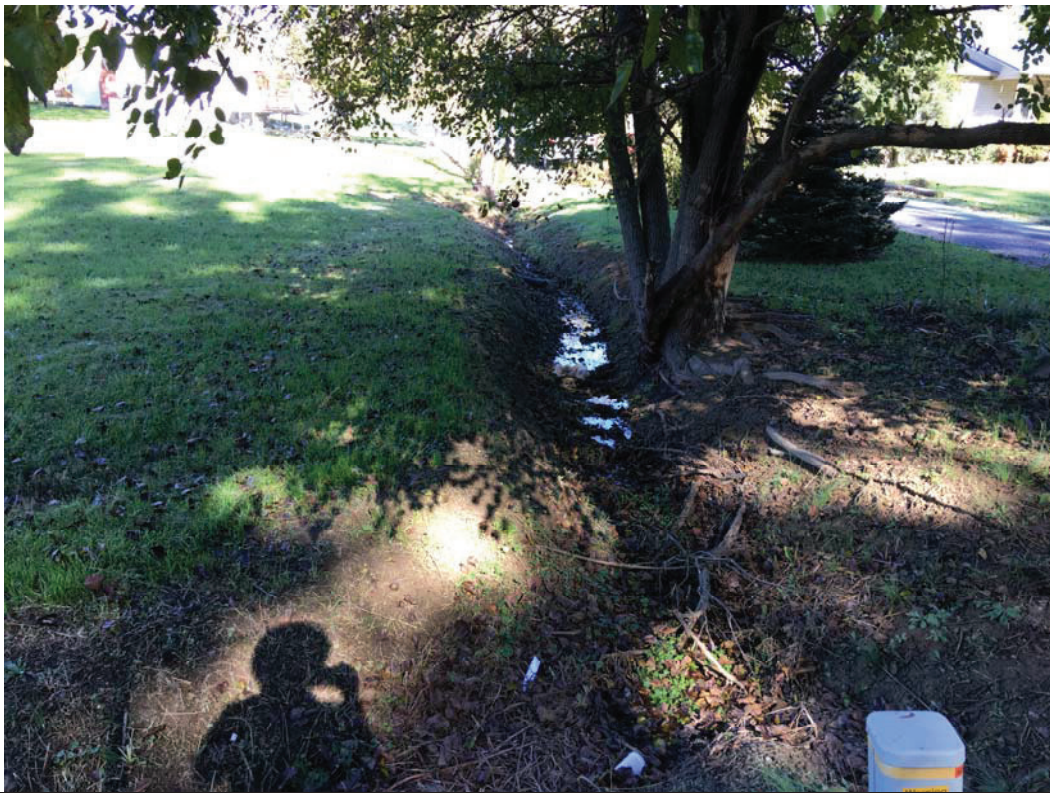
**Photo 43:** Upstream view of STR-22 at Sta. 342+50L.

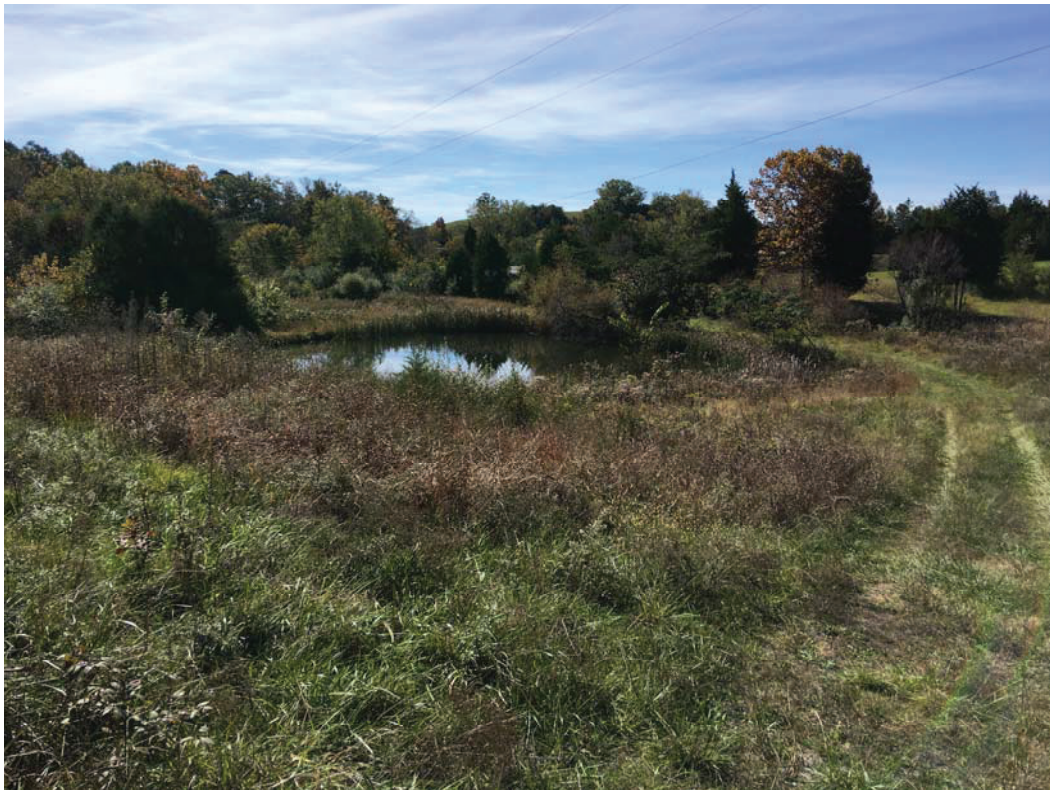
**Photo 44.** Southeast view of PND-6 at Sta. 351+50L.

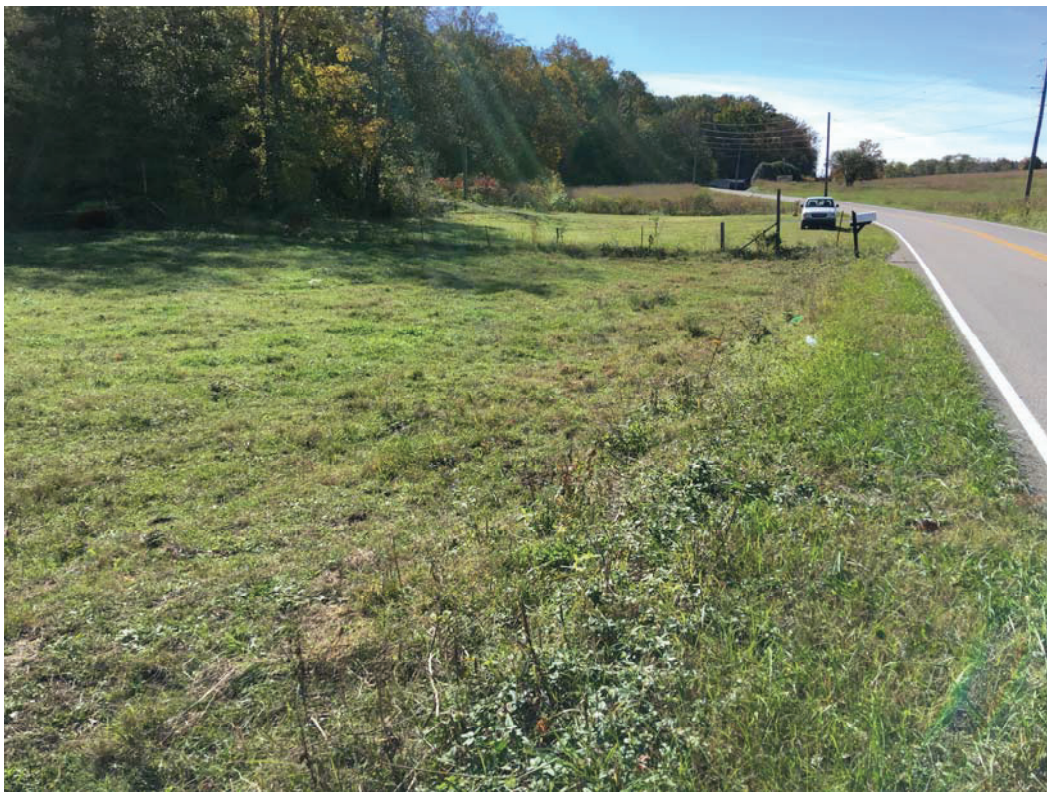
**Photo 50.** Southwest view of WTL-11 at Sta. 365+75R.

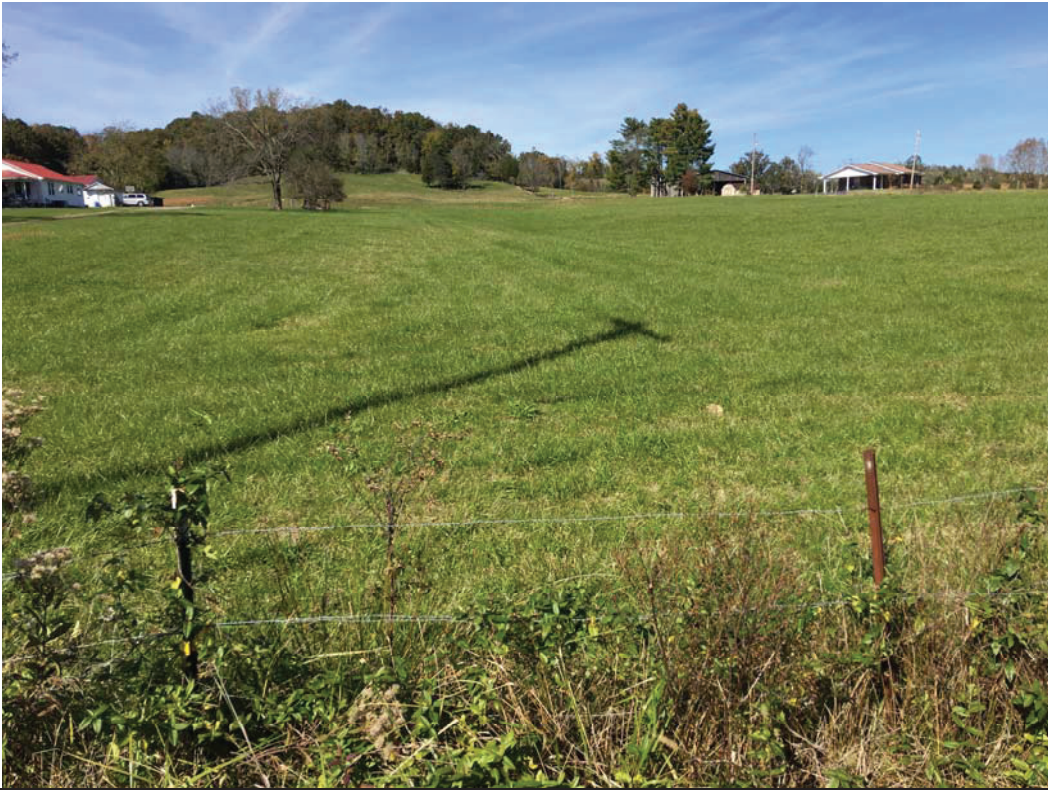
**Photo 51:** Northview of WTL-12 at Sta. 366+25L.
