SR-111/SR-325 Corridor Study

INTRODUCTION

The Town of Byrdstown and the Tennessee Department of Transportation (TDOT) initiated the SR-111/SR-325 Corridor Study in January 2021 after the Town made a successful application for Tennessee Community Transportation Planning Grant (CTPG) funds. This document identifies the vision and goals for the study and presents the findings of the study team in the form of a data inventory, overview of public involvement, existing conditions review, traffic operations and safety analyses, and recommendations for improvements and policy guidance.

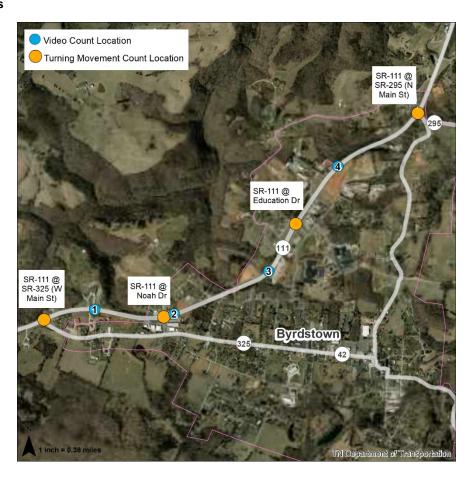
Figure 2.1: Traffic Count Locations

The count data was collected using digital video cameras on site and processed manually in the office. Turning movement counts were conducted between the hours of 7-9 AM and 3-6:30 PM. Video counts were taken for a full 24-hours. These counts made it possible to conduct traffic capacity analysis on an intersection basis. Counts were taken for 5.5 hours on March 23, 2017 at the locations marked Peak Hour TMC and 24 hours at the locations marked 24 hour TMC. Results of the counts are included in Appendix B.

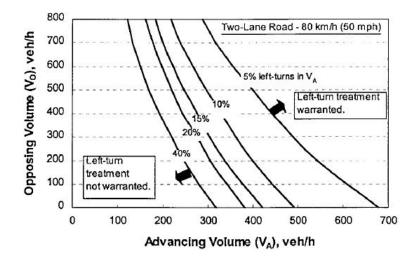
Figure 3.2: Harmelink Method – Left Turn Lane Warrant

Traffic counts were taken for 5.5 hours of the day at the above mentioned intersections. In accordance with the NCHRP Report 457 Harmelink Method, volumes had to meet a minimum threshold depending on the speed limit of the main roadway to warrant for an exclusive left turn lane or right turn lane. Figures 3.2 and 3.3 show these thresholds for both conditions.

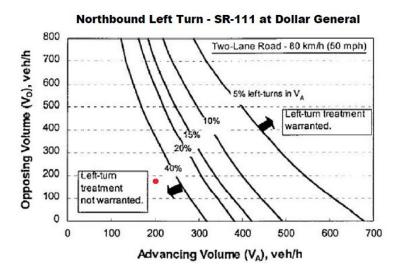
Figures 3.4 – SR-111 at Dollar General Left Turn Lane Warrant

Of the three intersections, SR-111 at Education Dr met the right turn lane warrant. SR-111 at Dollar General fell just below the right turn lane threshold.

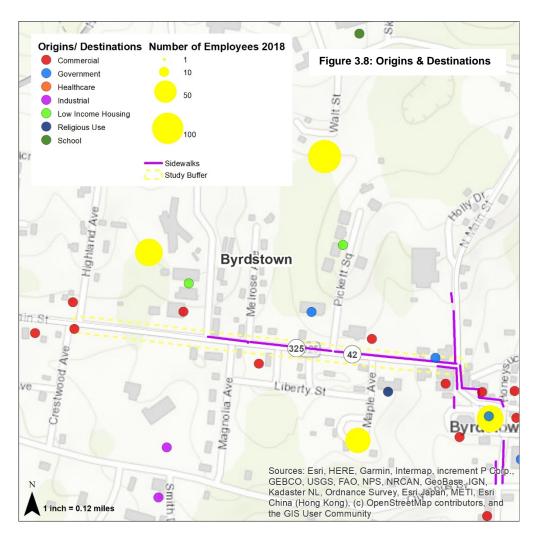
The existing sidewalk network is also shown in Figure 3.8. Within the Town, a network of sidewalks exists in the Downtown and adjacent to the downtown. There are few sidewalks outside of this area in the Town. Few bicycle or pedestrian amenities including signs, lighting or crosswalks were identified in the study area or adjacent Downtown area. The existing sidewalk network is not ADA compliant. Excessive slopes, missing sidewalk ramps, cracking and spalling are just some of the issues identified.
