Right-of-Way Reevaluation, State Route 54 (US Highway 641), From State Route 69 (Wood Street) in Paris to Crossland Road/Brannon Lane (North of Puryear), Henry County, Tennessee, PIN 101886.00, Federal Project No. NH-54(26), State Project No. 40003-1213-14

Date: 05/19/2022

Environmental Commitments

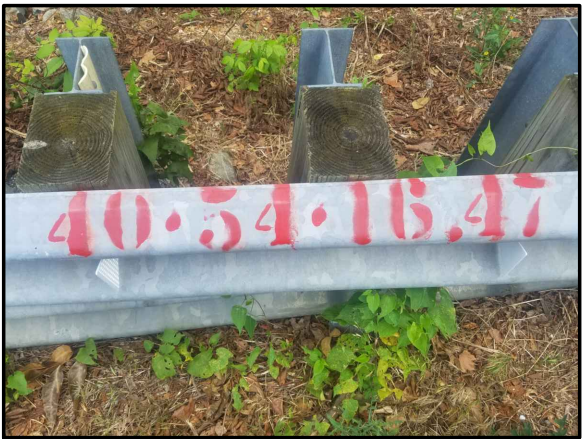
HOMOGENEOUS AREAS

HA-01 - OUTER LONGITUDINAL GIRDER COATING	HA-07 - LONGITUDINAL GIRDER
HA-02 - END WALL	HA-08 - BENT
HA-03 - BOTTOM OF DECKING OUTER STRIP	HA-09 - BEARING PAD
HA-04 - TOP OF DECKING	HA-10 - BOTTOM OF DECKING
HA-05 - WING WALL	HA-11 - BENT HEADER
HA-06 - PARAPET	HA-12 - ABUTMENT

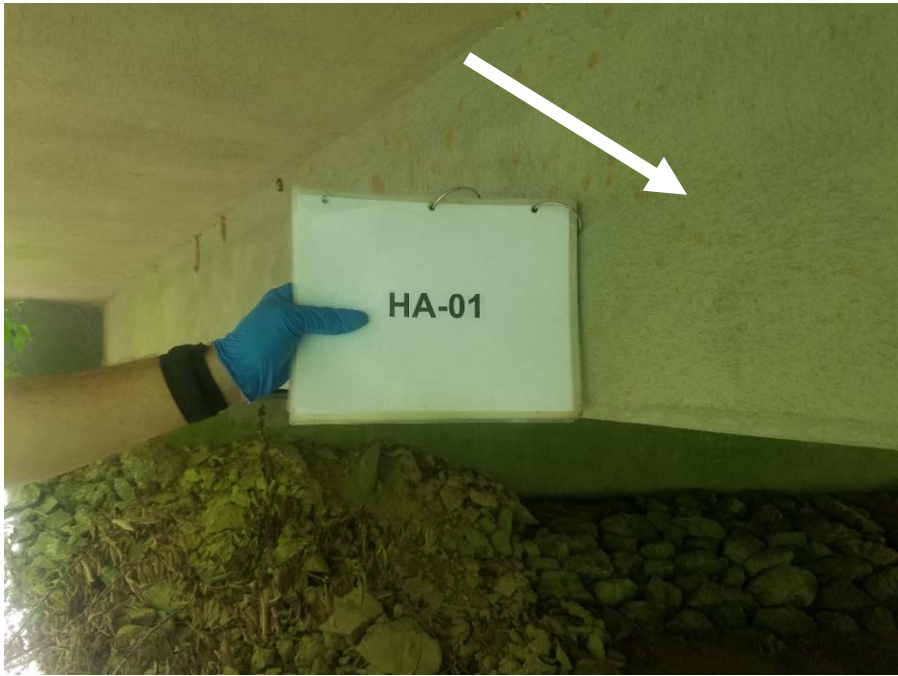
Date: 06/26/2019	
Description: Photograph 3 – HA-01 Outer Longitudinal Girder

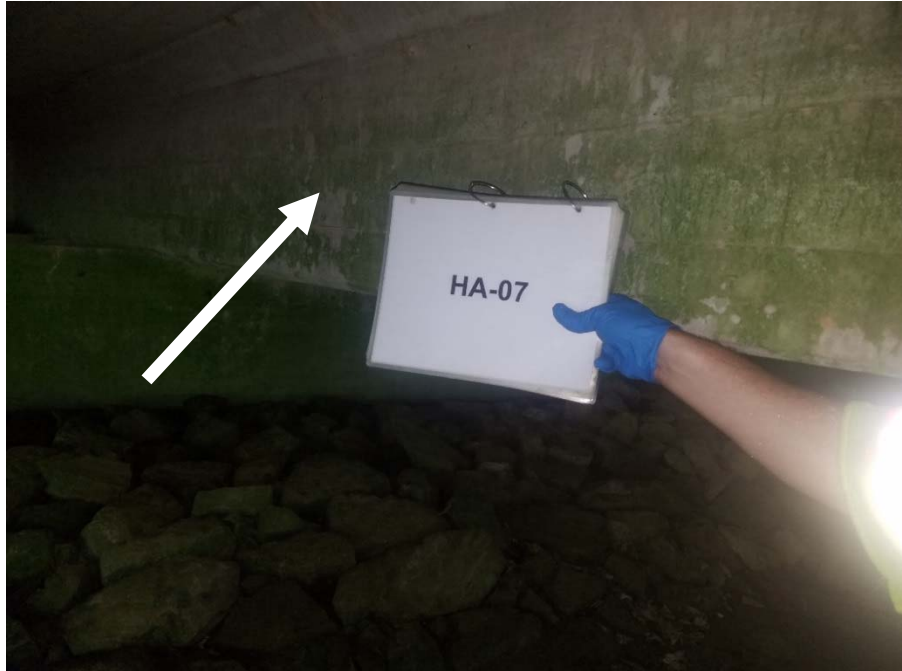
Date: 06/26/2019	
Description: Photograph 9 – HA-07 Longitudinal Girder

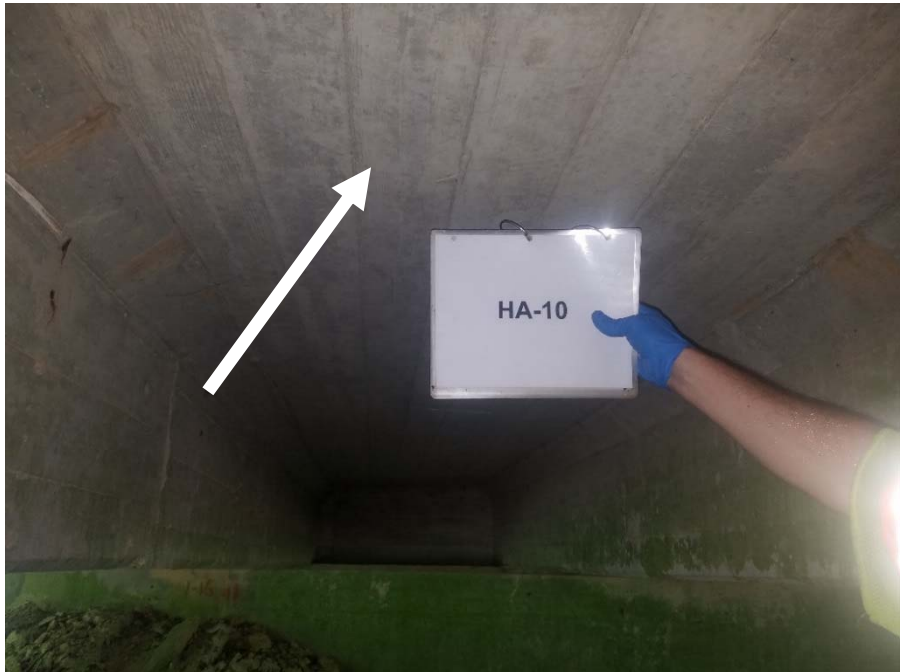
Date: 06/26/2019	
Description: Photograph 12 – HA-10 Bottom of Decking

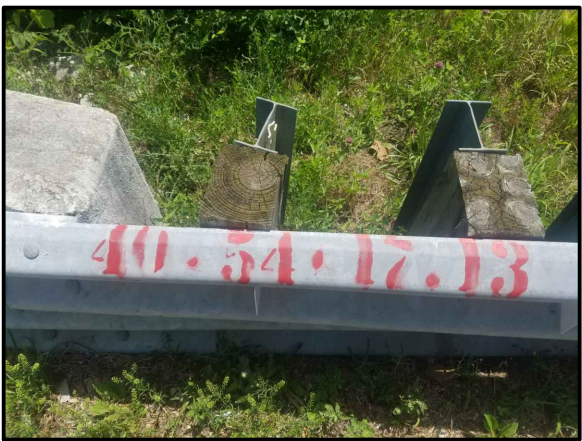
HOMOGENEOUS AREAS

HA-01 - PARAPET	HA-08 - ABUTMENT
HA-02 - TOP OF DECKING	HA-09 - END WALL
HA-03 - PARAPET COATING	HA-10 - CROSS GIRDER
HA-04 - LONGITUDINAL GIRDER	HA-11 - BOTTOM OF DECKING
HA-05 - BENT HEADER	HA-12 - OUTER LONGITUDINAL GIRDER COATING
HA-06 - BENT	HA-13 - BOTTOM OF DECKING OUTER STRIP
HA-07 - BEARING PAD

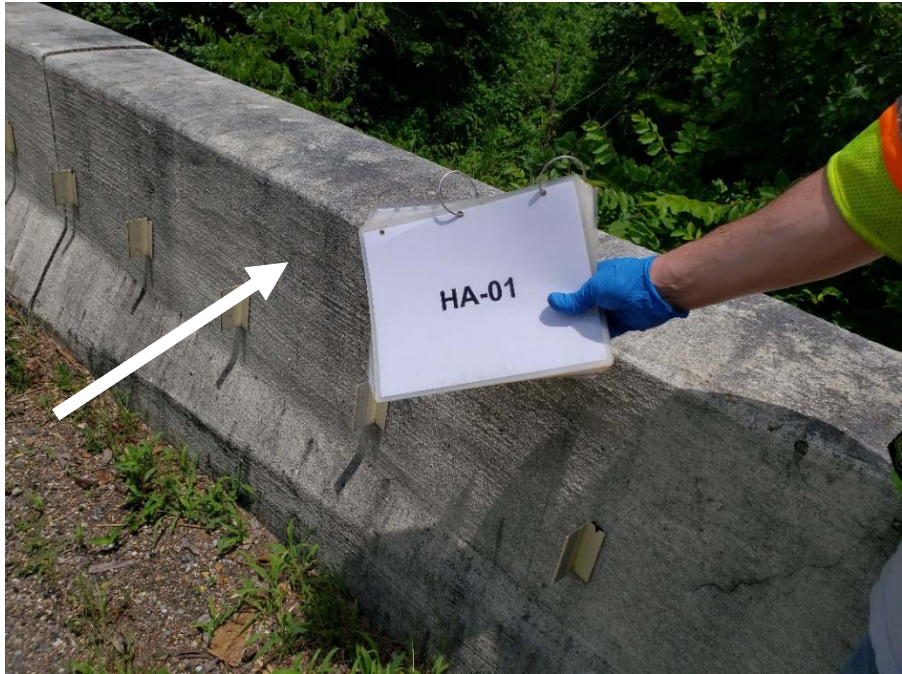
Date: 06/26/2019	
Description: Photograph 3 – HA-01 Parapet

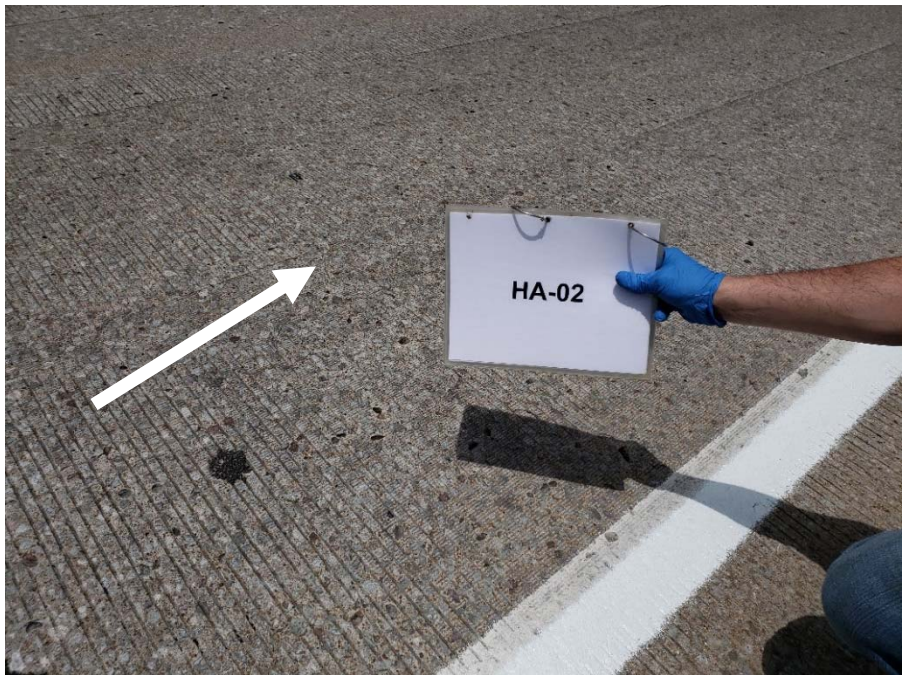
Date: 06/26/2019	
Description: Photograph 4 – HA-02 Top of Decking

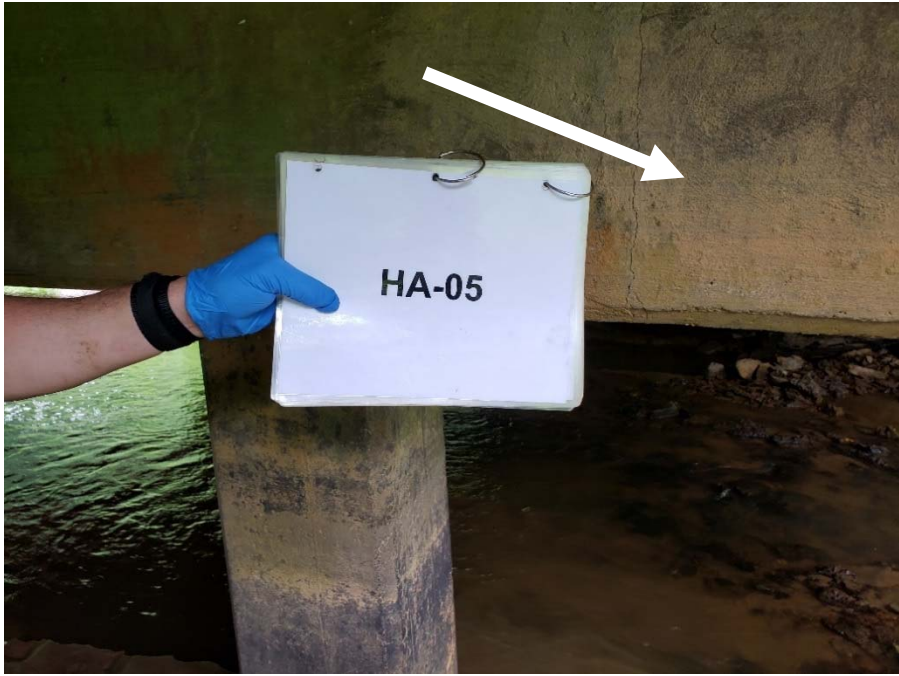
Date: 06/26/2019	
Description: Photograph 7 – HA-05 Bent Header

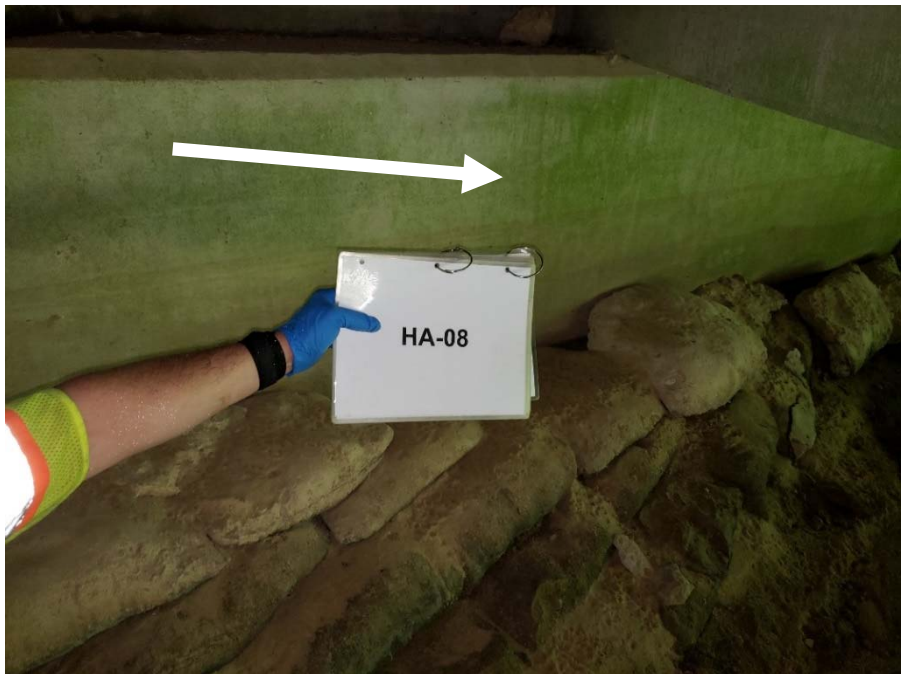
Photograph 9 –

Samples Contain
3% Chrysotile

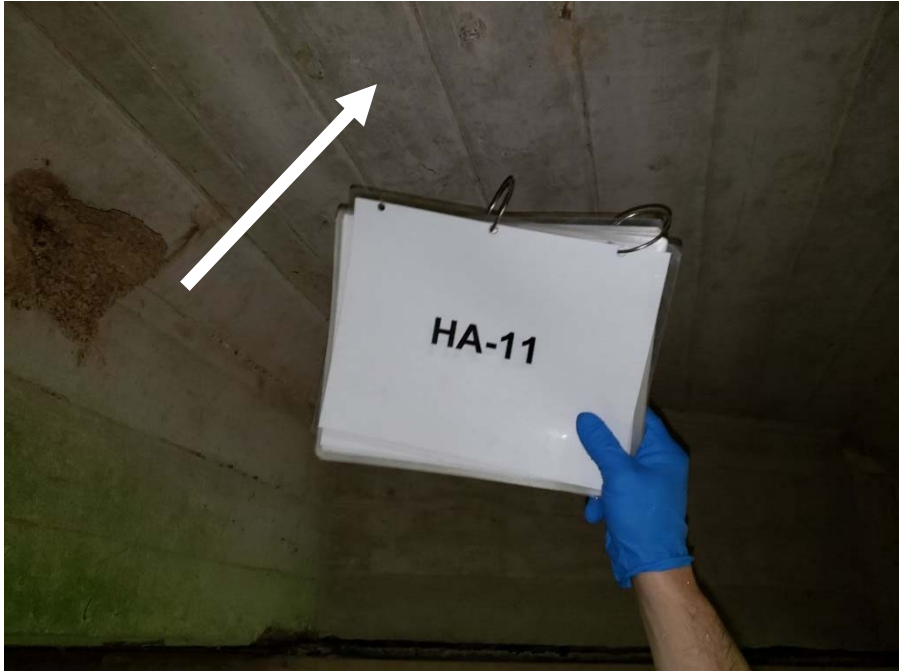
Date: 06/26/2019	
Description: Photograph 13 – HA-11 Bottom of Decking

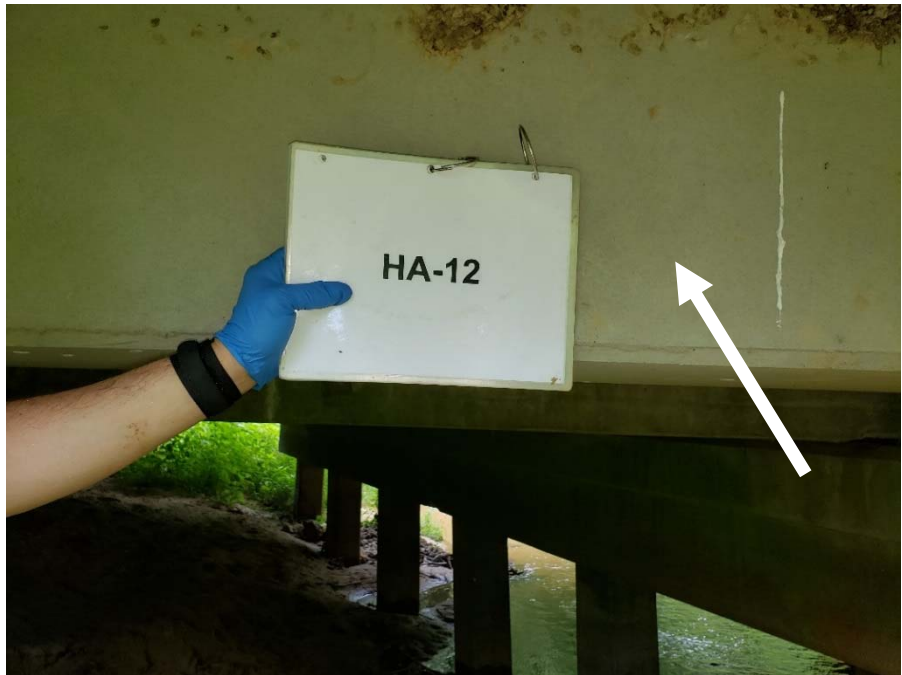
Date: 06/26/2019	
Description: Photograph 14 – HA-12 Outer Longitudinal Girder Coating

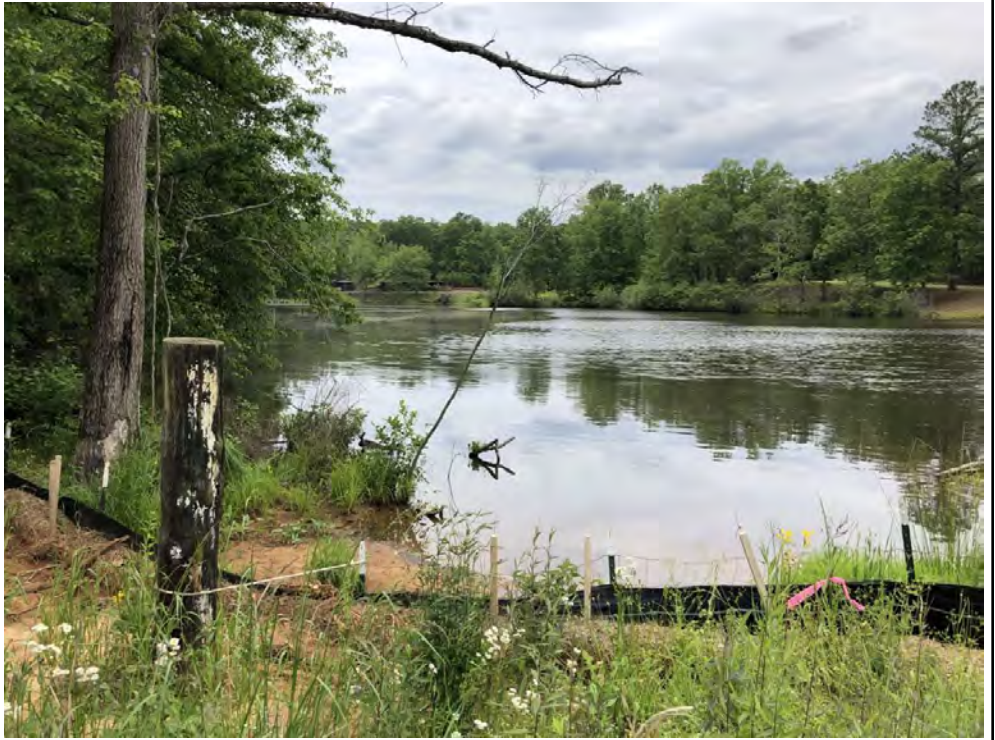
Client:	TN TDOT	Project:	PE: 40003-0200-14 PIN: 101886.02
Site Name:	SR-54 from Smith Rd to Near Howard Rd	Site Location:	Henry County, TN
Photograph ID: 13

Photo Location: PND-01			
Direction: West			
Survey Date: 5/17/2021			
Comments: PND-01 overview.			
Photograph ID: 14

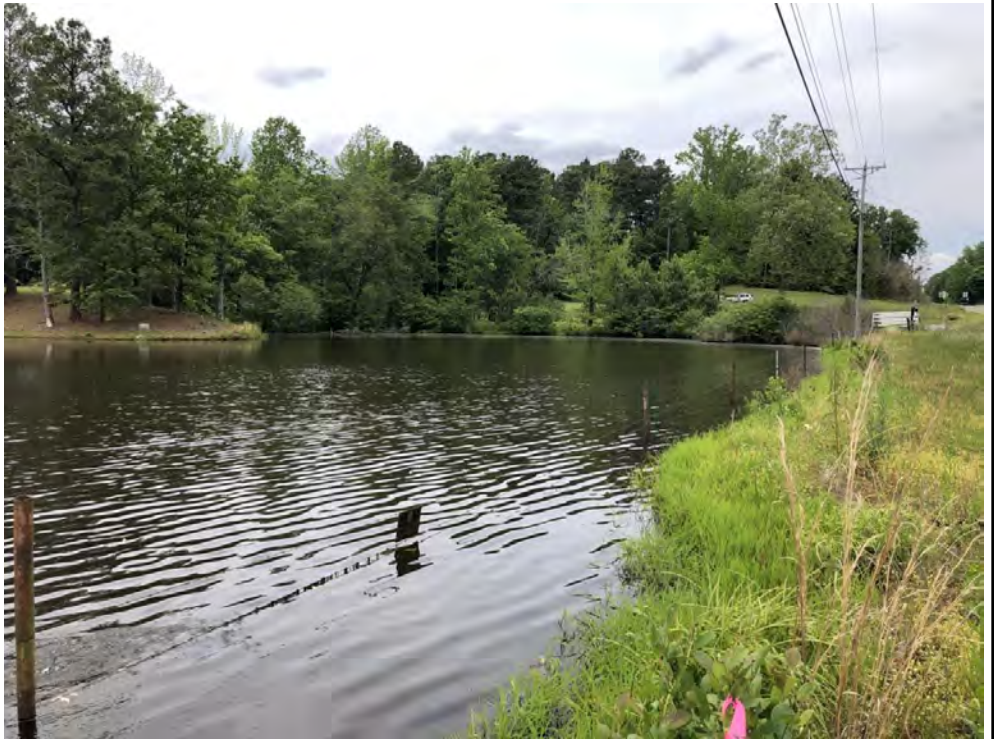
Photo Location: PND-01			
Direction: Northwest			
Survey Date: 5/17/2021			
Comments: PND-01 overview.

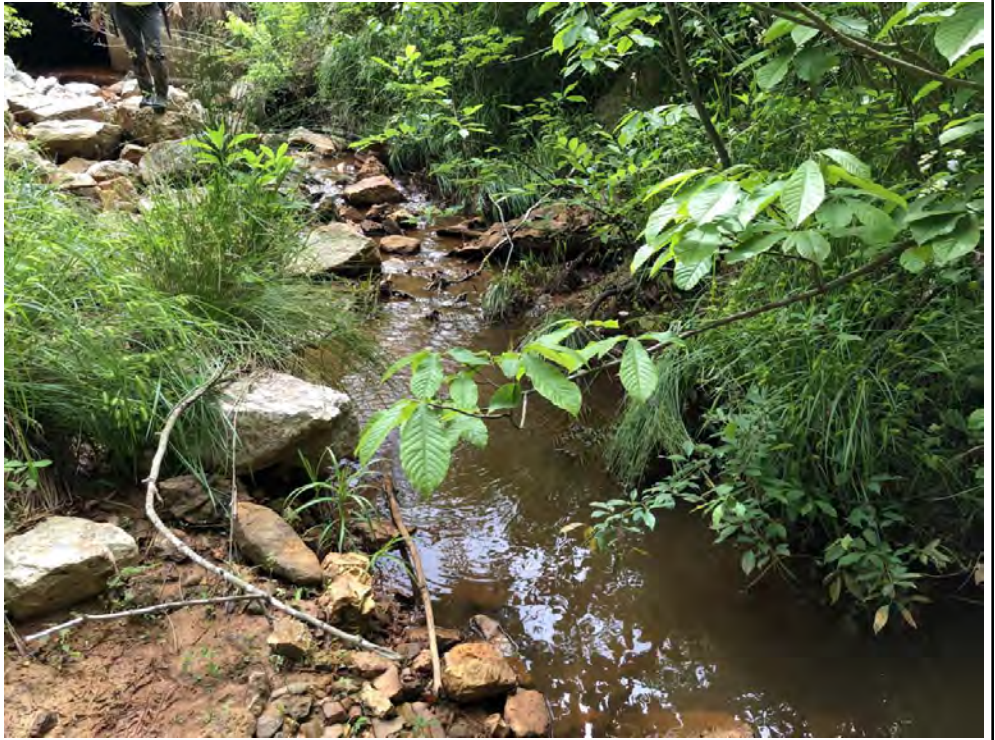
Client:	TN TDOT	Project:	PE: 40003-0200-14 PIN: 101886.02
Site Name:	SR-54 from Smith Rd to Near Howard Rd	Site Location:	Henry County, TN
Photograph ID: 15

Photo Location: STR-01			
Direction: Southwest			
Survey Date: 5/17/2021			
Comments: STR-01 upstream view.			
Photograph ID: 16

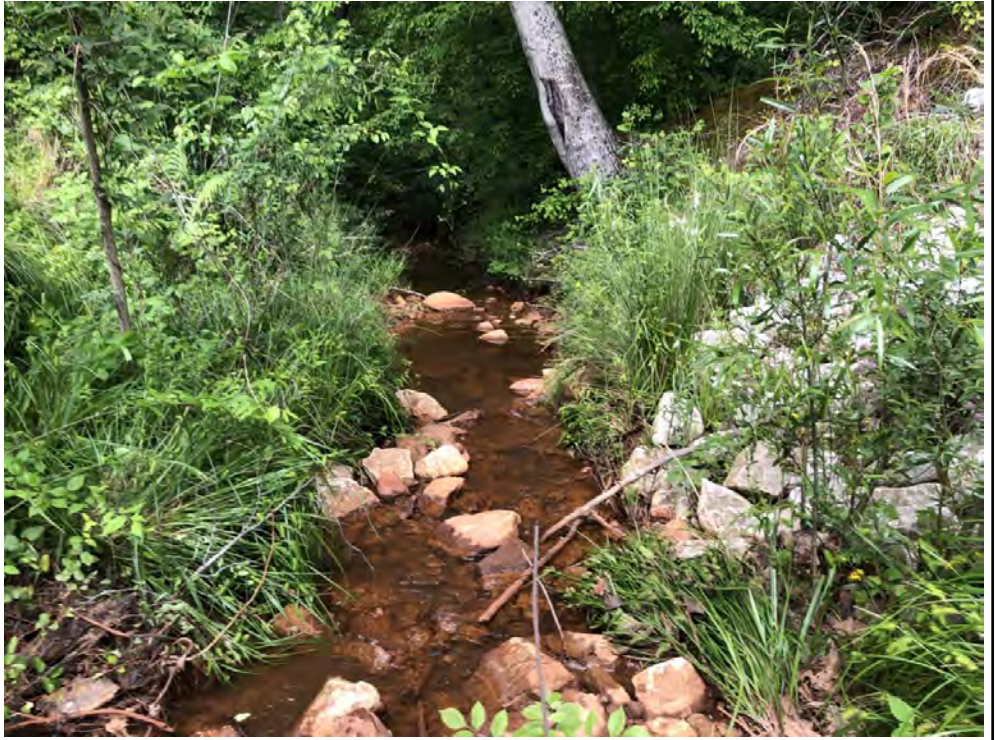
Photo Location: STR-01			
Direction: Southeast			
Survey Date: 5/17/2021			
Comments: STR-01 downstream view.

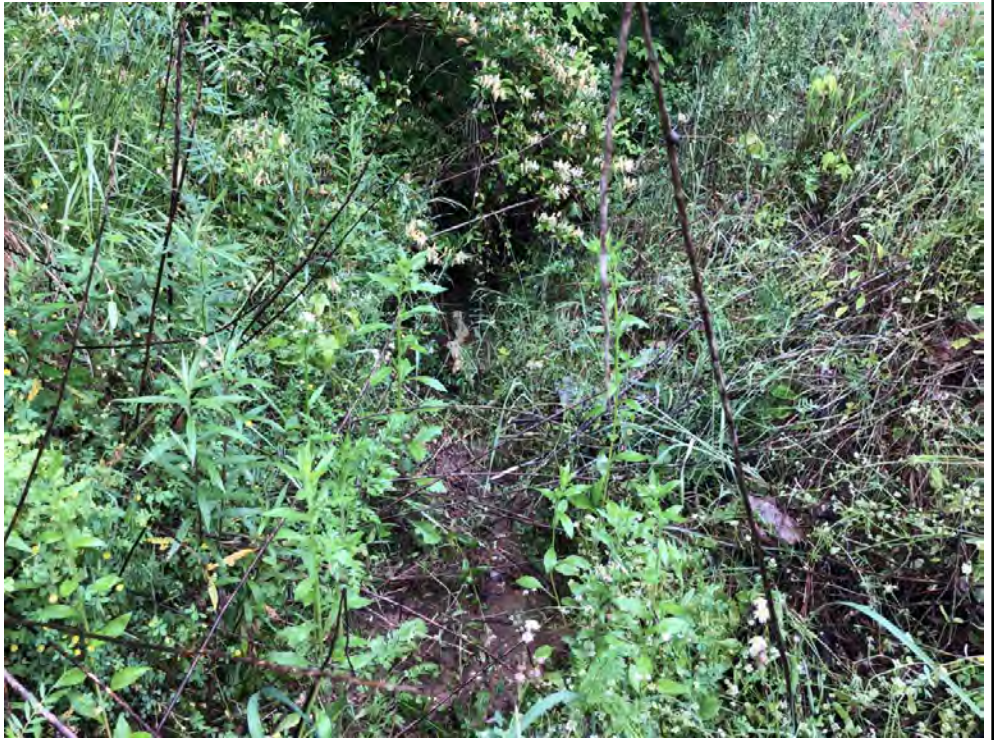
Client:	TN TDOT	Project:	PE: 40003-0200-14 PIN: 101886.02
Site Name:	SR-54 from Smith Rd to Near Howard Rd	Site Location:	Henry County, TN
Photograph ID: 21

Photo Location: WWC-02			
Direction: Northwest			
Survey Date: 5/18/2021			
Comments: WWC-02 downstream view.			
Photograph ID: 22	 		
Photo Location: WWC-02			
Direction: West			
Survey Date: 5/18/2021			
Comments: WWC-02 upstream view.

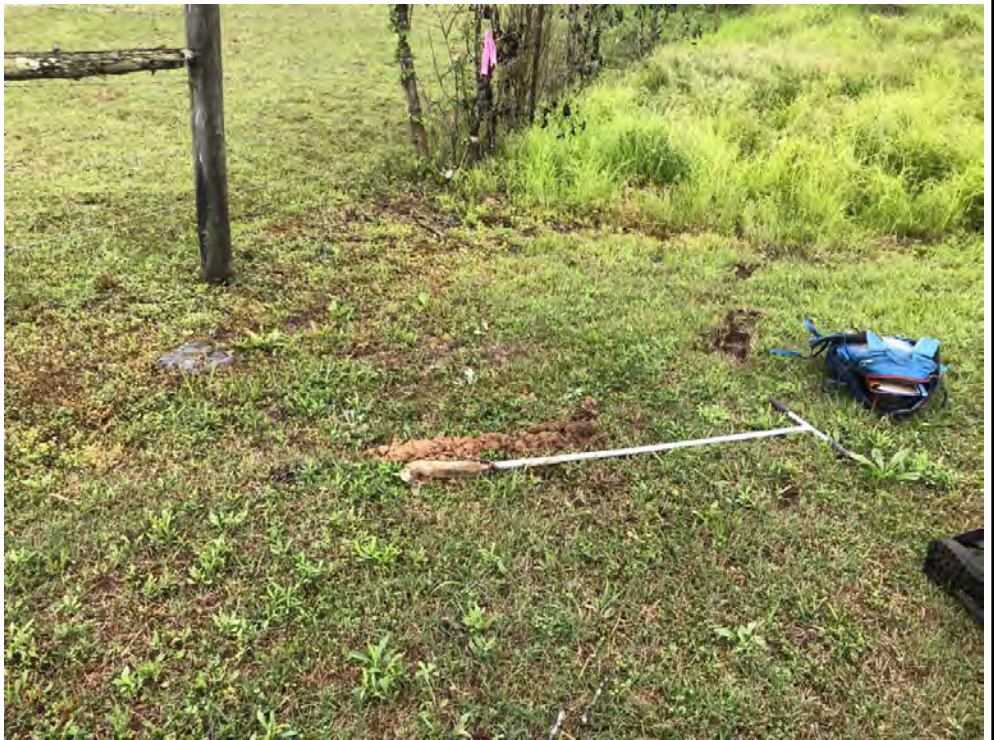
Client:	TN TDOT	Project:	PE: 40003-0200-14 PIN: 101886.02
Site Name:	SR-54 from Smith Rd to Near Howard Rd	Site Location:	Henry County, TN
Photograph ID: 25

Photo Location: WTL-04			
Direction: Southeast			
Survey Date: 5/18/2021			
Comments: WTL-04 upland point.			
Photograph ID: 26

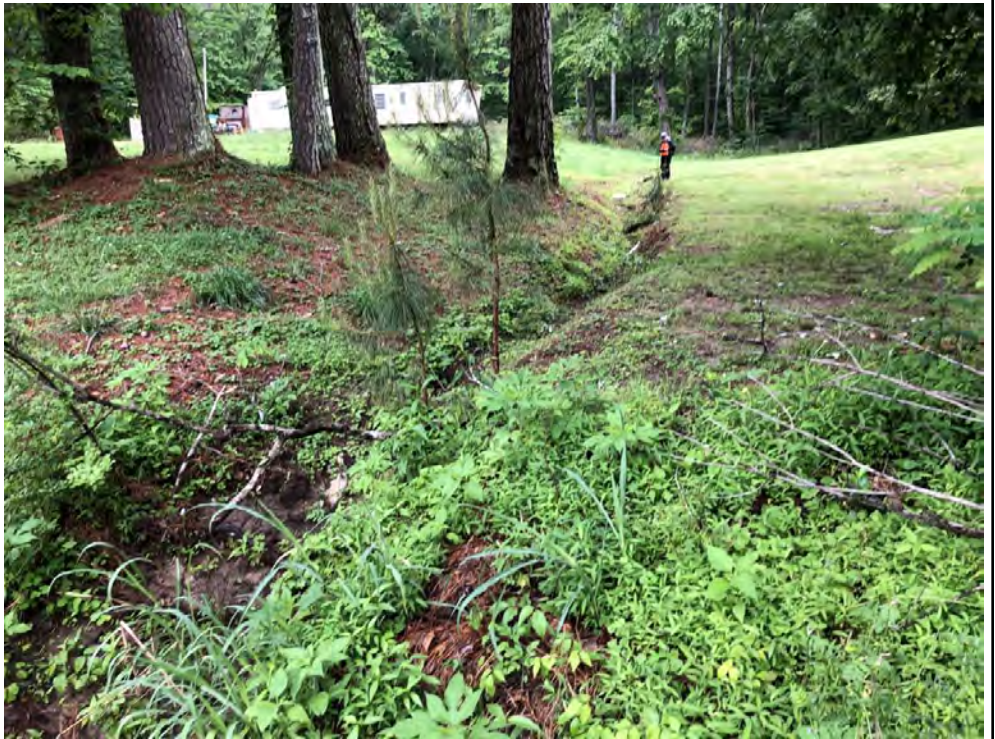
Photo Location: WWC-03			
Direction: Northeast			
Survey Date: 5/18/2021			
Comments: WWC-03 upstream view.

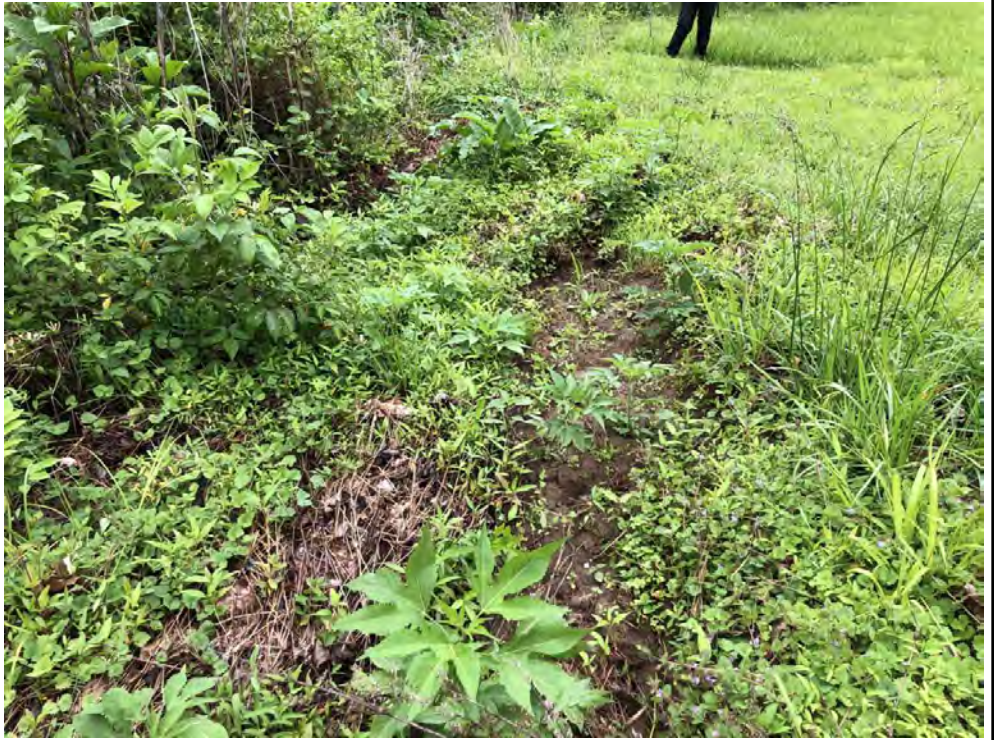
Photo Location: WWC-03			
Direction: South southwest			
Survey Date: 5/18/2021			
Comments: WWC-03 downstream view.			
Photograph ID: 30

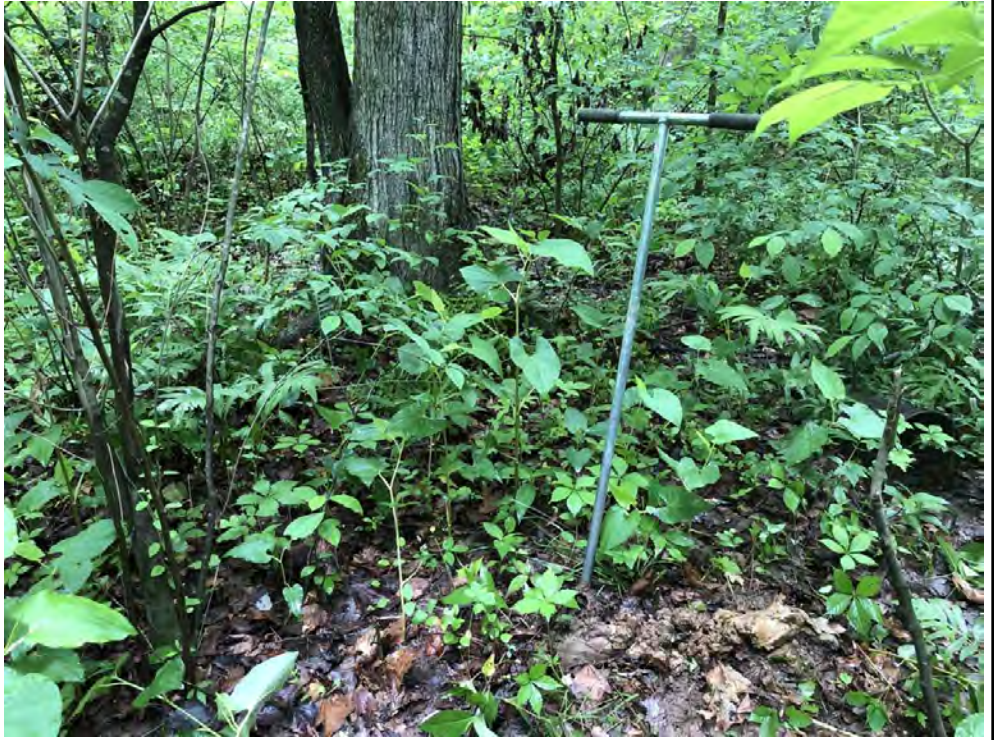
Photo Location: WTL-05			
Direction: Northeast			
Survey Date: 5/18/2021			
Comments: WTL-05 wetland point.

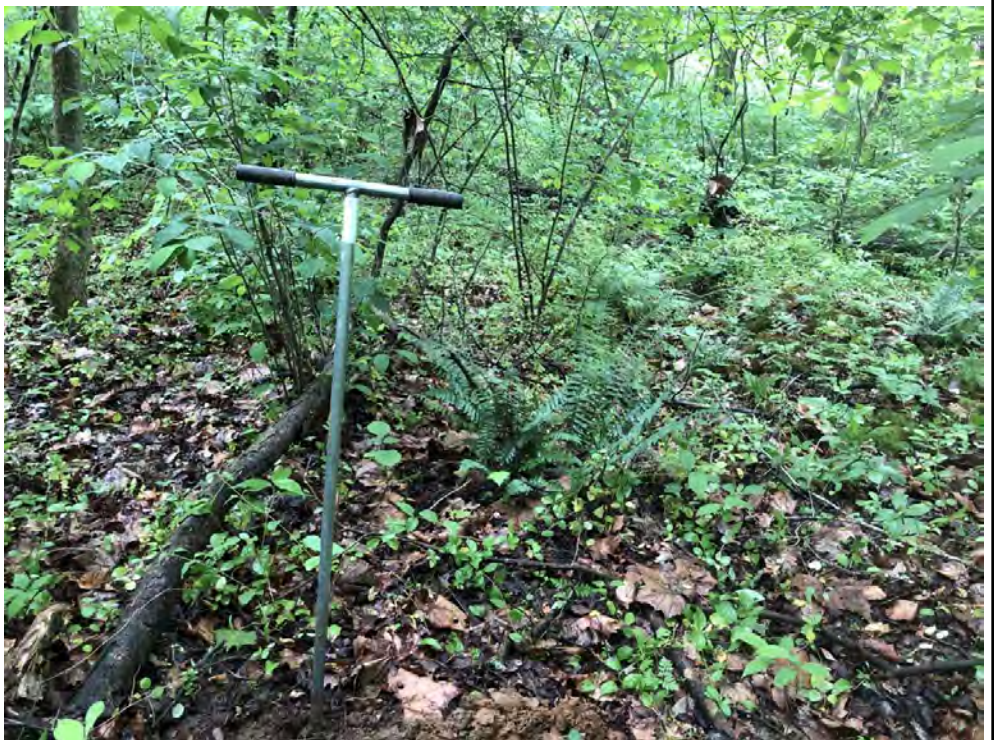
Photo Location: WTL-05			
Direction: West northwest			
Survey Date: 5/18/2021			
Comments: WTL-05 upland point.			
Photograph ID: 32

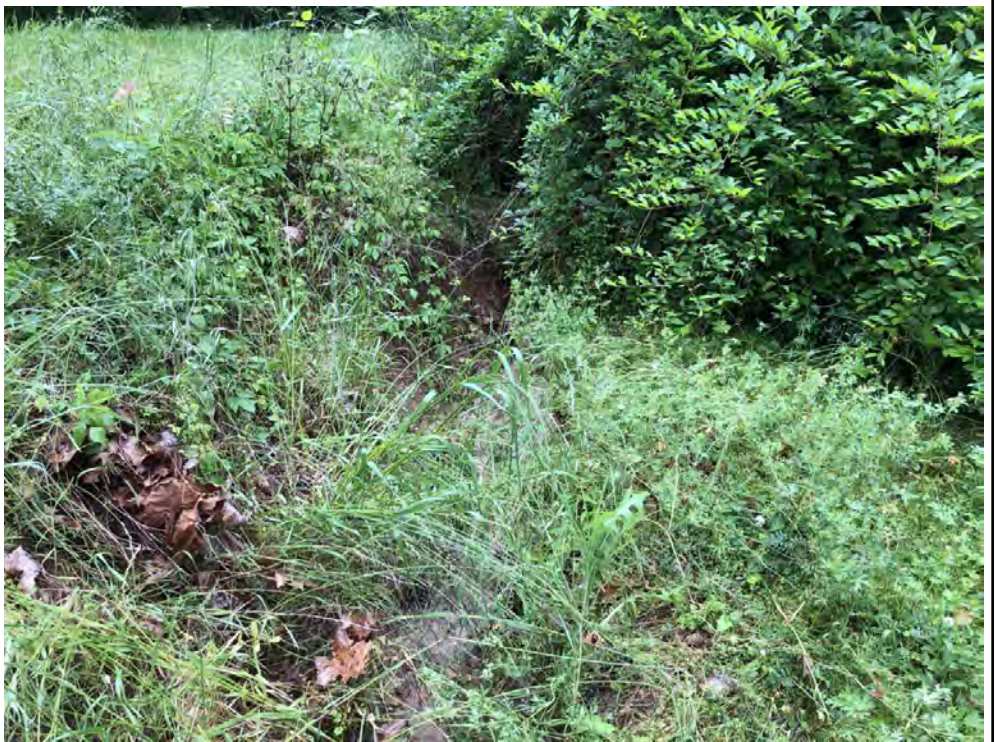
Photo Location: WWC-04			
Direction: South			
Survey Date: 5/18/2021			
Comments: WWC-04 upstream view.

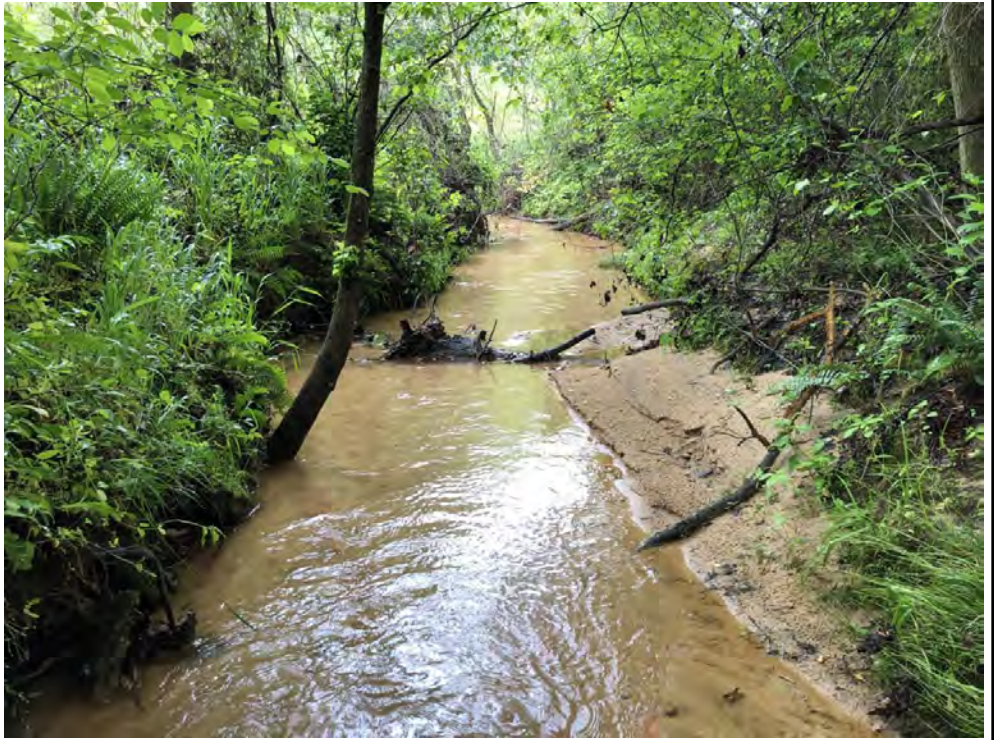
Photo Location: STR-02			
Direction: North northwest			
Survey Date: 5/18/2021			
Comments: STR-02 downstream view.			
Photograph ID: 38

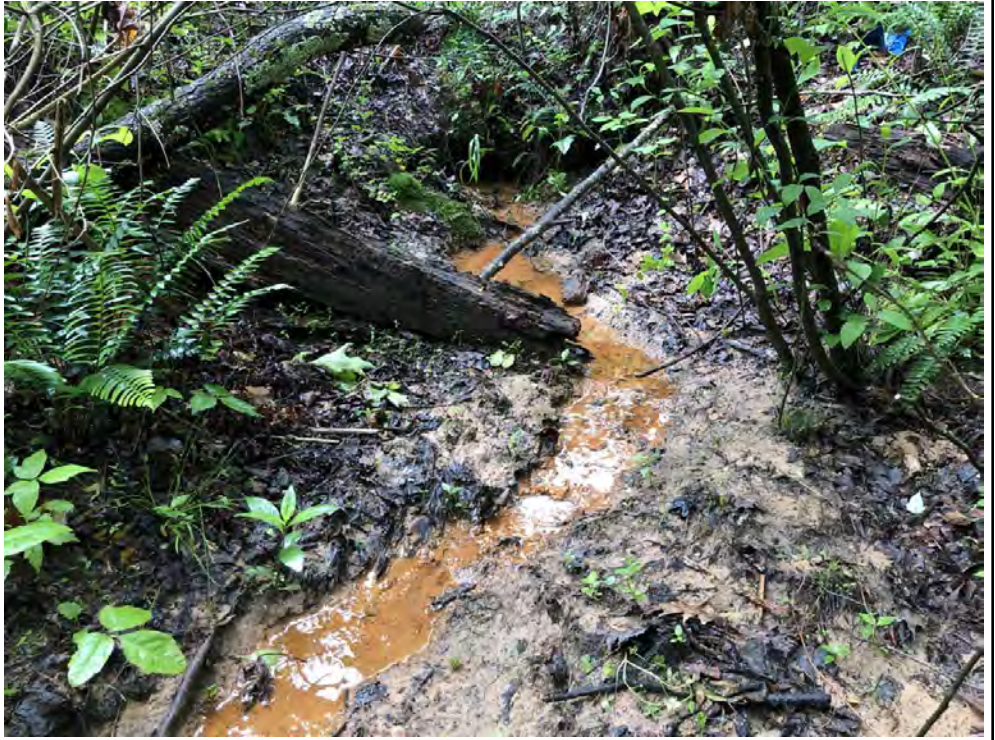
Photo Location: STR-03			
Direction: South southeast			
Survey Date: 5/18/2021			
Comments: STR-03 upstream view.

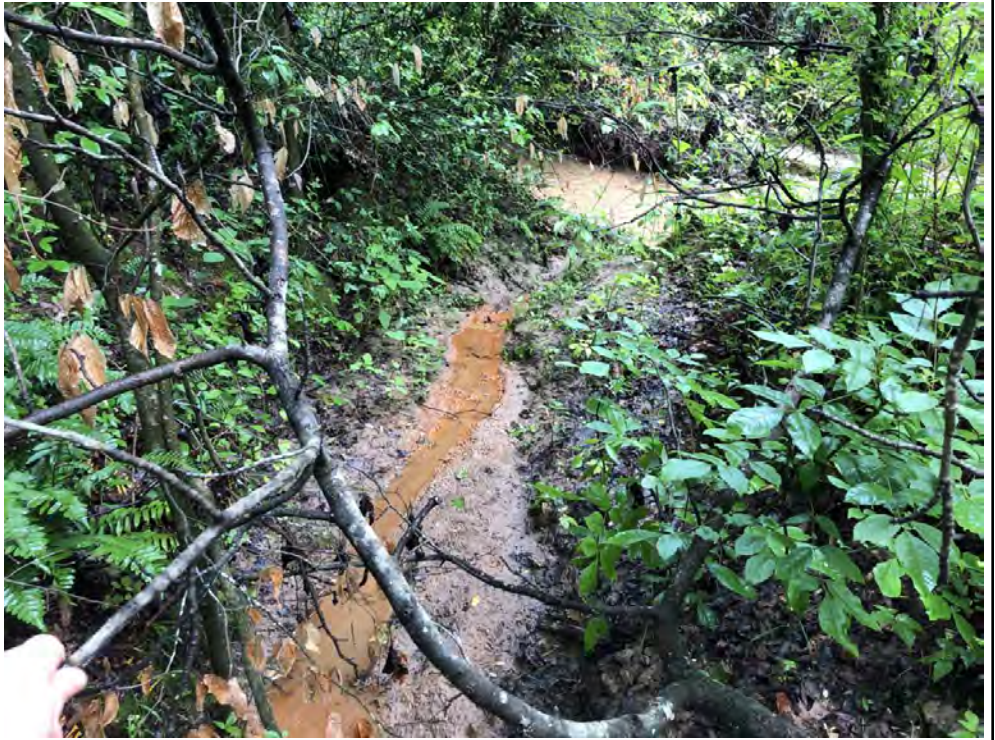
Photo Location: STR-03			
Direction: North northeast			
Survey Date: 5/18/2021			
Comments: STR-03 downstream view.			
Photograph ID: 40

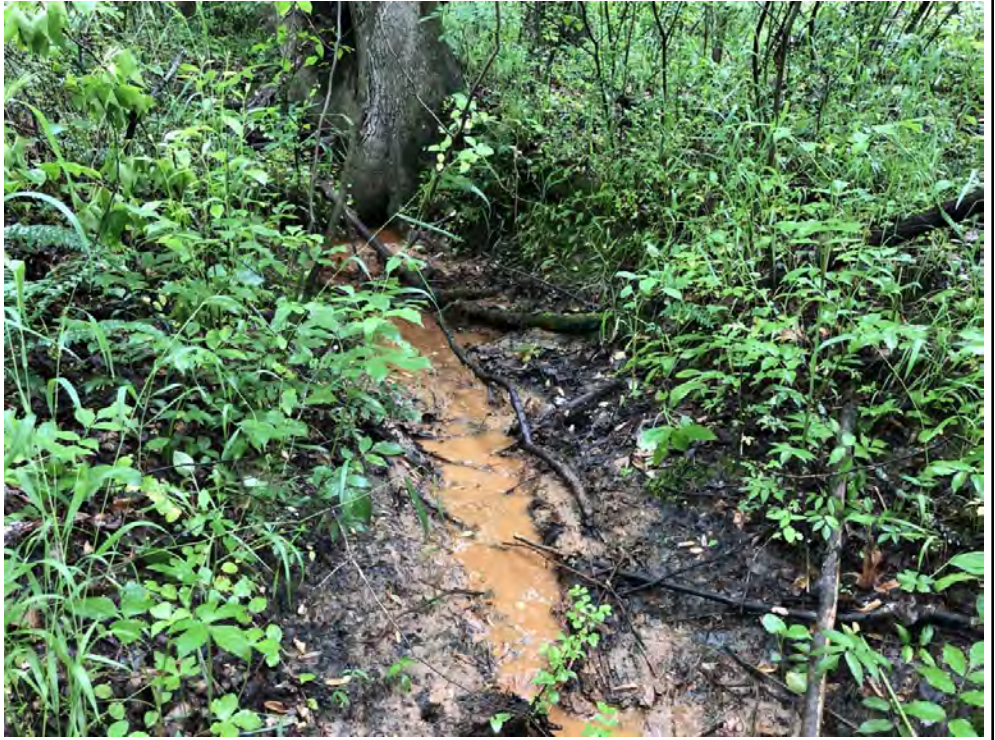
Photo Location: STR-04			
Direction: Northeast			
Survey Date: 5/18/2021			
Comments: STR-04 upstream view.

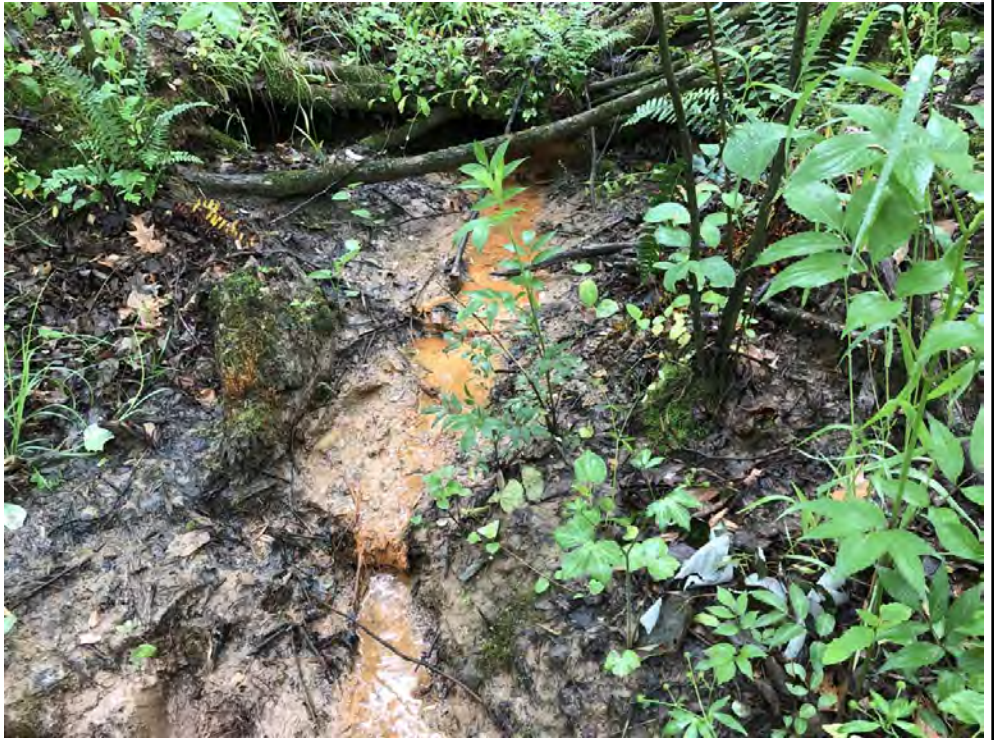
Photo Location: STR-04			
Direction: South			
Survey Date: 5/18/2021			
Comments: STR-04 downstream view.			
Photograph ID: 42

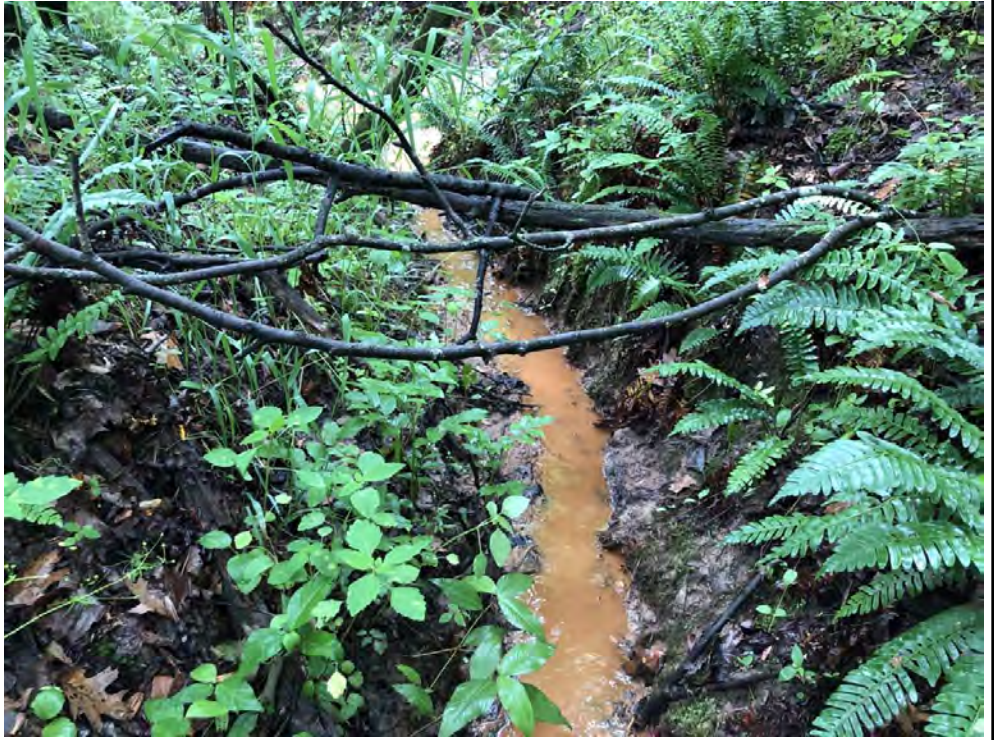
Photo Location: STR-04			
Direction: Southwest			
Survey Date: 5/18/2021			
Comments: STR-04 upstream view.

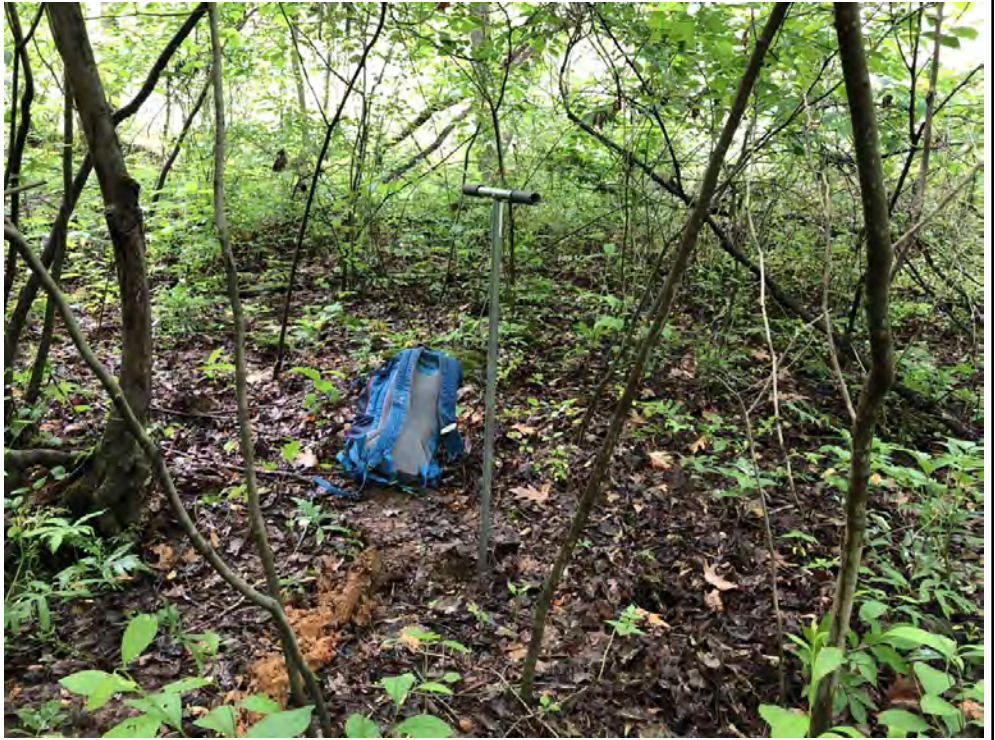
Photo Location: WTL-06			
Direction: Southeast			
Survey Date: 5/18/2021			
Comments: WTL-06 wetland point.			
Photograph ID: 44

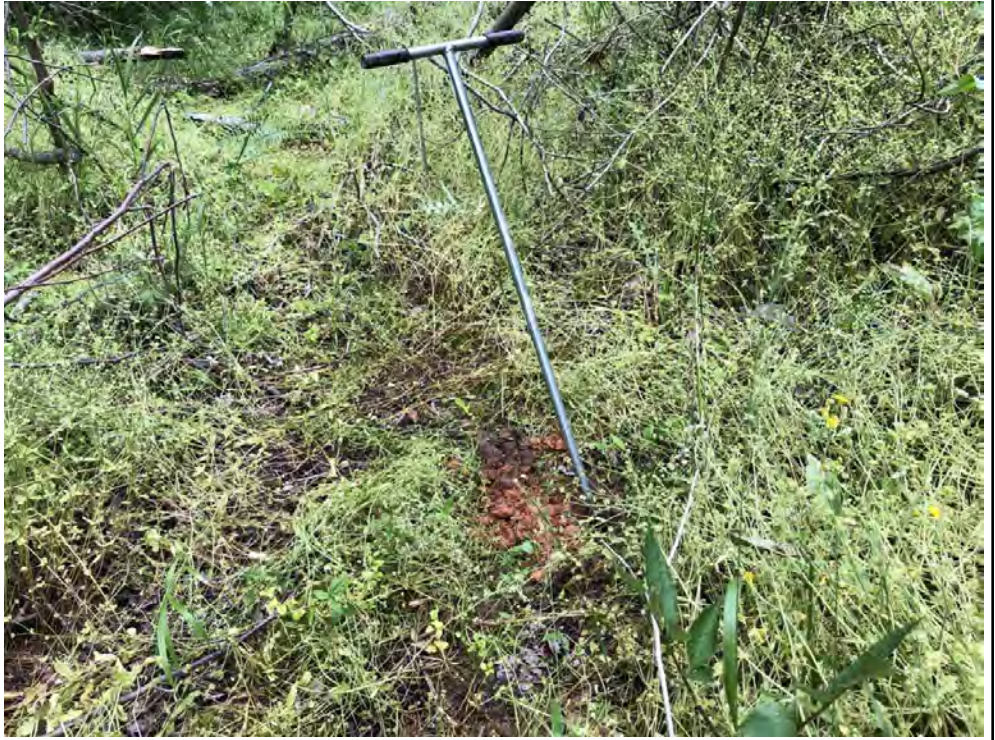
Photo Location: WTL-06			
Direction: North northwest			
Survey Date: 5/18/2021			
Comments: WTL-06 upland point.

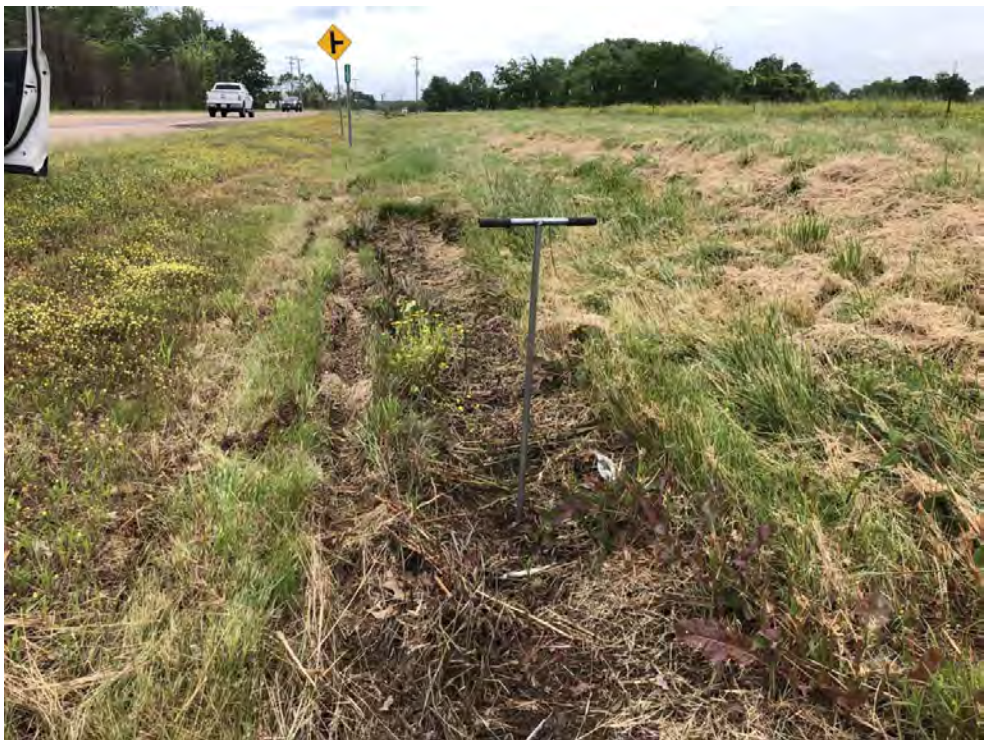
Photo Location: WTL-07			
Direction: North			
Survey Date: 5/18/2021			
Comments: WTL-07 wetland point.			
Photograph ID: 52

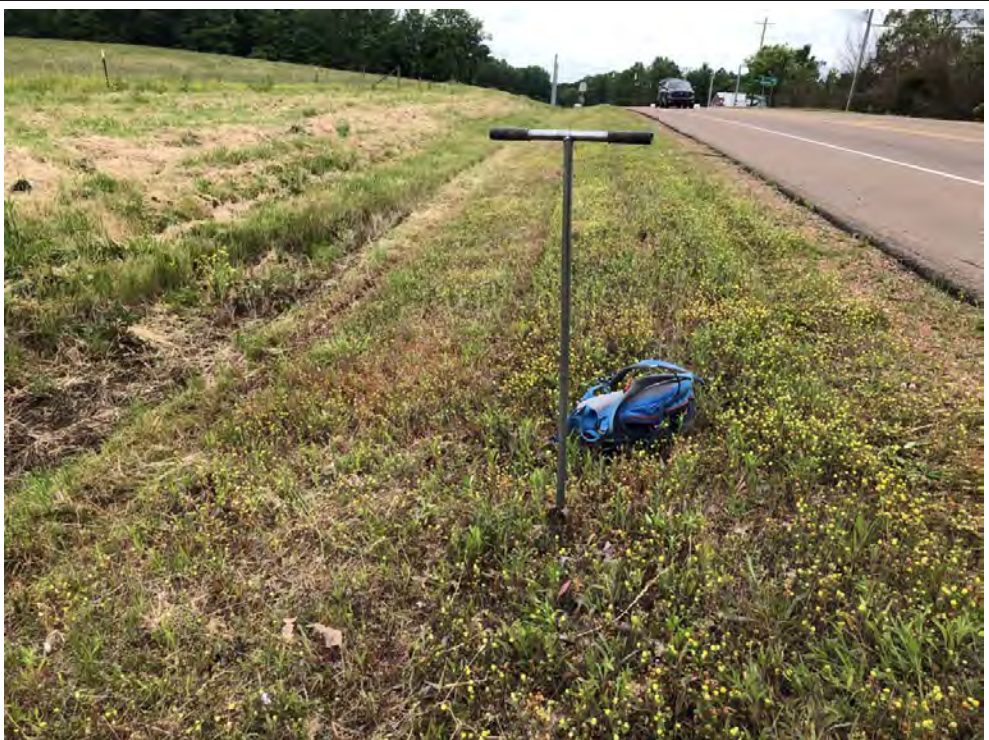
Photo Location: WTL-07			
Direction: West northwest			
Survey Date: 5/18/2021			
Comments: WTL-07 upland point.
