Right-of-Way Reevaluation, State Route 54 (US Highway 641), From State Route 69 (Wood Street) in Paris to Crossland Road/Brannon Lane (North of Puryear), Henry County, Tennessee, PIN 101886.00, Federal Project No. NH-54(26), State Project No. 40003-1213-14

Date: 05/19/2022

Environmental Commitments

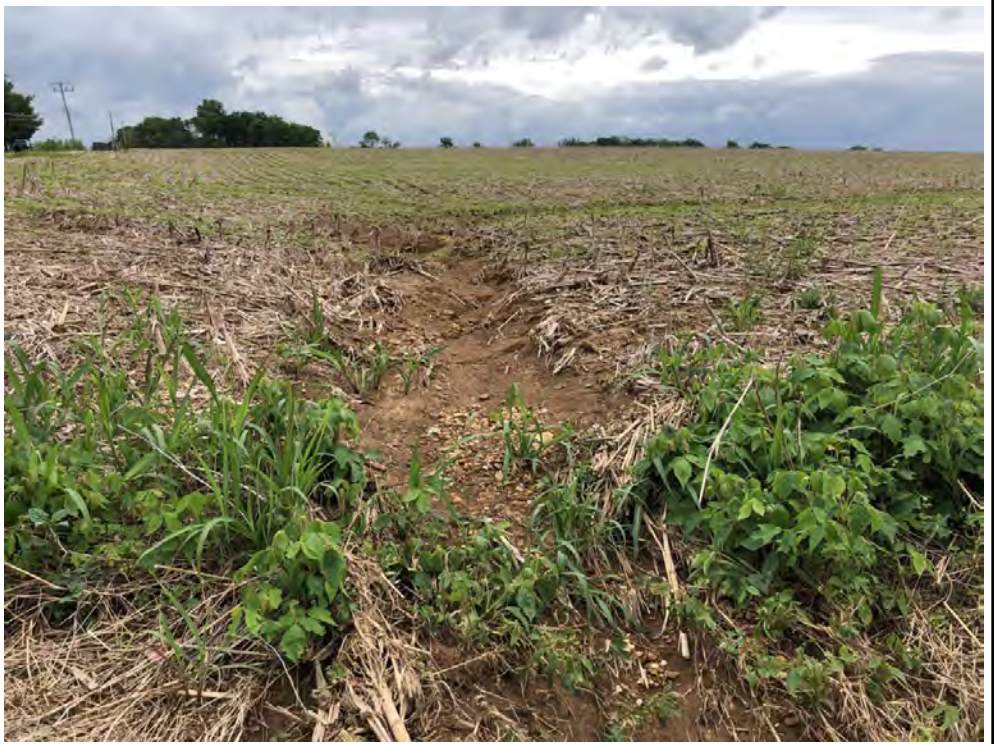
Photo Location: WWC-08			
Direction: North			
Survey Date: 5/18/2021			
Comments: WWC-08 upstream view.			
Photograph ID: 56

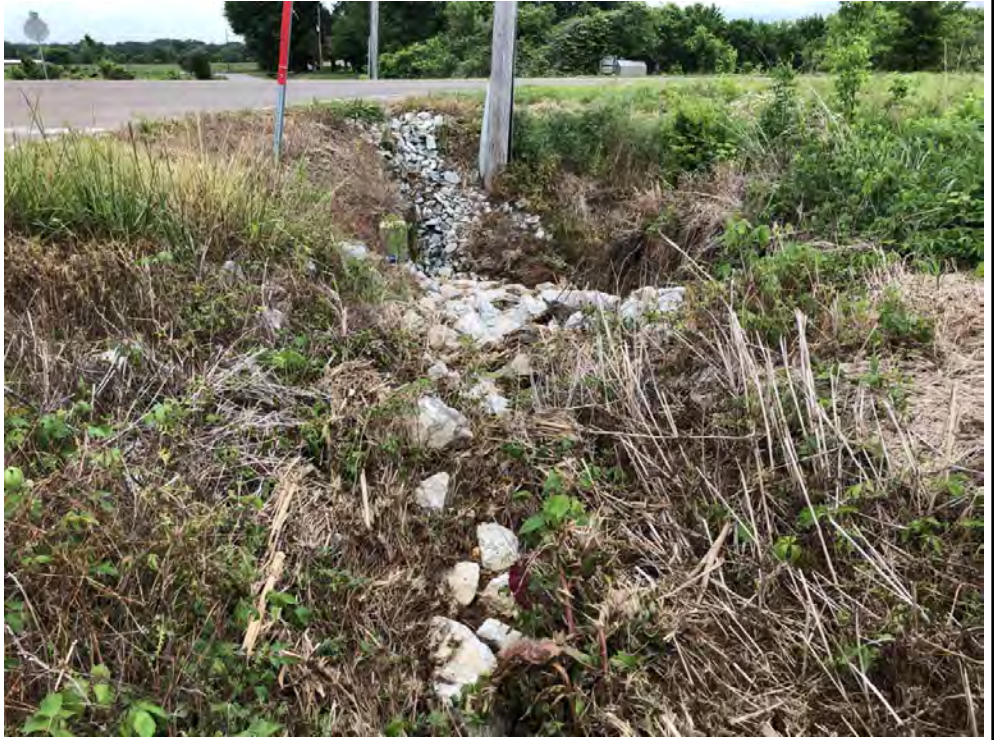
Photo Location: WWC-08			
Direction: West southwest			
Survey Date: 5/18/2021			
Comments: WWC-08 downstream view.

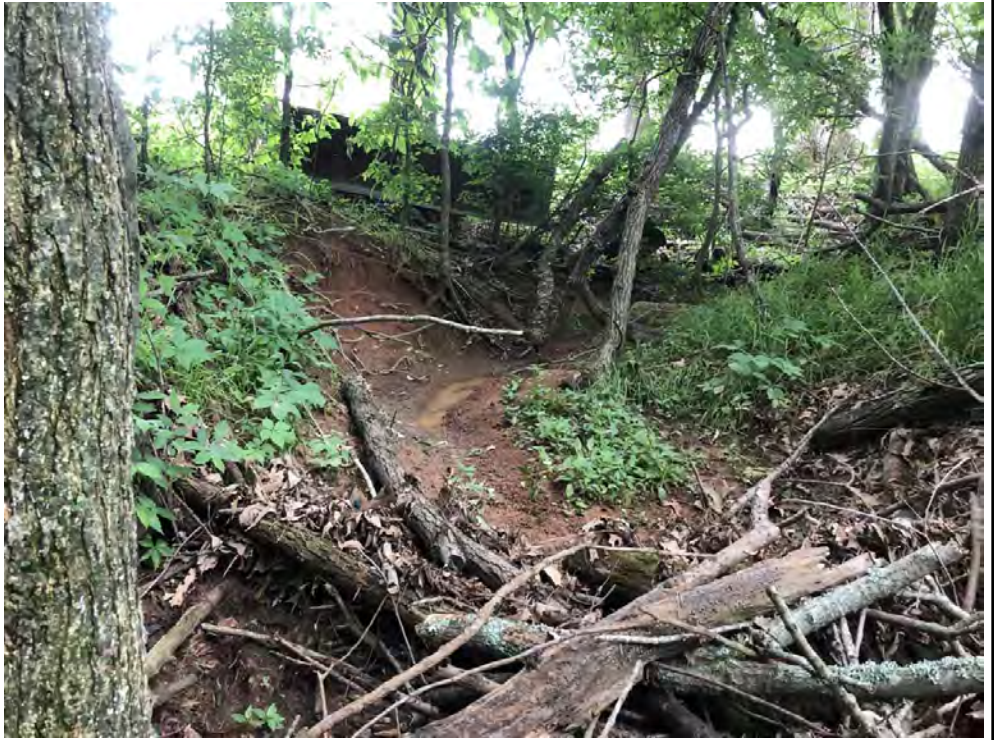
Photo Location: WWC-10			
Direction: Southwest			
Survey Date: 5/18/2021			
Comments: WWC-10 upstream view.			
Photograph ID: 60

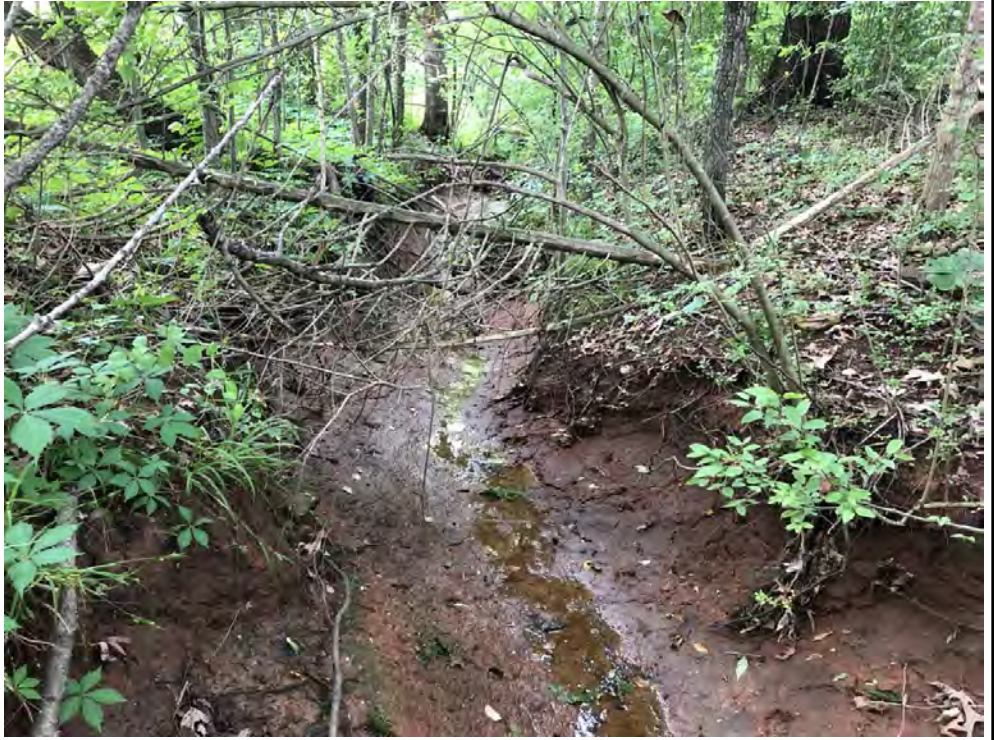
Photo Location: WWC-10			
Direction: Southeast			
Survey Date: 5/18/2021			
Comments: WWC-10 downstream view.

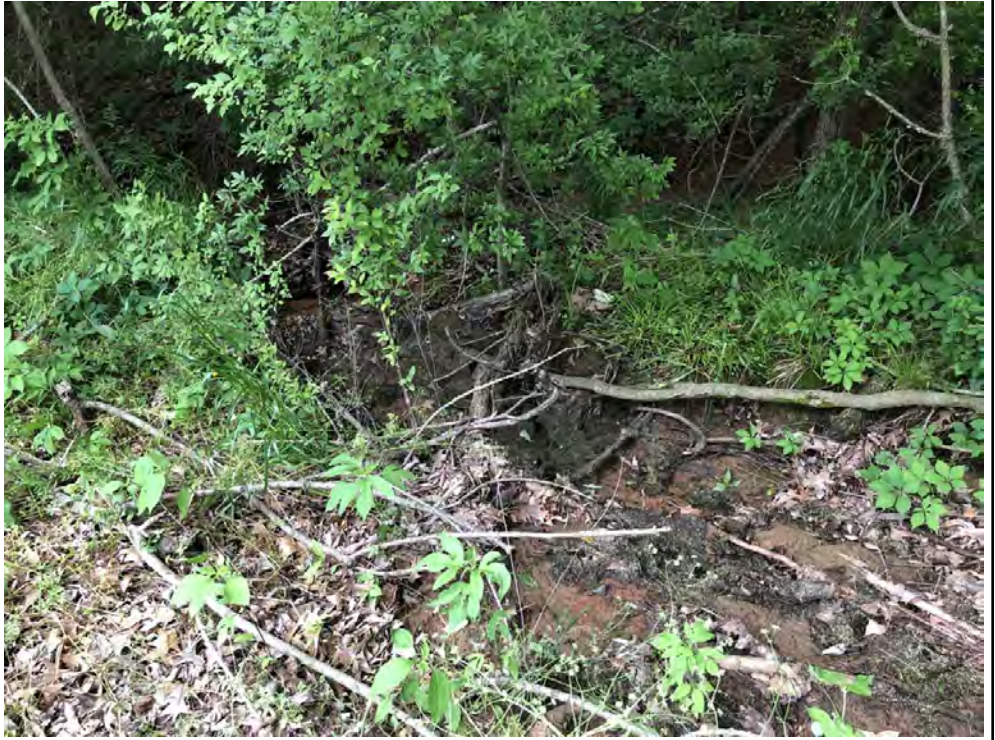
Photo Location: WWC-11			
Direction: North northeast			
Survey Date: 5/18/2021			
Comments: WWC-11 downstream view.

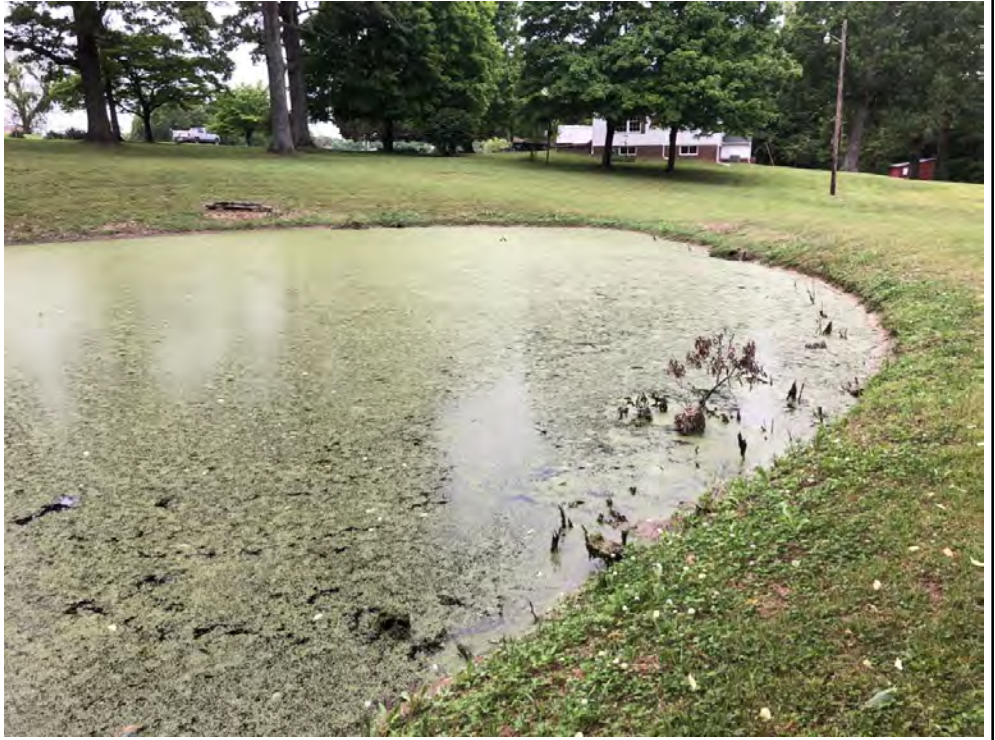
Photo Location: PND-02			
Direction: Southwest			
Survey Date: 5/18/2021			
Comments: PND-02 overview.			
Photograph ID: 64

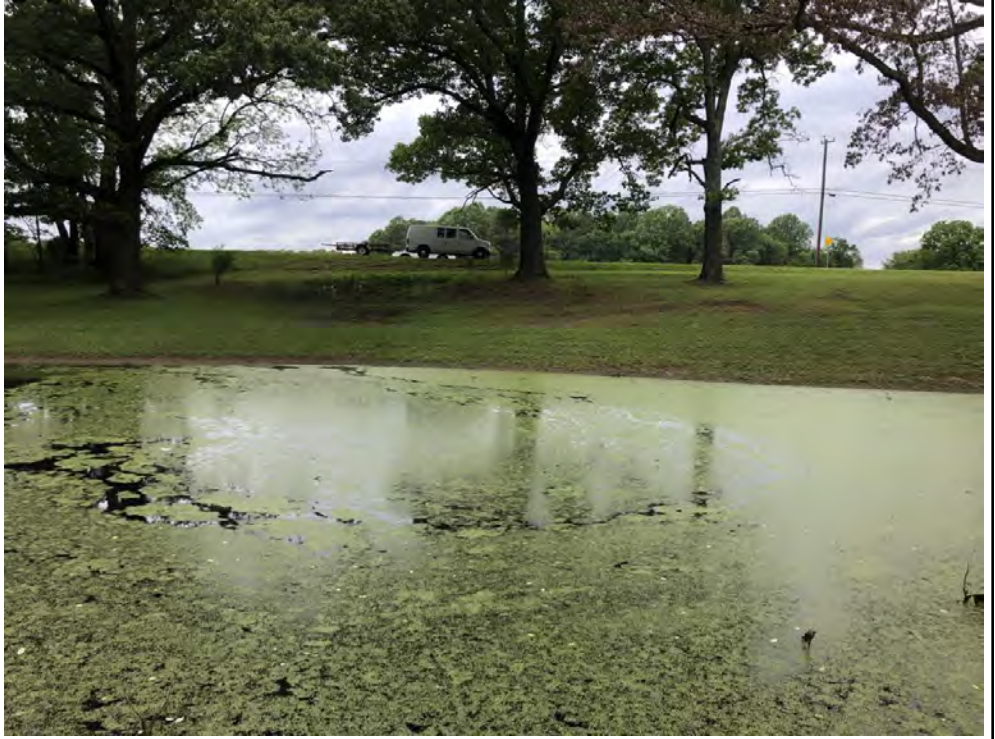
Photo Location: PND-02			
Direction: North			
Survey Date: 5/18/2021			
Comments: PND-02 overview.

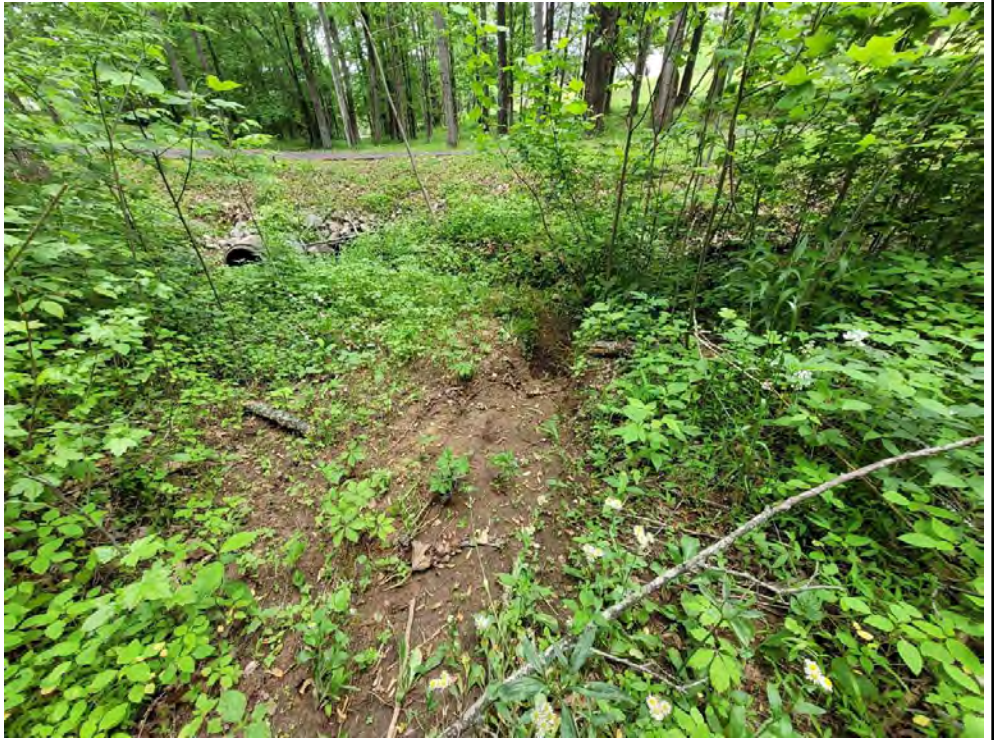
Photo Location: WWC-12			
Direction: Northwest			
Survey Date: 5/17/2021			
Comments: WWC-12 downstream view.			
Photograph ID: 68	 		
Photo Location: WWC-12			
Direction: Southeast			
Survey Date: 5/17/2021			
Comments: WWC-12 upstream view.

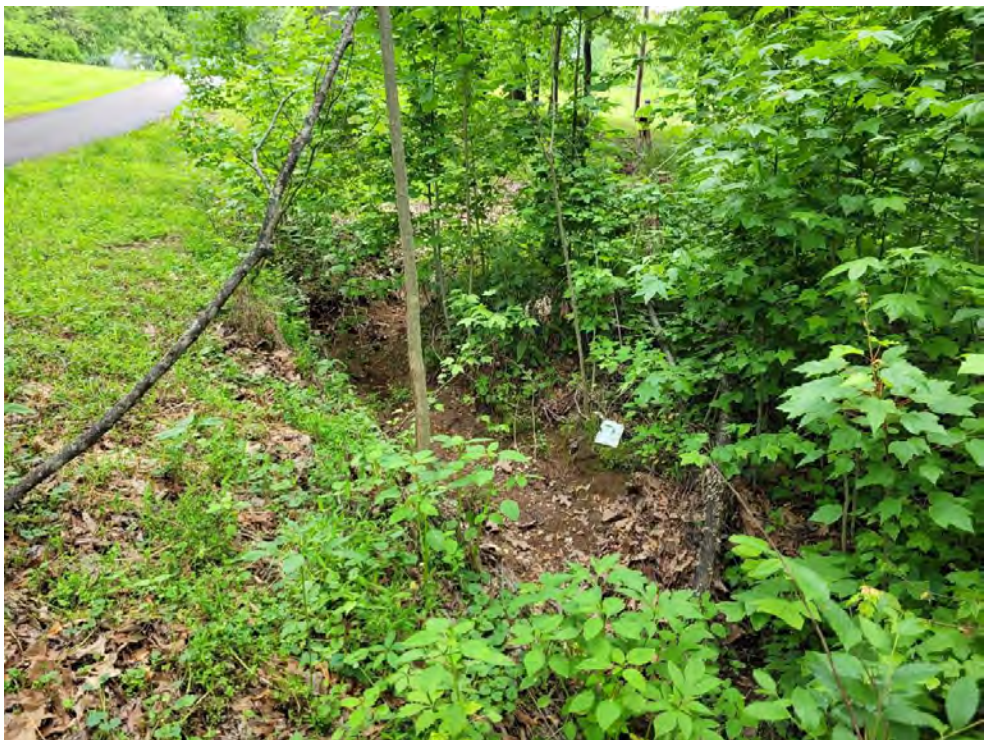
Photo Location: WWC-13			
Direction: Southeast			
Survey Date: 5/17/2021			
Comments: WWC-13 upstream view			
Photograph ID: 72

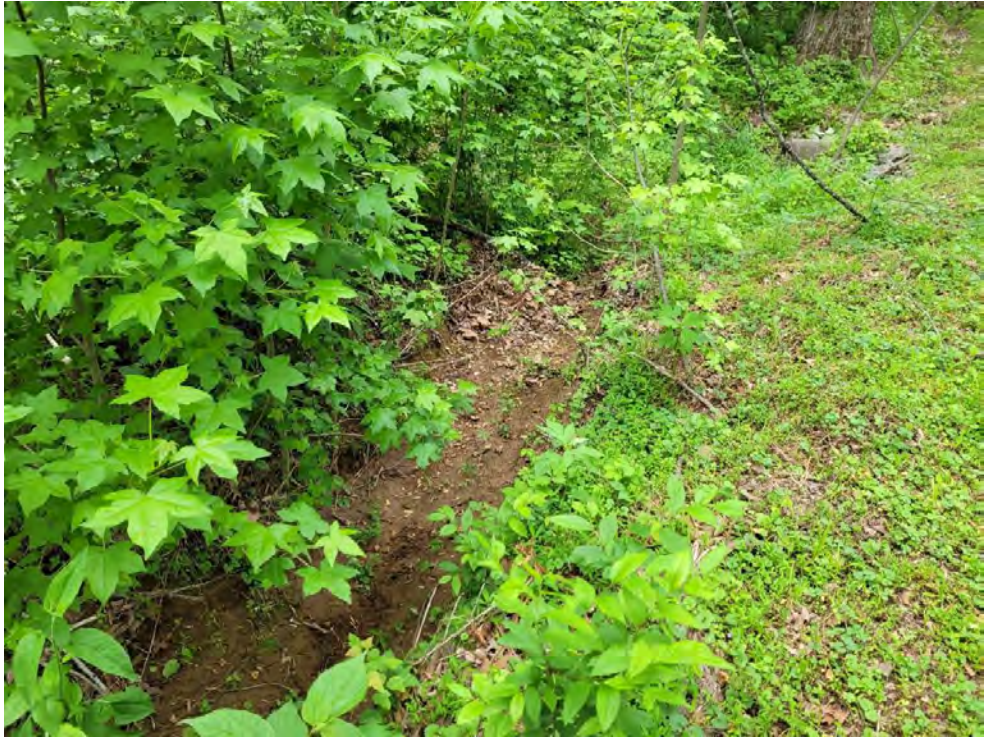
Photo Location: WWC-13			
Direction: Southeast			
Survey Date: 5/17/2021			
Comments: WWC-13 downstream view.

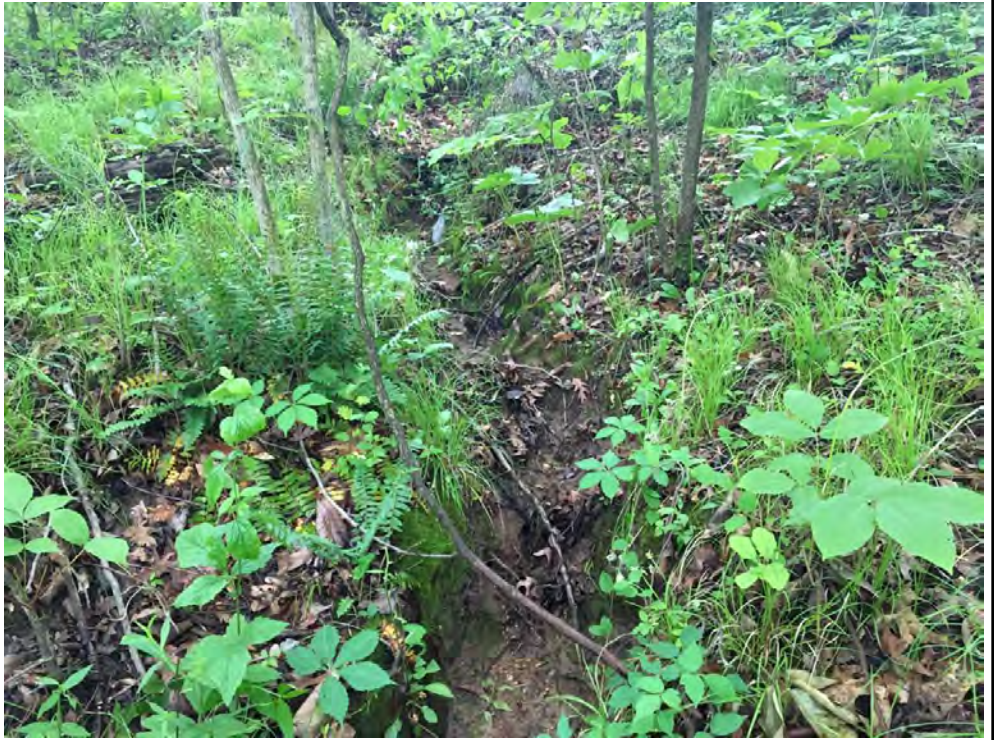
Photo Location: WWC-14			
Direction: West			
Survey Date: 5/18/2021			
Comments: WWC-14 upstream view.			
Photograph ID: 74

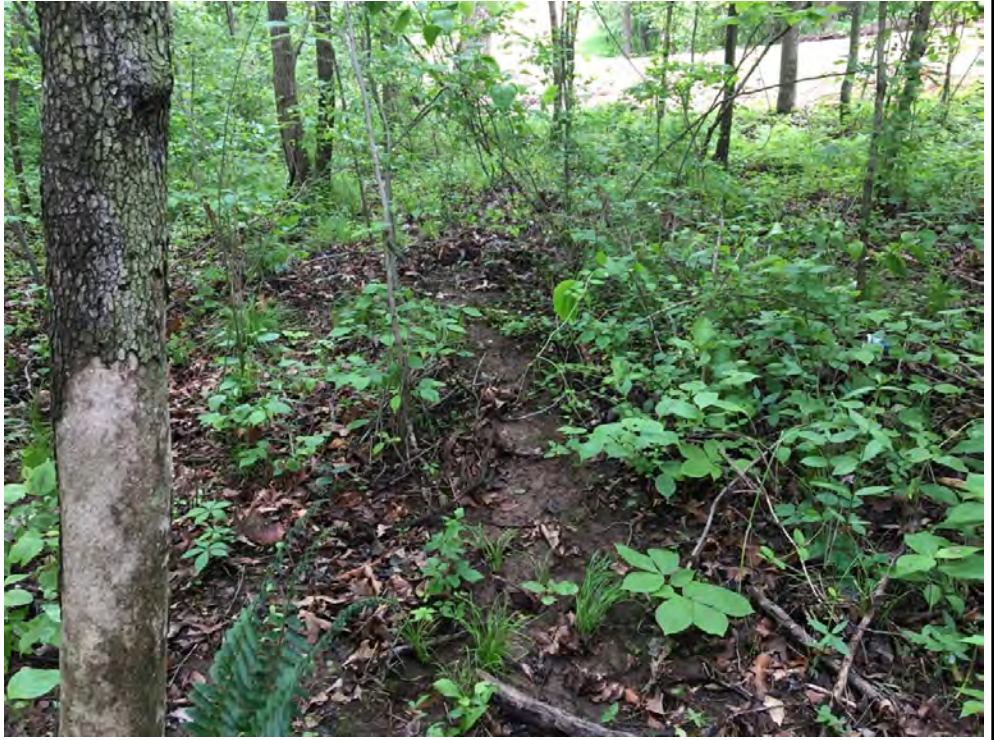
Photo Location: WWC-14			
Direction: South southeast			
Survey Date: 5/18/2021			
Comments: WWC-14 downstream view.

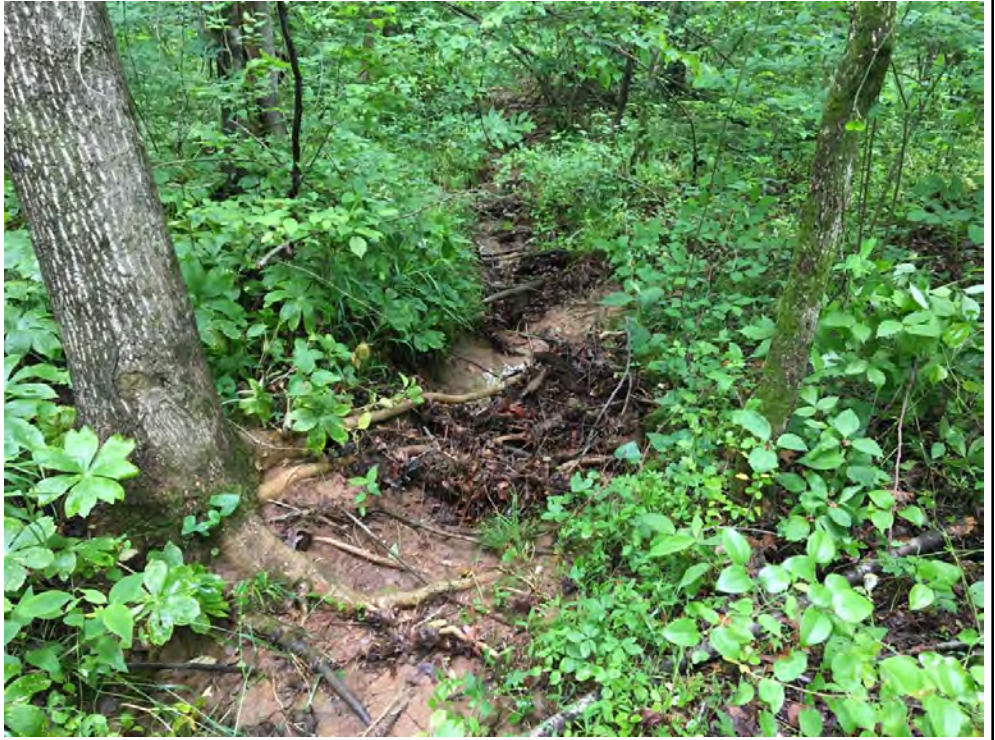
Photo Location: WWC-15			
Direction: East northeast			
Survey Date: 5/18/2021			
Comments: WWC-15 downstream view.

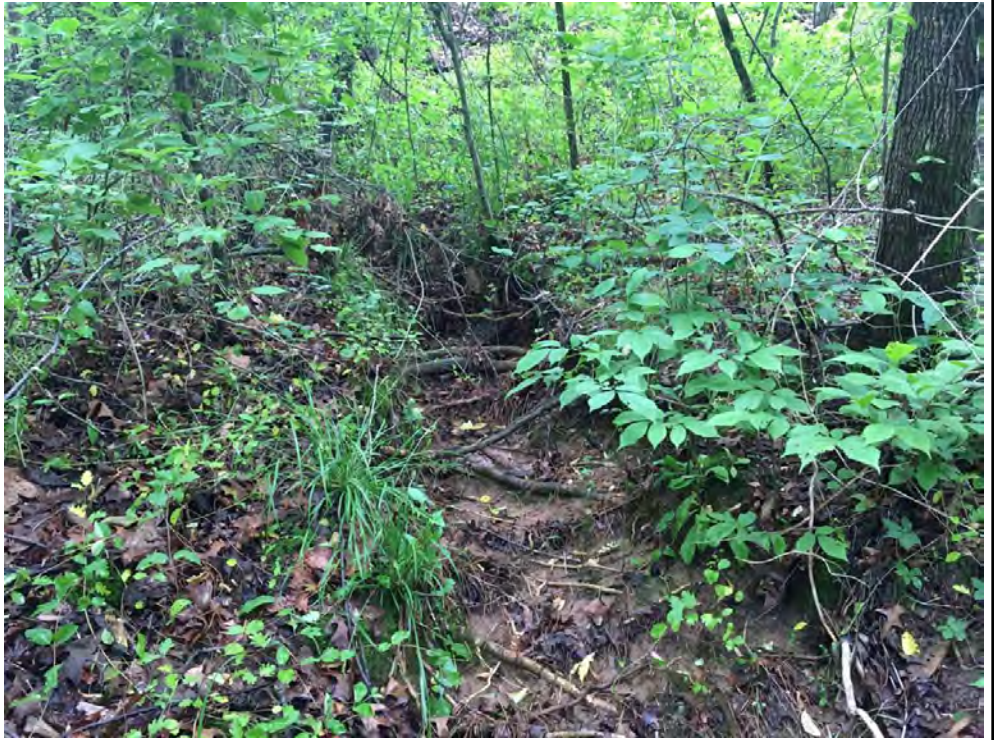
Photo Location: WWC-15			
Direction: South southwest			
Survey Date: 5/18/2021			
Comments: WWC-16 upstream view			
Photograph ID: 78

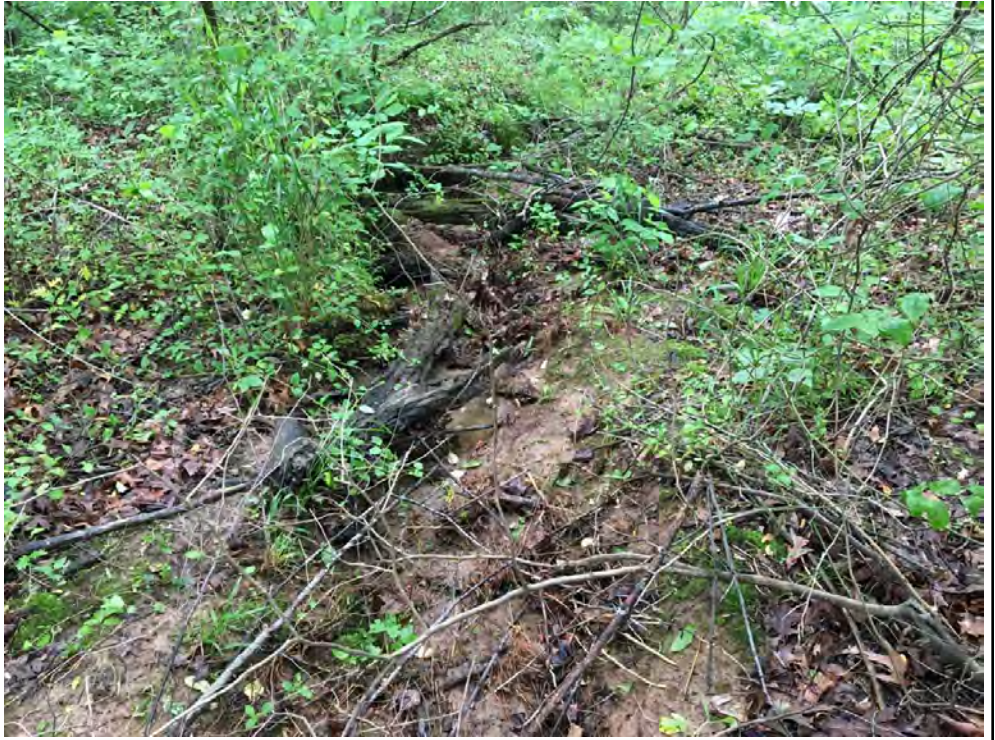
Photo Location: WWC-15			
Direction: South southeast			
Survey Date: 5/18/2021			
Comments: WWC-16 downstream view.

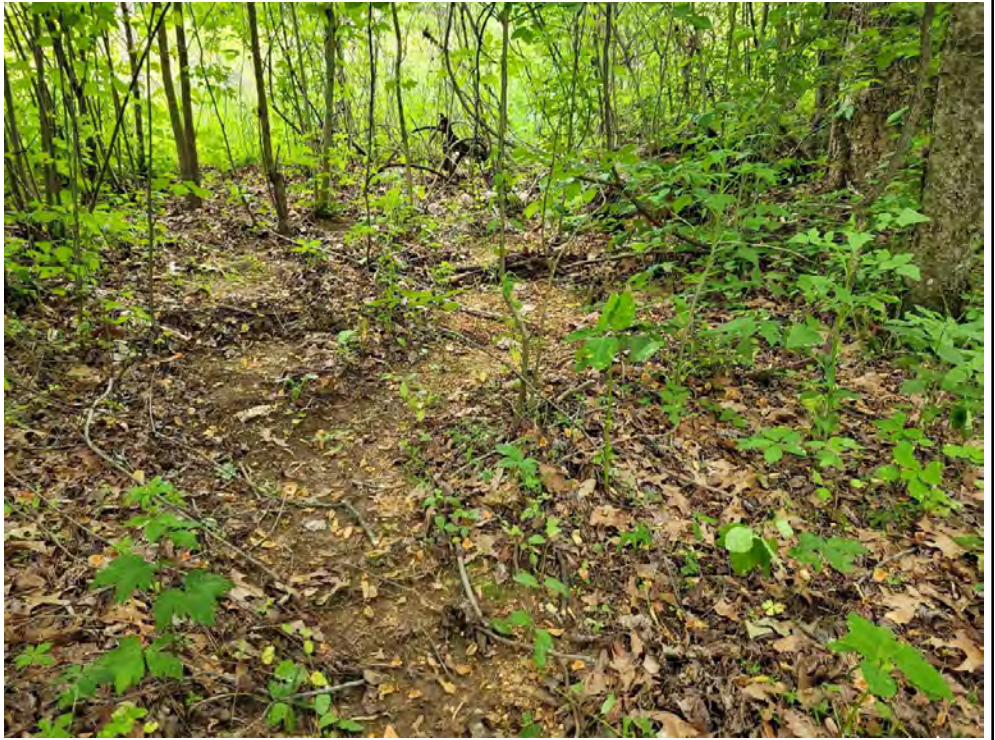
Photo Location: WWC-16			
Direction: South			
Survey Date: 5/17/2021			
Comments: WWC-16 upstream view.			
Photograph ID: 84	 		
Photo Location: WWC-16			
Direction: North			
Survey Date: 5/17/2021			
Comments: WWC-16 downstream view.

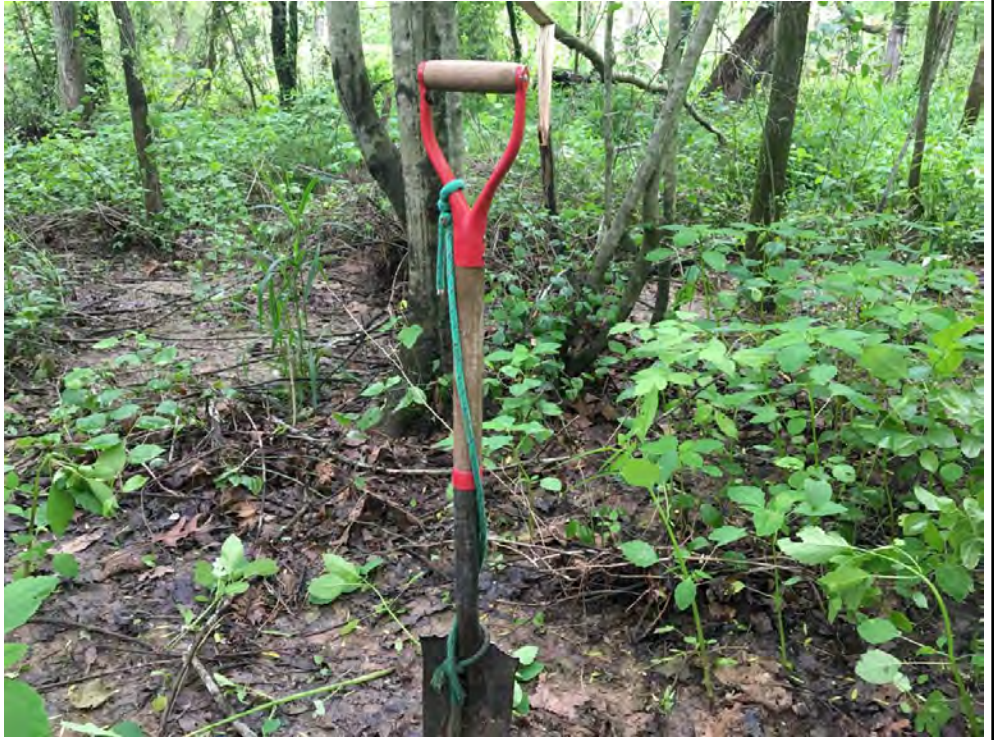
Photo Location: WTL-08			
Direction: South southwest			
Survey Date: 5/18/2021			
Comments: WTL-08 wetland point.

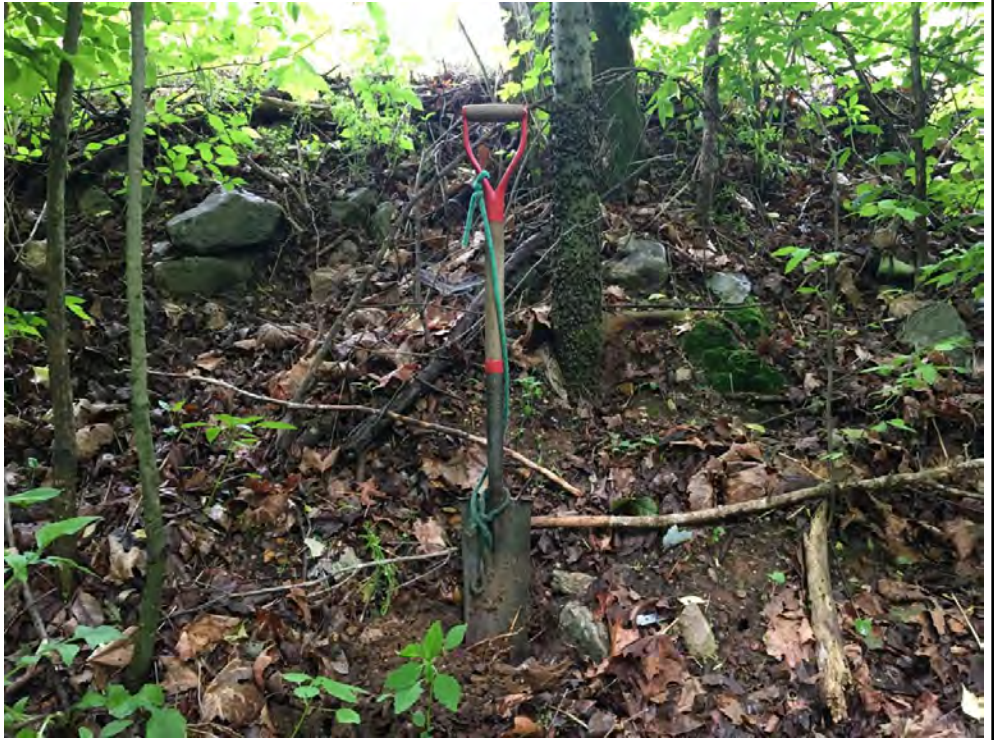
Photo Location: WTL-08			
Direction: West southwest			
Survey Date: 5/18/2021			
Comments: WTL-08 upland point.			
Photograph ID: 88

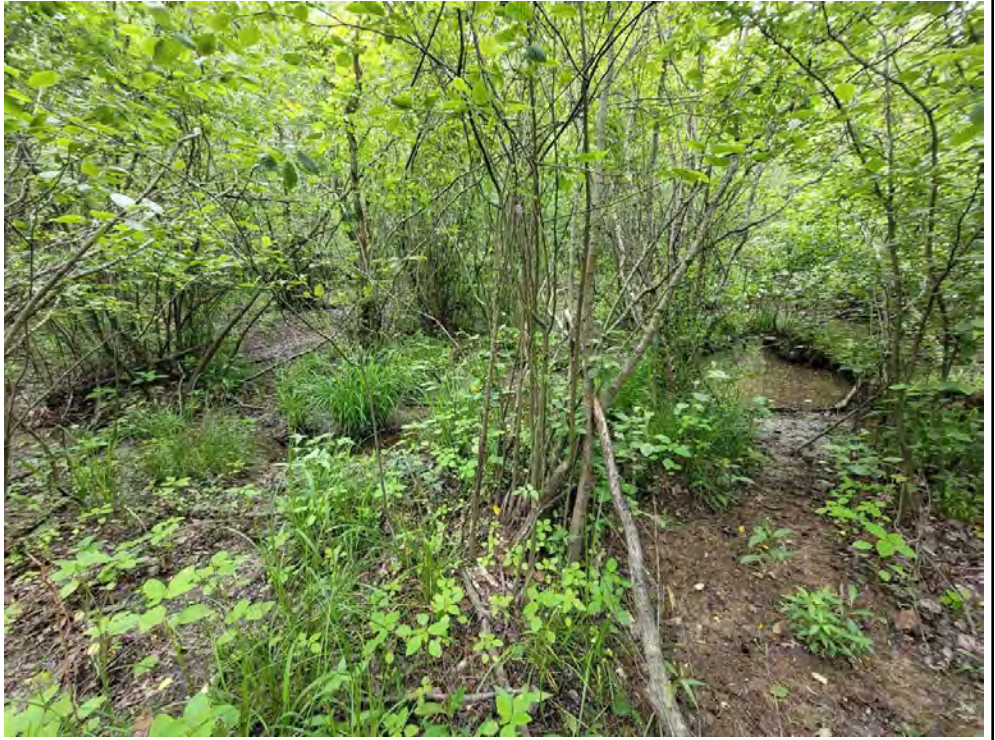
Photo Location: WTL-09			
Direction: North			
Survey Date: 5/17/2021			
Comments: WTL-09 wetland overview.

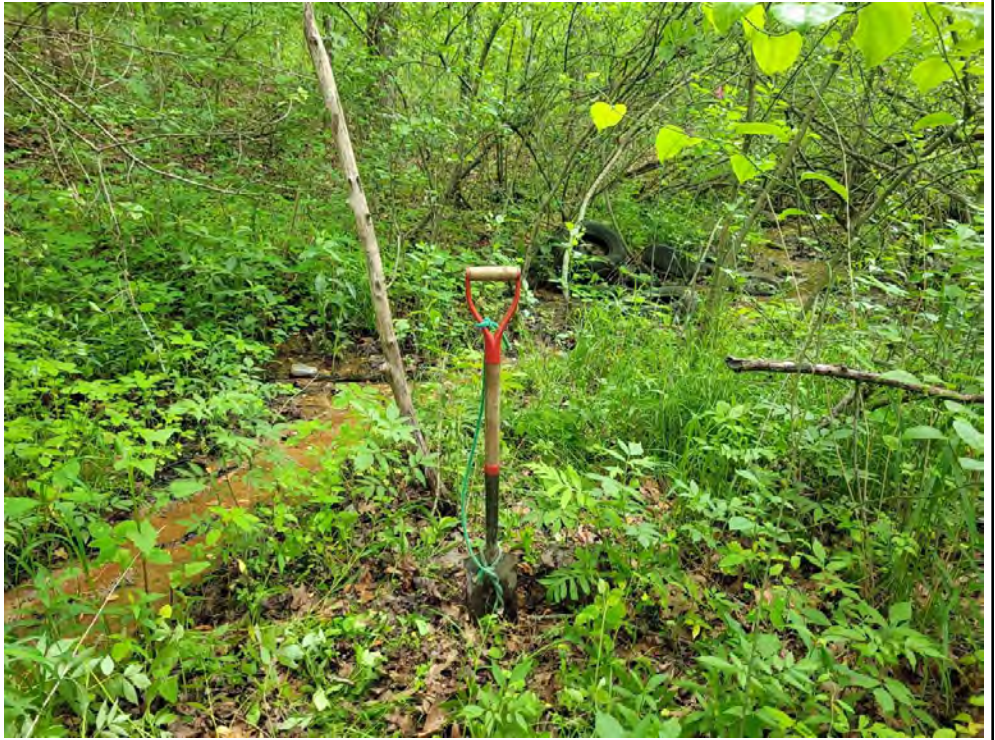
Photo Location: WTL-09			
Direction: Northeast			
Survey Date: 5/17/2021			
Comments: WTL-09 wetland point.			
Photograph ID: 90	 		
Photo Location: WTL-09			
Direction: East			
Survey Date: 5/17/2021			
Comments: WTL-09 upland point.

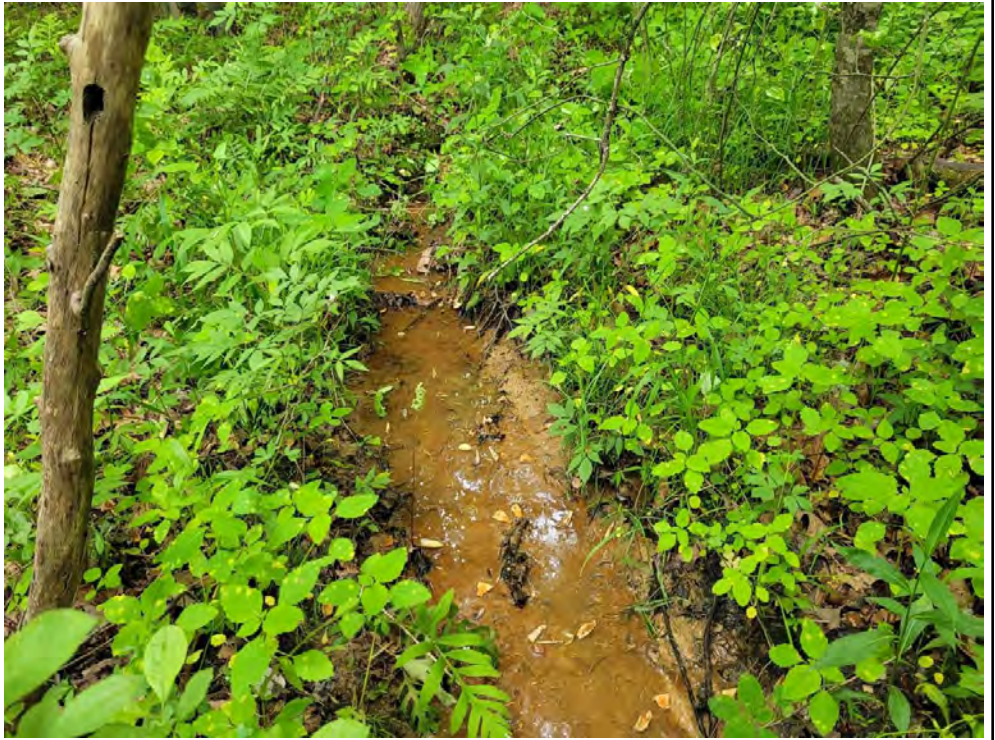
Photo Location: STR-06			
Direction: Southeast			
Survey Date: 5/17/2021			
Comments: STR-06 upstream view.			
Photograph ID: 92

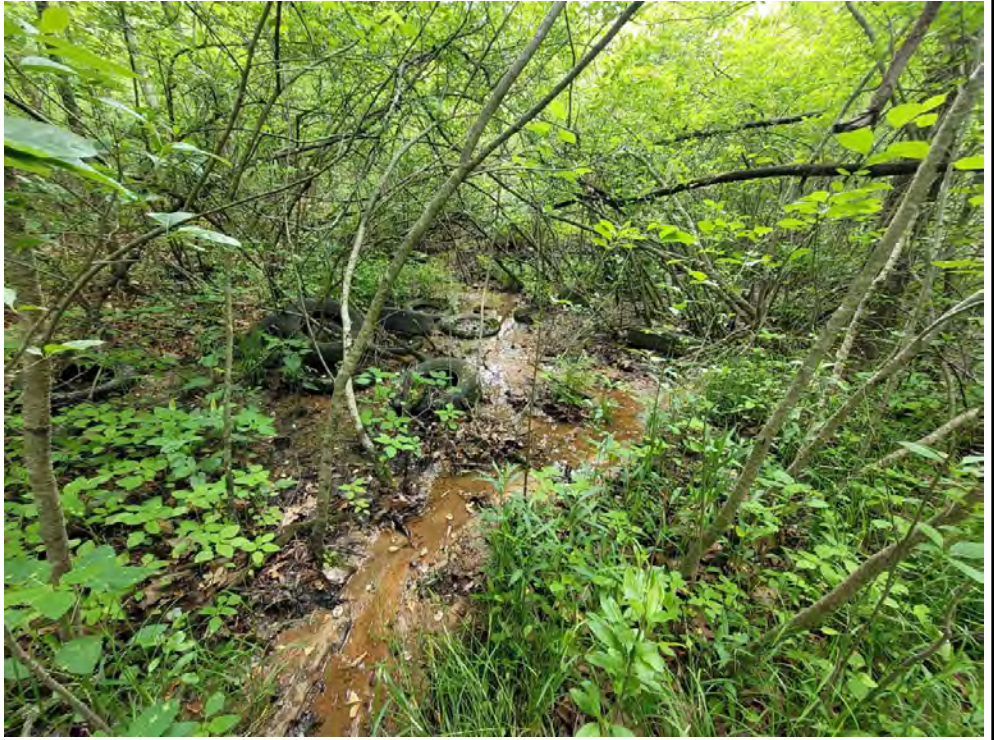
Photo Location: STR-06			
Direction: Northwest			
Survey Date: 5/17/2021			
Comments: STR-06 downstream view.

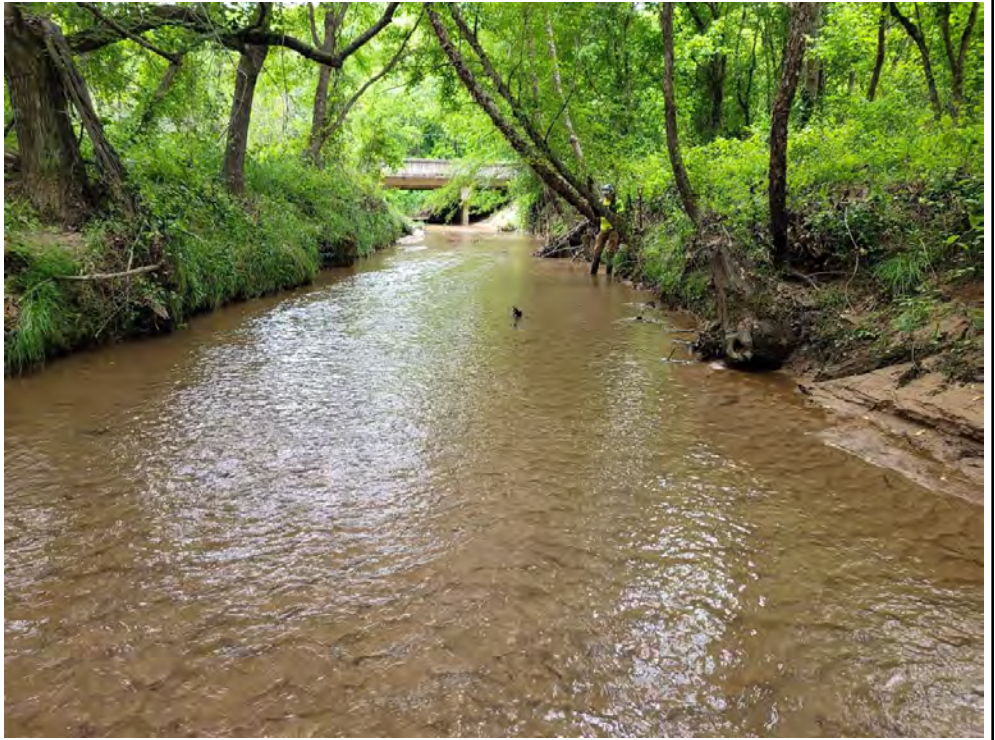
Photo Location: STR-07			
Direction: East			
Survey Date: 5/17/2021			
Comments: STR-07 upstream view.			
Photograph ID: 94

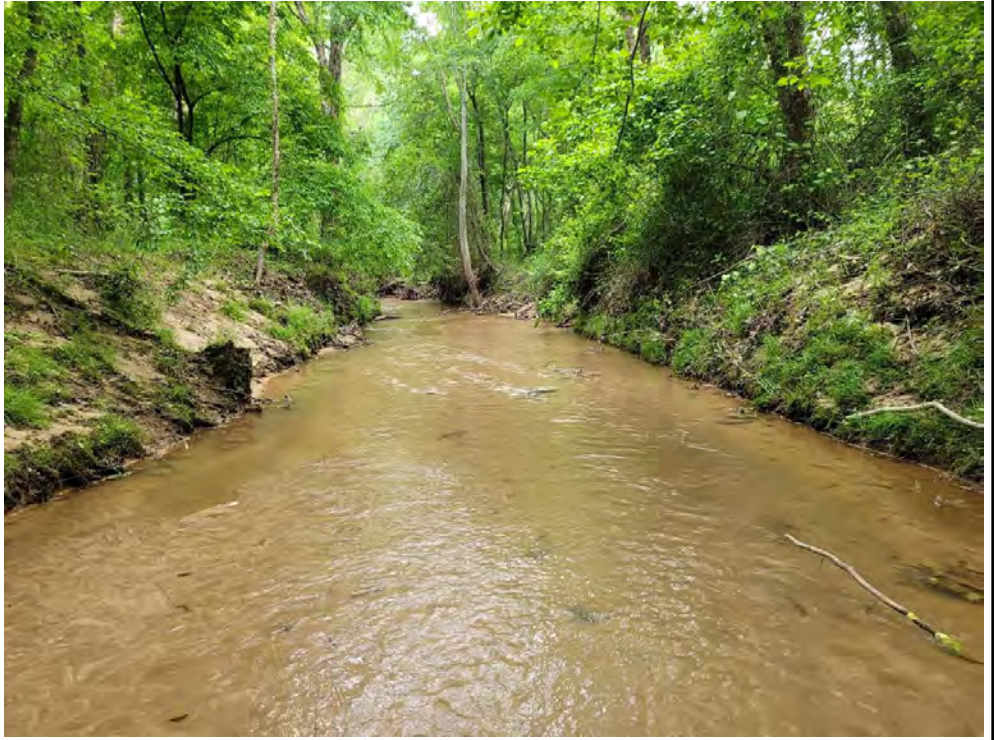
Photo Location: STR-07			
Direction: West			
Survey Date: 5/17/2021			
Comments: STR-07 downstream view.

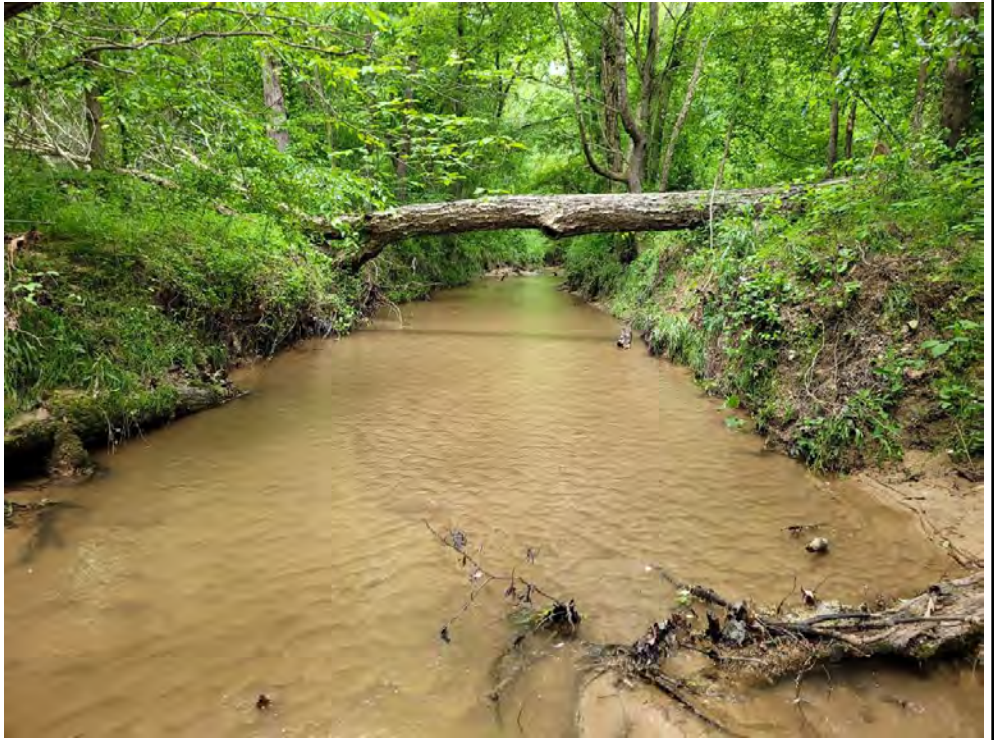
Photo Location: STR-07			
Direction: West			
Survey Date: 5/17/2021			
Comments: STR-07 upstream view.			
Photograph ID: 96

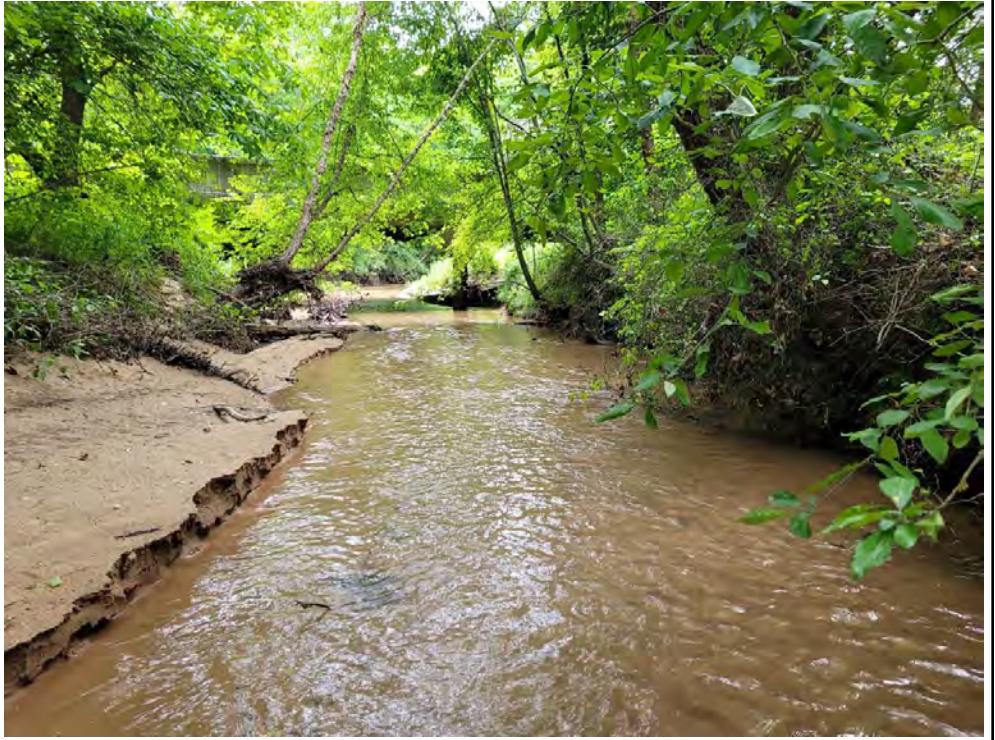
Photo Location: STR-07			
Direction: East			
Survey Date: 5/17/2021			
Comments: STR-07 downstream view.

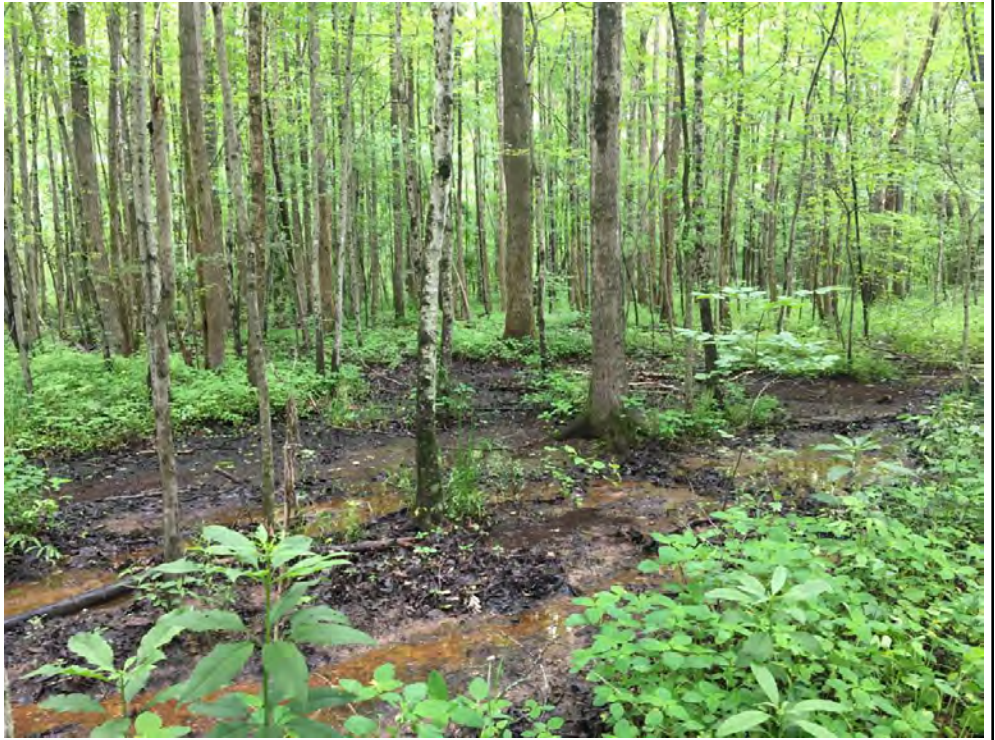
Photo Location: WTL-10			
Direction: South southeast			
Survey Date: 5/18/2021			
Comments: WTL-10 wetland overview.			
Photograph ID: 100

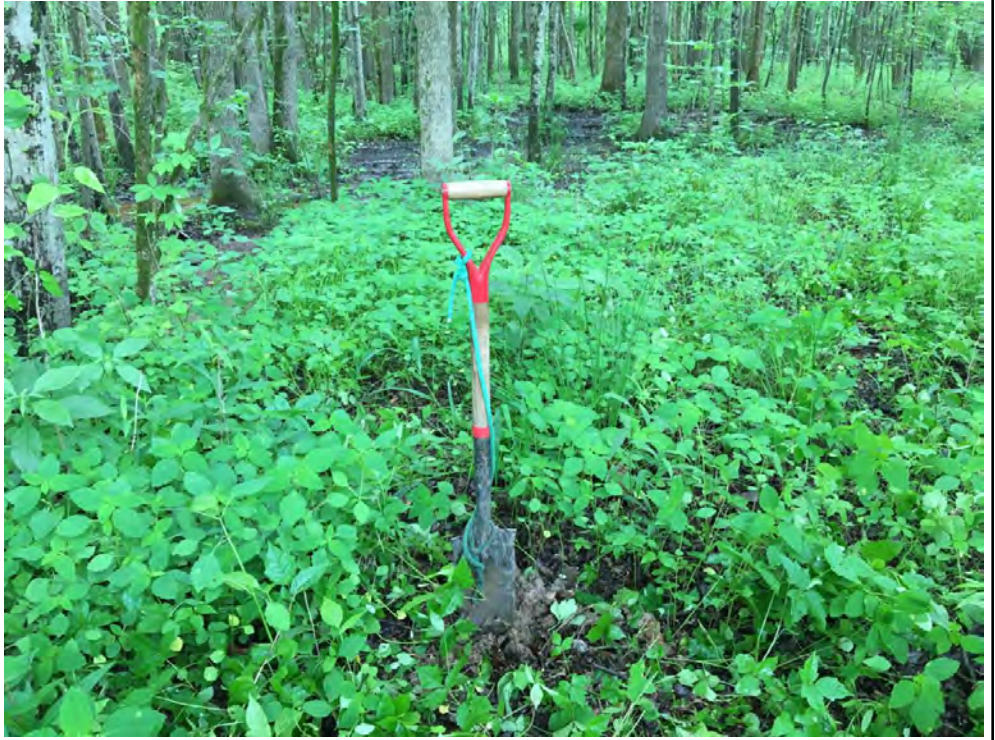
Photo Location: WTL-10			
Direction: Southwest			
Survey Date: 5/18/2021			
Comments: WTL-10 wetland point.

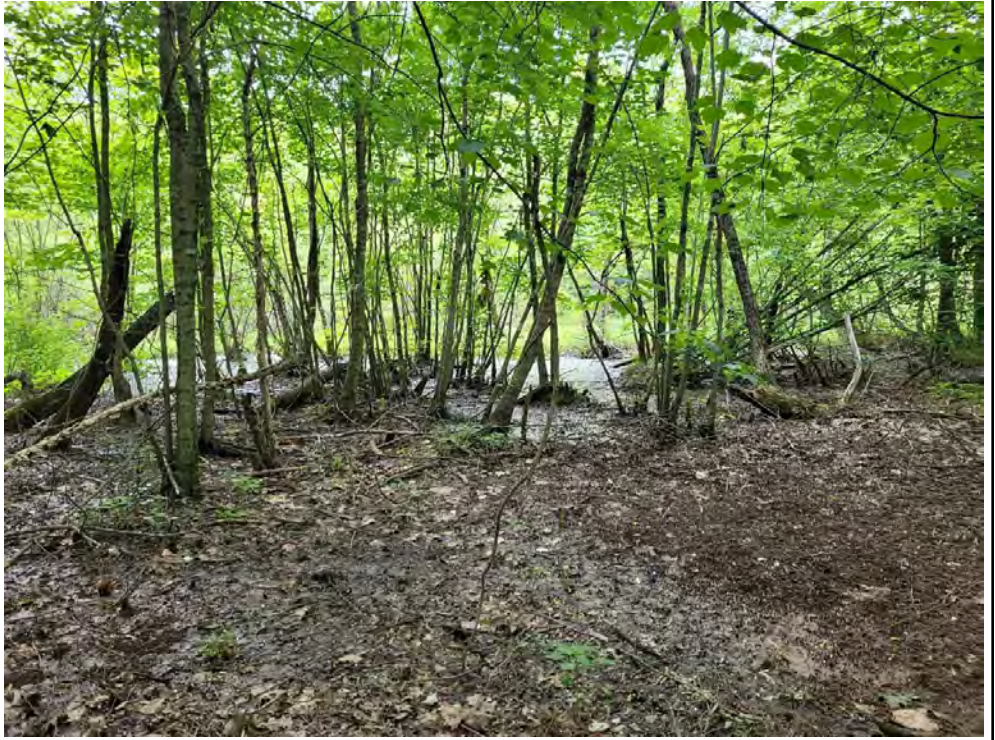
Photo Location: WTL-11			
Direction: North			
Survey Date: 5/17/2021			
Comments: WTL-11 wetland overview.

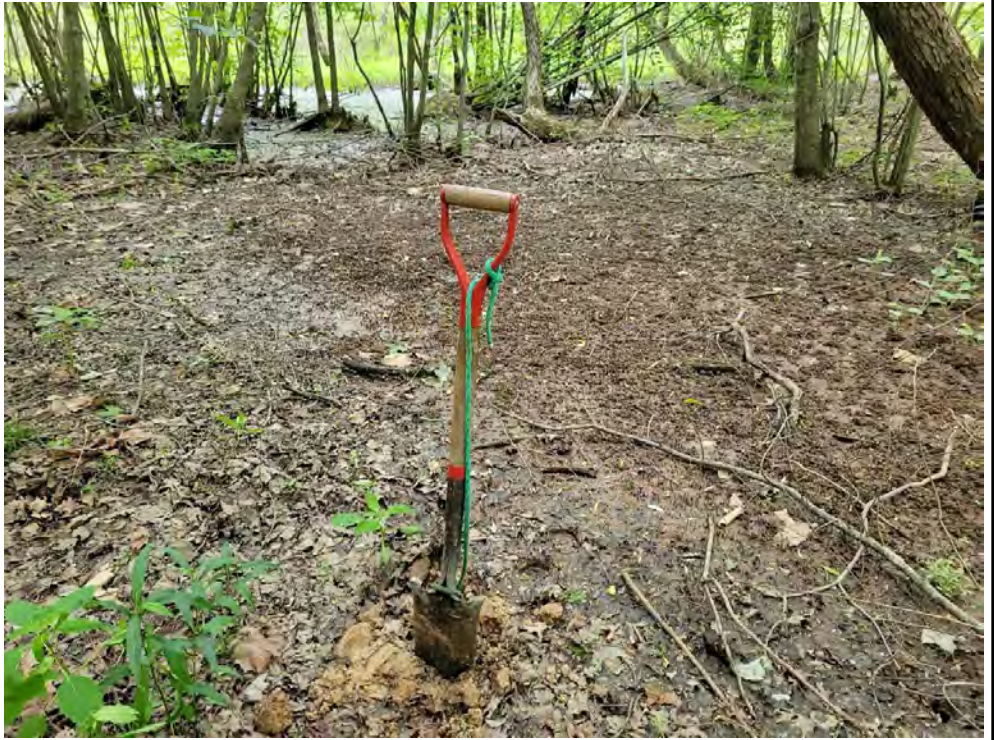
Photo Location: WTL-11			
Direction: Northeast			
Survey Date: 5/17/2021			
Comments: WTL-11 wetland point.			
Photograph ID: 104
