Right-of-Way Reevaluation, State Route 54 (US Highway 641), From State Route 69 (Wood Street) in Paris to Crossland Road/Brannon Lane (North of Puryear), Henry County, Tennessee, PIN 101886.00, Federal Project No. NH-54(26), State Project No. 40003-1213-14

Date: 05/19/2022

Environmental Commitments

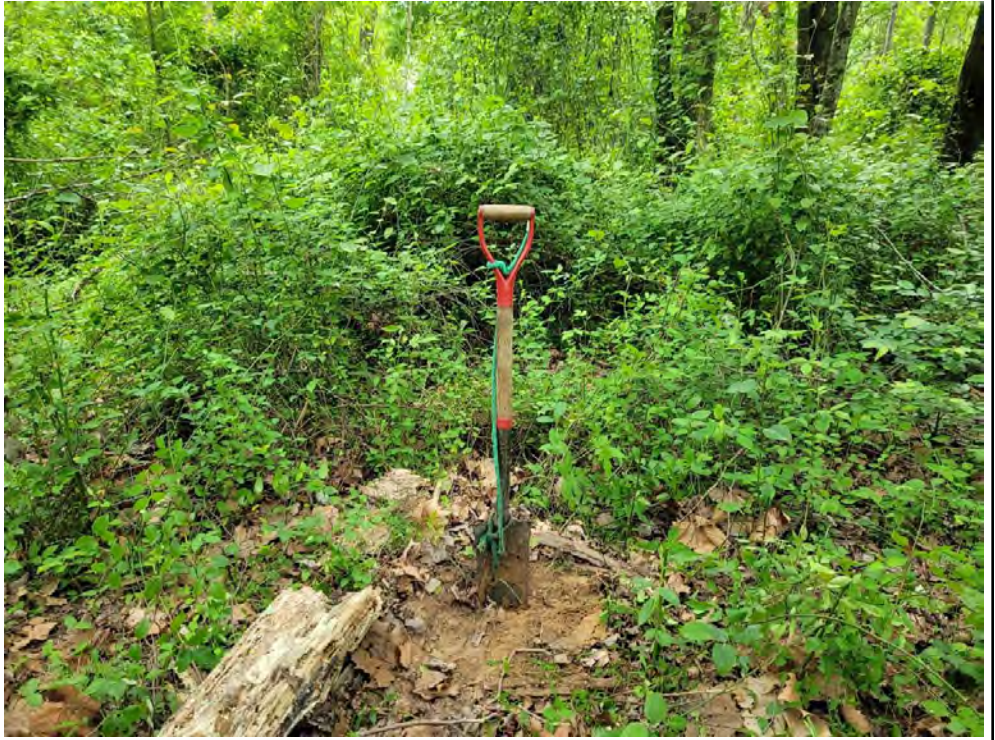
Photo Location: WTL-11			
Direction: Southeast			
Survey Date: 5/17/2021			
Comments: WTL-11 upland point.

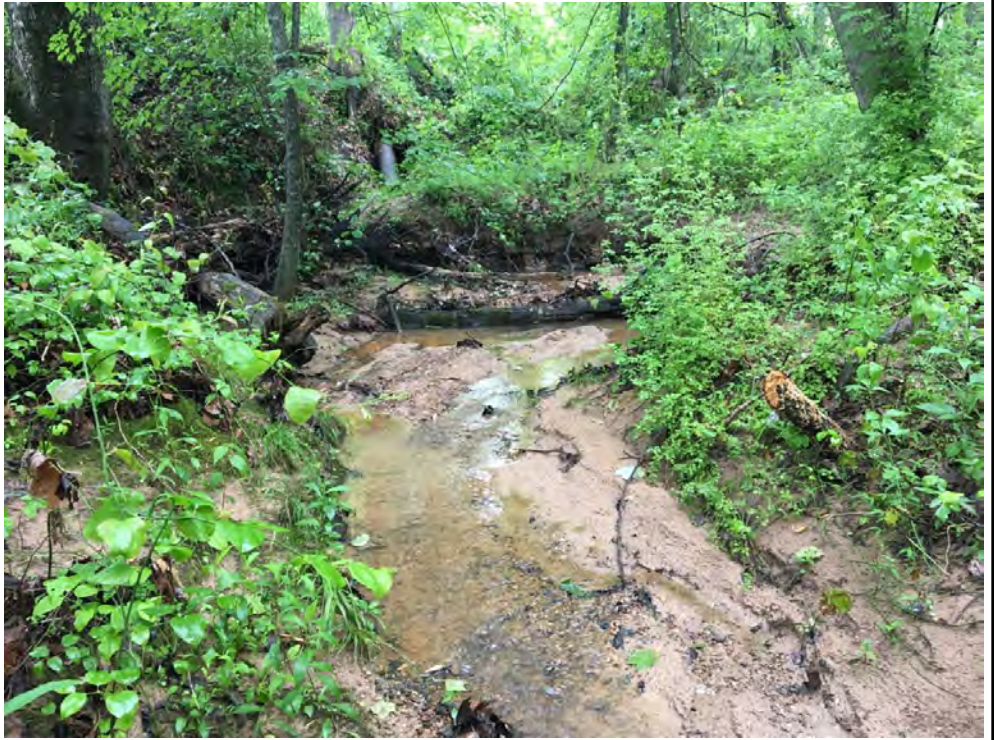
Photo Location: STR-09			
Direction: West northwest			
Survey Date: 5/18/2021			
Comments: STR-09 upstream view.			
Photograph ID: 106

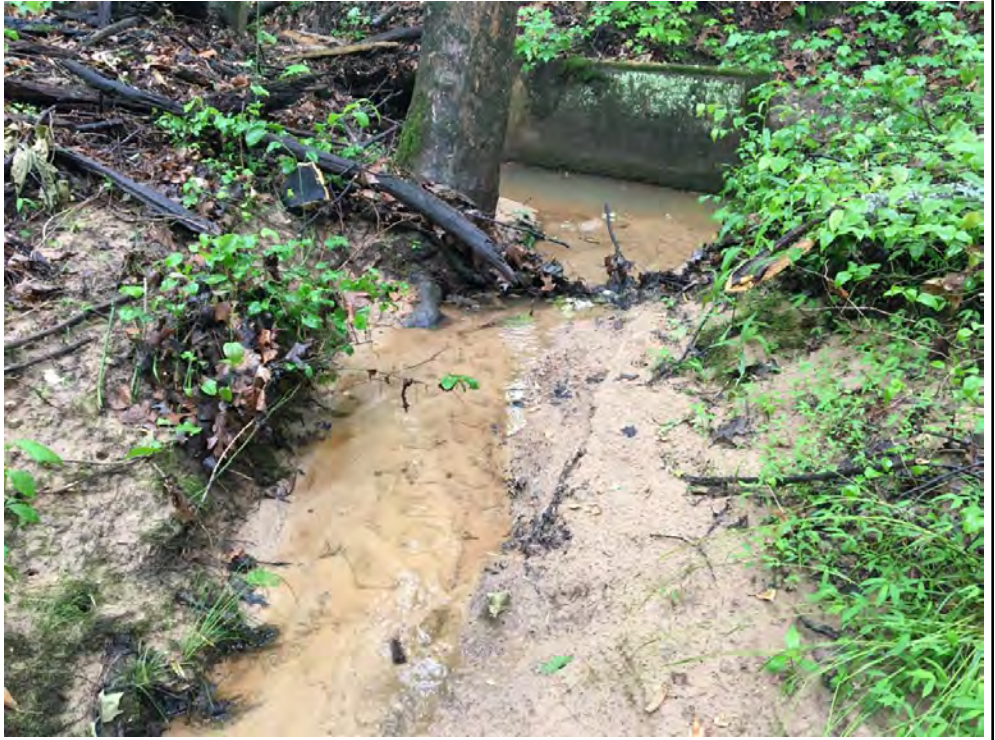
Photo Location: STR-09			
Direction: Southwest			
Survey Date: 5/18/2021			
Comments: STR-09 upstream view towards culvert inlet.

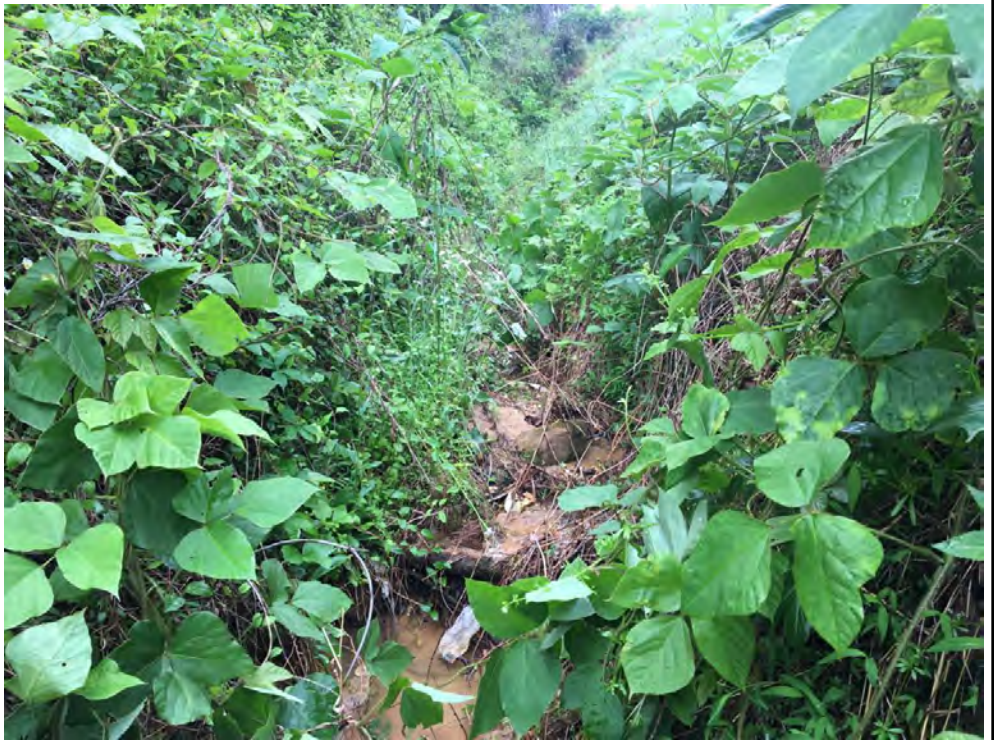
Photo Location: WWC-17			
Direction: Northwest			
Survey Date: 5/18/2021			
Comments: WWC-17 upstream view.			
Photograph ID: 110

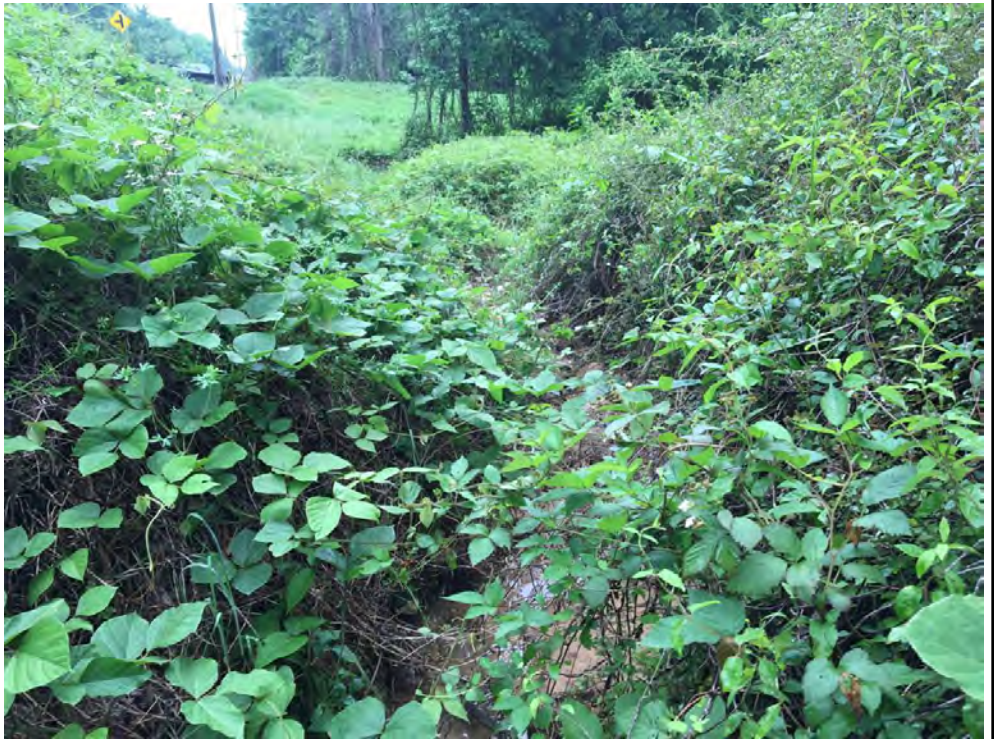
Photo Location: WWC-17			
Direction: Southeast			
Survey Date: 5/18/2021			
Comments: WWC-17 downstream view.

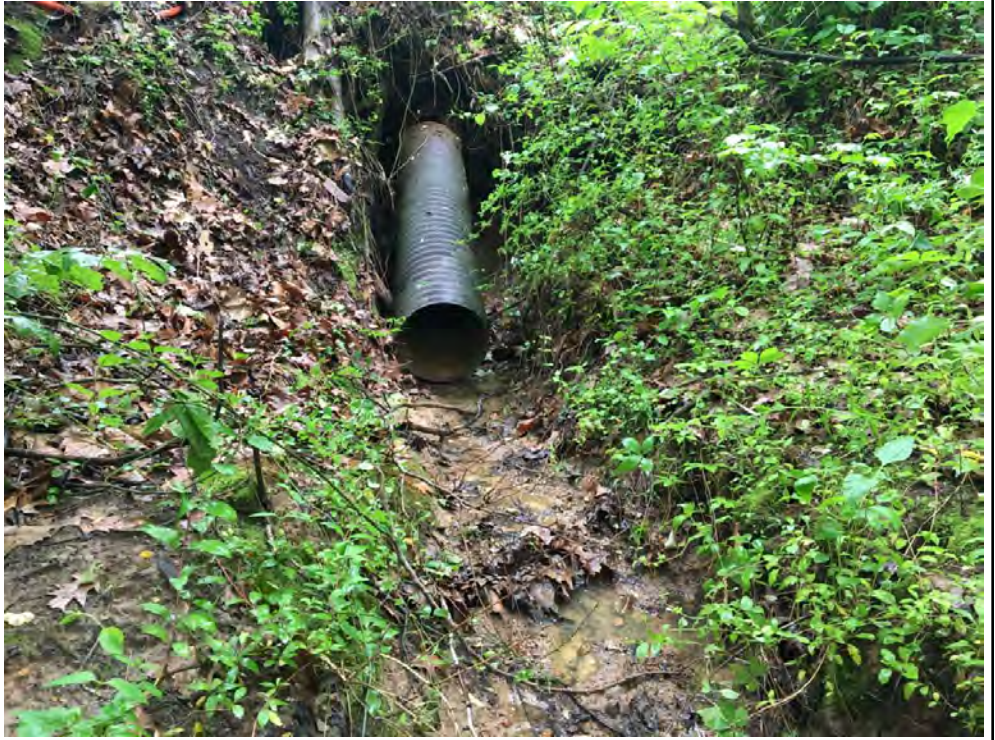
Photo Location: WWC-18			
Direction: South			
Survey Date: 5/18/2021			
Comments: WWC-18 upstream view.

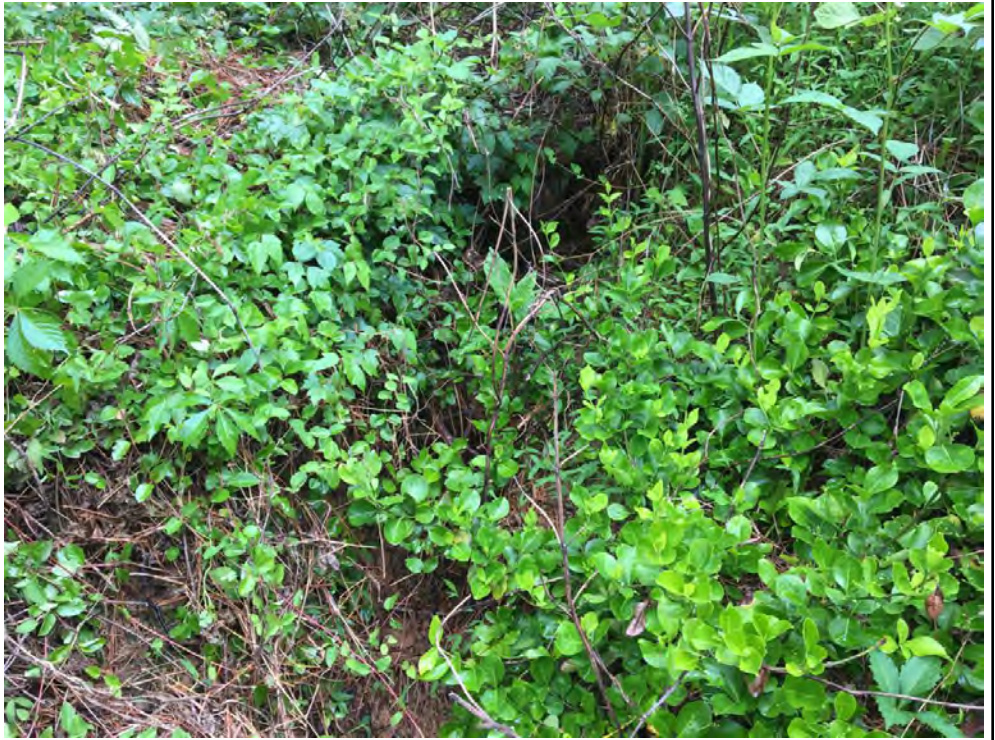
Photo Location: WWC-19			
Direction: Southeast			
Survey Date: 5/18/2021			
Comments: WWC-19 upstream view.			
Photograph ID: 116

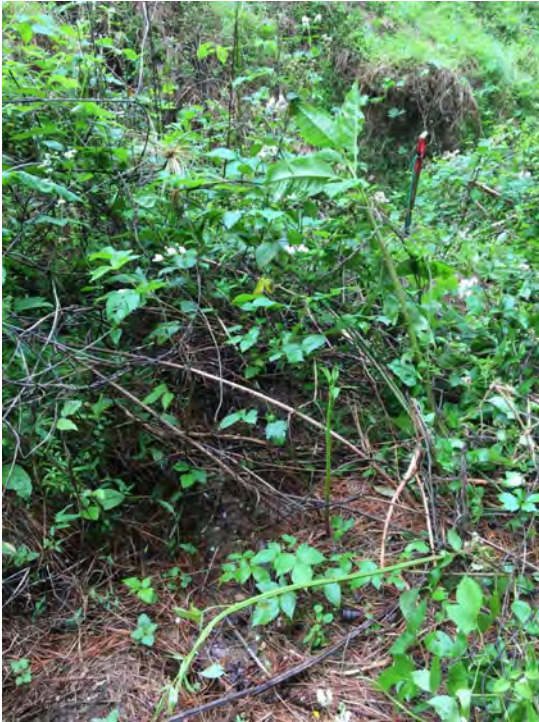
Photo Location: WWC-19			
Direction: East			
Survey Date: 5/18/2021			
Comments: WWC-19 downstream view.

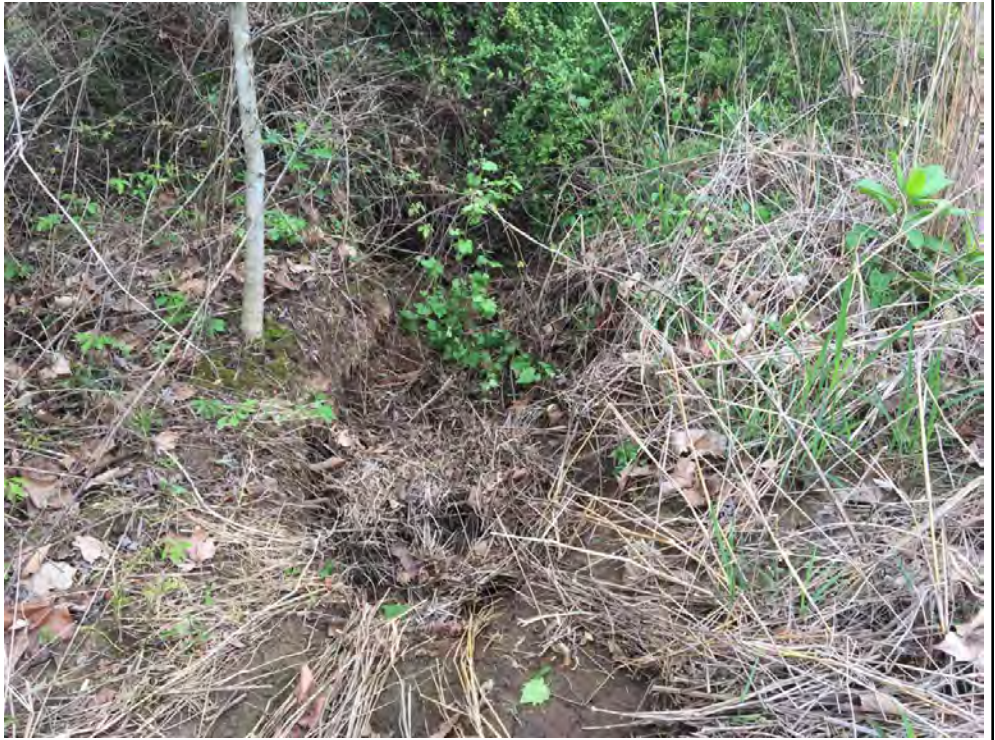
Photo Location: WWC-21			
Direction: South southeast			
Survey Date: 5/19/2021			
Comments: WWC-21 downstream view.			
Photograph ID: 122

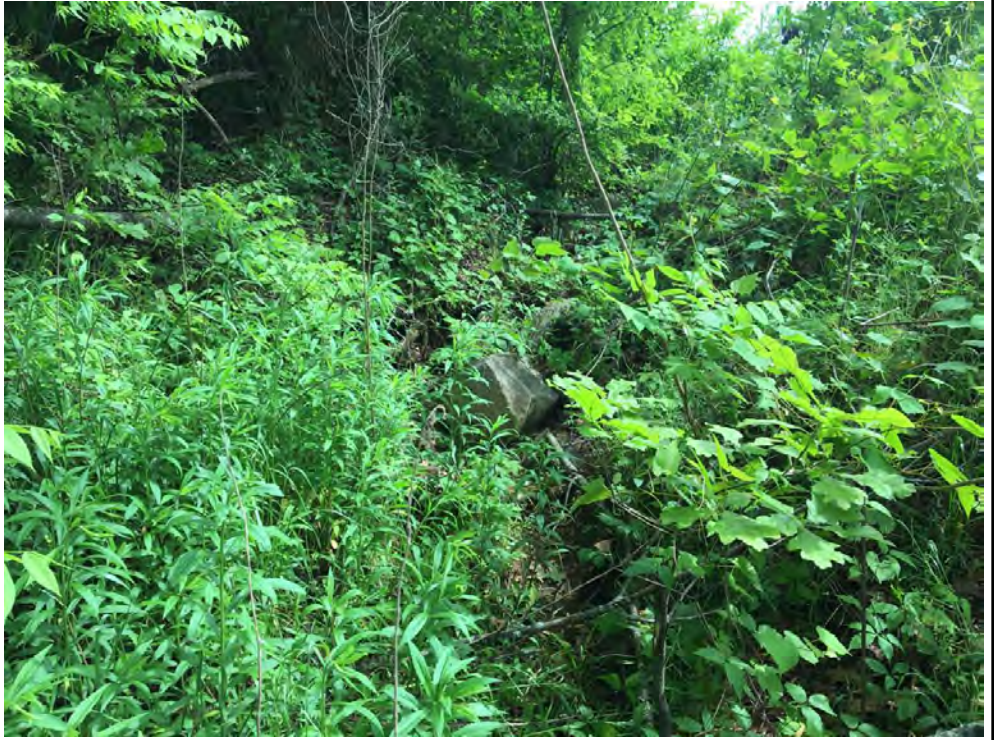
Photo Location: WWC-22			
Direction: West northwest			
Survey Date: 5/18/2021			
Comments: WWC-22 upstream view.

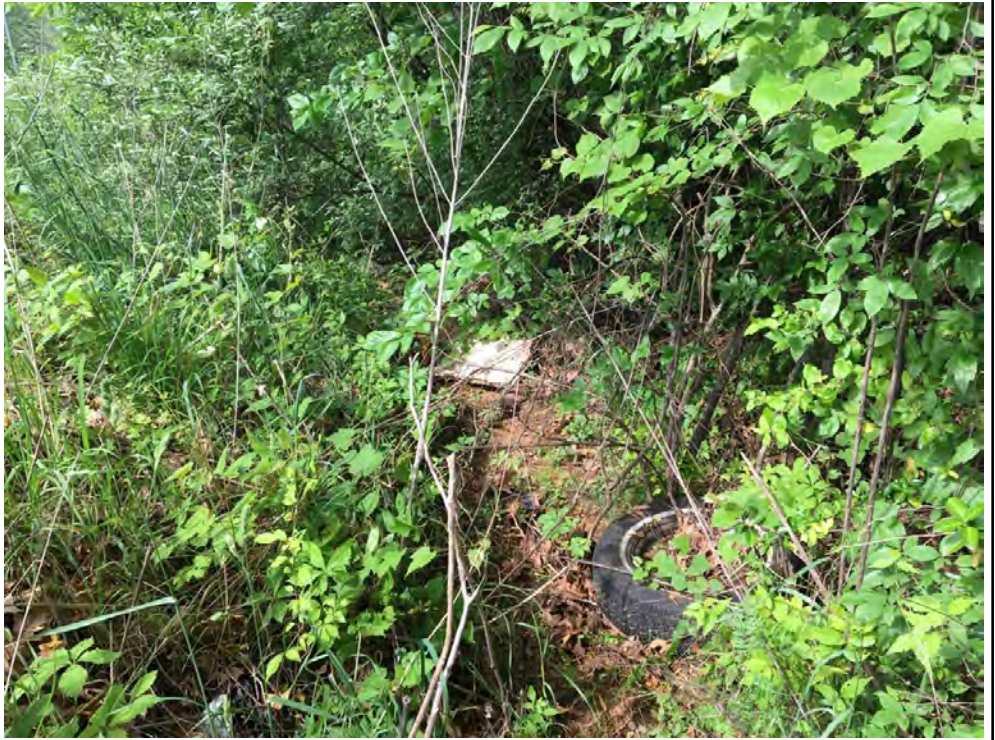
Photo Location: WWC-22			
Direction: North			
Survey Date: 5/18/2021			
Comments: WWC-22 downstream view.			
Photograph ID: 124	 		
Photo Location: WWC-22			
Direction: North northeast			
Survey Date: 5/18/2021			
Comments: WWC-22 upstream view.

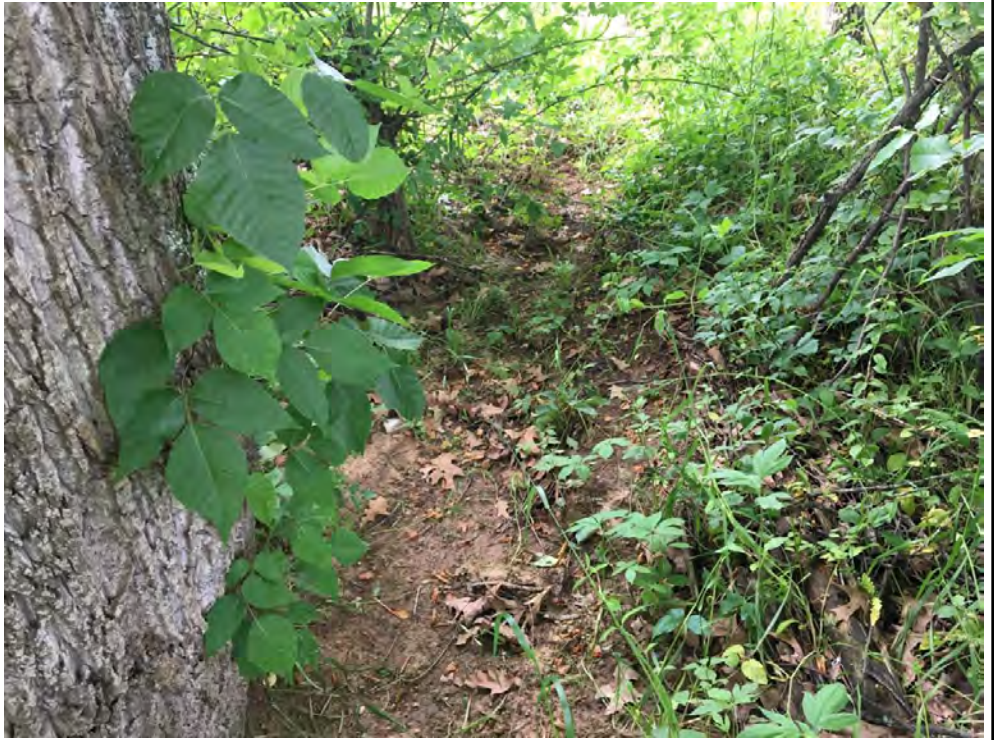
Photo Location: WWC-22			
Direction: West southwest			
Survey Date: 5/18/2021			
Comments: WWC-22 downstream view.			
Photograph ID: 126

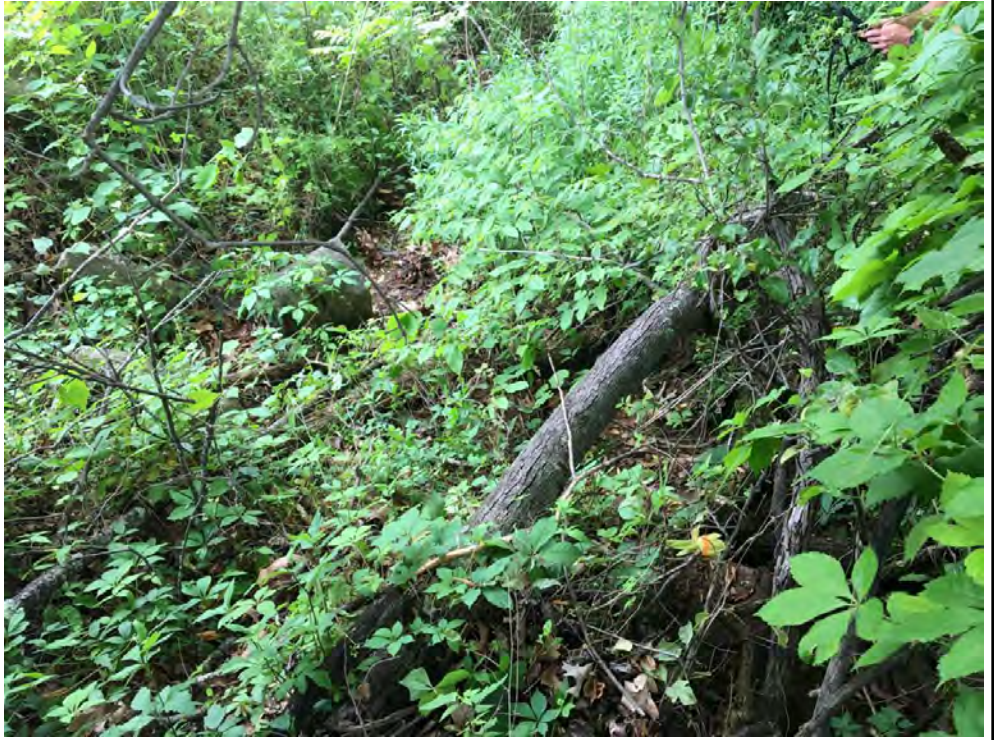
Photo Location: WWC-23			
Direction: Northwest			
Survey Date: 5/18/2021			
Comments: WWC-23 upstream view.

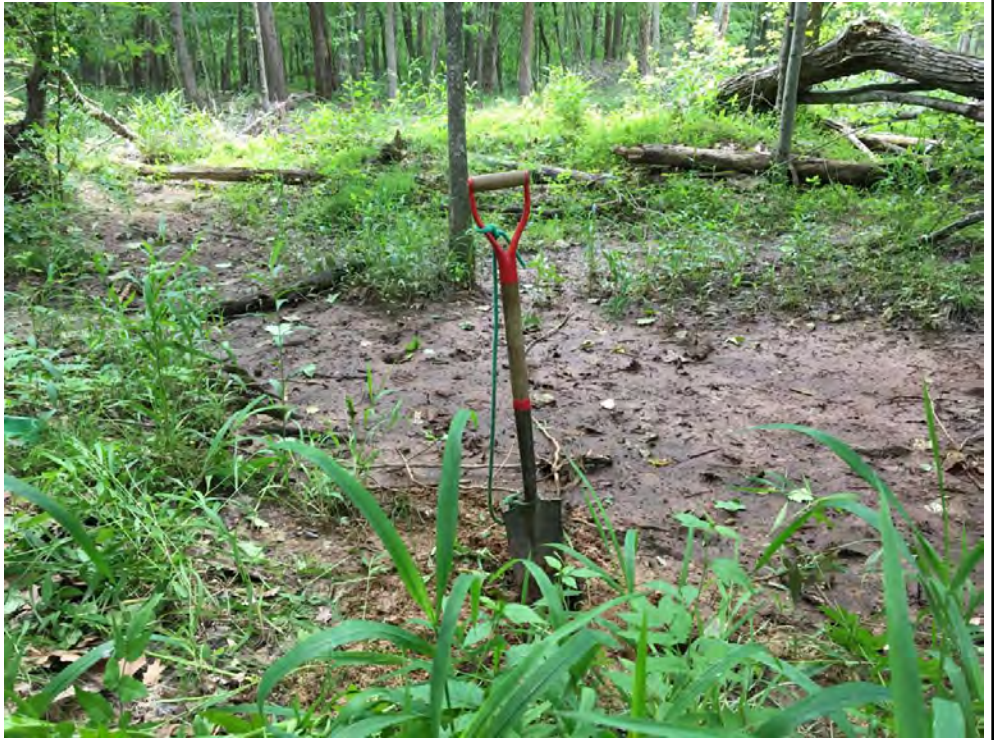
Photo Location: WTL-13			
Direction: Southeast			
Survey Date: 5/19/2021			
Comments: WTL-13 wetland point.			
Photograph ID: 132

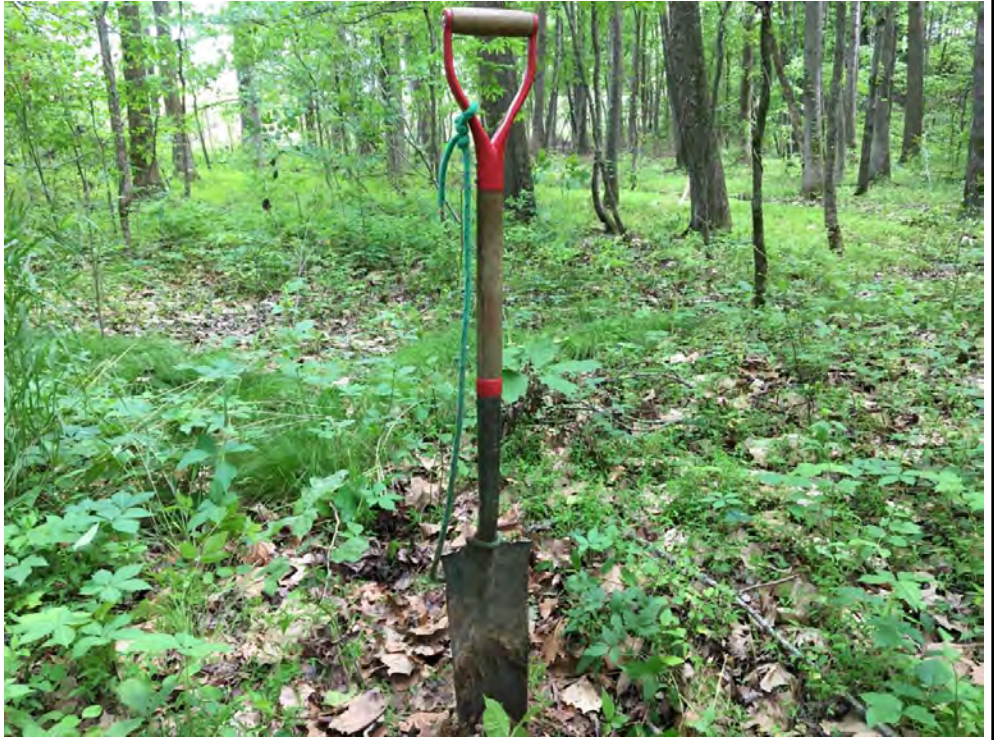
Photo Location: WTL-13			
Direction: Southeast			
Survey Date: 5/19/2021			
Comments: WTL-13 upland point.

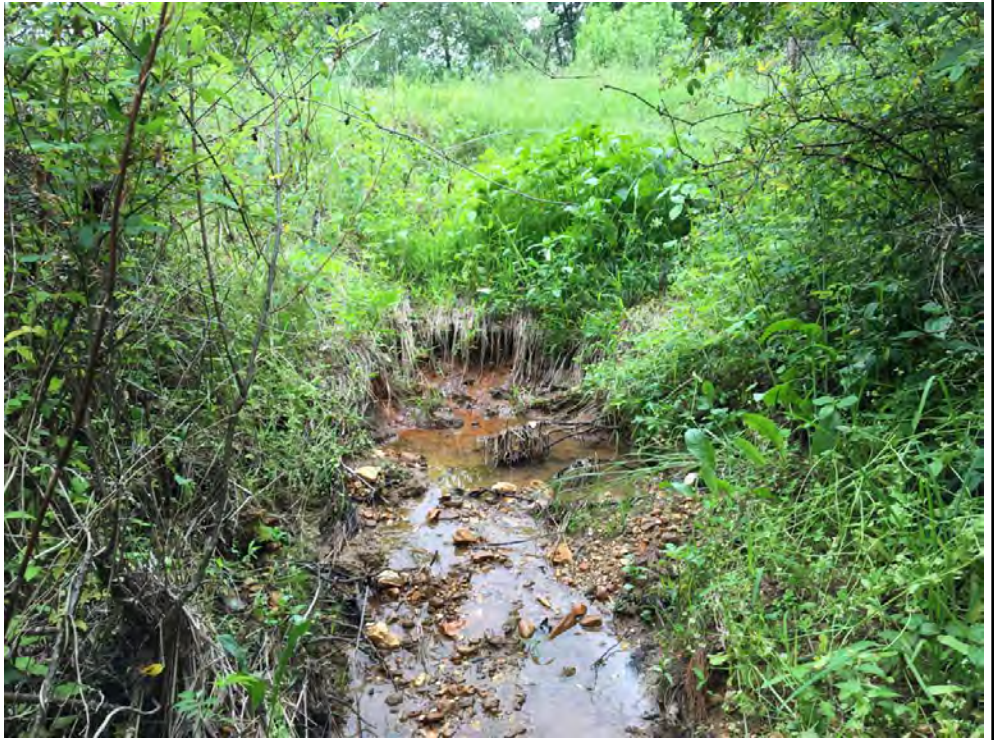
Photo Location: STR-10			
Direction: Northeast			
Survey Date: 5/18/2021			
Comments: STR-10 upstream view.			
Photograph ID: 134

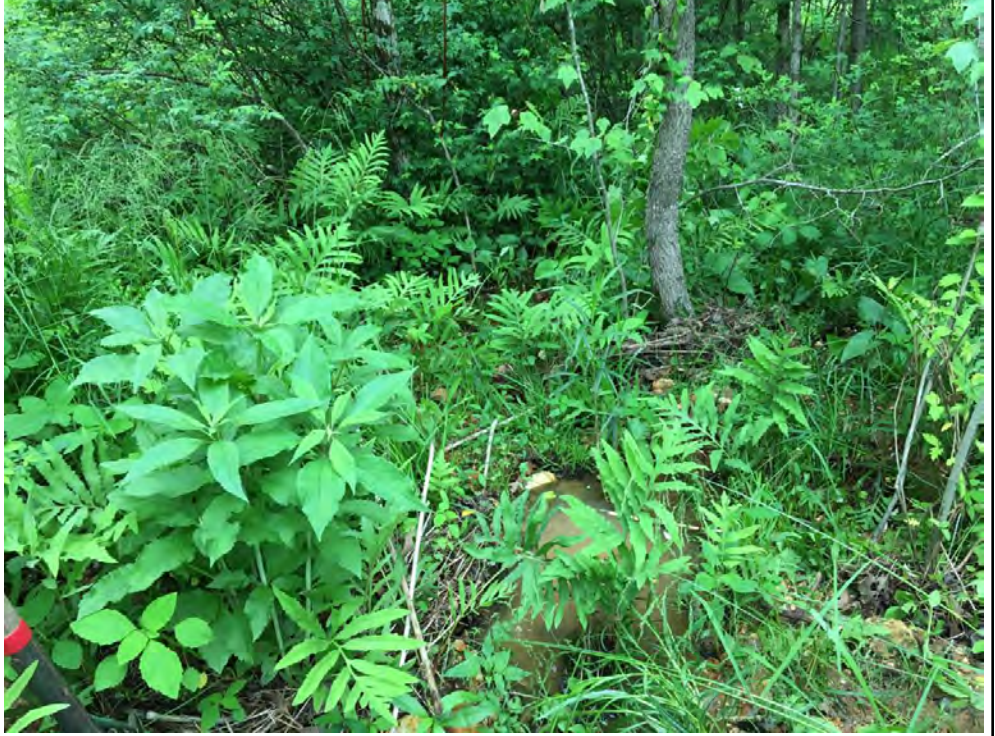
Photo Location: STR-10			
Direction: South southeast			
Survey Date: 5/18/2021			
Comments: STR-10 downstream view.

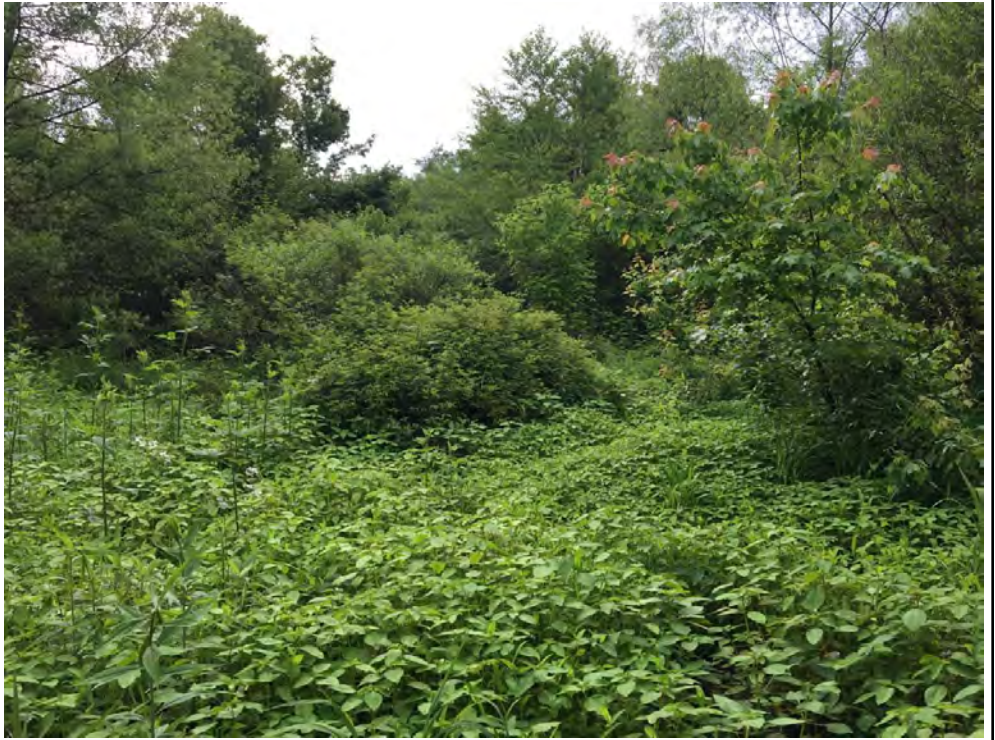
Photo Location: WTL-14			
Direction: North northeast			
Survey Date: 5/19/2021			
Comments: WTL-14 wetland overview.			
Photograph ID: 136

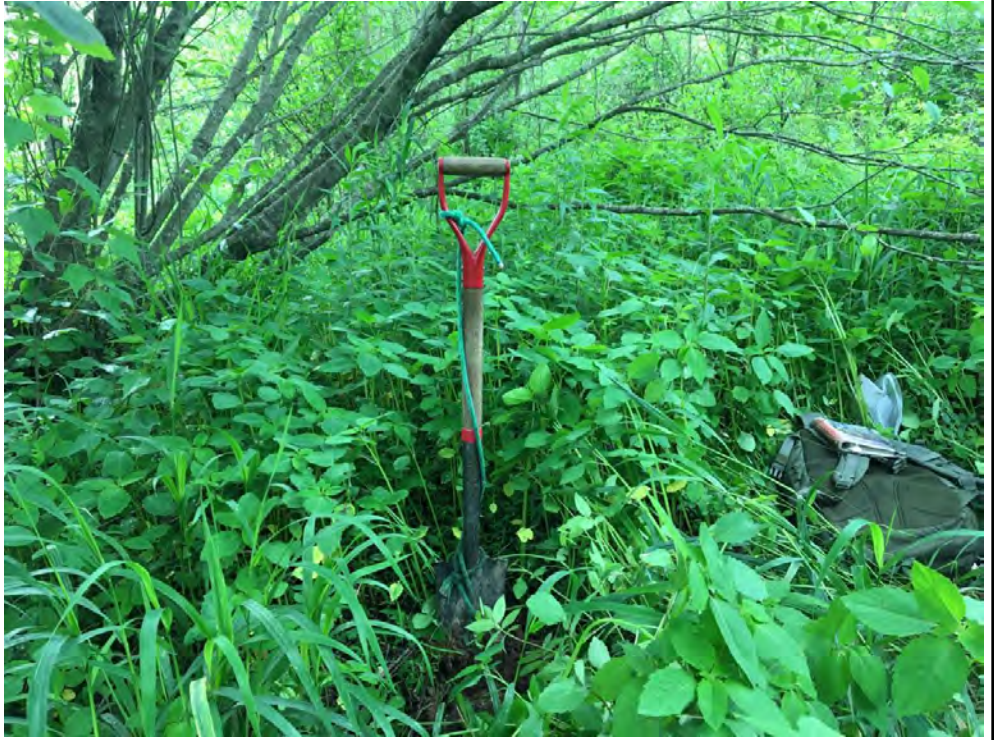
Photo Location: WTL-14			
Direction: South			
Survey Date: 5/19/2021			
Comments: WTL-14 wetland point.

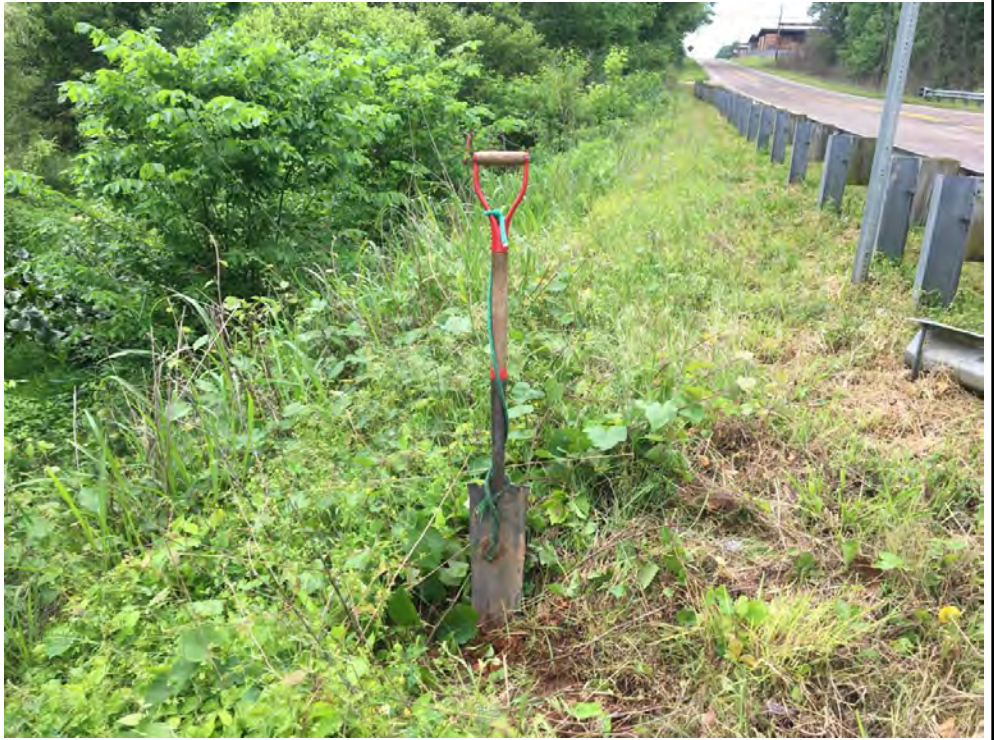
Photo Location: WTL-14			
Direction: Southwest			
Survey Date: 5/19/2021			
Comments: WTL-14 upland point.			
Photograph ID: 138

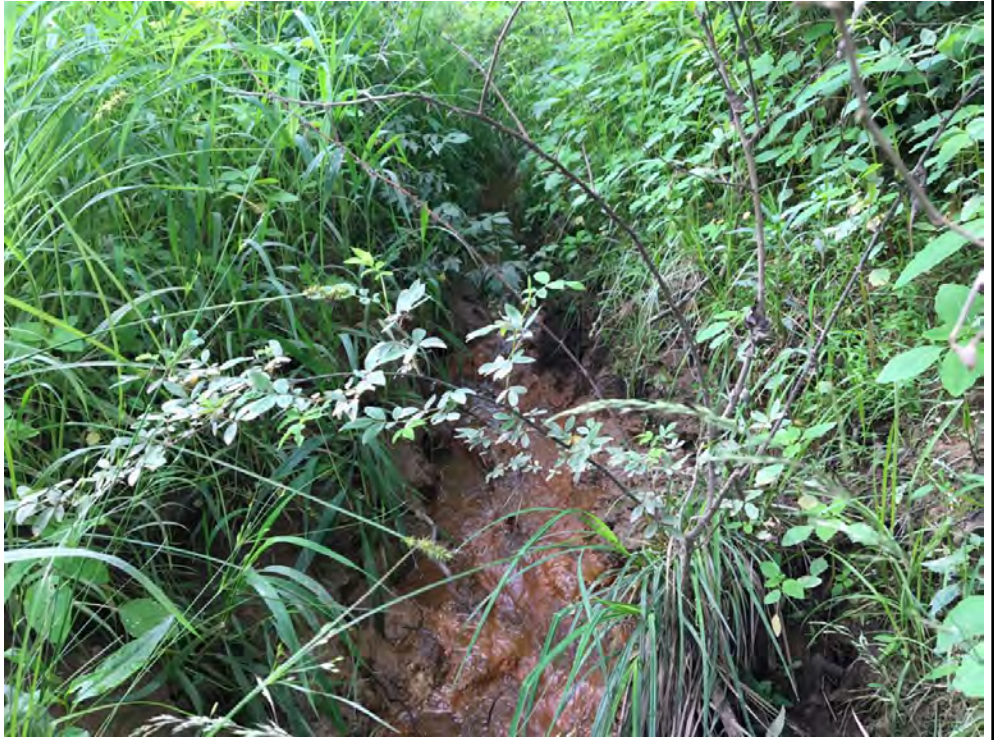
Photo Location: STR-11			
Direction: Northwest			
Survey Date: 5/19/2021			
Comments: STR-11 upstream view.

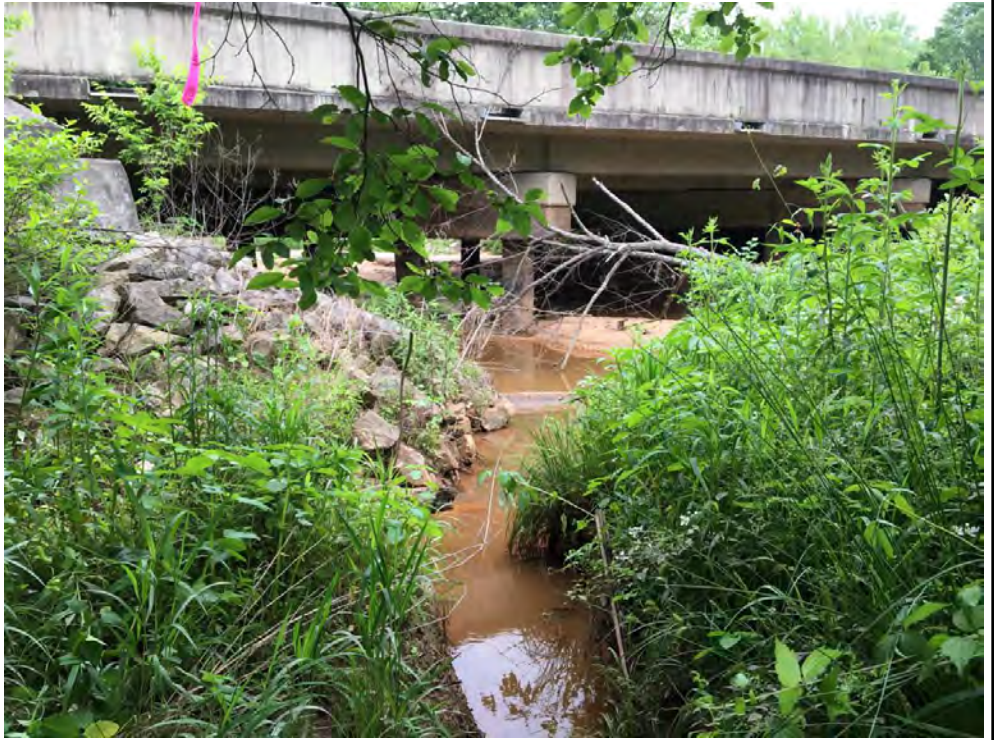
Photo Location: STR-11			
Direction: North			
Survey Date: 5/19/2021			
Comments: STR-11 downstream view.			
Photograph ID: 140

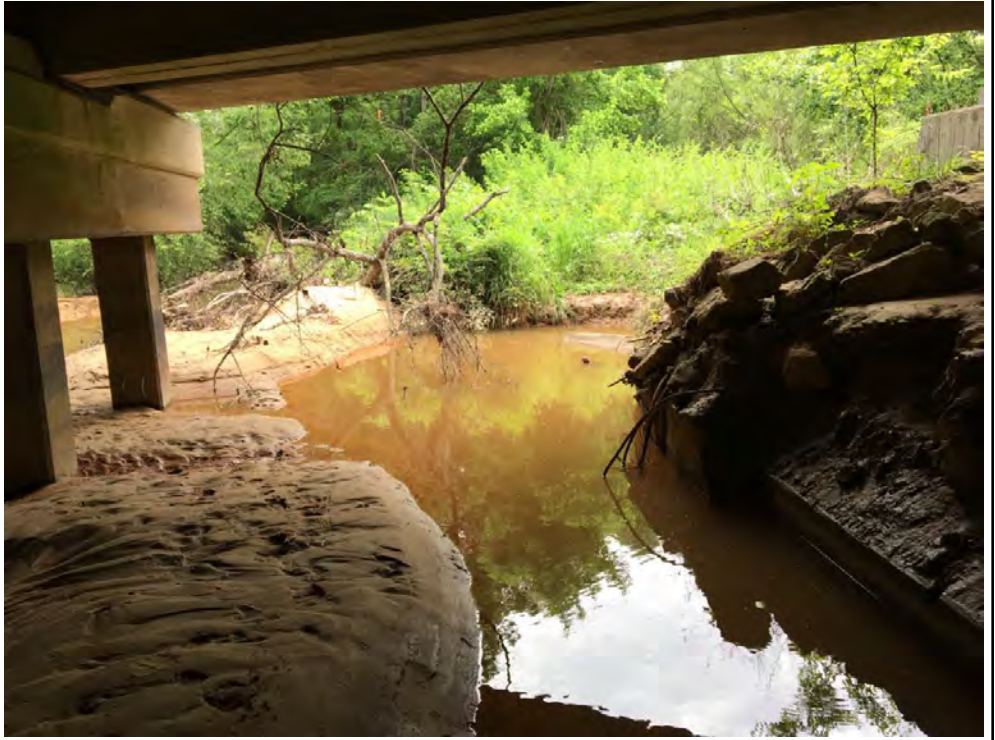
Photo Location: STR-11			
Direction: North			
Survey Date: 5/19/2021			
Comments: STR-11 upstream view.

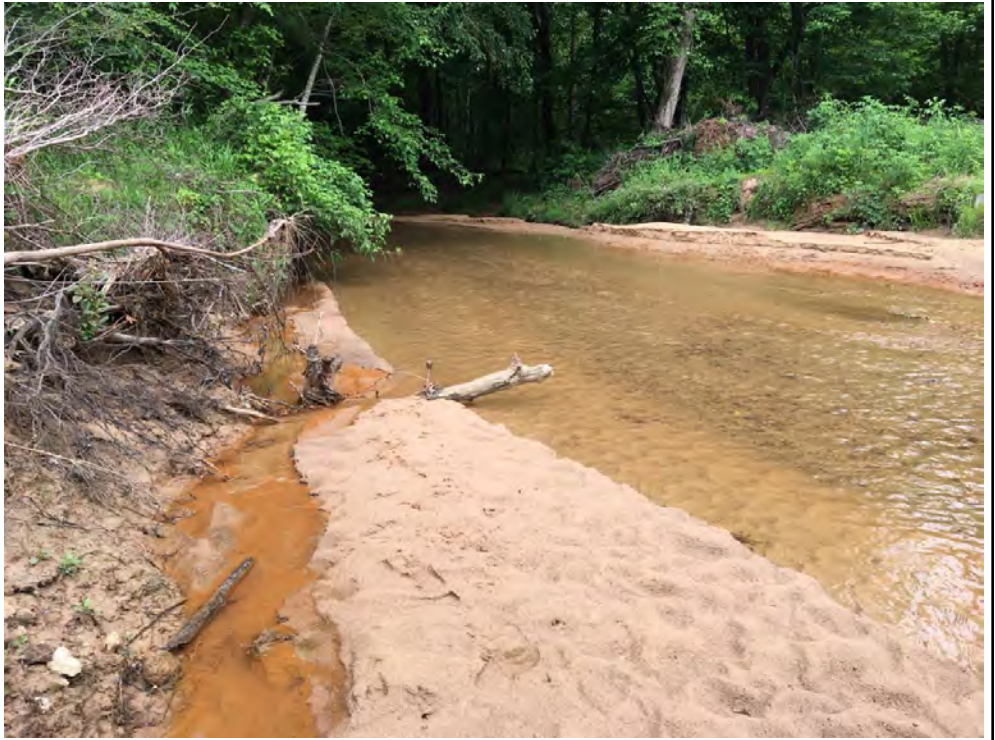
Photo Location: STR-11			
Direction: West northwest			
Survey Date: 5/19/2021			
Comments: STR-11 downstream view.			
Photograph ID: 144

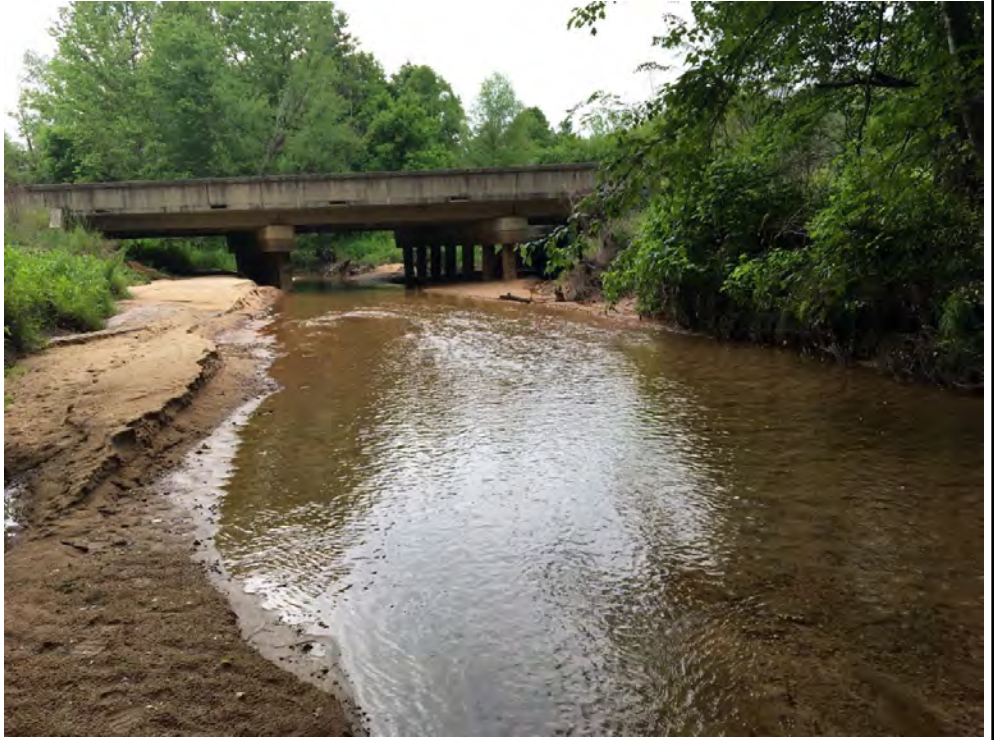
Photo Location: STR-12			
Direction: Northwest			
Survey Date: 5/19/2021			
Comments: STR-12 upstream view.

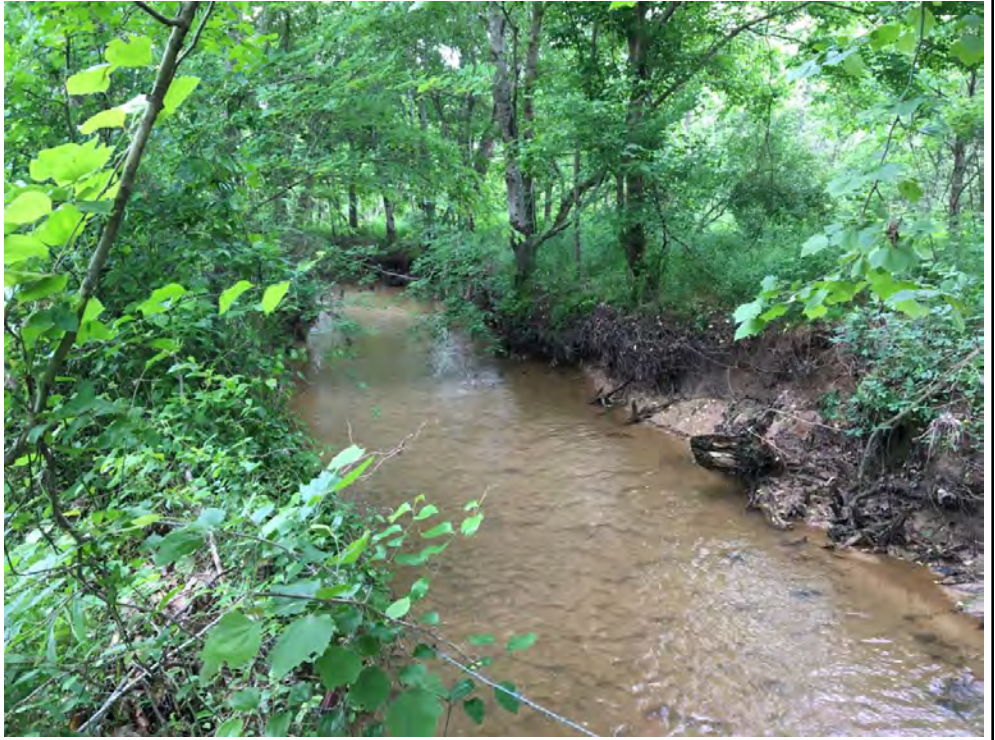
Photo Location: STR-12			
Direction: North			
Survey Date: 5/19/2021			
Comments: STR-12 upstream view.

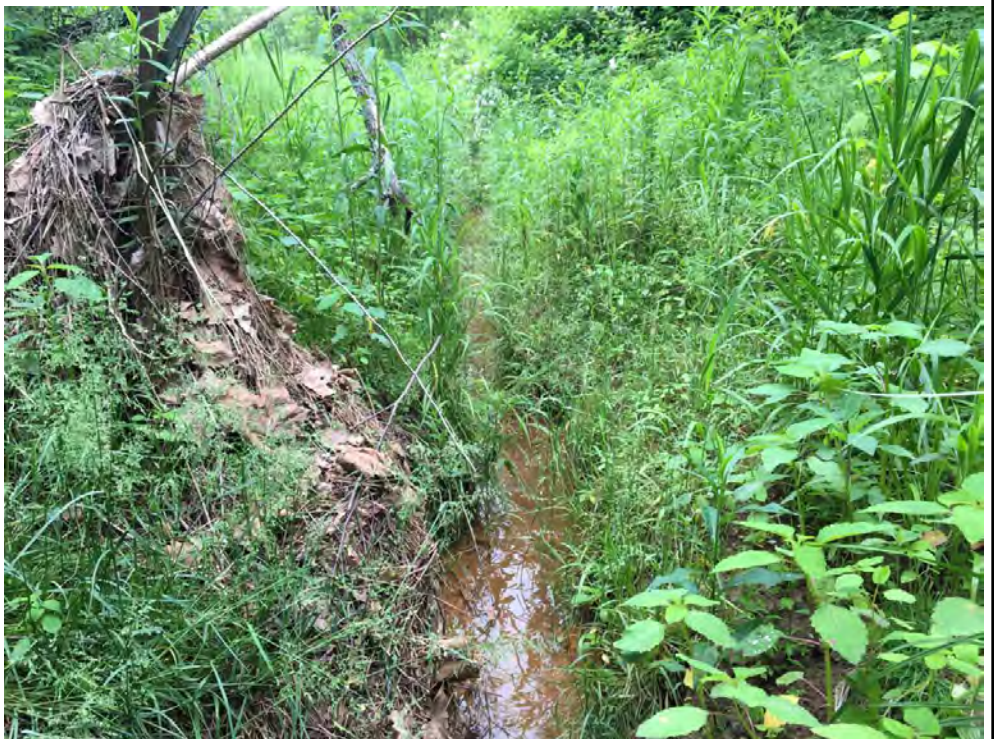
Photo Location: STR-13			
Direction: North northwest			
Survey Date: 5/19/2021			
Comments: STR-13 upstream view.

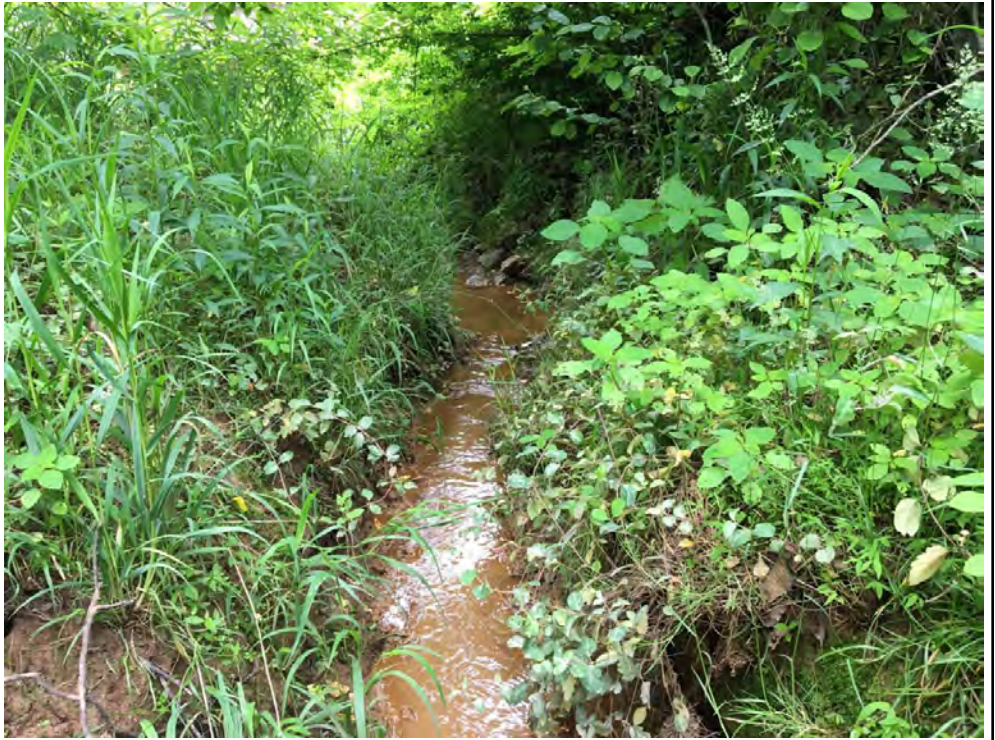
Photo Location: STR-13			
Direction: North			
Survey Date: 5/19/2021			
Comments: STR-13 downstream view.			
Photograph ID: 152

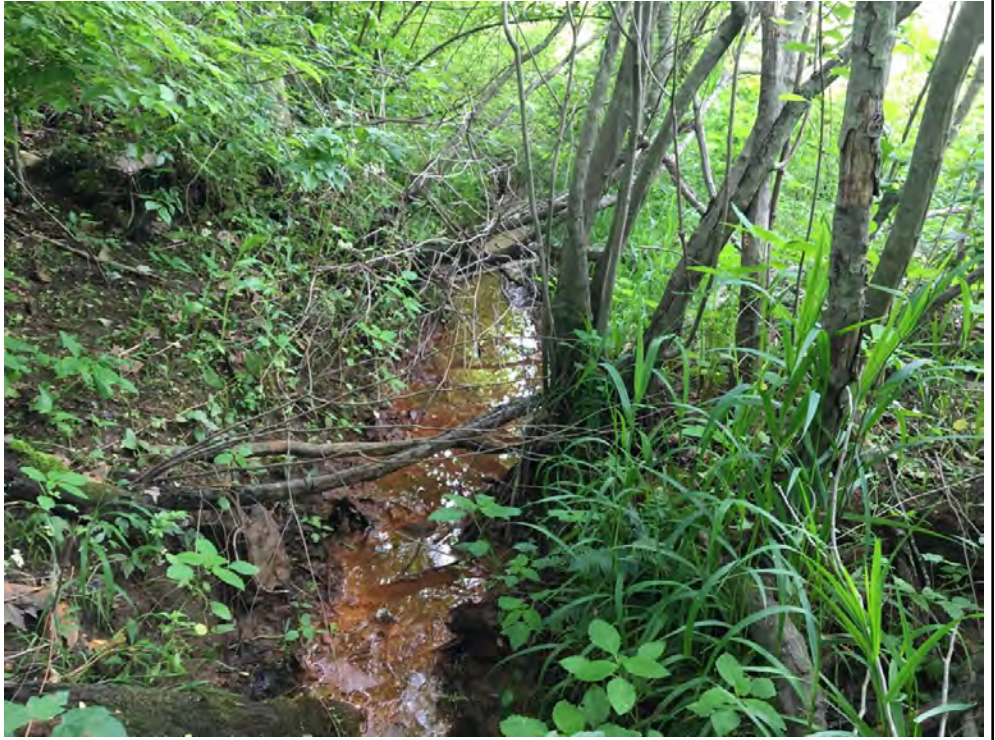
Photo Location: STR-14			
Direction: Northeast			
Survey Date: 5/19/2021			
Comments: STR-14 upstream view.

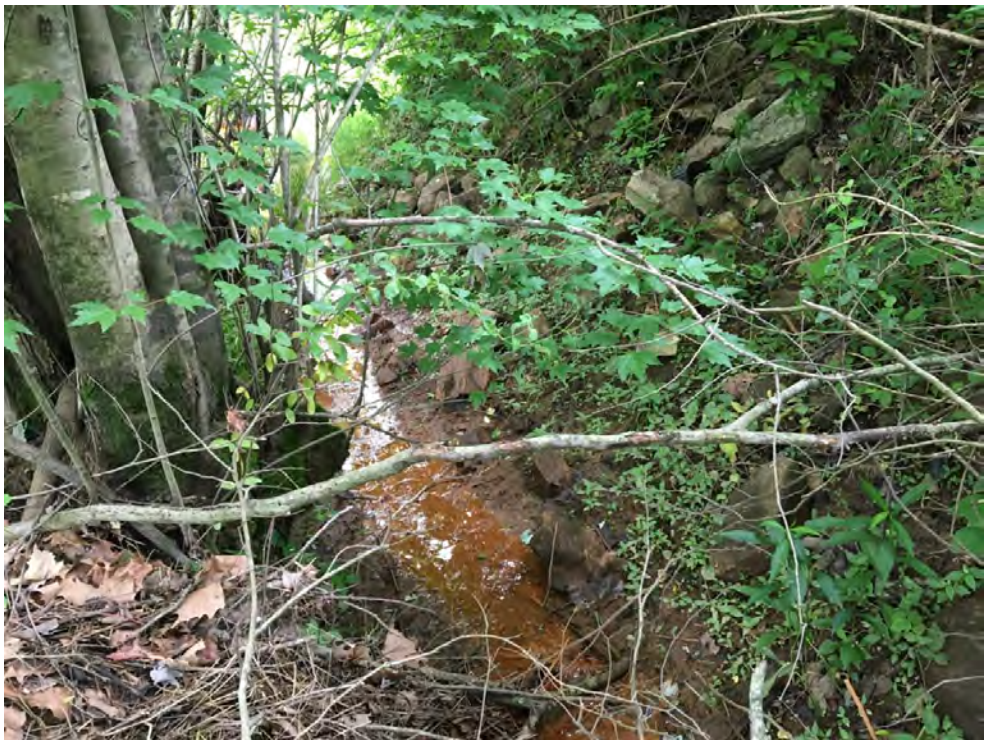
Photo Location: STR-14			
Direction: South southeast			
Survey Date: 5/19/2021			
Comments: STR-14 downstream view.			
Photograph ID: 154
