Right-of-Way Reevaluation, State Route 54 (US Highway 641), From State Route 69 (Wood Street) in Paris to Crossland Road/Brannon Lane (North of Puryear), Henry County, Tennessee, PIN 101886.00, Federal Project No. NH-54(26), State Project No. 40003-1213-14

Date: 05/19/2022

Environmental Commitments

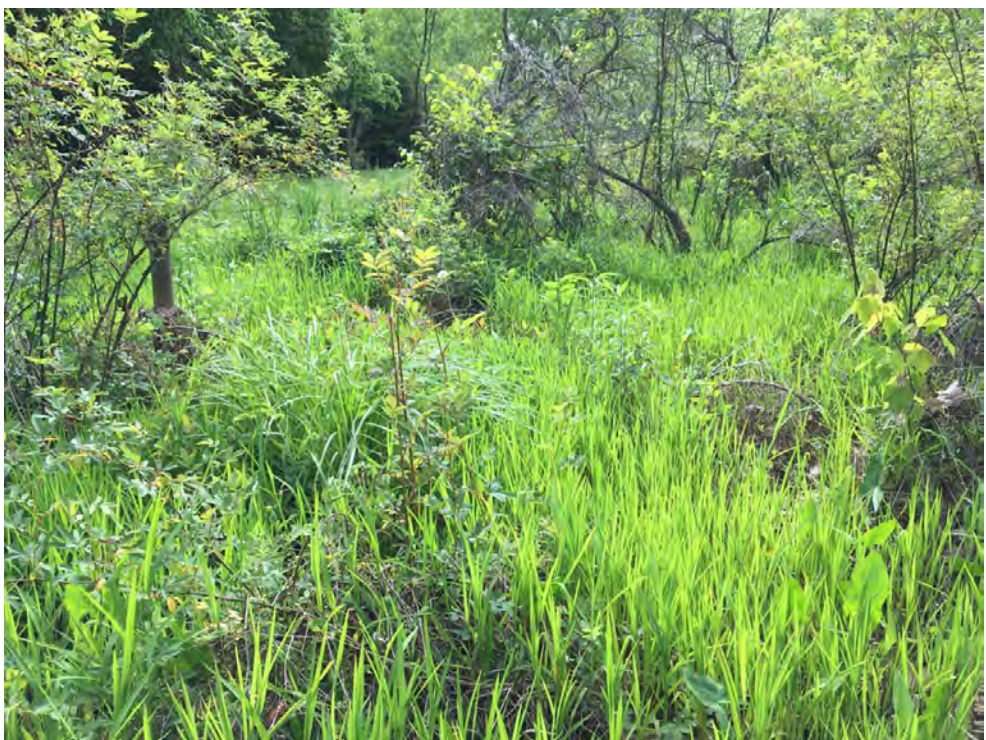
Photo Location: WTL-15			
Direction: South			
Survey Date: 5/19/2021			
Comments: WTL-15 wetland overview.

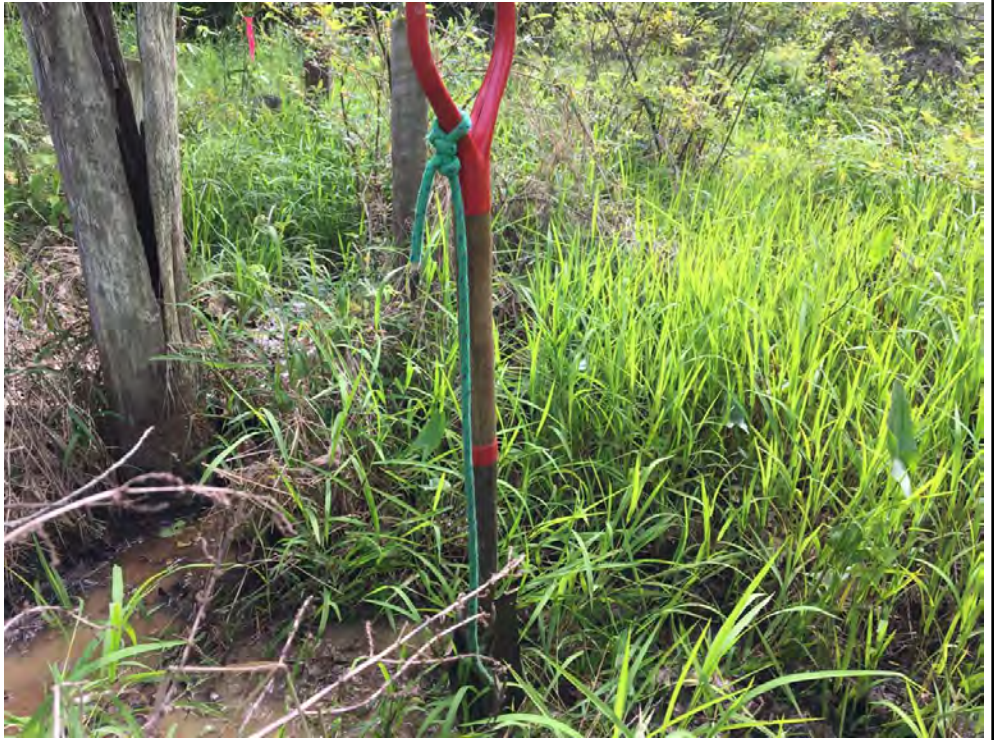
Photo Location: WTL-15			
Direction: South southwest			
Survey Date: 5/19/2021			
Comments: WTL-15 wetland point.			
Photograph ID: 156	 		
Photo Location: WTL-15			
Direction: South southwest			
Survey Date: 5/19/2021			
Comments: WTL-15 upland point.

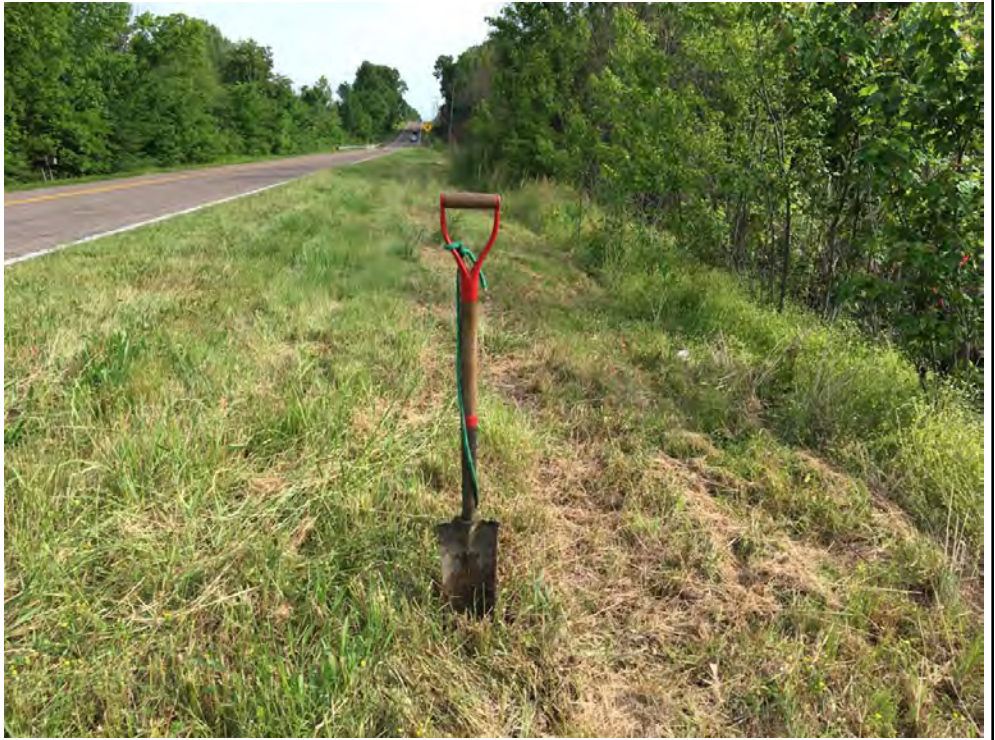
Photo Location: WTL-16			
Direction: West			
Survey Date: 5/19/2021			
Comments: WTL-16 upland point.			
Photograph ID: 158

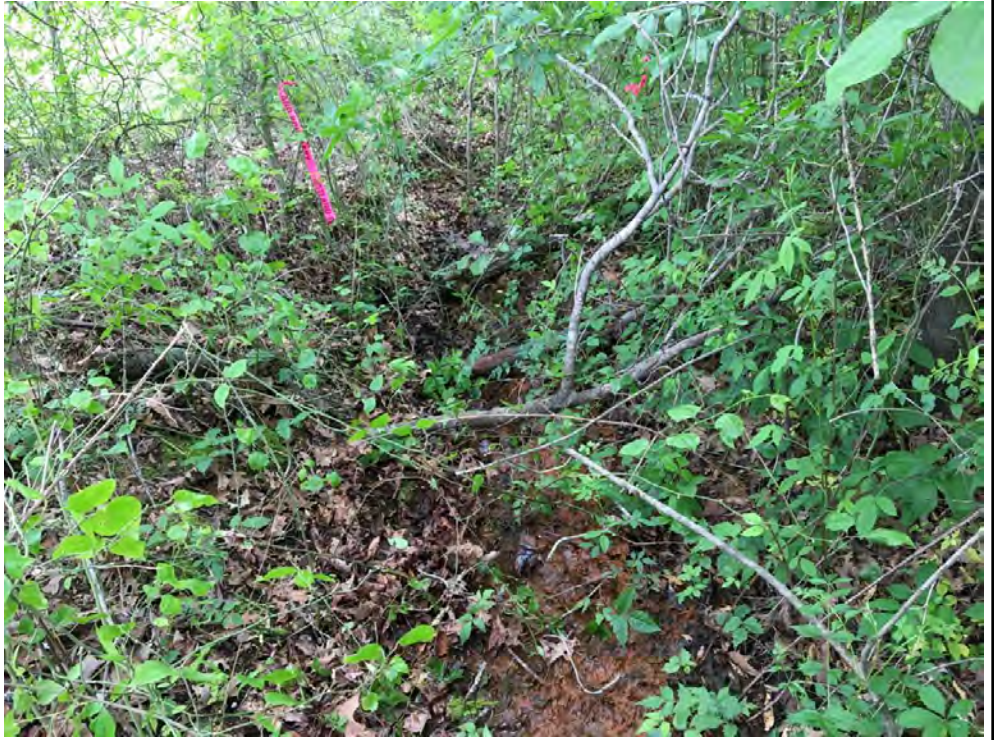
Photo Location: WTL-17			
Direction: North northeast			
Survey Date: 5/19/2021			
Comments: WTL-17 wetland overview.

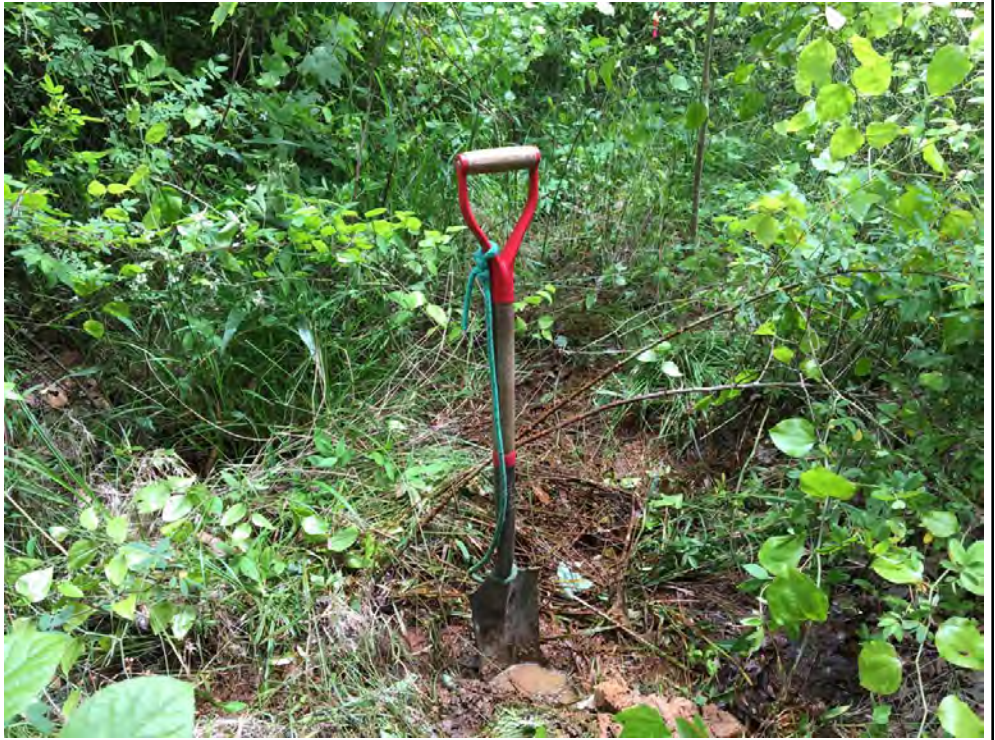
Photo Location: WTL-17			
Direction: East northeast			
Survey Date: 5/19/2021			
Comments: WTL-17 wetland point.			
Photograph ID: 160

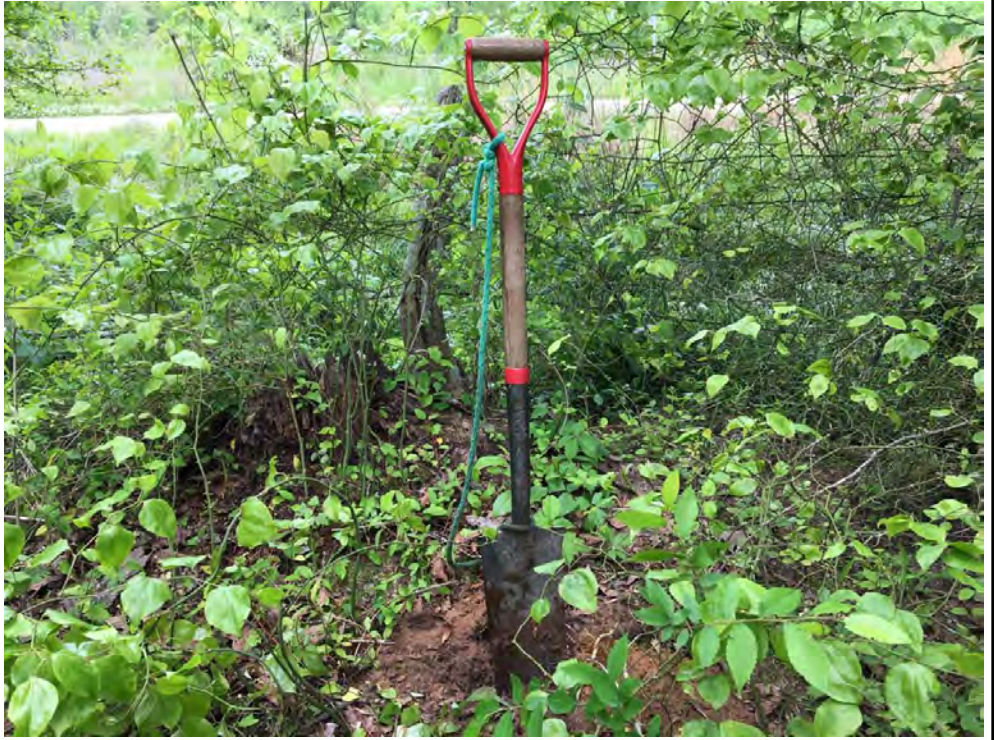
Photo Location: WTL-17			
Direction: South southwest			
Survey Date: 5/19/2021			
Comments: WTL-17 upland point.

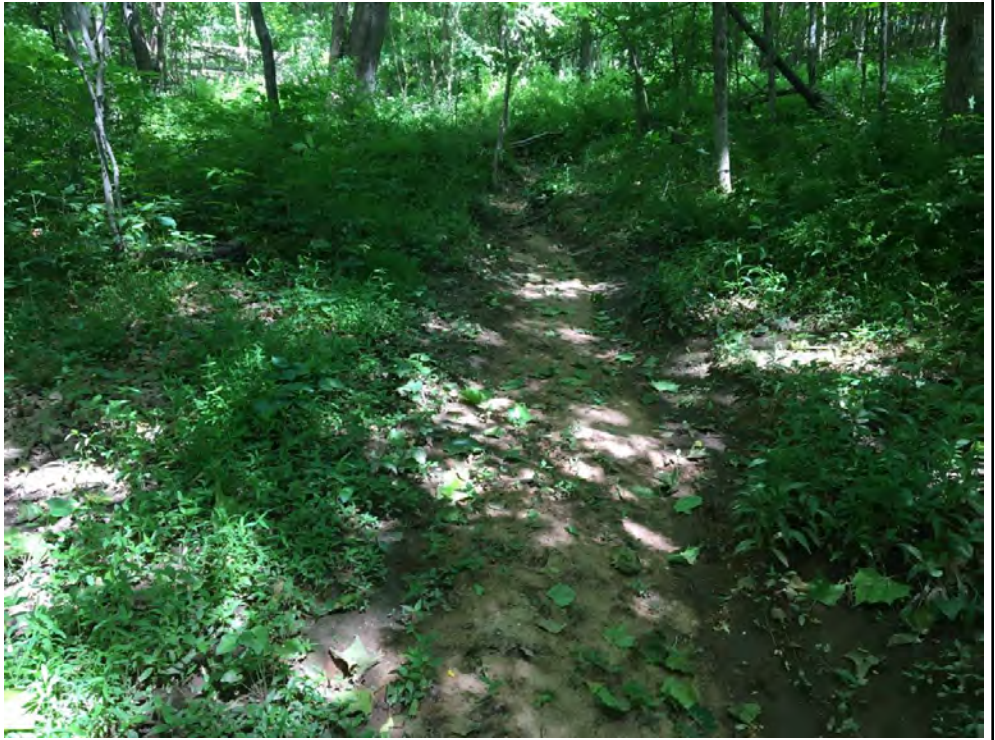
Photo Location: WWC-24			
Direction: West southwest			
Survey Date: 5/20/2021			
Comments: WWC-24 upstream view.			
Photograph ID: 164

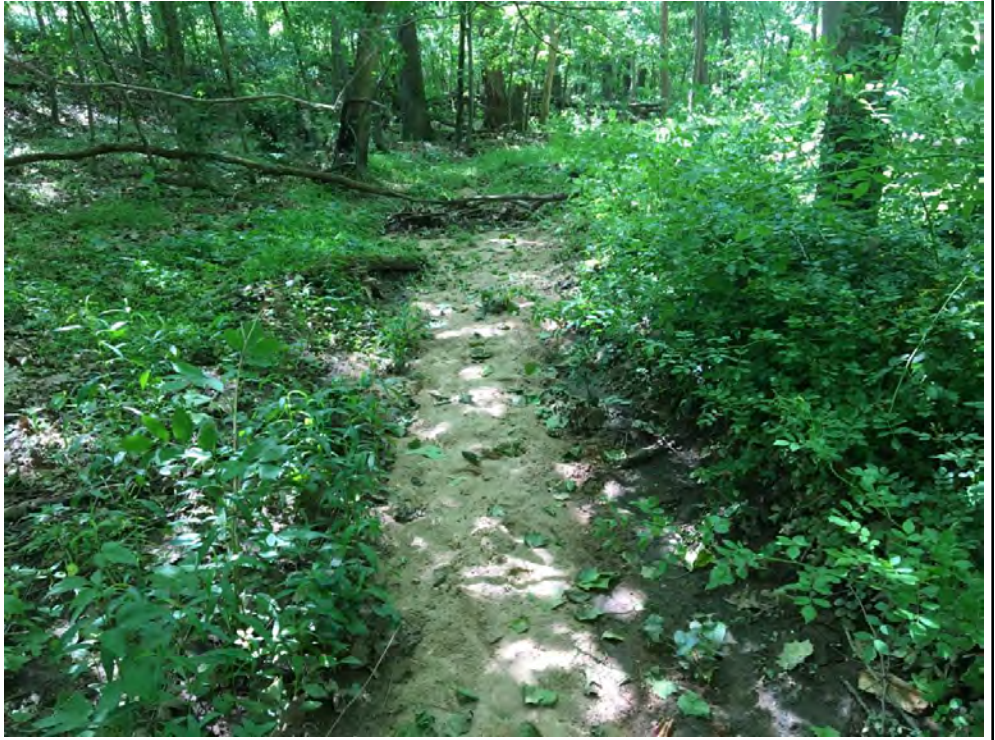
Photo Location: WWC-24			
Direction: East southeast			
Survey Date: 5/20/2021			
Comments: WWC-24 downstream view.

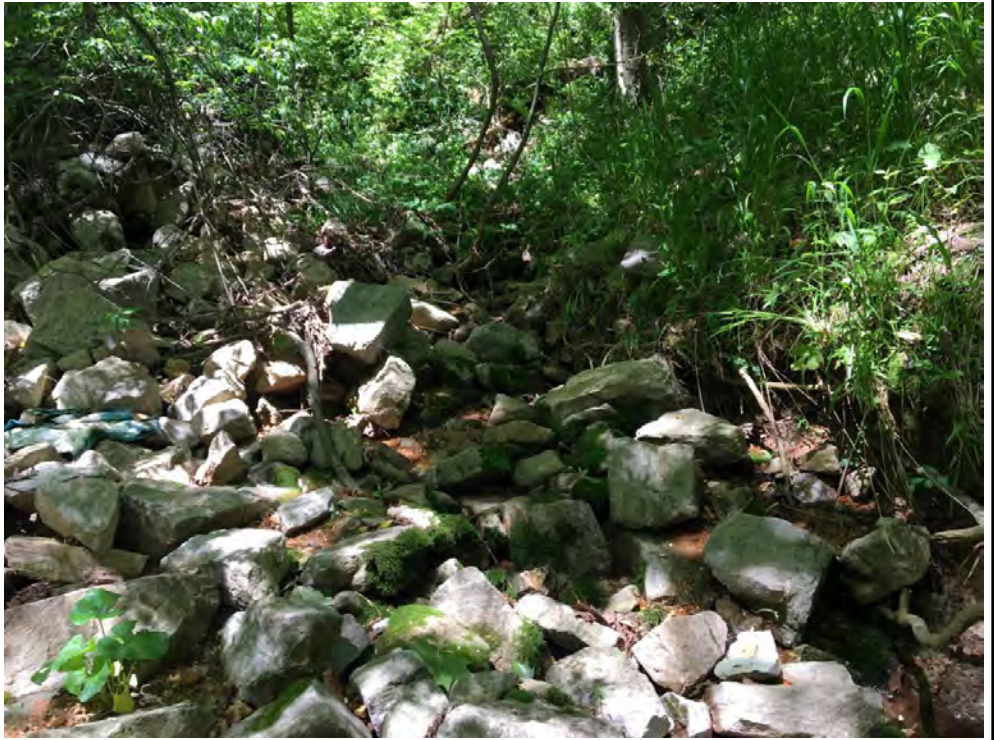
Photo Location: STR-15			
Direction: North northeast			
Survey Date: 5/20/2021			
Comments: STR-15 upstream view.			
Photograph ID: 166

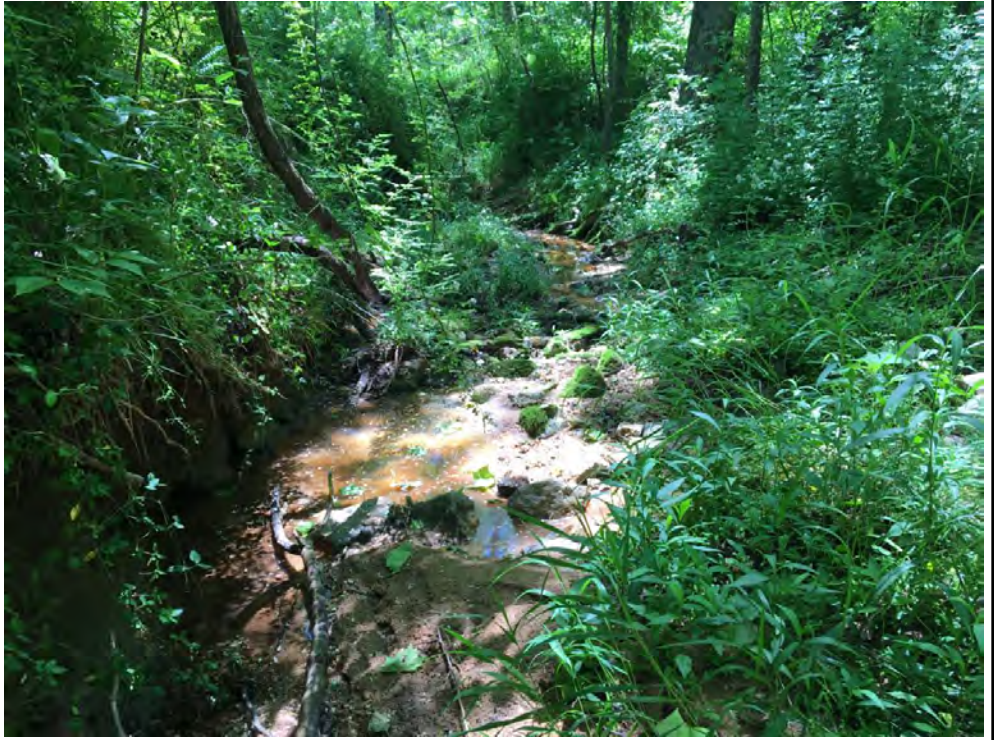
Photo Location: STR-15			
Direction: East northeast			
Survey Date: 5/20/2021			
Comments: STR-15 downstream view.

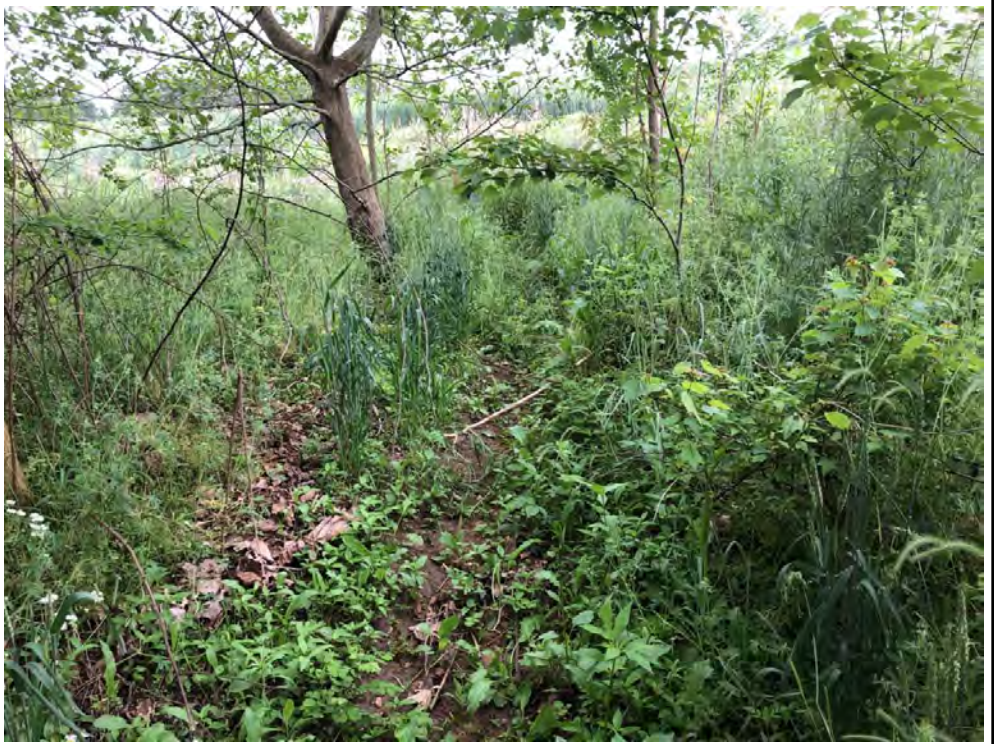
Photo Location: WWC-26			
Direction: East			
Survey Date: 5/19/2021			
Comments: WWC-26 downstream view.			
Photograph ID: 174

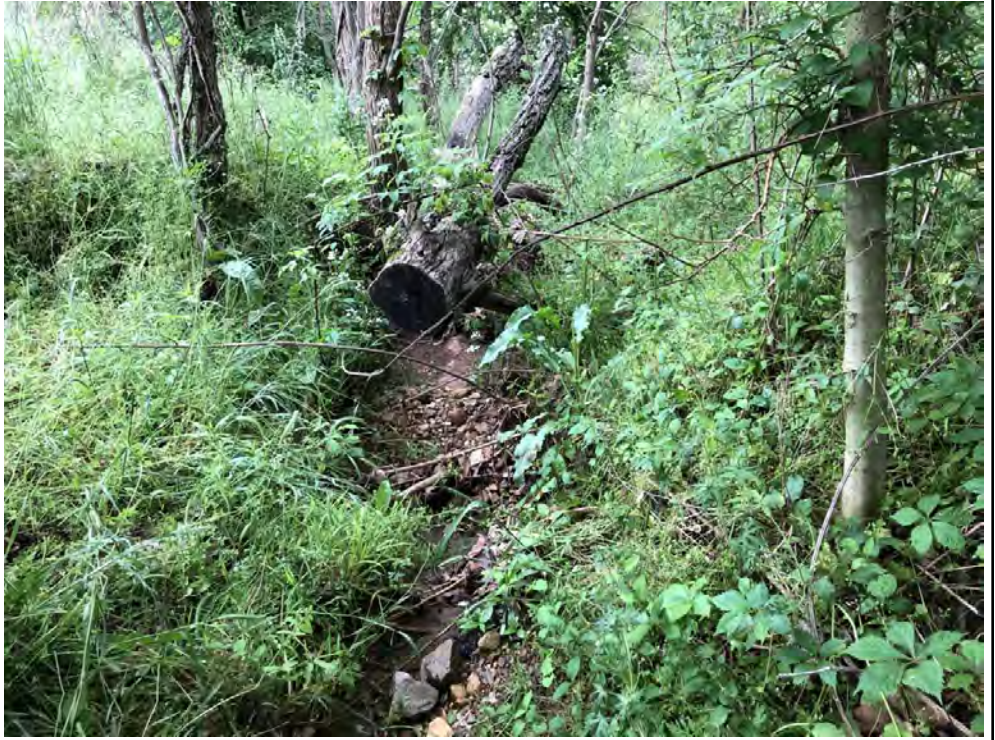
Photo Location: WWC-26			
Direction: Northwest			
Survey Date: 5/19/2021			
Comments: WWC-26 upstream view.

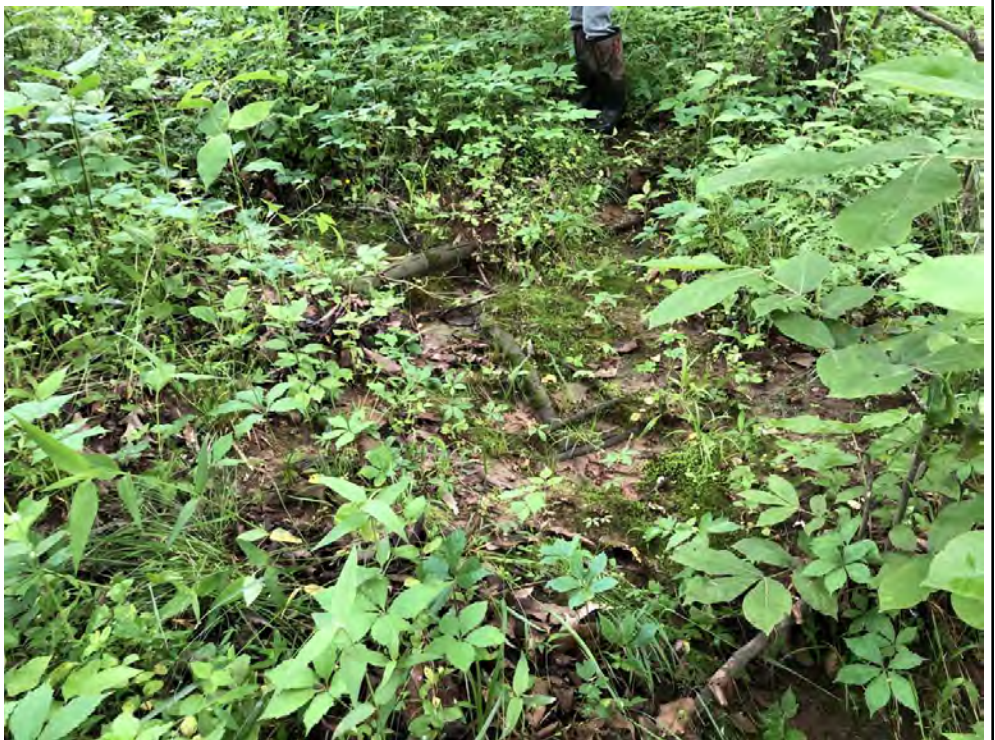
Photo Location: WWC-28			
Direction: South			
Survey Date: 5/19/2021			
Comments: WWC-28 upstream view.			
Photograph ID: 178

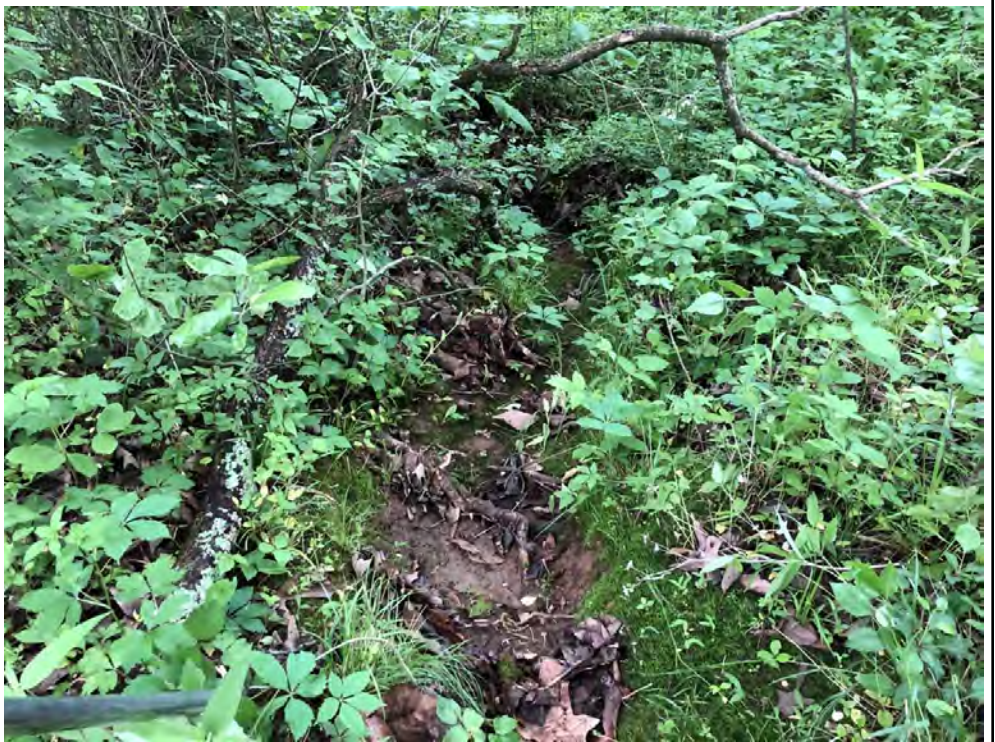
Photo Location: WWC-28			
Direction: South			
Survey Date: 5/19/2021			
Comments: WWC-28 downstream view.

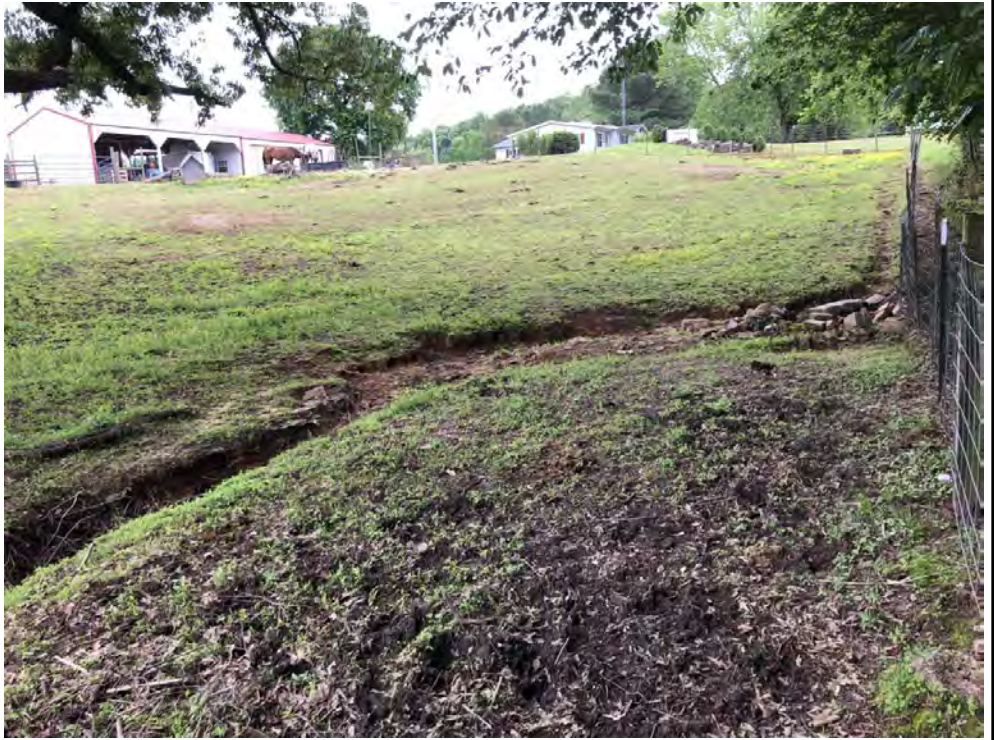
Photo Location: WWC-29			
Direction: South			
Survey Date: 5/19/2021			
Comments: WWC-29 upstream view.			
Photograph ID: 182

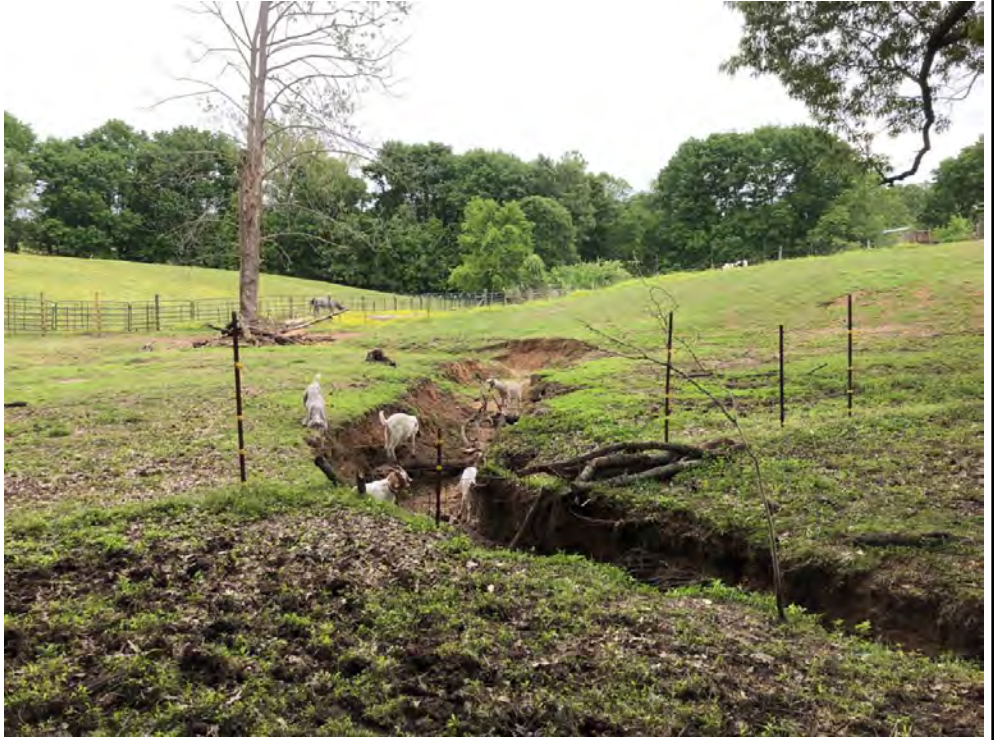
Photo Location: WWC-29			
Direction: West northwest			
Survey Date: 5/19/2021			
Comments: WWC-29 downstream view.

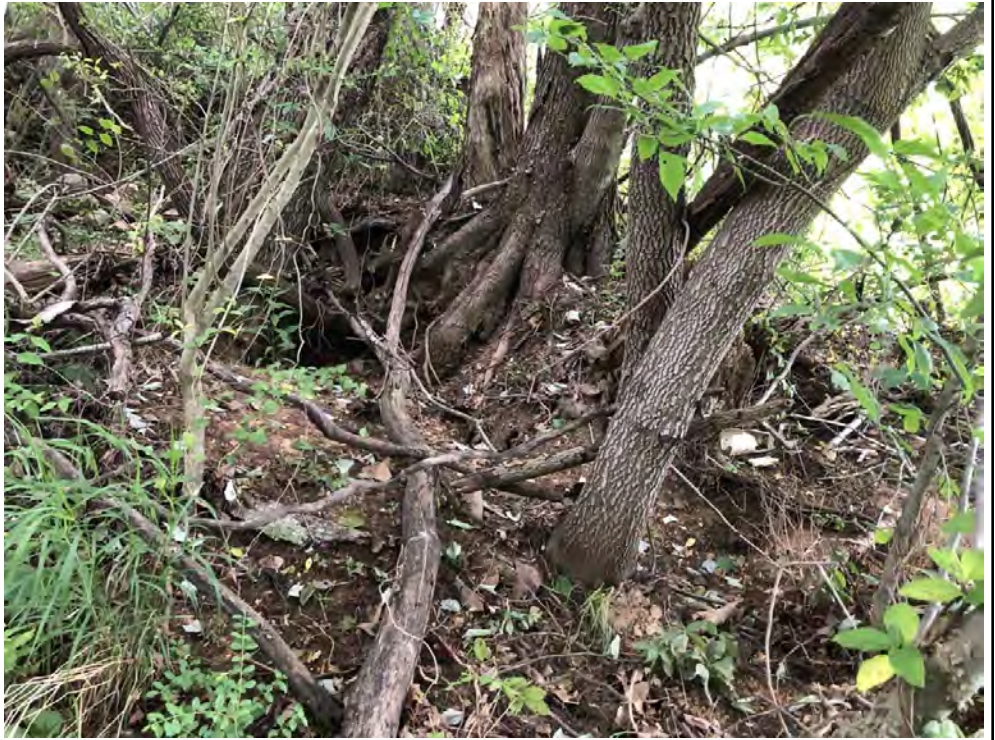
Photo Location: WWC-30			
Direction: North northwest			
Survey Date: 5/19/2021			
Comments: WWC-30 upstream view.			
Photograph ID: 186

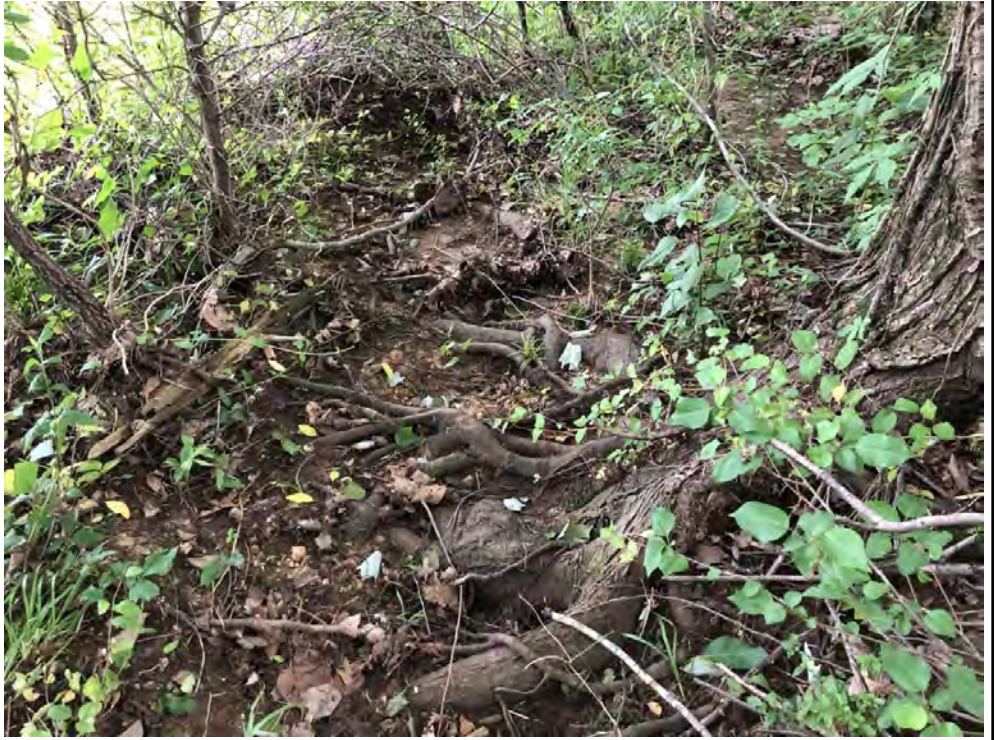
Photo Location: WWC-30			
Direction: East northeast			
Survey Date: 5/19/2021			
Comments: WWC-30 downstream view.

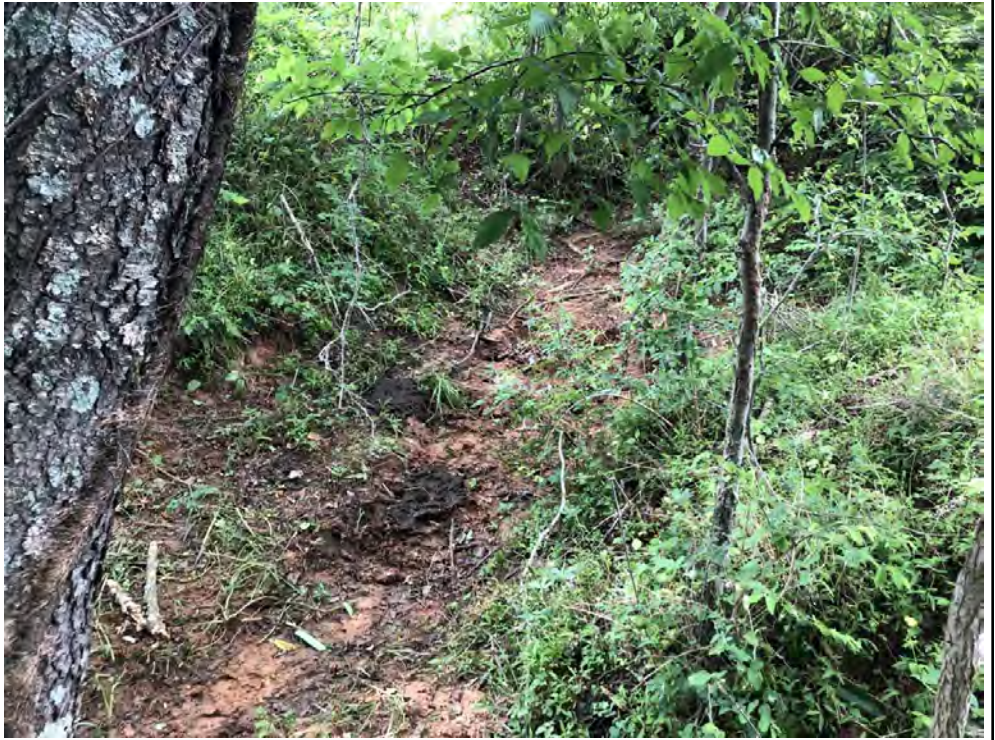
Photo Location: WWC-32			
Direction: West northwest			
Survey Date: 5/19/2021			
Comments: WWC-32 upstream view.			
Photograph ID: 194

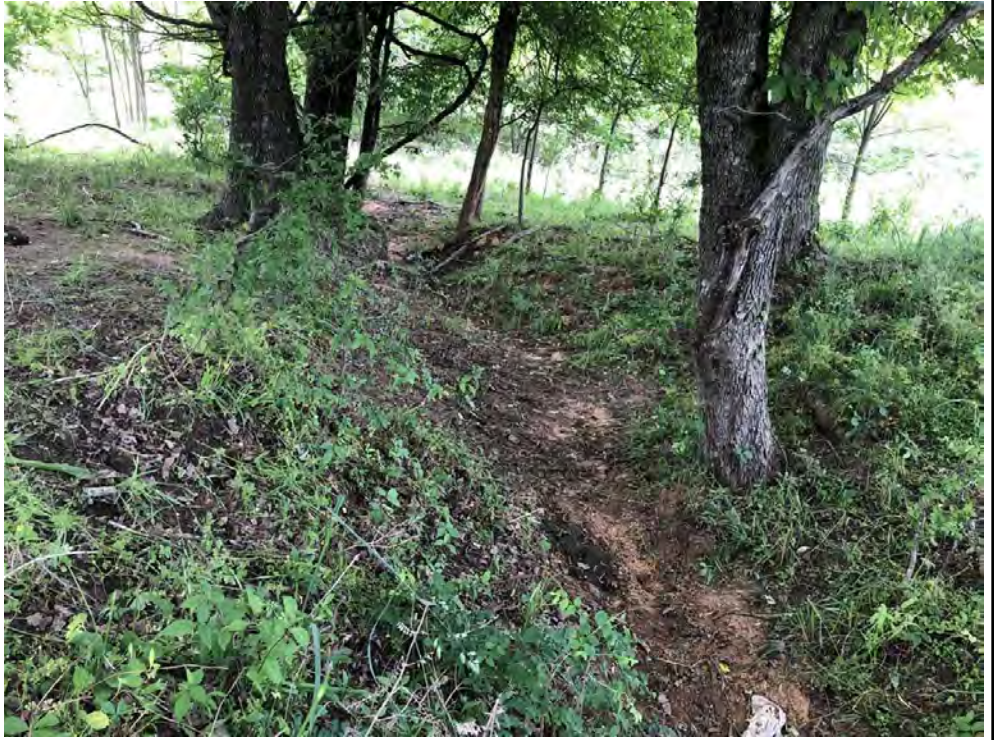
Photo Location: WWC-32			
Direction: South southeast			
Survey Date: 5/19/2021			
Comments: WWC-32 downstream view

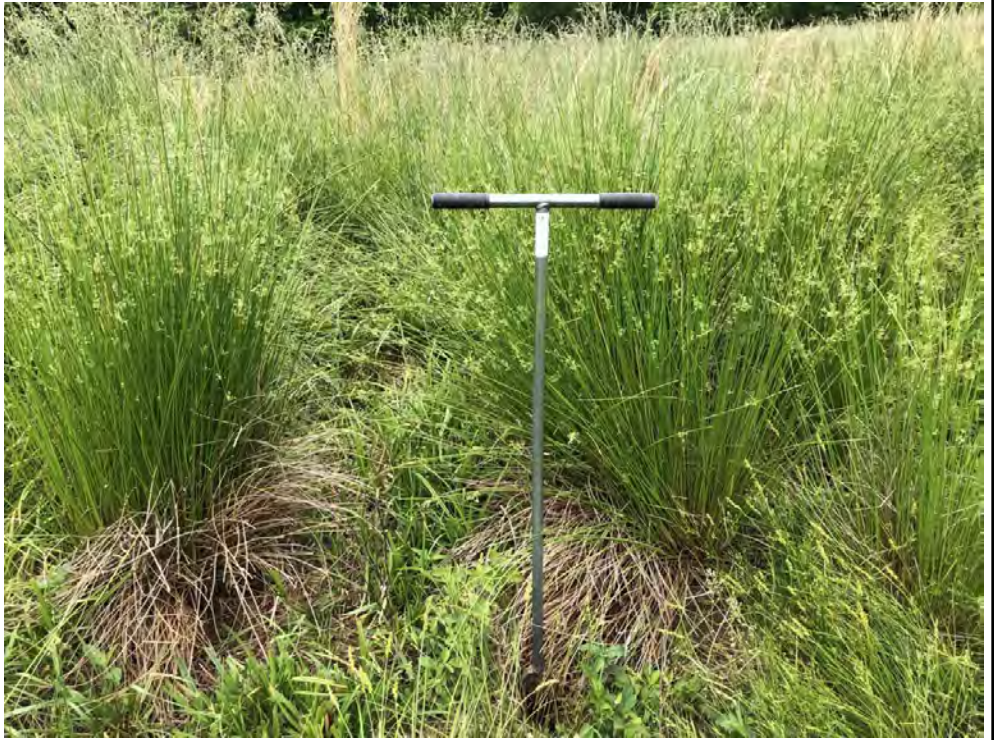
Photo Location: WTL-21			
Direction: South southwest			
Survey Date: 5/19/2021			
Comments: WTL-21 wetland point.			
Photograph ID: 200

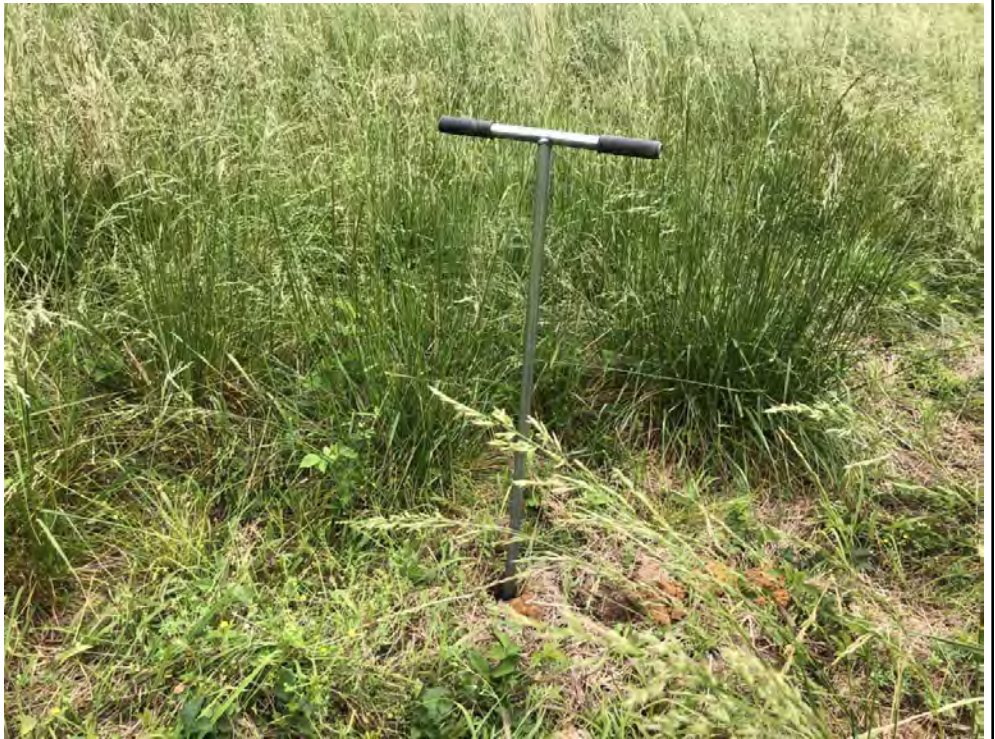
Photo Location: WTL-21			
Direction: Northeast			
Survey Date: 5/19/2021			
Comments: WTL-21 upland point.

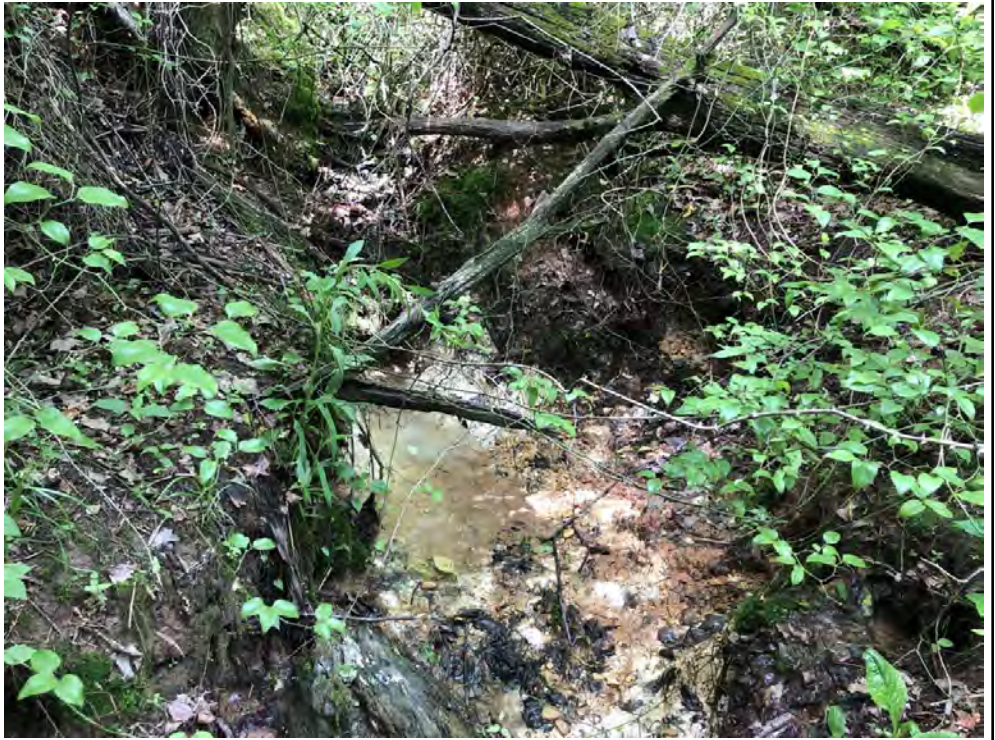
Photo Location: WWC-33			
Direction: West southwest			
Survey Date: 5/19/2021			
Comments: WWC-33 upstream view.			
Photograph ID: 202

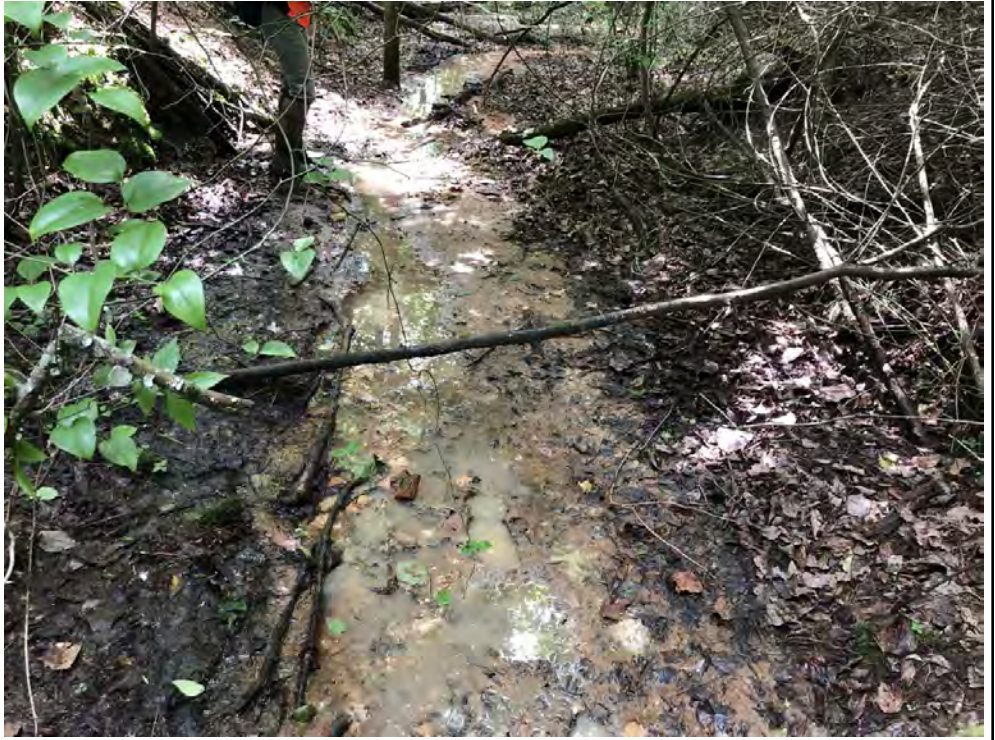
Photo Location: WWC-33			
Direction: West			
Survey Date: 5/19/2021			
Comments: WWC-33 downstream view.

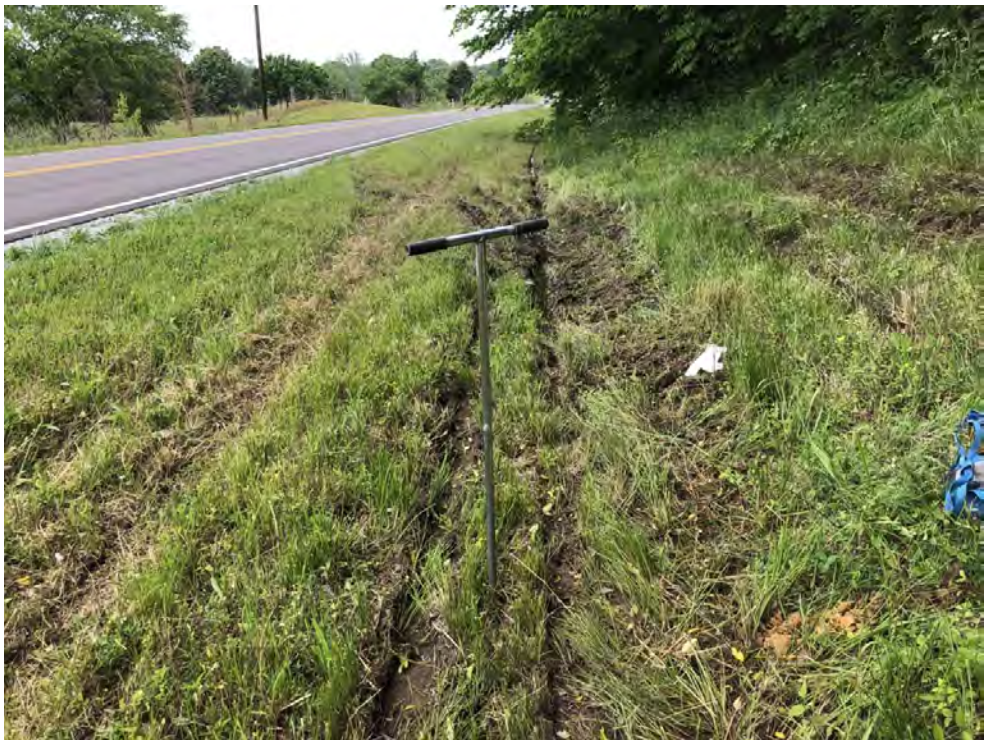
Photo Location: WTL-22			
Direction: North			
Survey Date: 5/19/2021			
Comments: WTL-22 wetland point.			
Photograph ID: 204

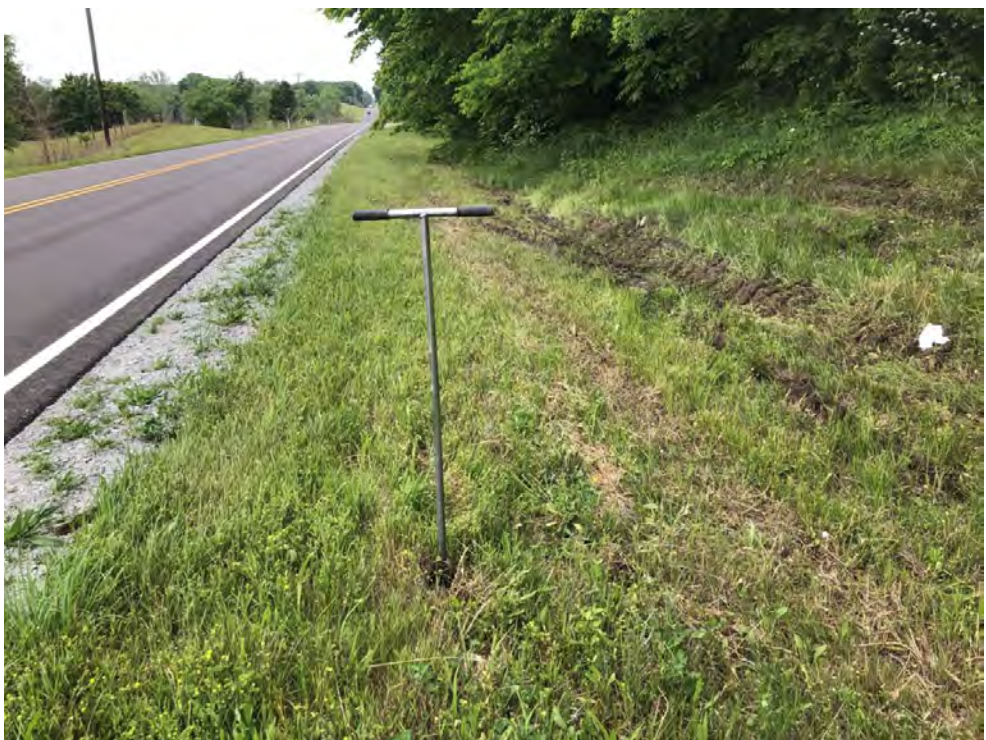
Photo Location: WTL-22			
Direction: South southwest			
Survey Date: 5/19/2021			
Comments: WTL-22 upland point.

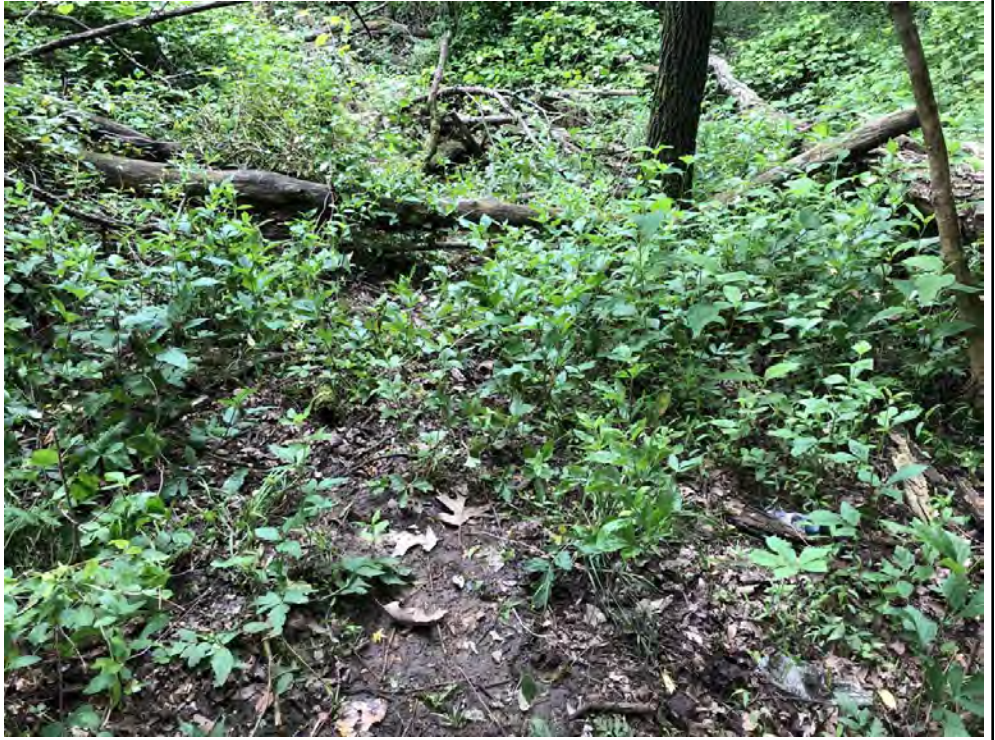
Photo Location: WWC-34			
Direction: East southeast			
Survey Date: 5/19/2021			
Comments: WWC-34 downstream view.

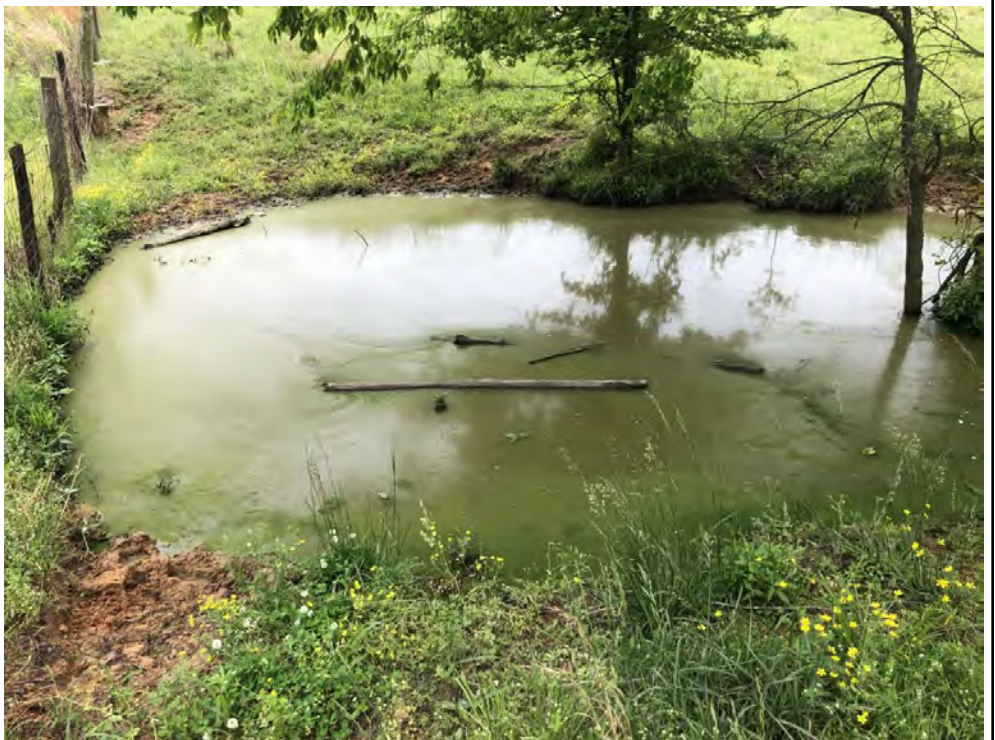
Photo Location: PND-03			
Direction: West			
Survey Date: 5/19/2021			
Comments: PND-03 overview.			
Photograph ID: 208

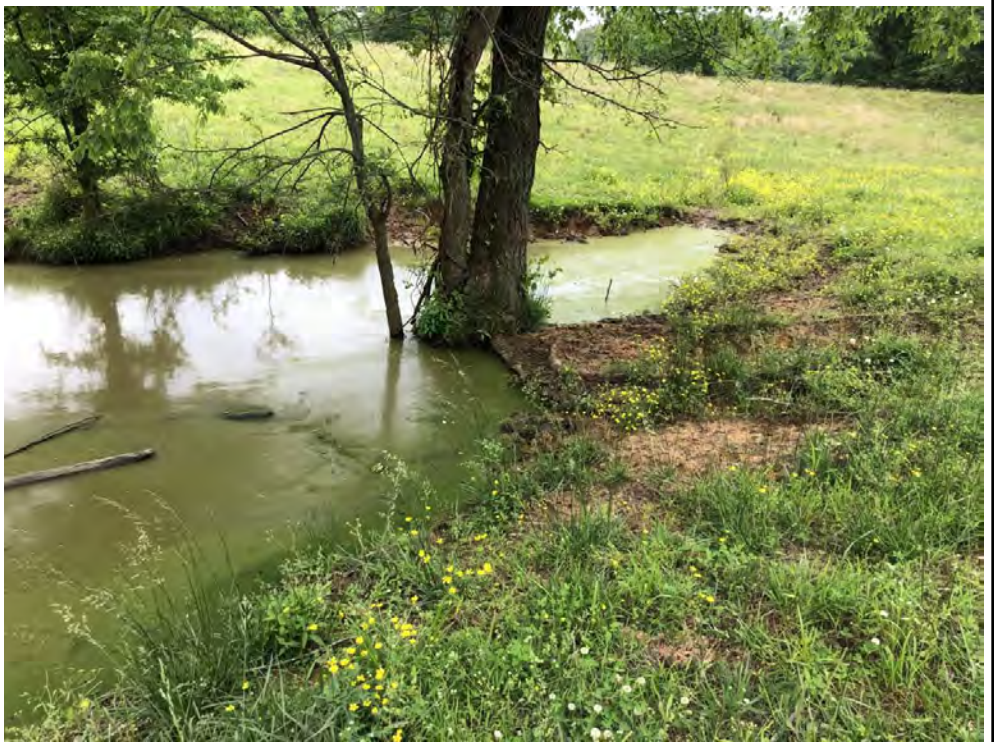
Photo Location: PND-03			
Direction: Southwest			
Survey Date: 5/19/2021			
Comments: PND-03 overview.

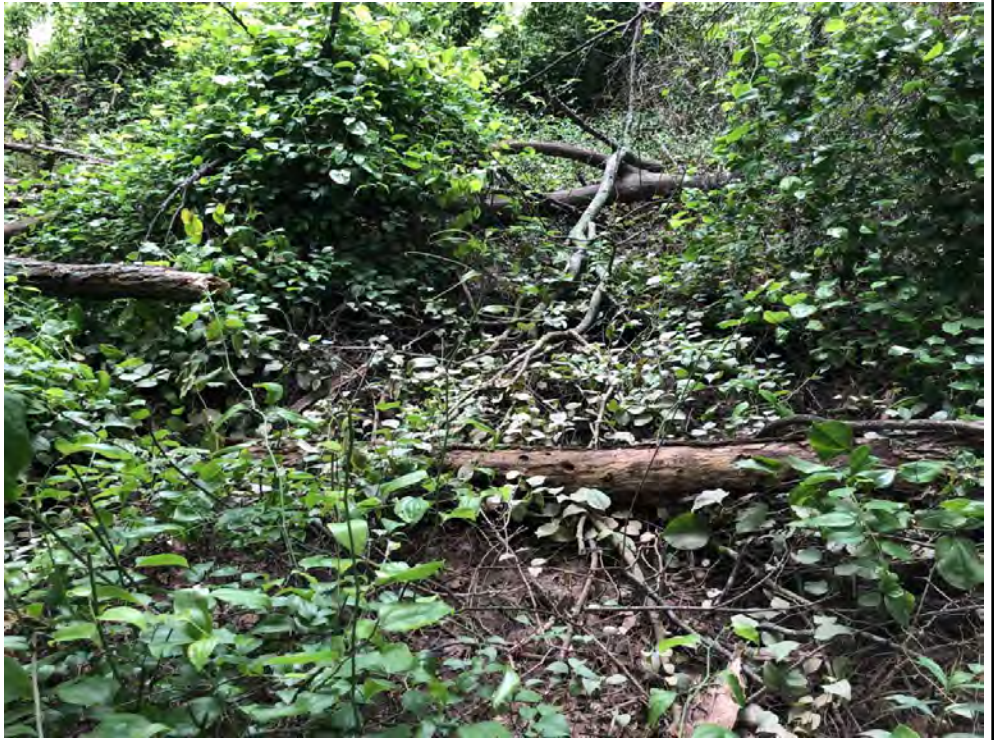
Photo Location: WWC-35			
Direction: Southwest			
Survey Date: 5/19/2021			
Comments: WWC-35 upstream view.			
Photograph ID: 210
