Right-of-Way Reevaluation, State Route 54 (US Highway 641), From State Route 69 (Wood Street) in Paris to Crossland Road/Brannon Lane (North of Puryear), Henry County, Tennessee, PIN 101886.00, Federal Project No. NH-54(26), State Project No. 40003-1213-14

Date: 05/19/2022

Environmental Commitments

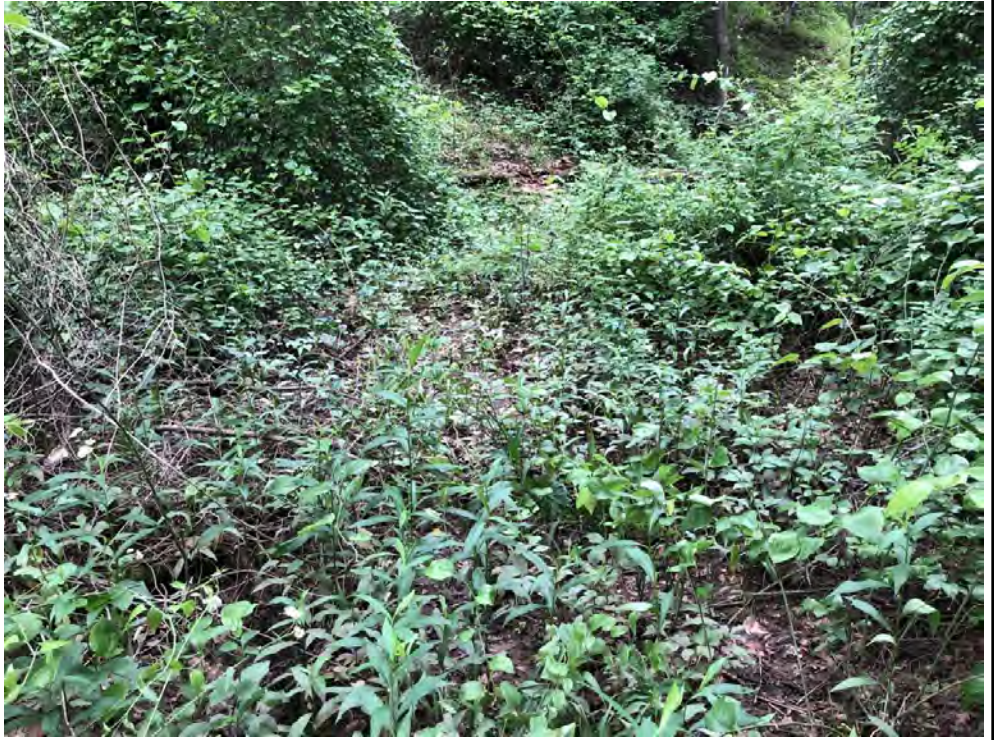
Photo Location: WWC-35			
Direction: Northwest			
Survey Date: 5/19/2021			
Comments: WWC-35 downstream view.

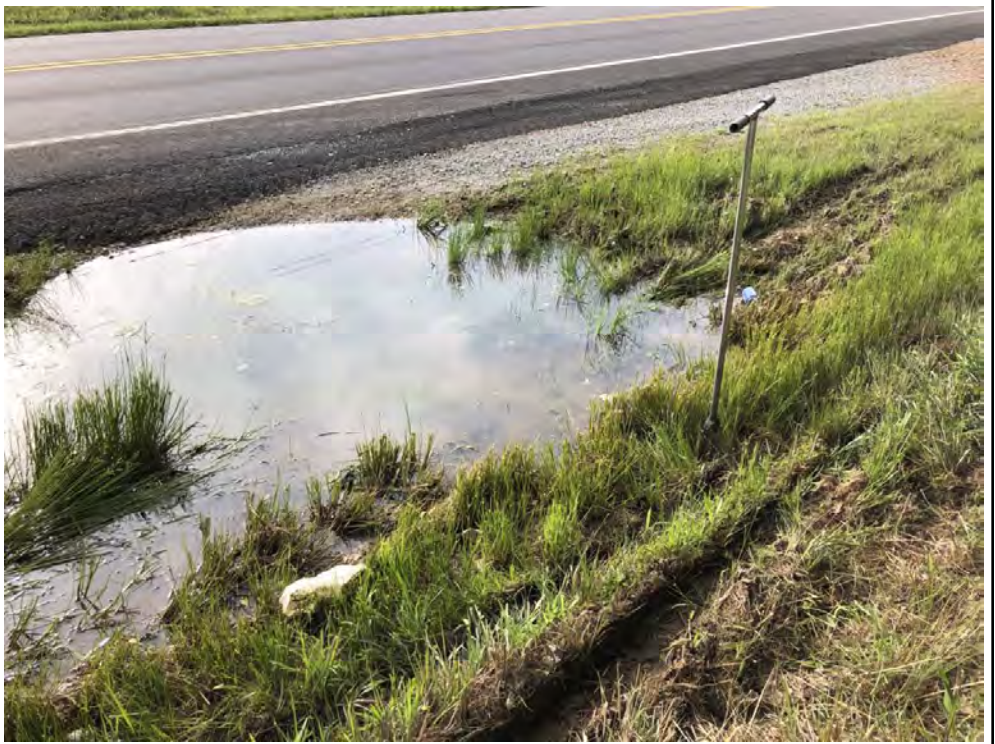
Photo Location: WTL-23			
Direction: North northeast			
Survey Date: 5/19/2021			
Comments: WTL-23 wetland point.			
Photograph ID: 212	 		
Photo Location: WTL-23			
Direction: North			
Survey Date: 5/19/2021			
Comments: WTL-23 upland point.

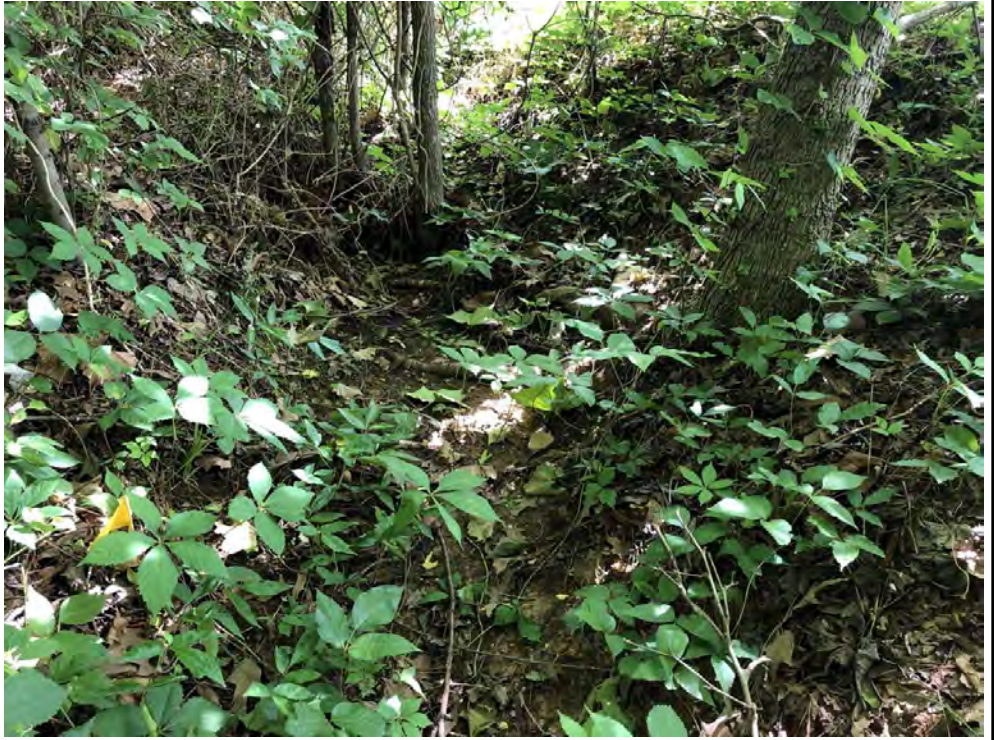
Photo Location: WWC-36			
Direction: South			
Survey Date: 5/19/2021			
Comments: WWC-36 upstream view.			
Photograph ID: 214

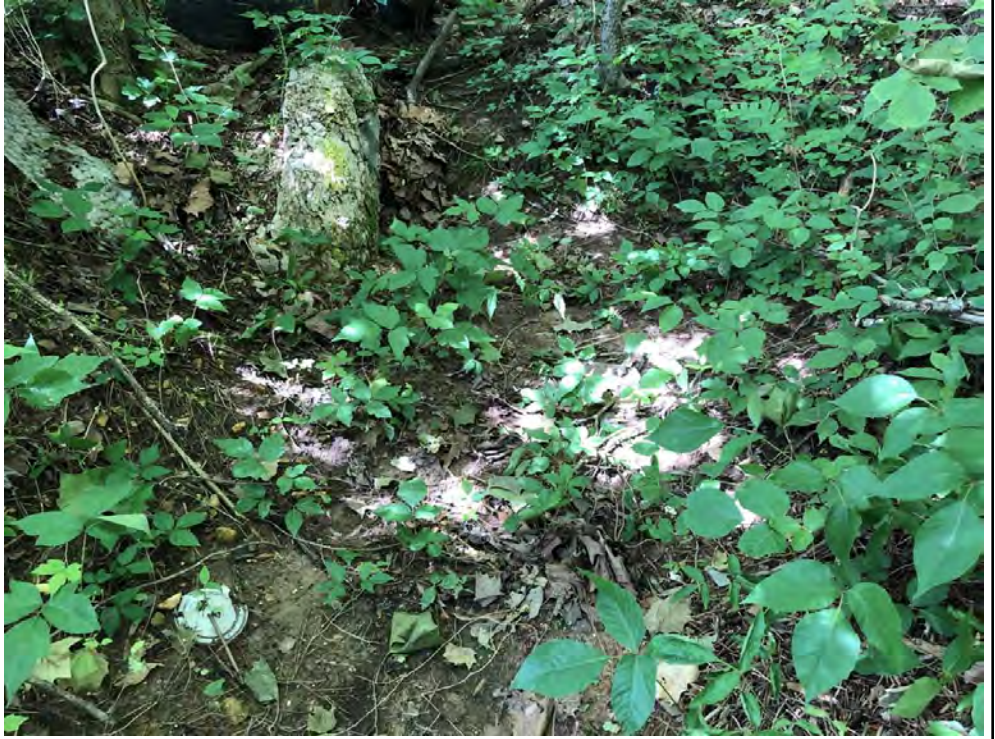
Photo Location: WWC-36			
Direction: West northwest			
Survey Date: 5/19/2021			
Comments: WWC-36 downstream view.

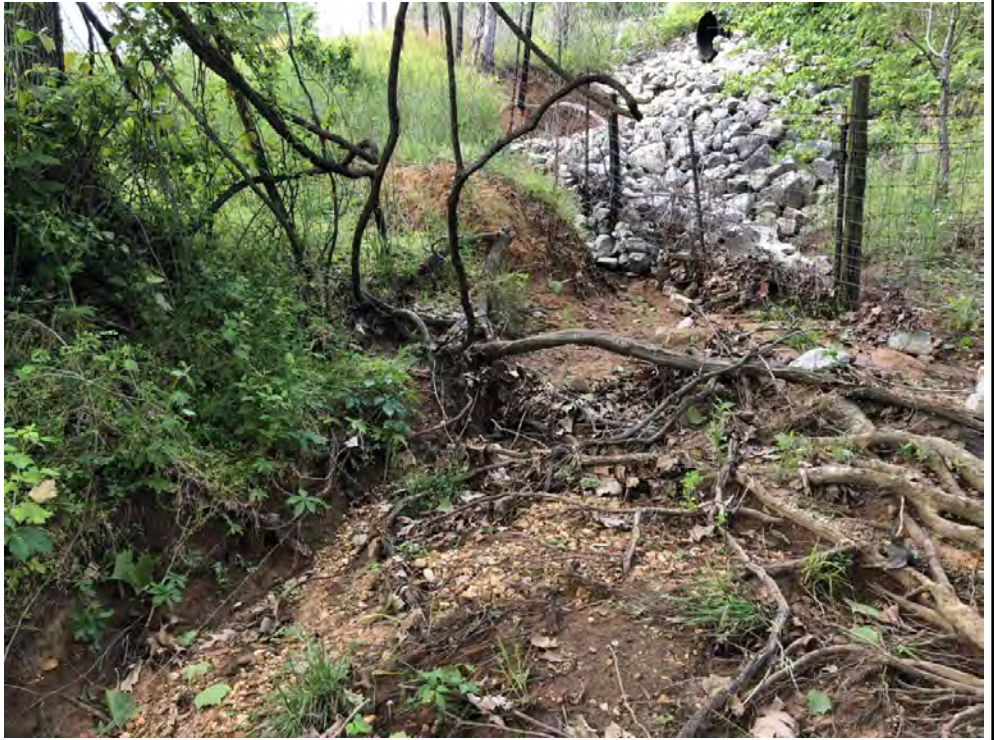
Photo Location: WWC-37			
Direction: North northeast			
Survey Date: 5/19/2021			
Comments: WWC-37 upstream view.			
Photograph ID: 216

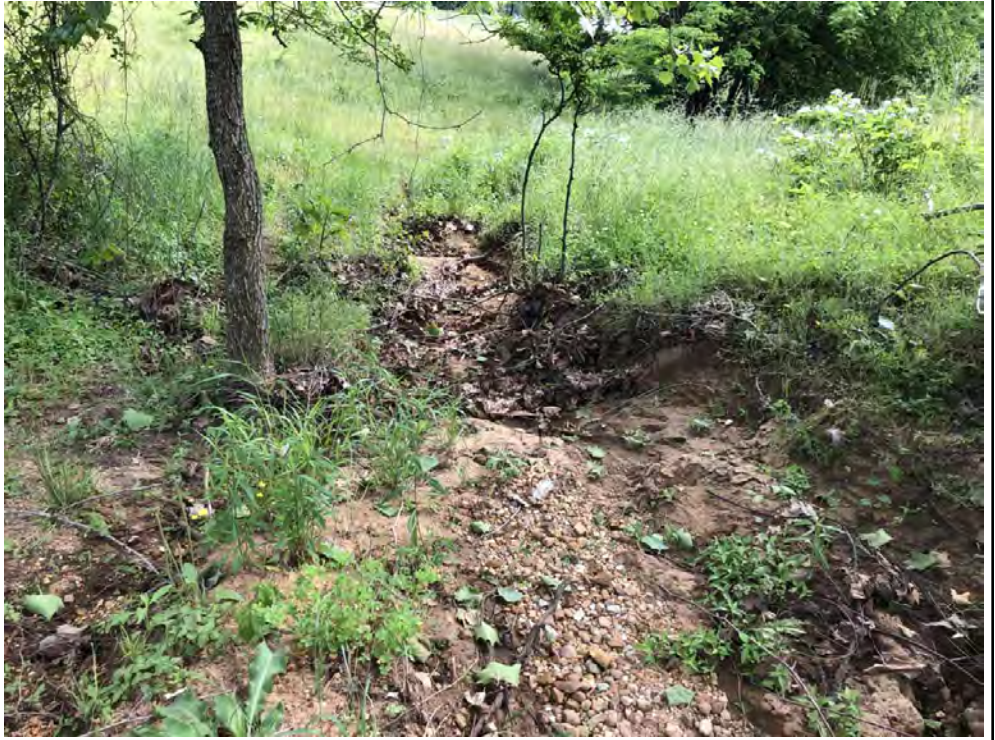
Photo Location: WWC-37			
Direction: South southwest			
Survey Date: 5/19/2021			
Comments: WWC-37 downstream view.

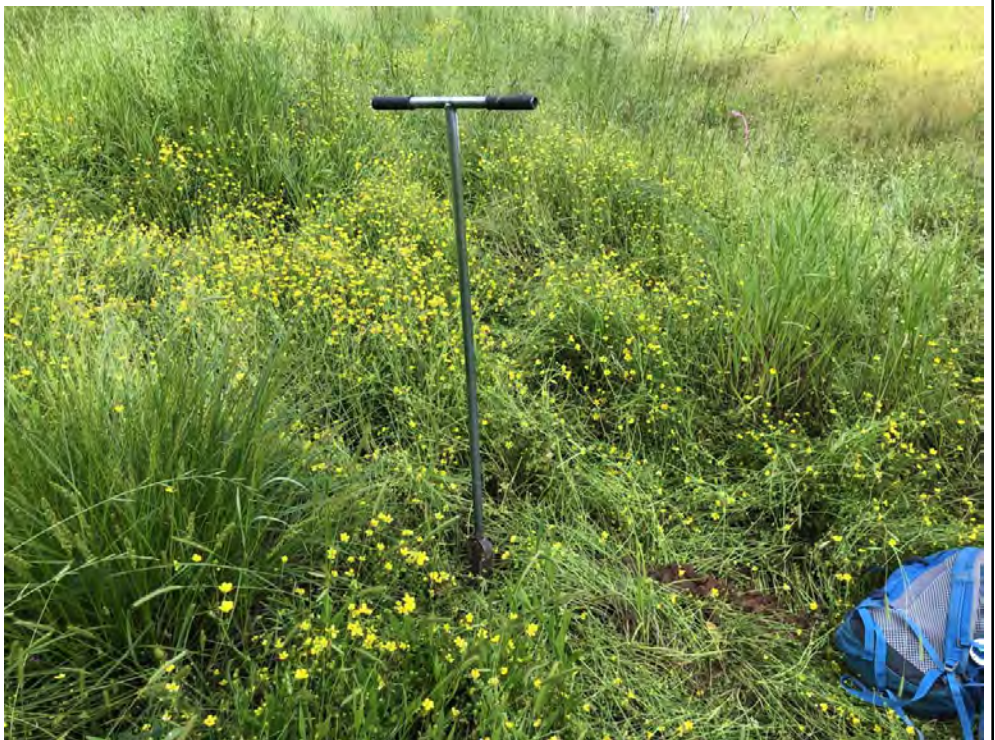
Photo Location: WTL-25			
Direction: East southeast			
Survey Date: 5/19/2021			
Comments: WTL-25 wetland point.			
Photograph ID: 220

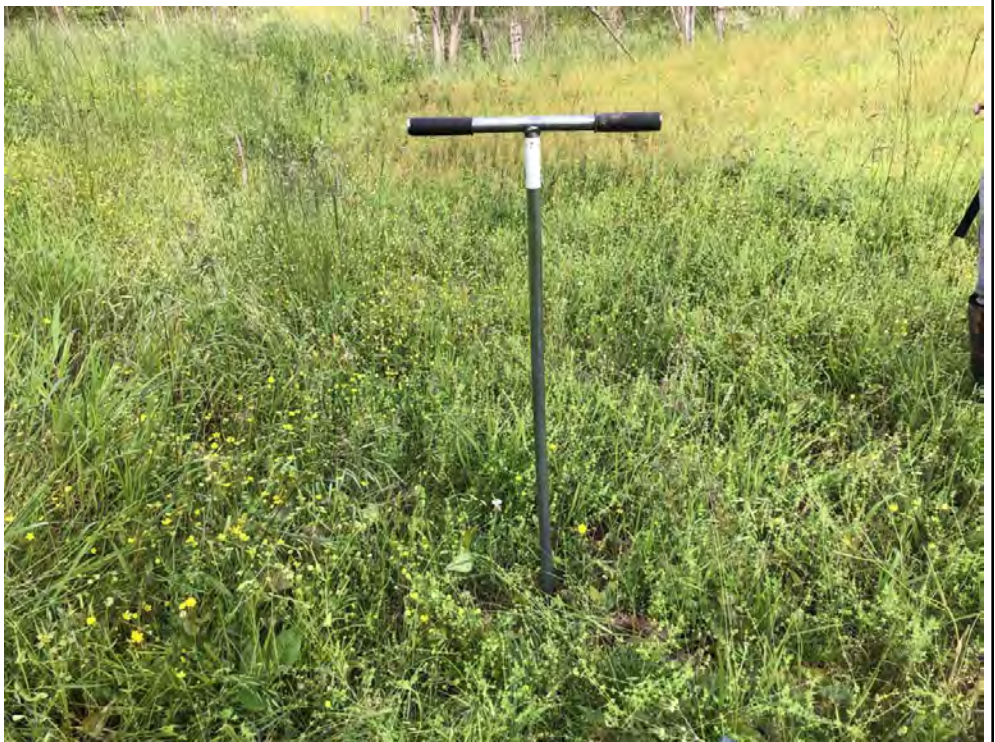
Photo Location: WTL-25			
Direction: North			
Survey Date: 5/19/2021			
Comments: WTL-25 upland point.

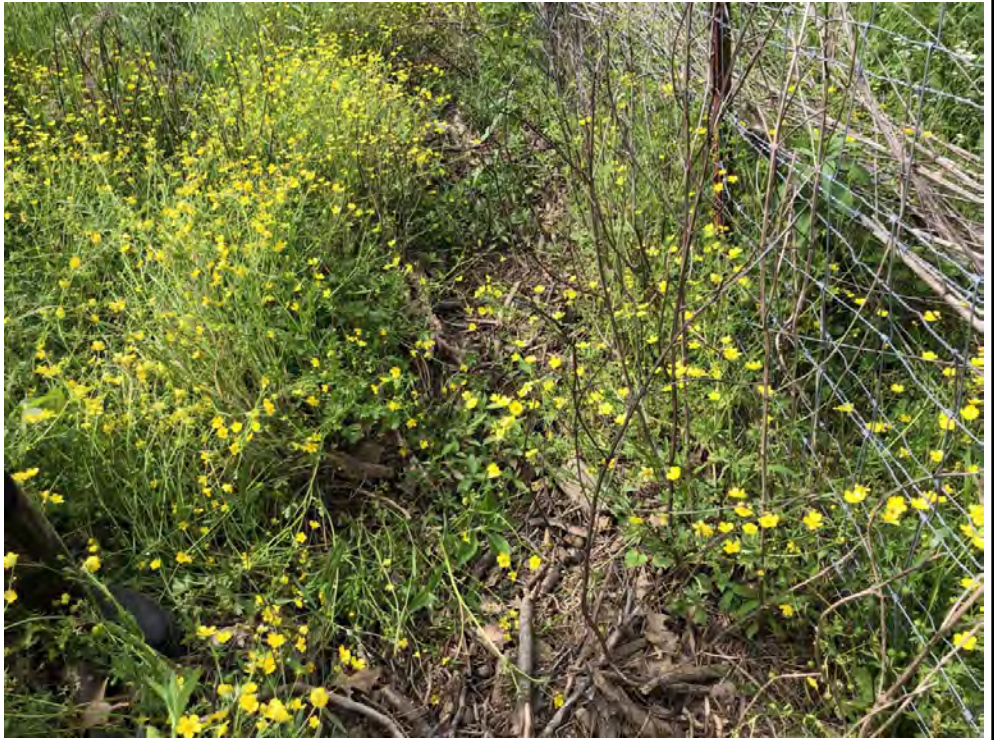
Photo Location: WWC-38			
Direction: Northwest			
Survey Date: 5/19/2021			
Comments: WWC-38 upstream view.			
Photograph ID: 222

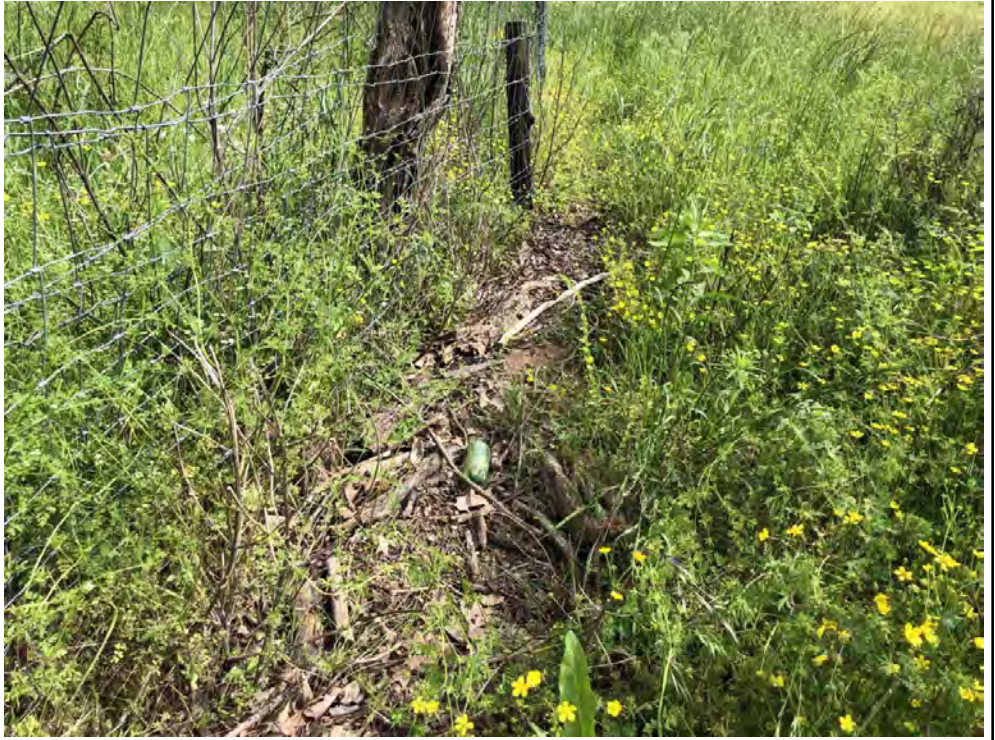
Photo Location: WWC-38			
Direction: North northeast			
Survey Date: 5/19/2021			
Comments: WWC-38 downstream view.

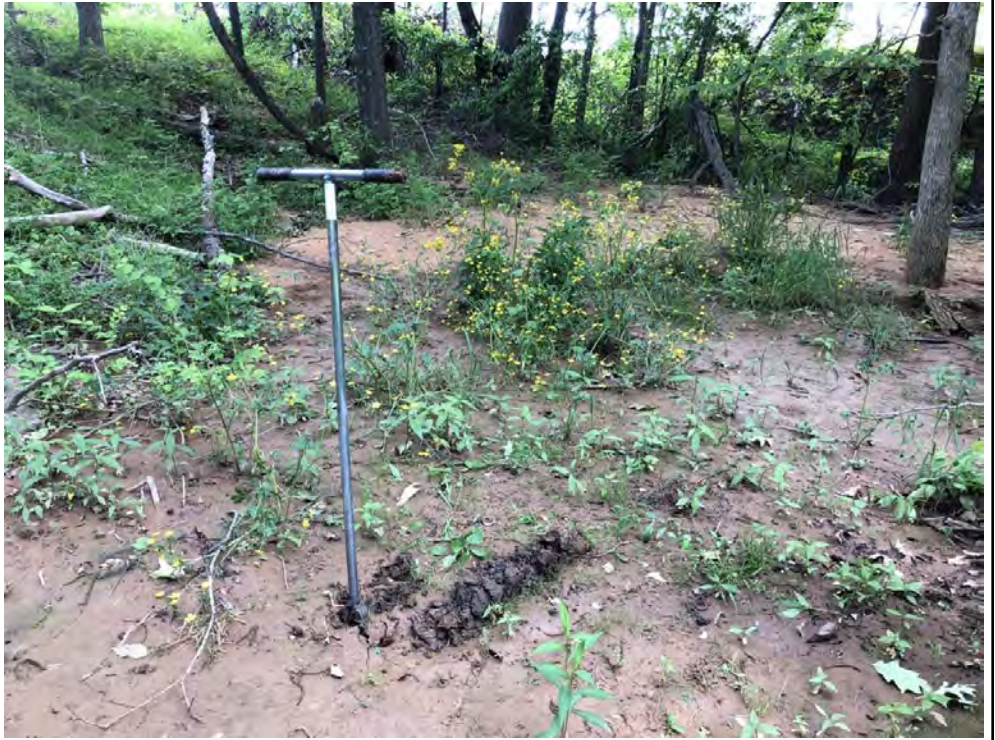
Photo Location: WTL-26			
Direction: South southwest			
Survey Date: 5/19/2021			
Comments: WTL-26 wetland point.			
Photograph ID: 224

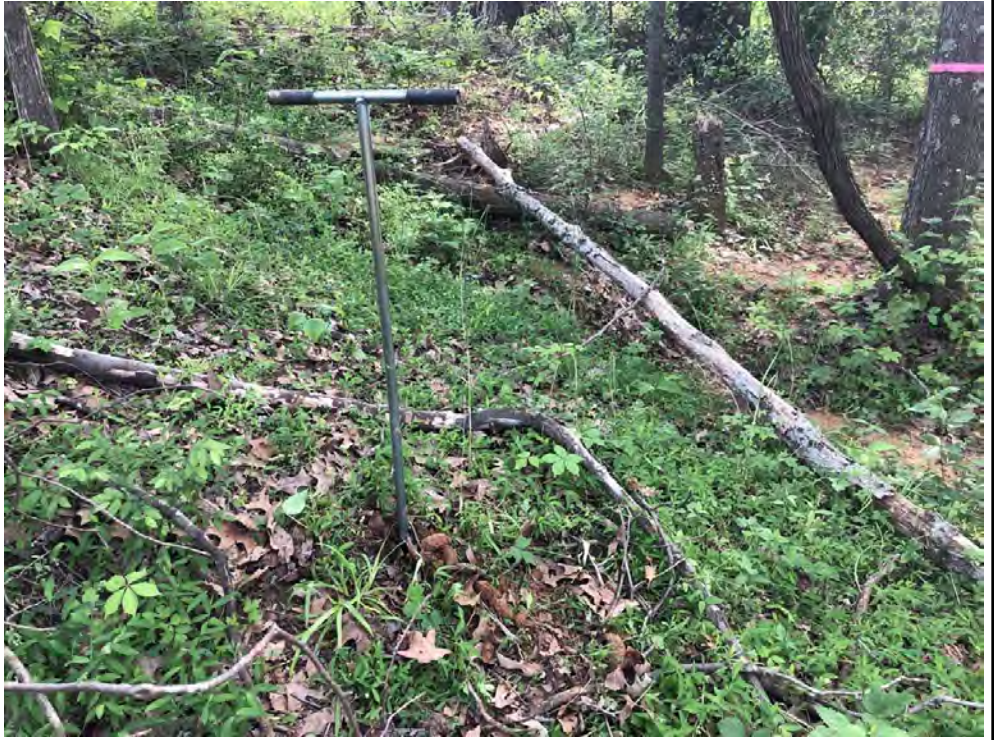
Photo Location: WTL-26			
Direction: South southwest			
Survey Date: 5/19/2021			
Comments: WTL-26 upland point.

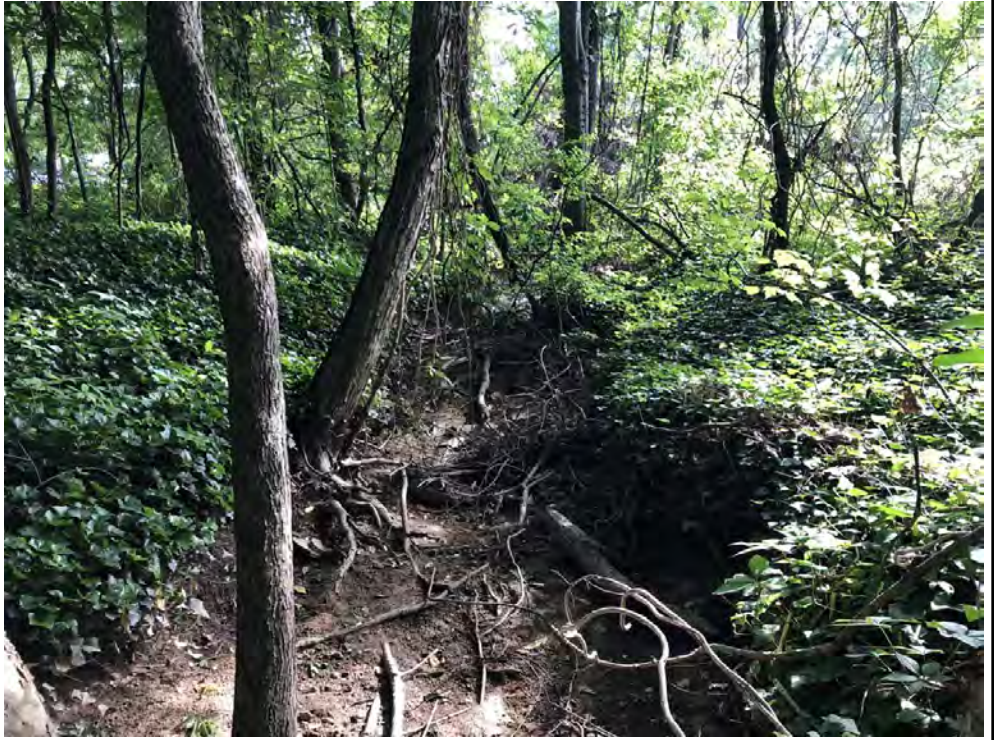
Photo Location: WWC-52			
Direction: North northeast			
Survey Date: 5/21/2021			
Comments: WWC-52 downstream view.

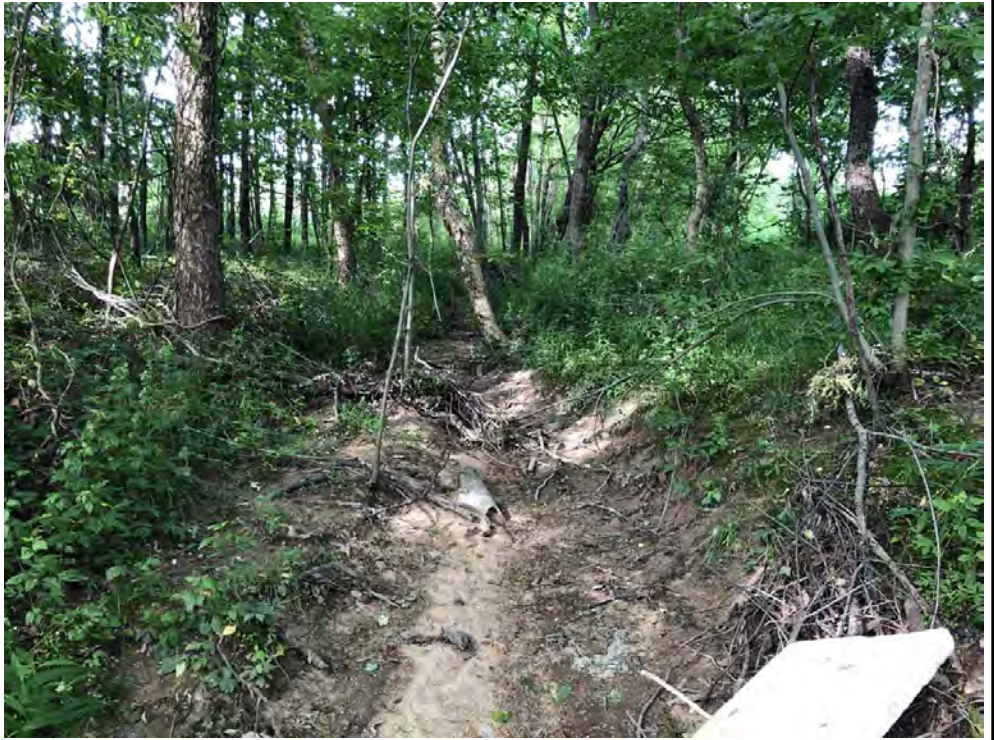
Photo Location: WWC-52			
Direction: East			
Survey Date: 5/21/2021			
Comments: WWC-52 upstream view			
Photograph ID: 310

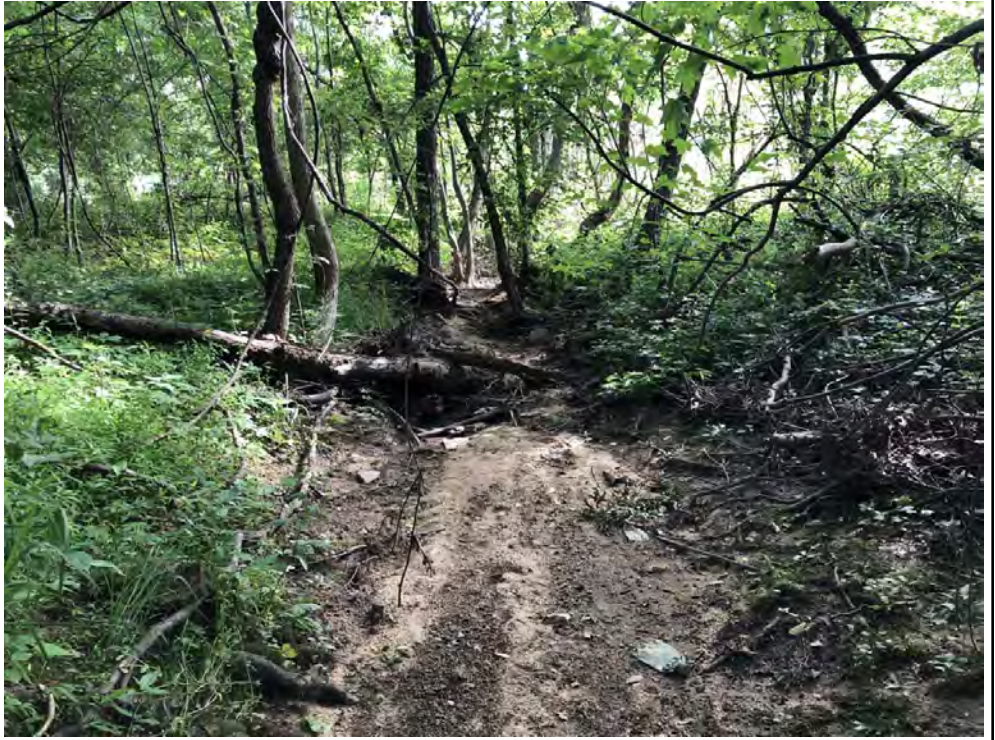
Photo Location: WWC-52			
Direction: West southwest			
Survey Date: 5/21/2021			
Comments: WWC-52 downstream view.

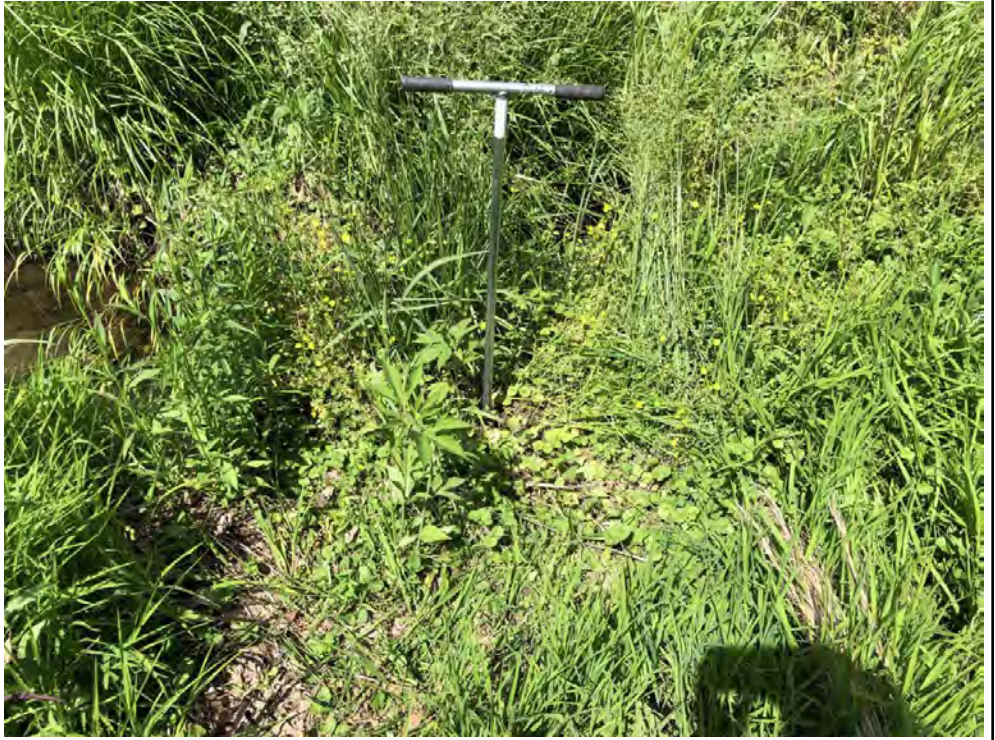
Photo Location: WTL-34			
Direction: North northeast			
Survey Date: 5/21/2021			
Comments: WTL-34 wetland point.

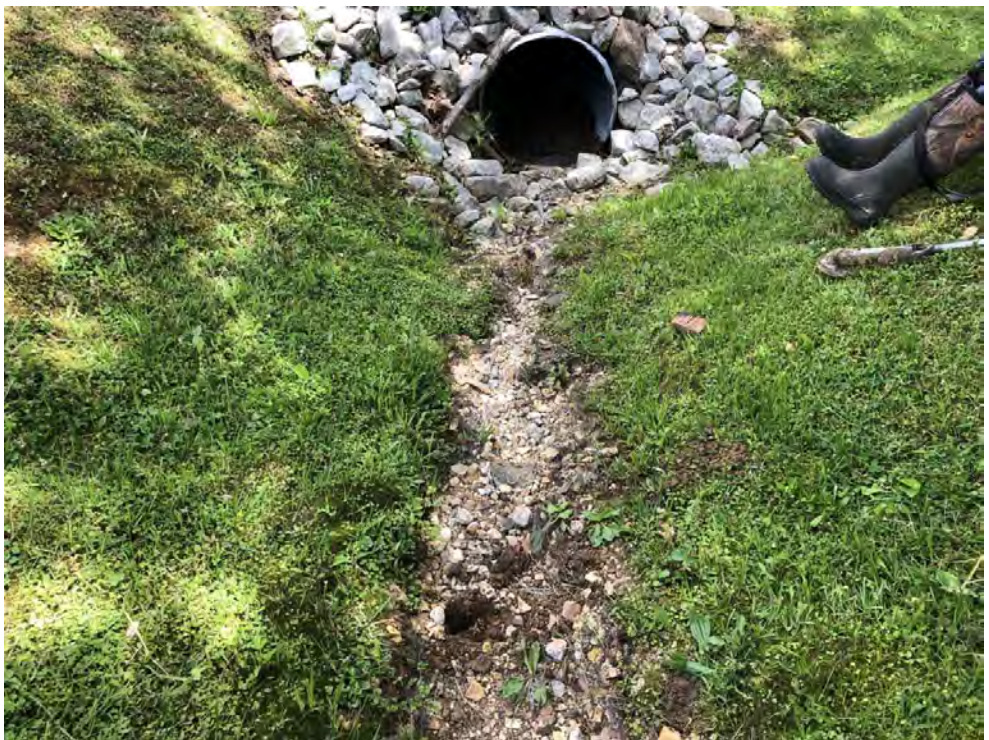
Photo Location: WWC-55			
Direction: East			
Survey Date: 5/21/2021			
Comments: WWC-55 downstream view.			
Photograph ID: 322

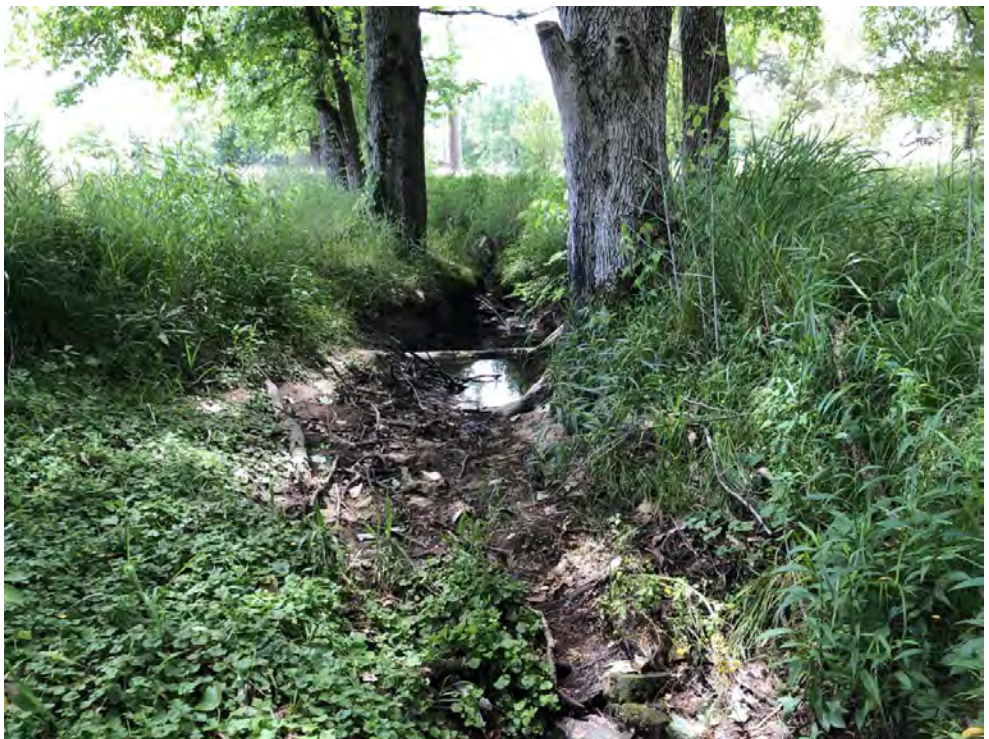
Photo Location: WWC-55			
Direction: South			
Survey Date: 5/21/2021			
Comments: WWC-55 upstream view.

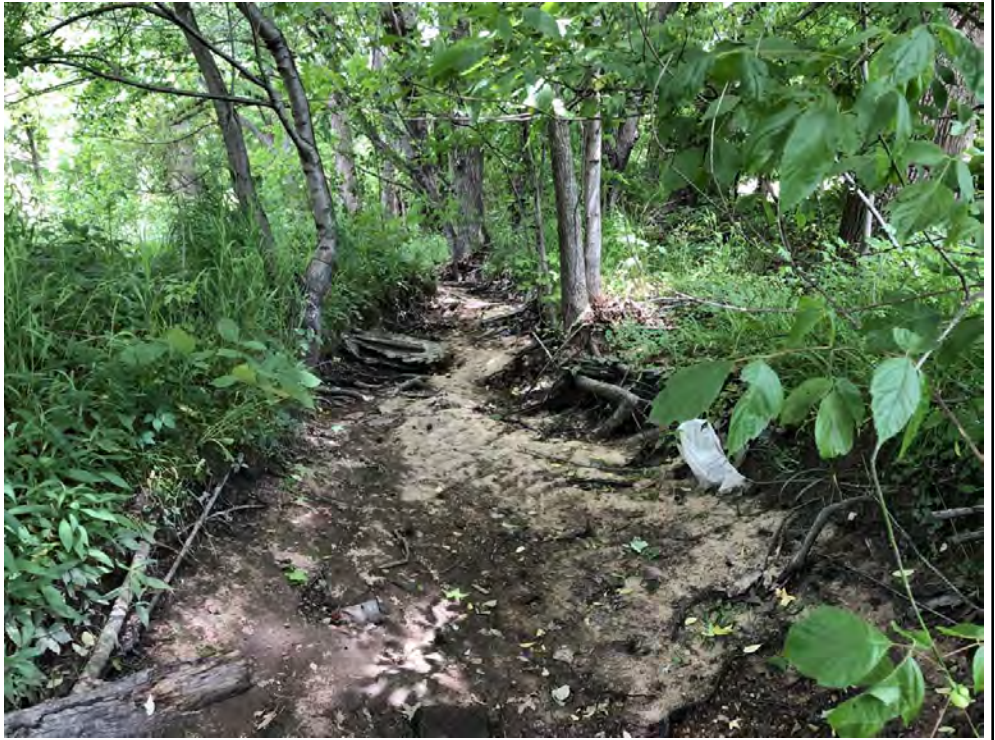
Photo Location: WWC-56			
Direction: Northeast			
Survey Date: 5/21/2021			
Comments: WWC-56 downstream view.			
Photograph ID: 324

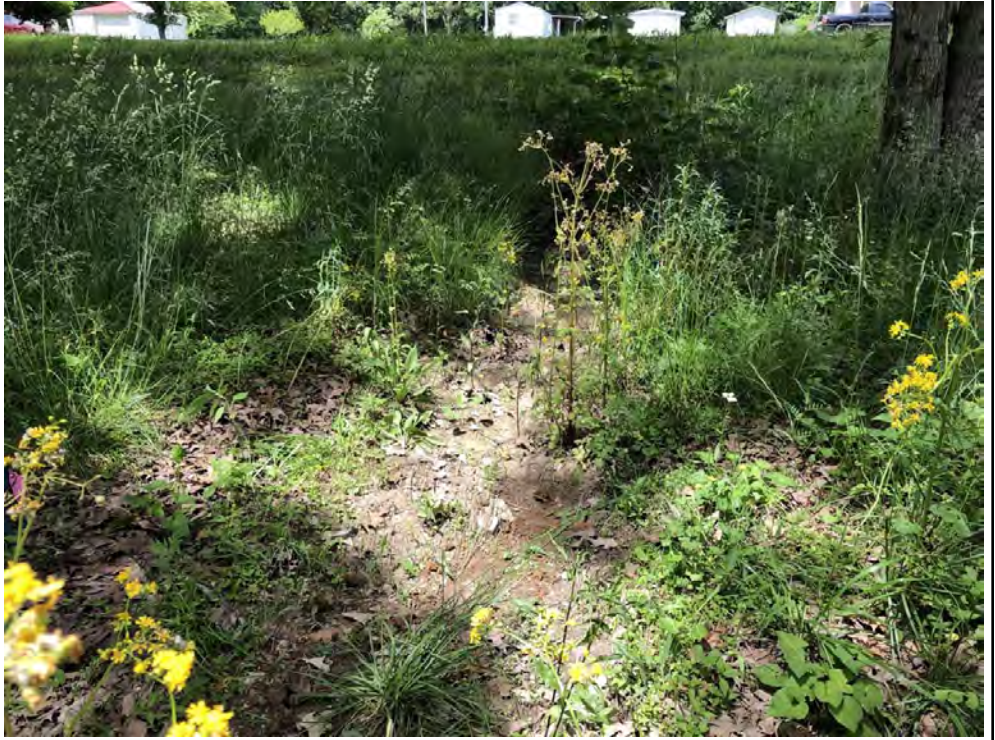
Photo Location: WTL-35			
Direction: North northeast			
Survey Date: 5/21/2021			
Comments: WTL-35 wetland overview.

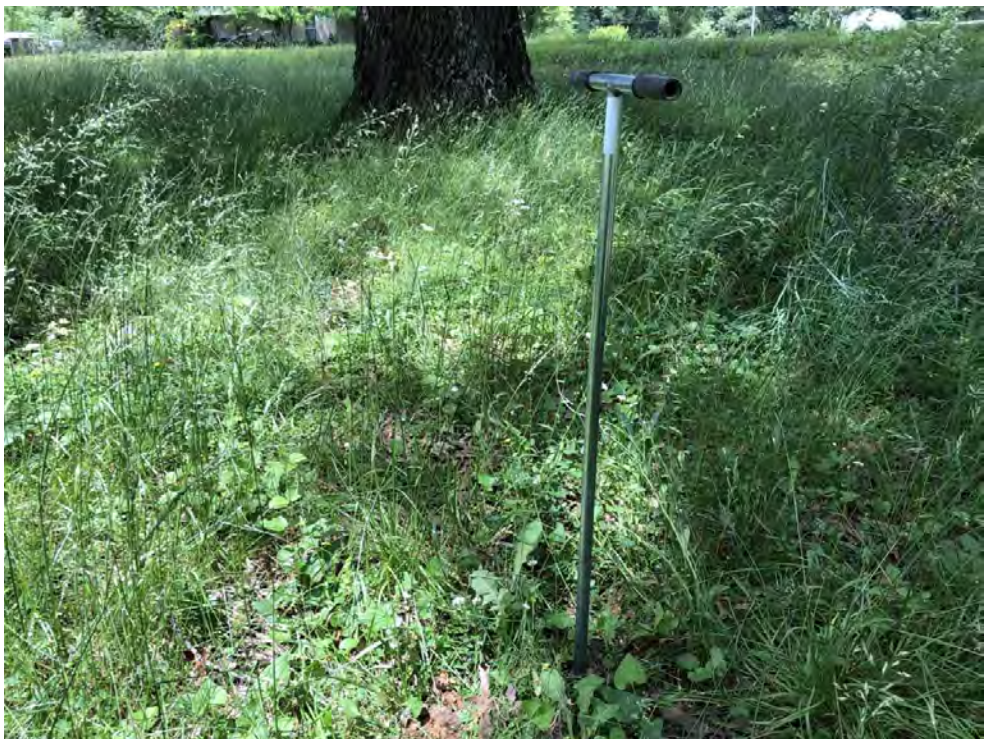
Photo Location: WTL-35			
Direction: West northwest			
Survey Date: 5/21/2021			
Comments: WTL-35 upland point.

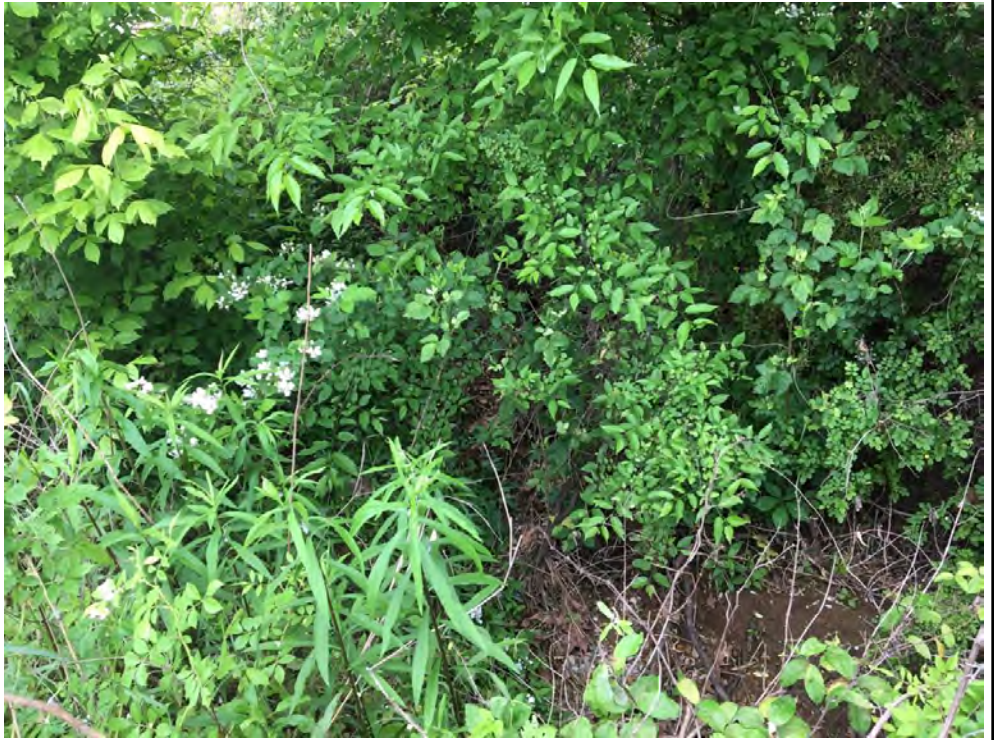
Photo Location: STR-21			
Direction: Northwest			
Survey Date: 5/19/2021			
Comments: STR-21 upstream view.			
Photograph ID: 328

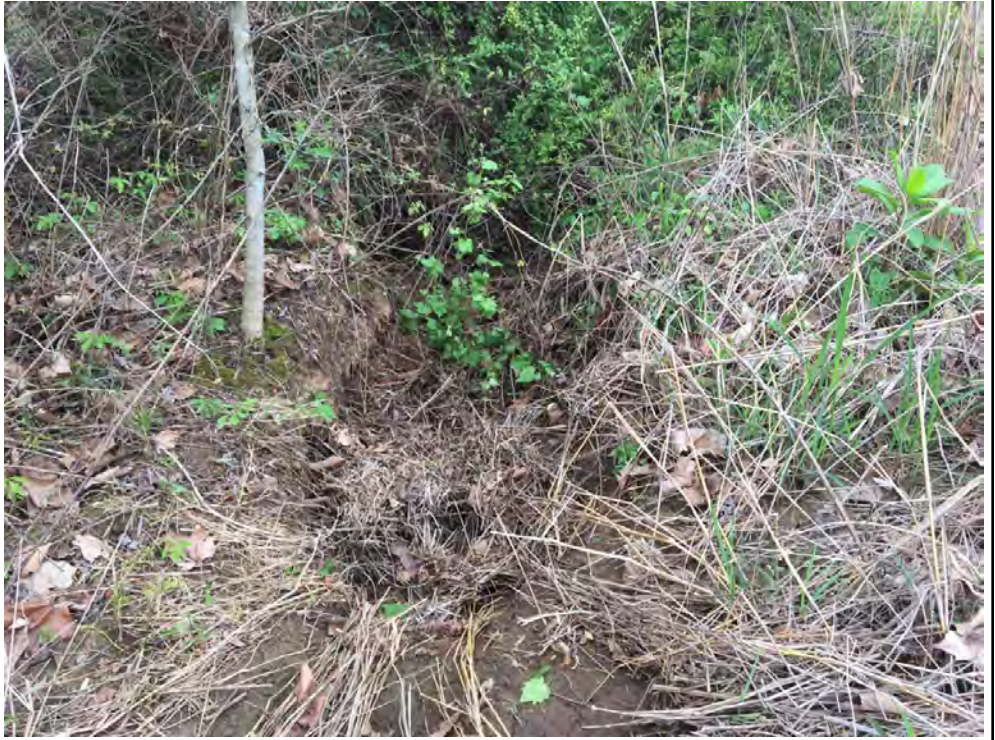
Photo Location: STR-21			
Direction: South southeast			
Survey Date: 5/19/2021			
Comments: STR-21 downstream view.

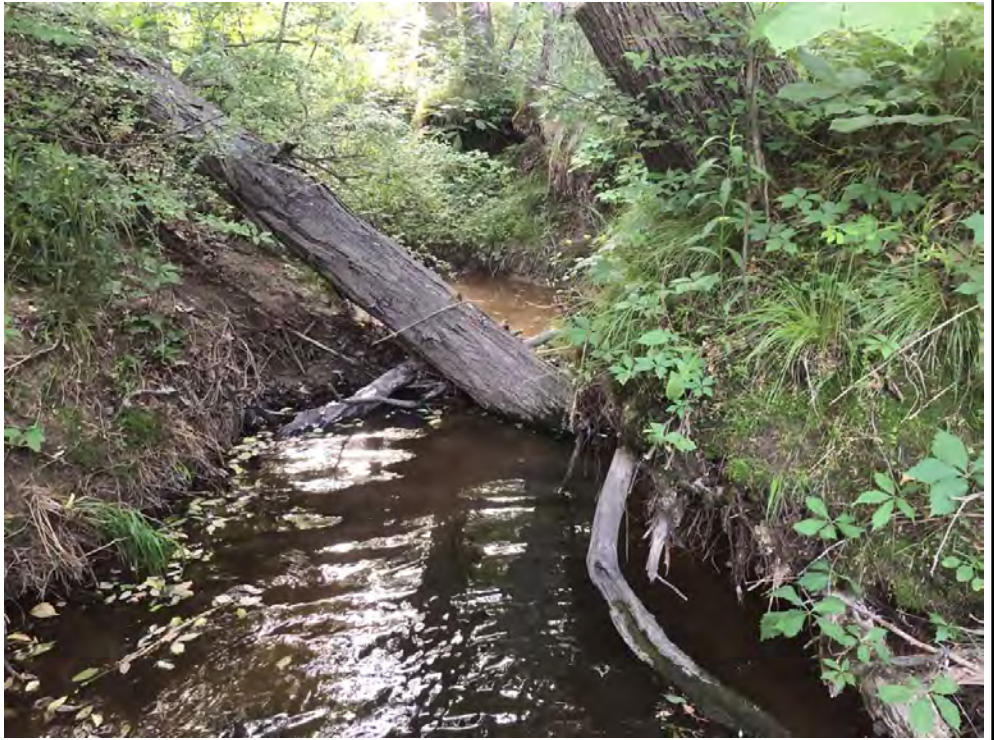
Photo Location: STR-22			
Direction: Northwest			
Survey Date: 5/20/2021			
Comments: STR-22 upstream view.			
Photograph ID: 332

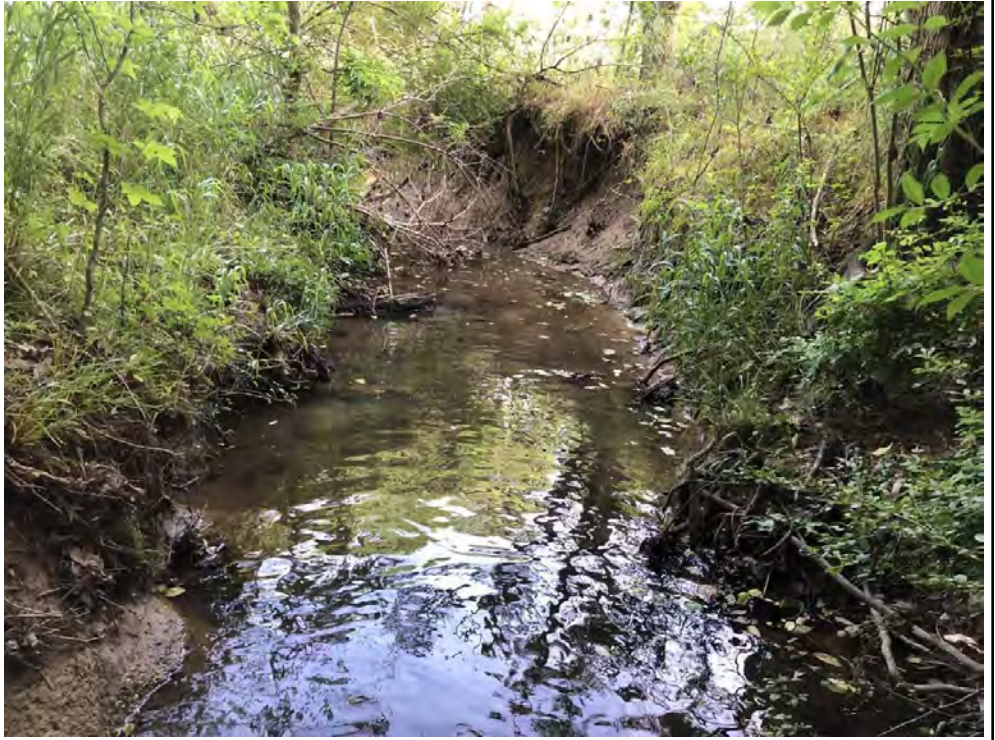
Photo Location: STR-22			
Direction: East southeast			
Survey Date: 5/20/2021			
Comments: STR-22 downstream view.

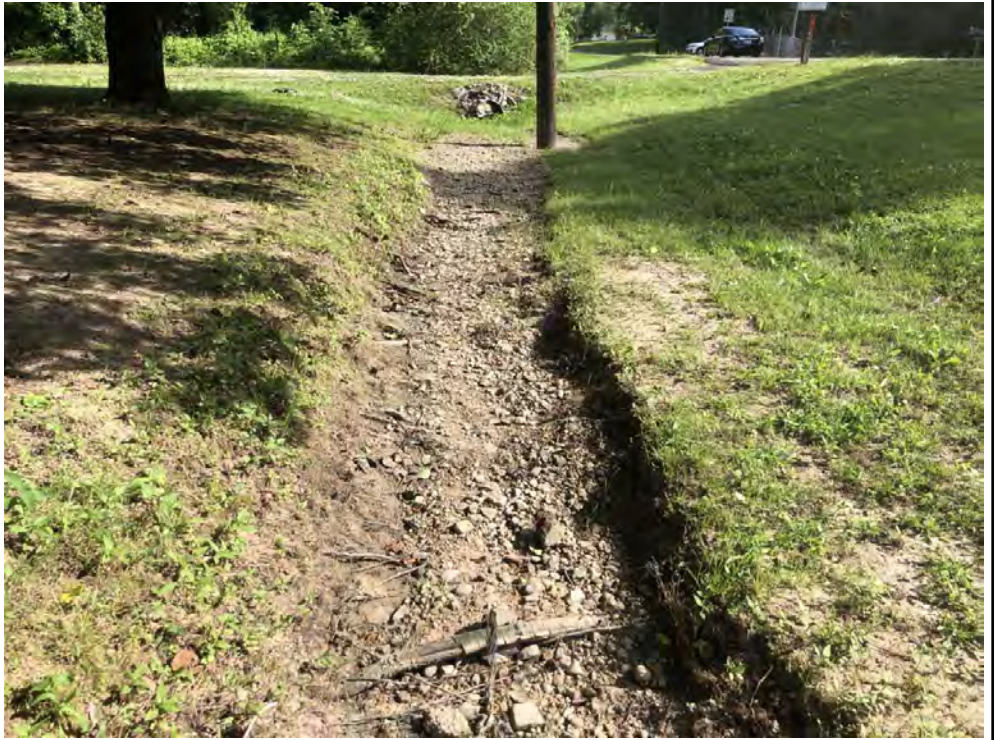
Photo Location: WWC-59			
Direction: South			
Survey Date: 5/20/2021			
Comments: WWC-59 downstream view.			
Photograph ID: 340

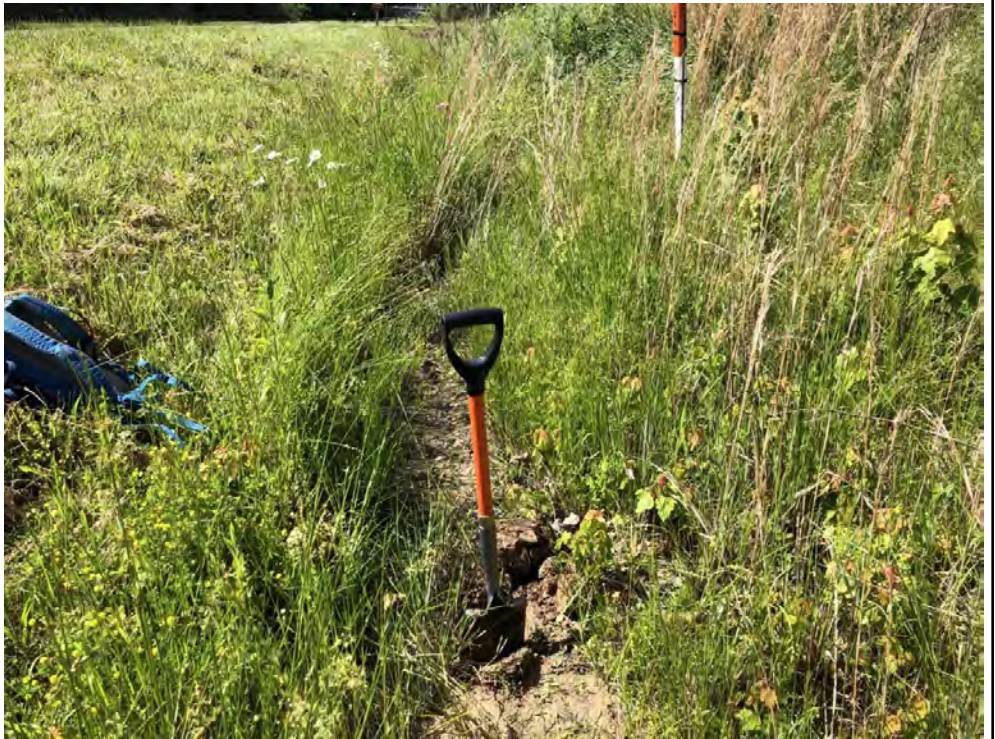
Photo Location: WTL-36			
Direction: West			
Survey Date: 5/21/2021			
Comments: WTL-36 wetland point.

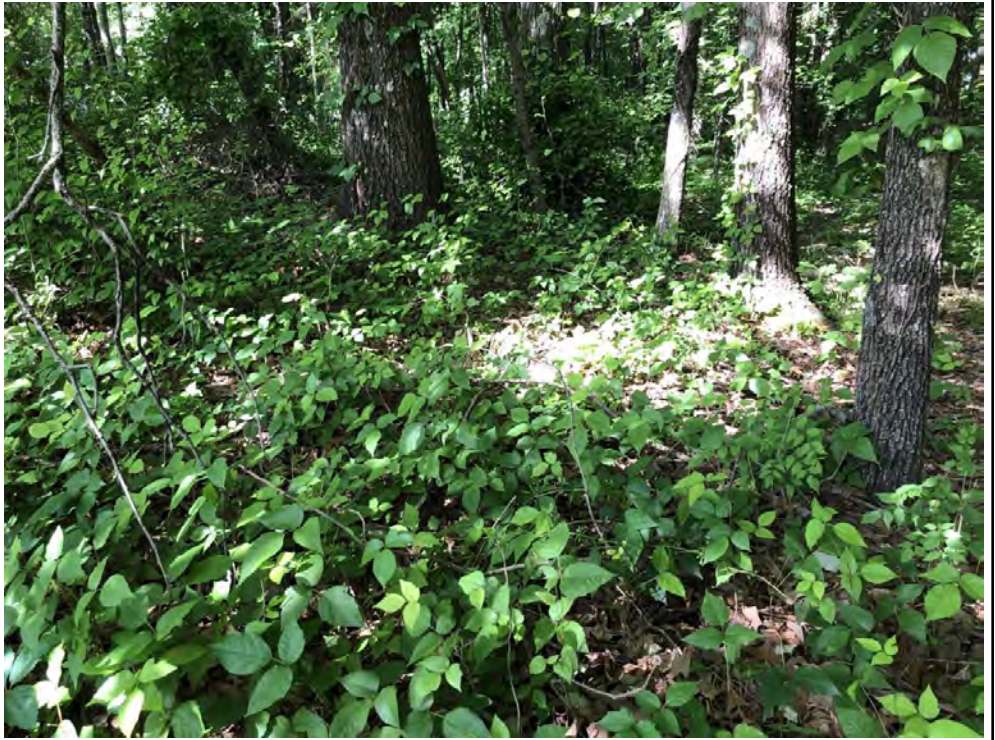
Photo Location: WTL-38			
Direction: West southwest			
Survey Date: 5/21/2021			
Comments: WTL-38 upland point.			
Photograph ID: 346

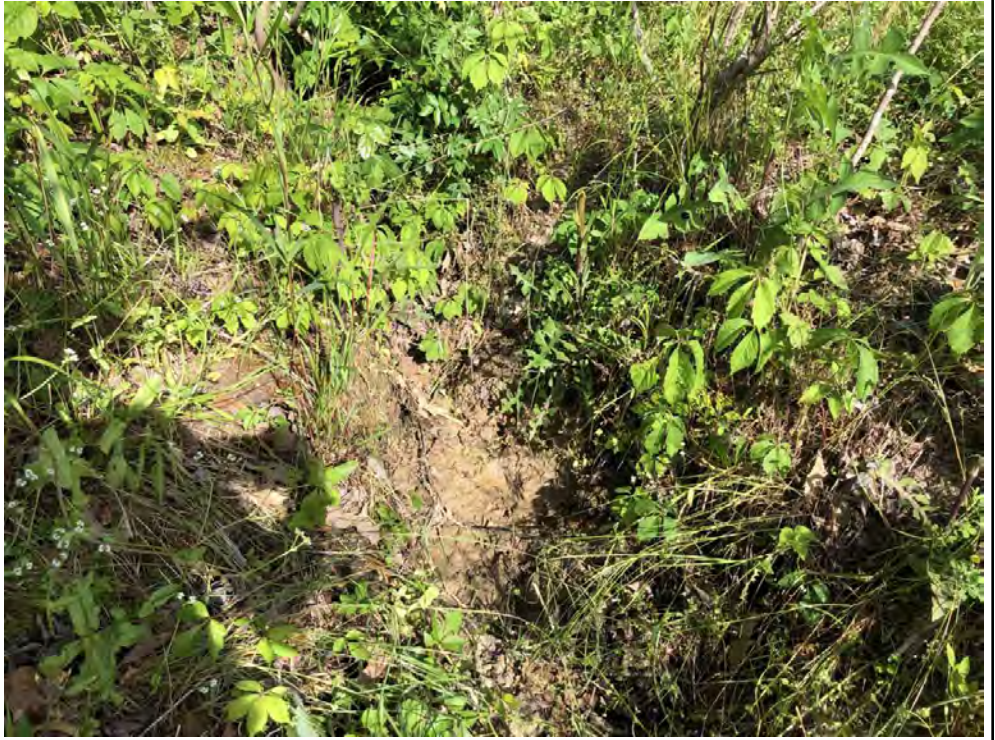
Photo Location: WWC-60			
Direction: Southeast			
Survey Date: 5/21/2021			
Comments: WWC-60 upstream view.

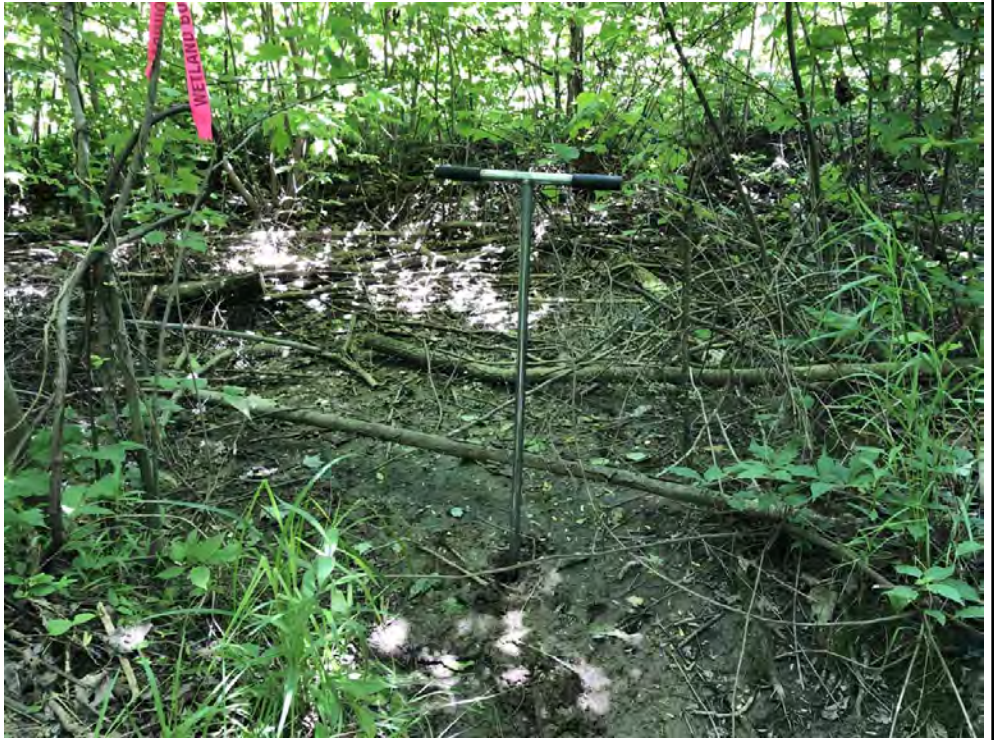
Photo Location: WTL-43			
Direction: South southeast			
Survey Date: 5/21/2021			
Comments: WTL-43 wetland point.			
Photograph ID: 358
