Right-of-Way Reevaluation, State Route 54 (US Highway 641), From State Route 69 (Wood Street) in Paris to Crossland Road/Brannon Lane (North of Puryear), Henry County, Tennessee, PIN 101886.00, Federal Project No. NH-54(26), State Project No. 40003-1213-14

Date: 05/19/2022

Environmental Commitments

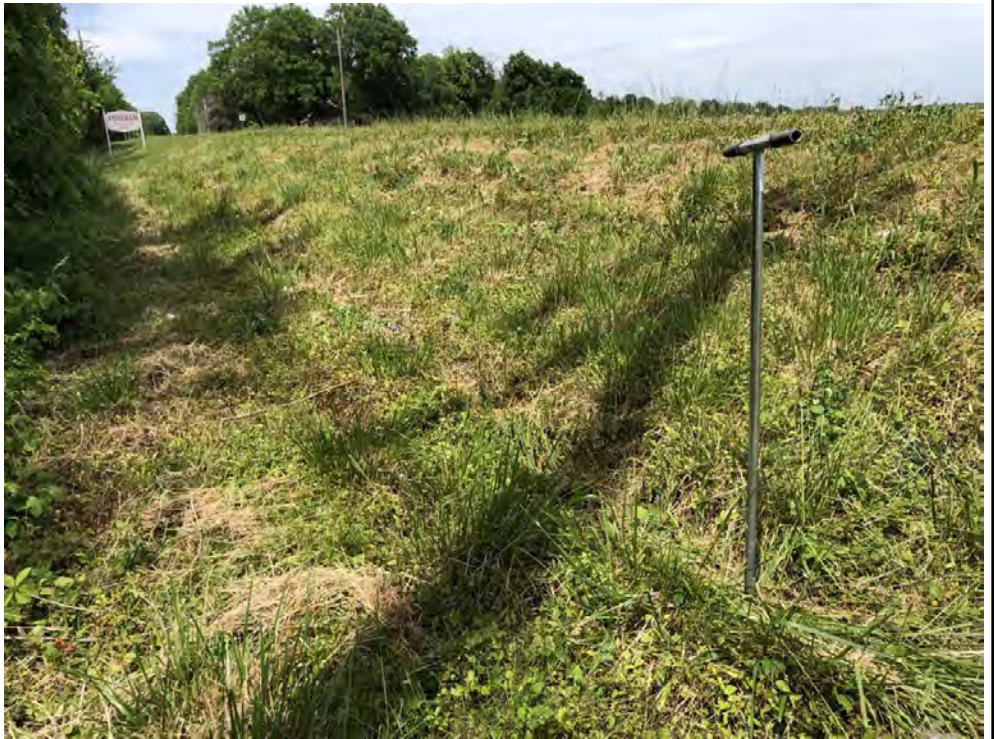
Photo Location: WTL-43			
Direction: South			
Survey Date: 5/21/2021			
Comments: WTL-43 upland point.

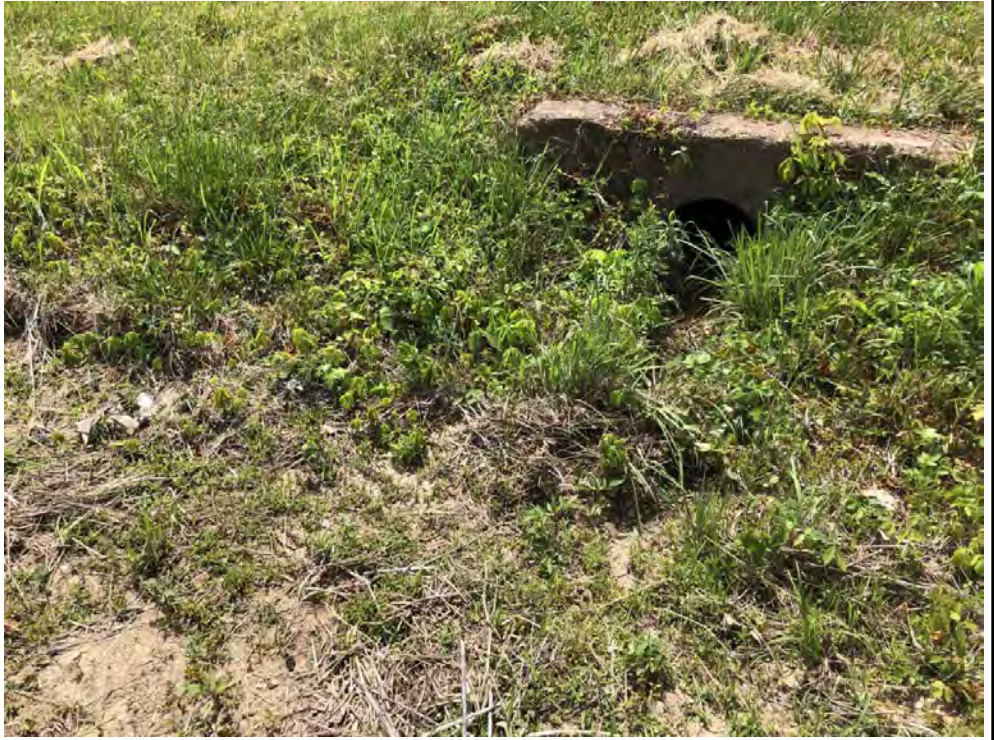
Photo Location: WWC-61			
Direction: South southeast			
Survey Date: 5/21/2021			
Comments: WWC-61 downstream view.

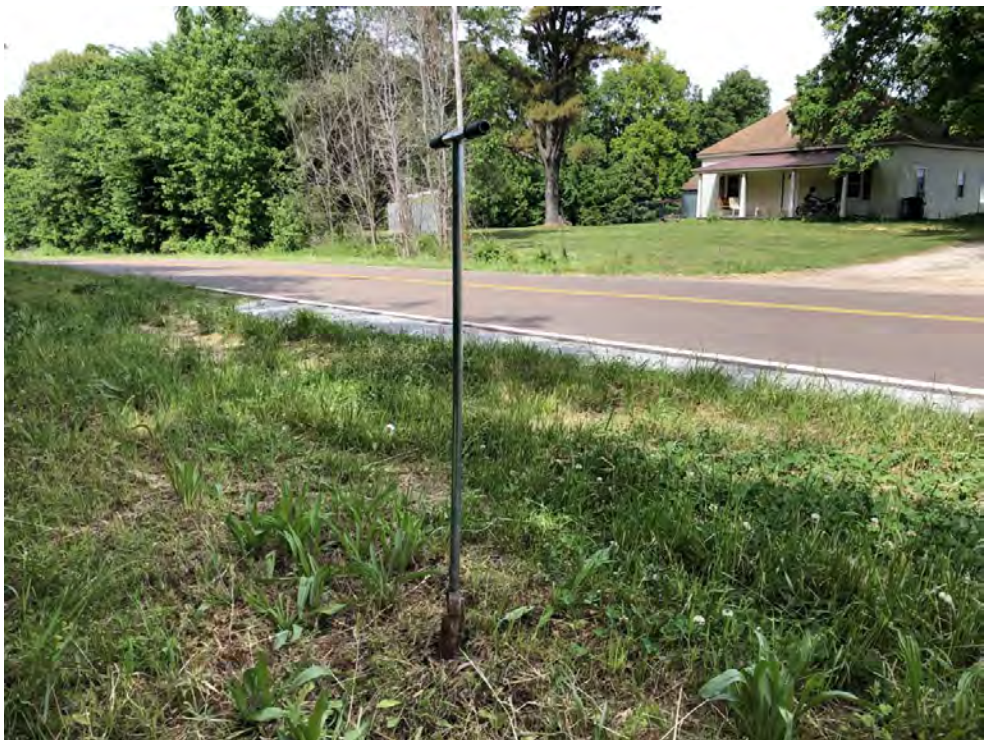
Photo Location: WTL-44			
Direction: South southwest			
Survey Date: 5/21/2021			
Comments: WTL-44 upland point.			
Photograph ID: 366

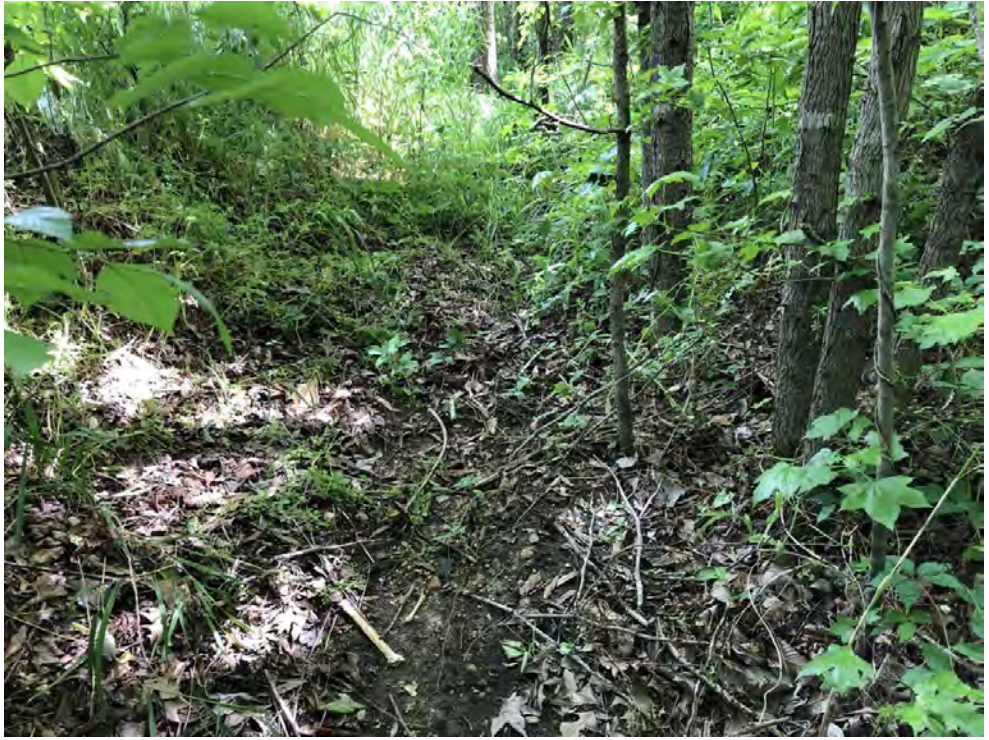
Photo Location: WWC-63			
Direction: South southeast			
Survey Date: 5/21/2021			
Comments: WWC-63 upstream view.

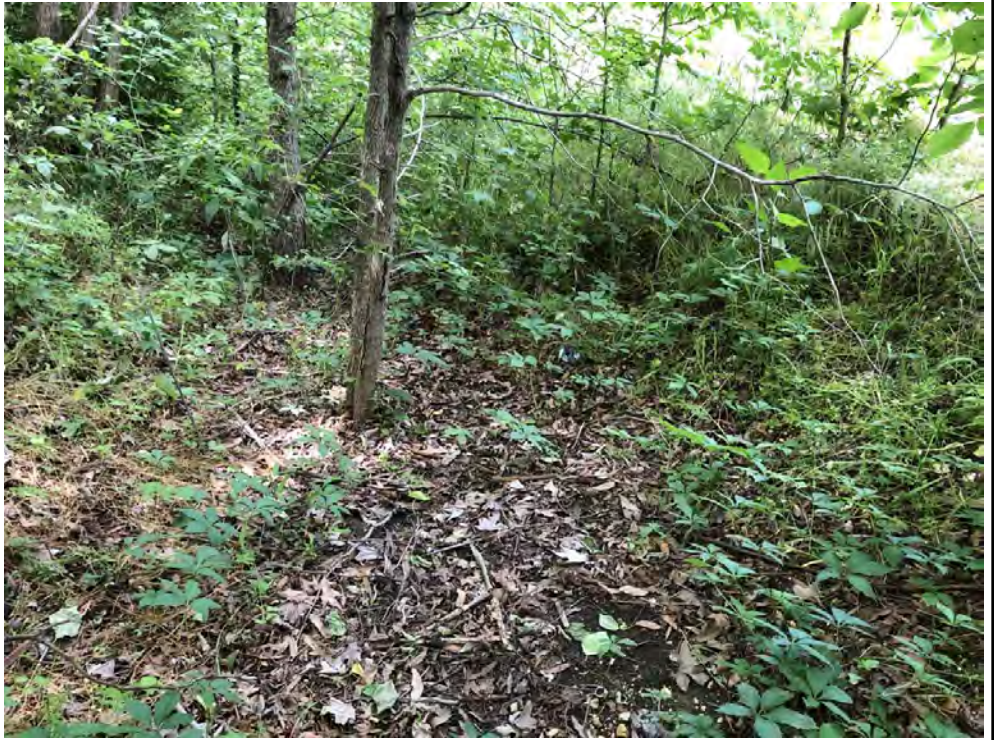
Photo Location: WWC-63			
Direction: North			
Survey Date: 5/21/2021			
Comments: WWC-63 downstream view.			
Photograph ID: 368

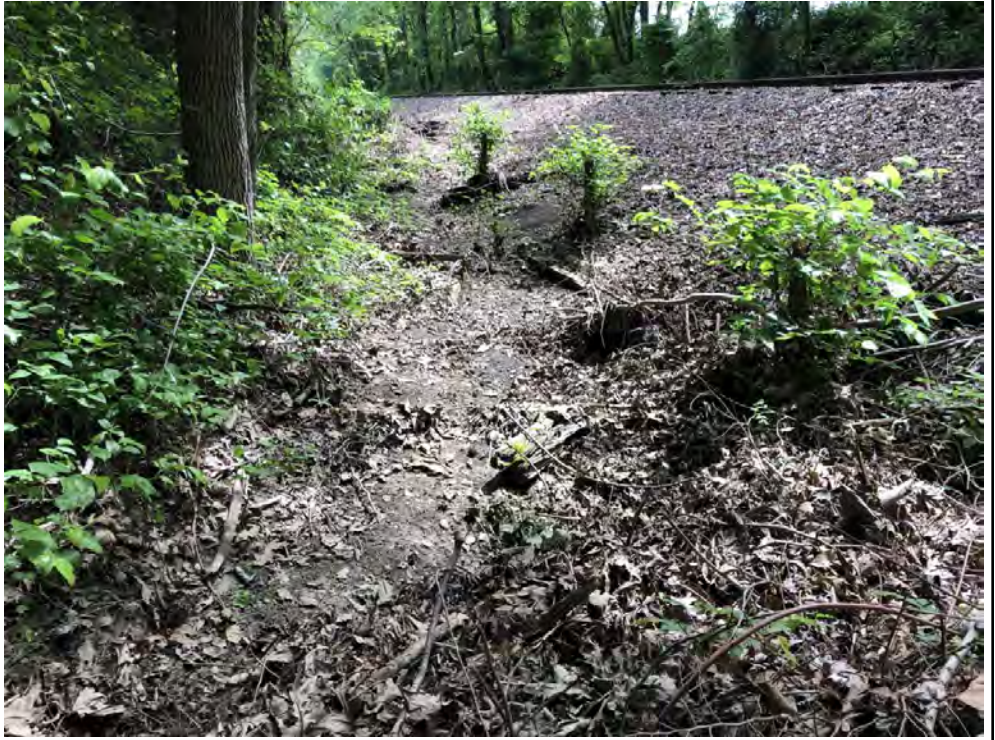
Photo Location: WWC-64			
Direction: Southeast			
Survey Date: 5/21/2021			
Comments: WWC-64 upstream view.

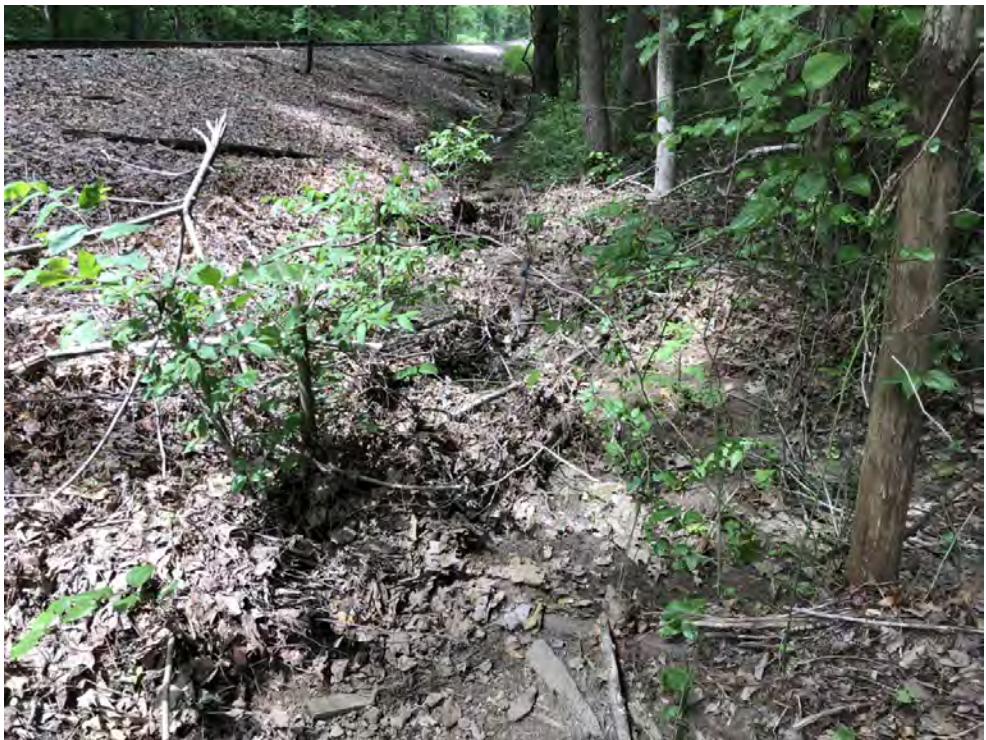
Photo Location: WWC-64			
Direction: Southeast			
Survey Date: 5/21/2021			
Comments: WWC-64 downstream view.			
Photograph ID: 370

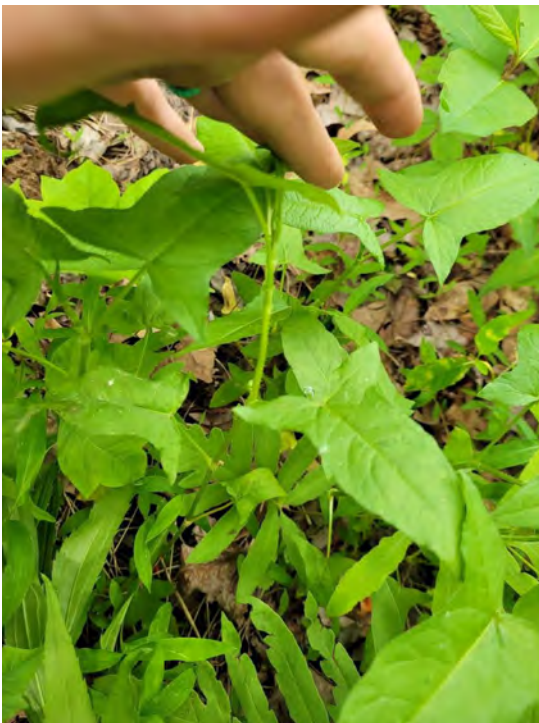
Photo Location: WTL-09			
Direction: West			
Survey Date: 5/17/2021			
Comments: Halberd-leaf tearthumb (<i>Polygonum arifolium</i>) within WTL-09.

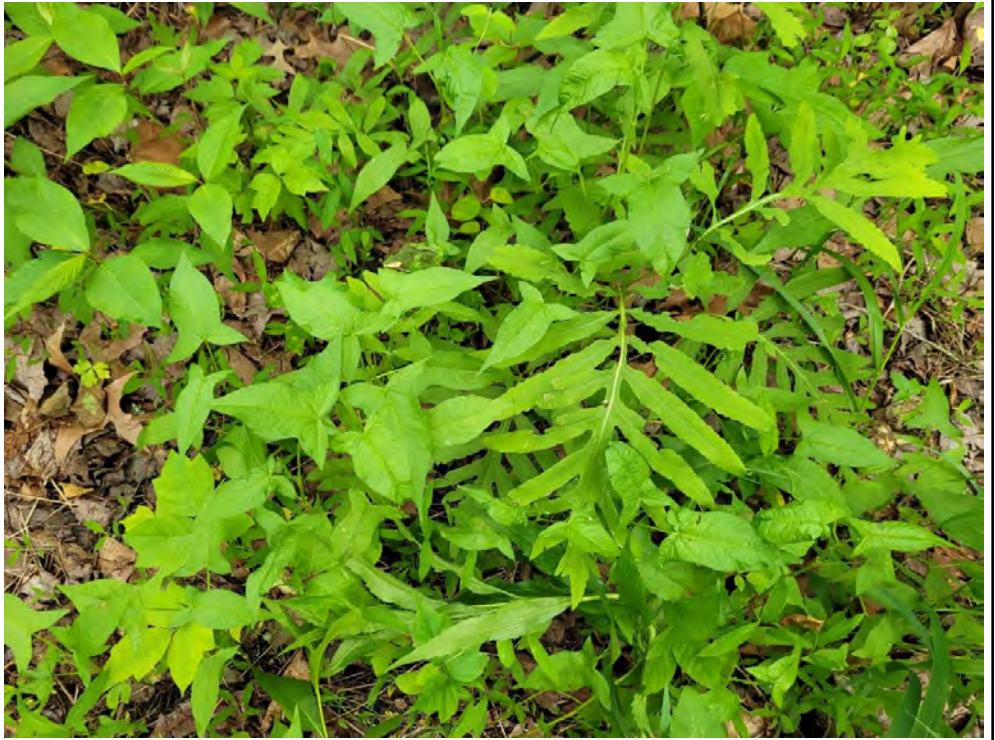
Photo Location: WTL-09			
Direction: West			
Survey Date: 5/17/2021			
Comments: Halberd-leaf tearthumb (Polygonum arifolium) within WTL-09.			
Photograph ID: 372

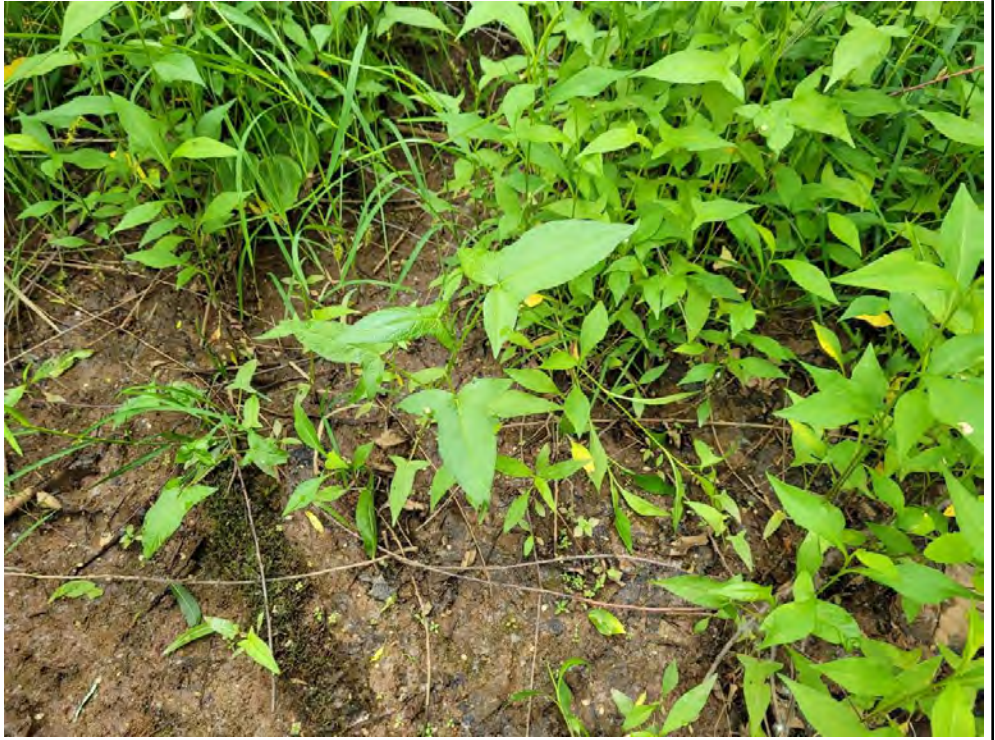
Photo Location: WTL-09			
Direction: Southwest			
Survey Date: 5/17/2021			
Comments: Halberd-leaf tearthumb (Polygonum arifolium) within WTL-09.

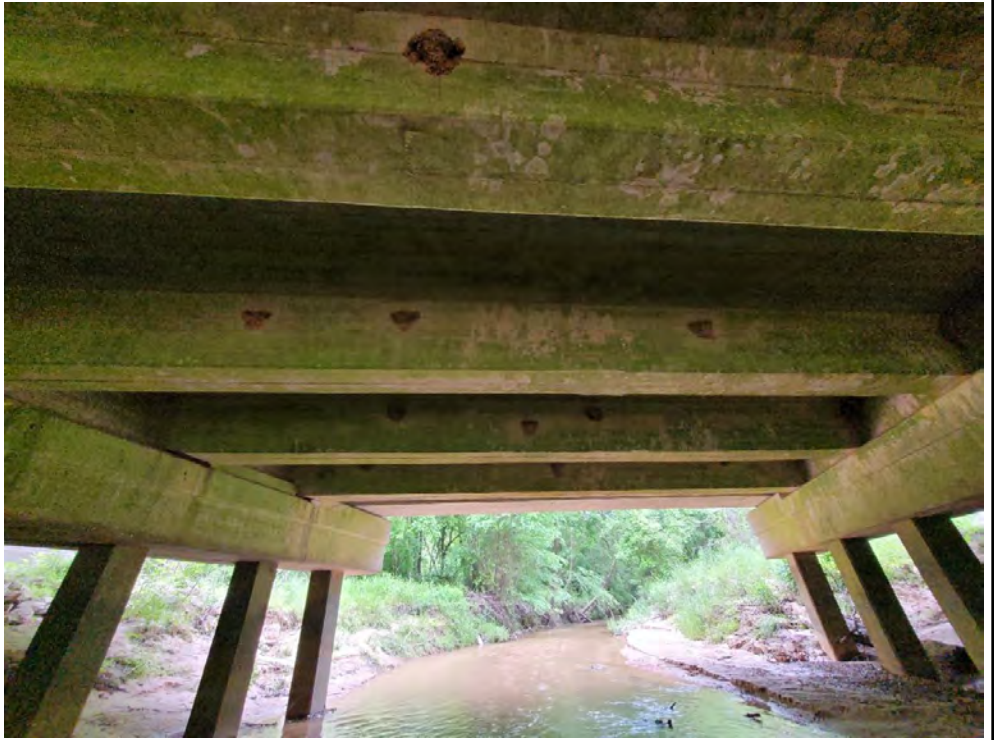
Photo Location: STR-07			
Direction: East			
Survey Date: 5/17/2021			
Comments: Swallow nests under STR-07 (North Fork Obion River) bridge.			
Photograph ID: 374

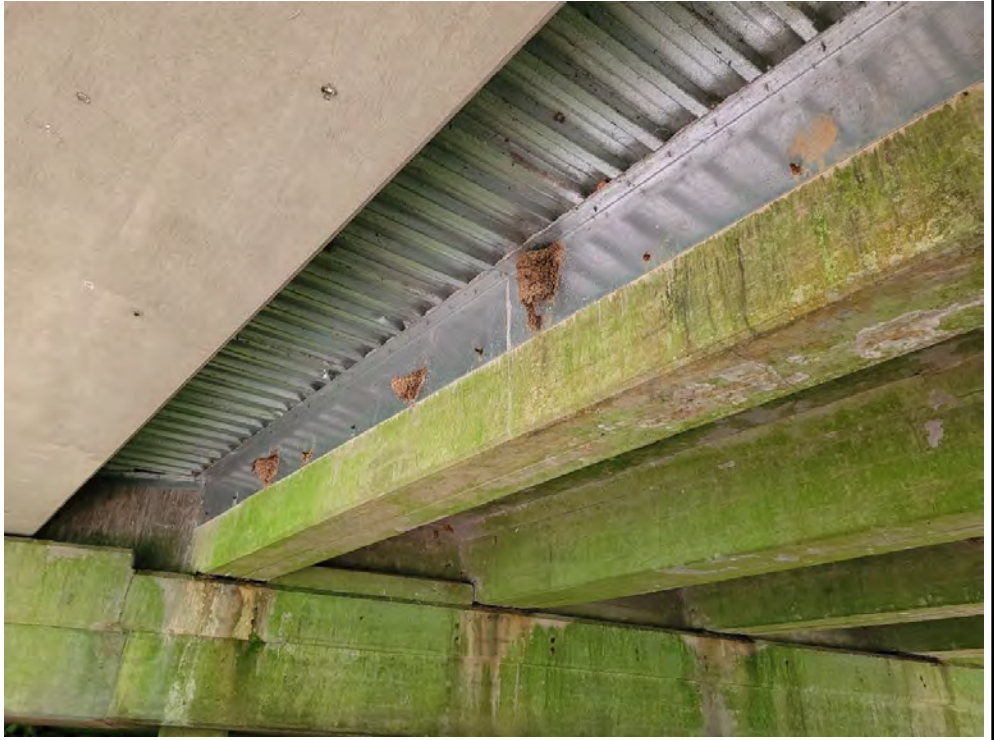
Photo Location: STR-07			
Direction: North northeast			
Survey Date: 5/17/2021			
Comments: Swallow nests under STR-07 (North Fork Obion River) bridge.

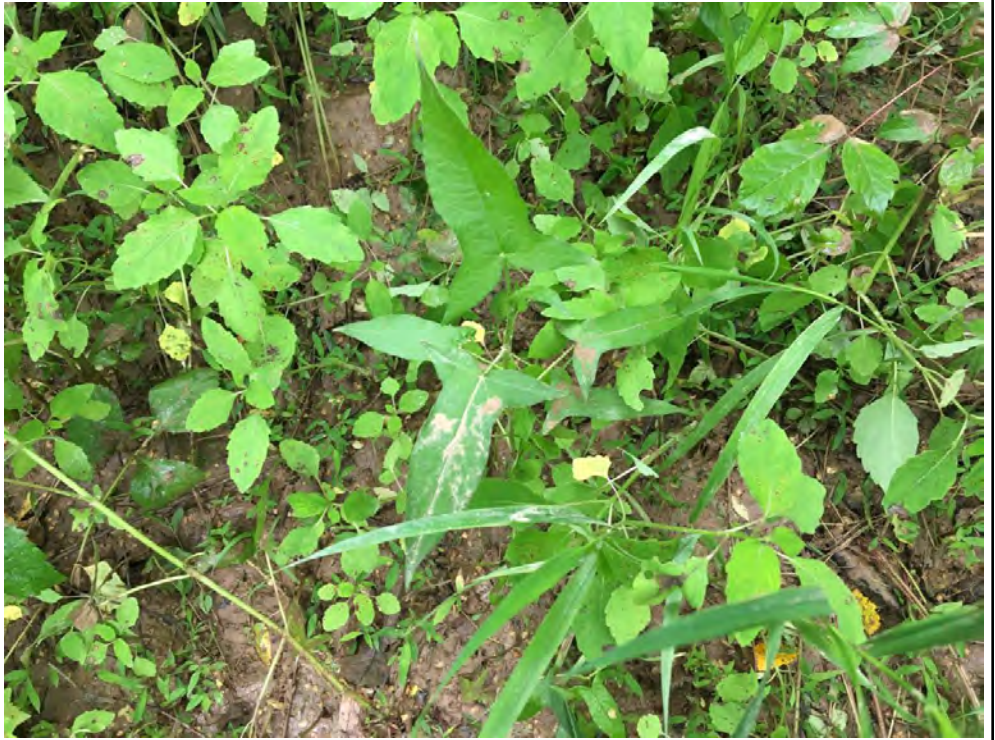
Photo Location: WTL-10			
Direction: East northeast			
Survey Date: 5/18/2021			
Comments: Halberd-leaf tearthumb (Polygonum arifolium) within WTL-10.			
Photograph ID: 376

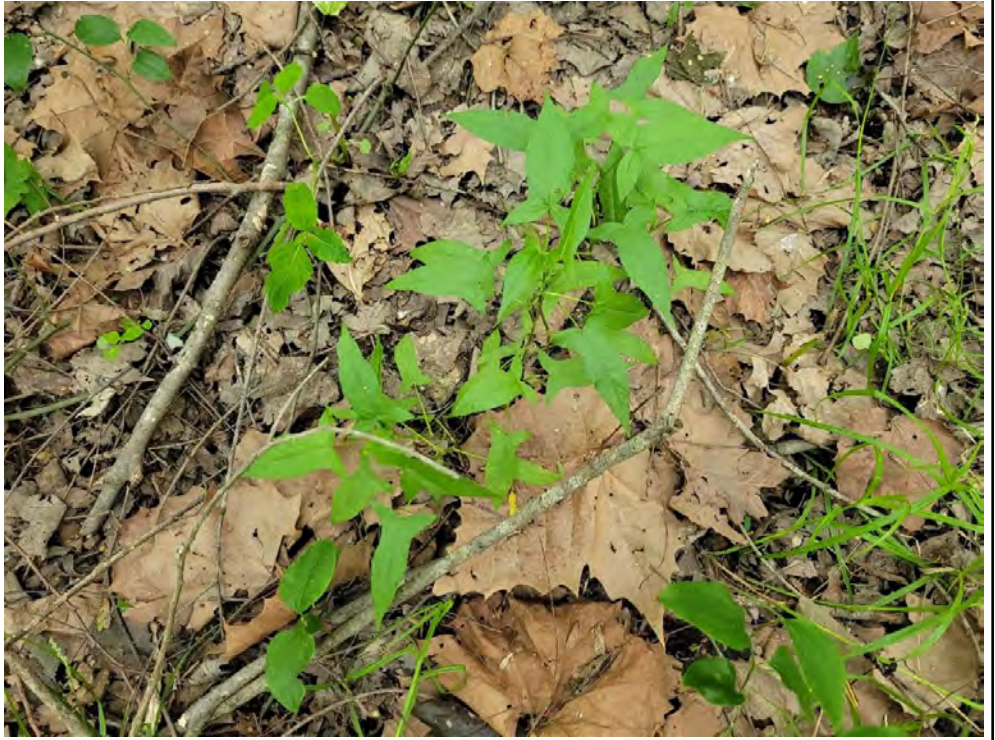
Photo Location: WTL-11			
Direction: Northeast			
Survey Date: 5/17/2021			
Comments: Halberd-leaf tearthumb (Polygonum arifolium) within WTL-11.

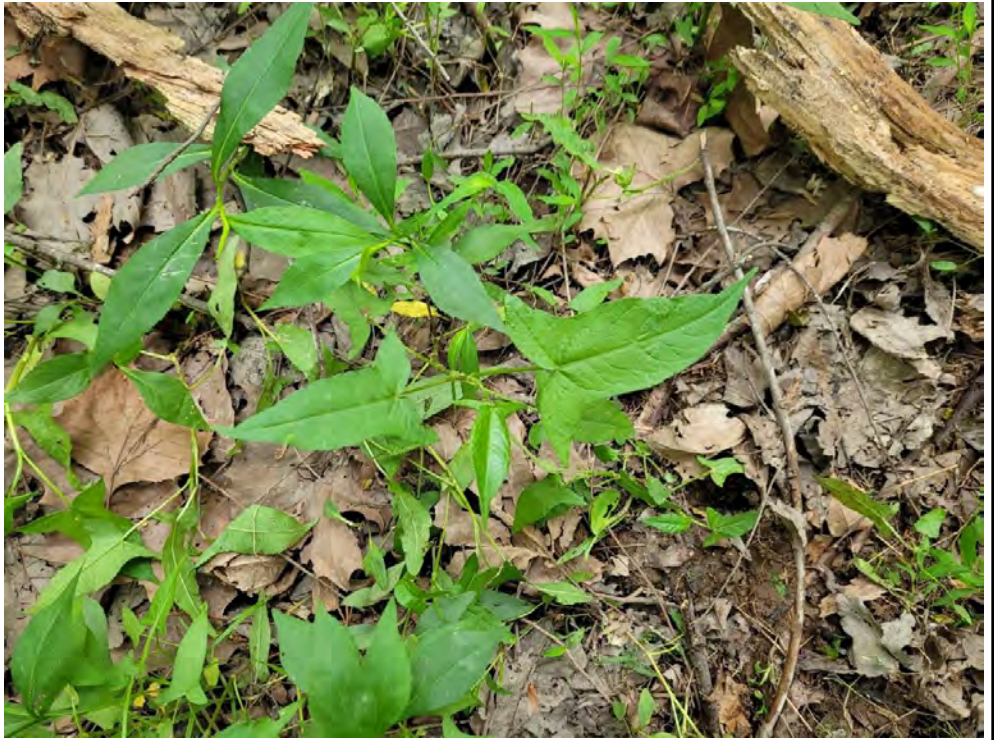
Photo Location: WTL-11			
Direction: Northeast			
Survey Date: 5/17/2021			
Comments: Halberd-leaf tearthumb (Polygonum arifolium) within WTL-11.			
Photograph ID: 378

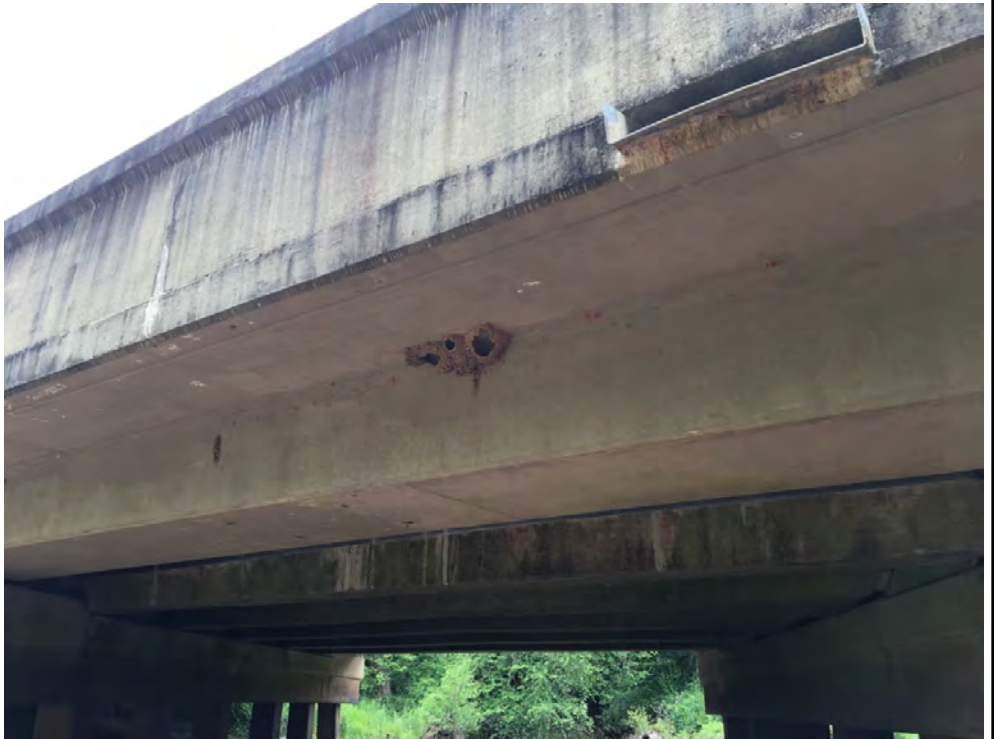
Photo Location: STR-12			
Direction: East northeast			
Survey Date: 5/19/2021			
Comments: Cliff swallow nests under STR-12 (Rowe Creek) bridge.

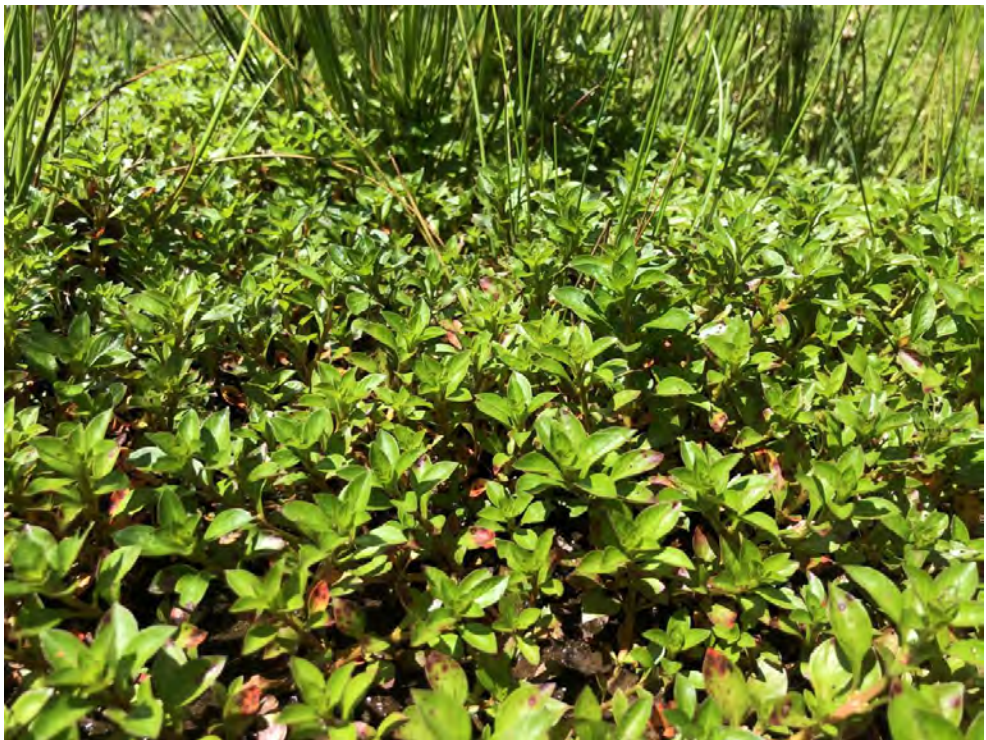
Photo Location: WTL-27			
Direction: North northeast			
Survey Date: 5/20/2021			
Comments: Water purslane (Didiplis diandra) within WTL-27.			
Photograph ID: 380

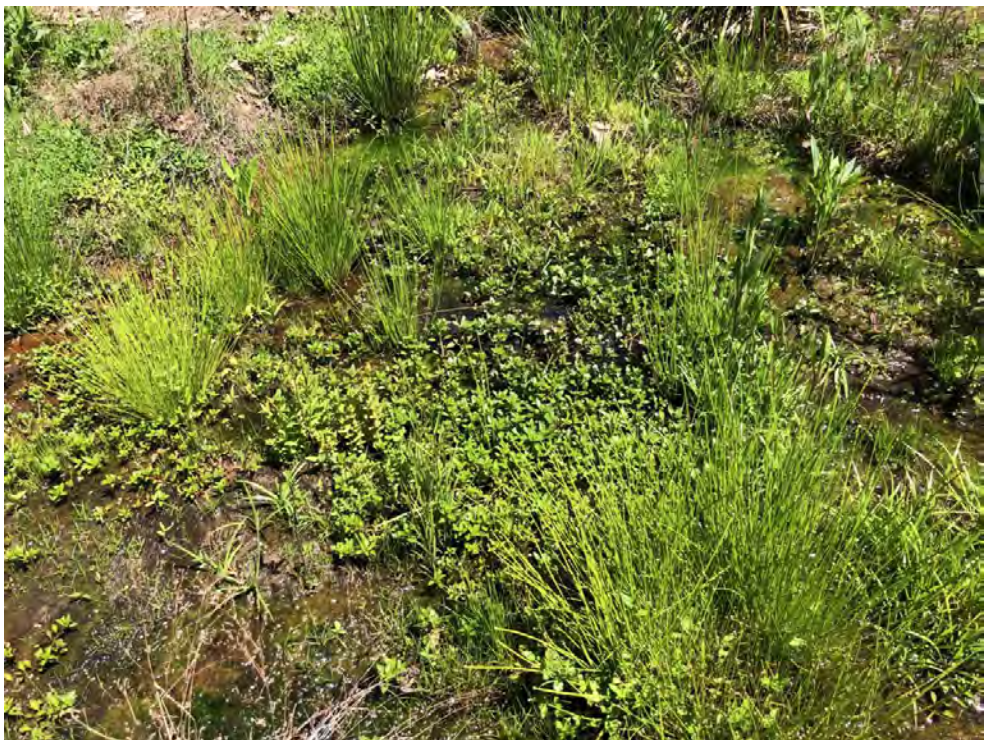
Photo Location: WTL-27			
Direction: South southeast			
Survey Date: 5/20/2021			
Comments: Water purslane (Didiplis diandra) within WTL-27.

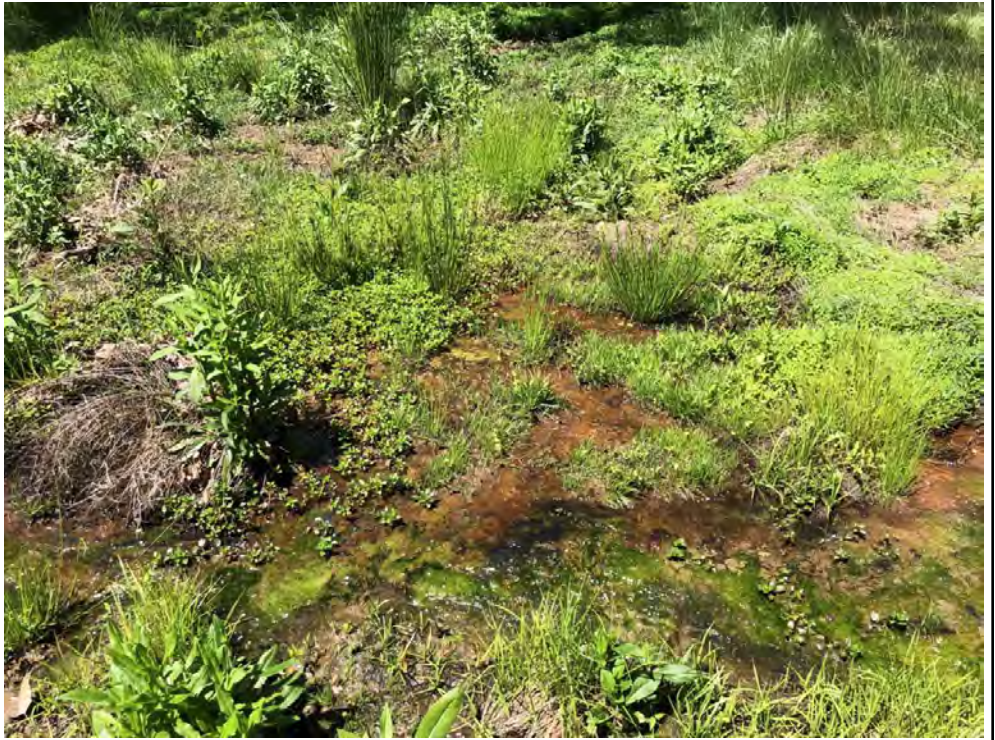
Photo Location: WTL-27			
Direction: North northeast			
Survey Date: 5/20/2021			
Comments: Water purslane (Didiplis diandra) within WTL-27.			
Photograph ID: 382

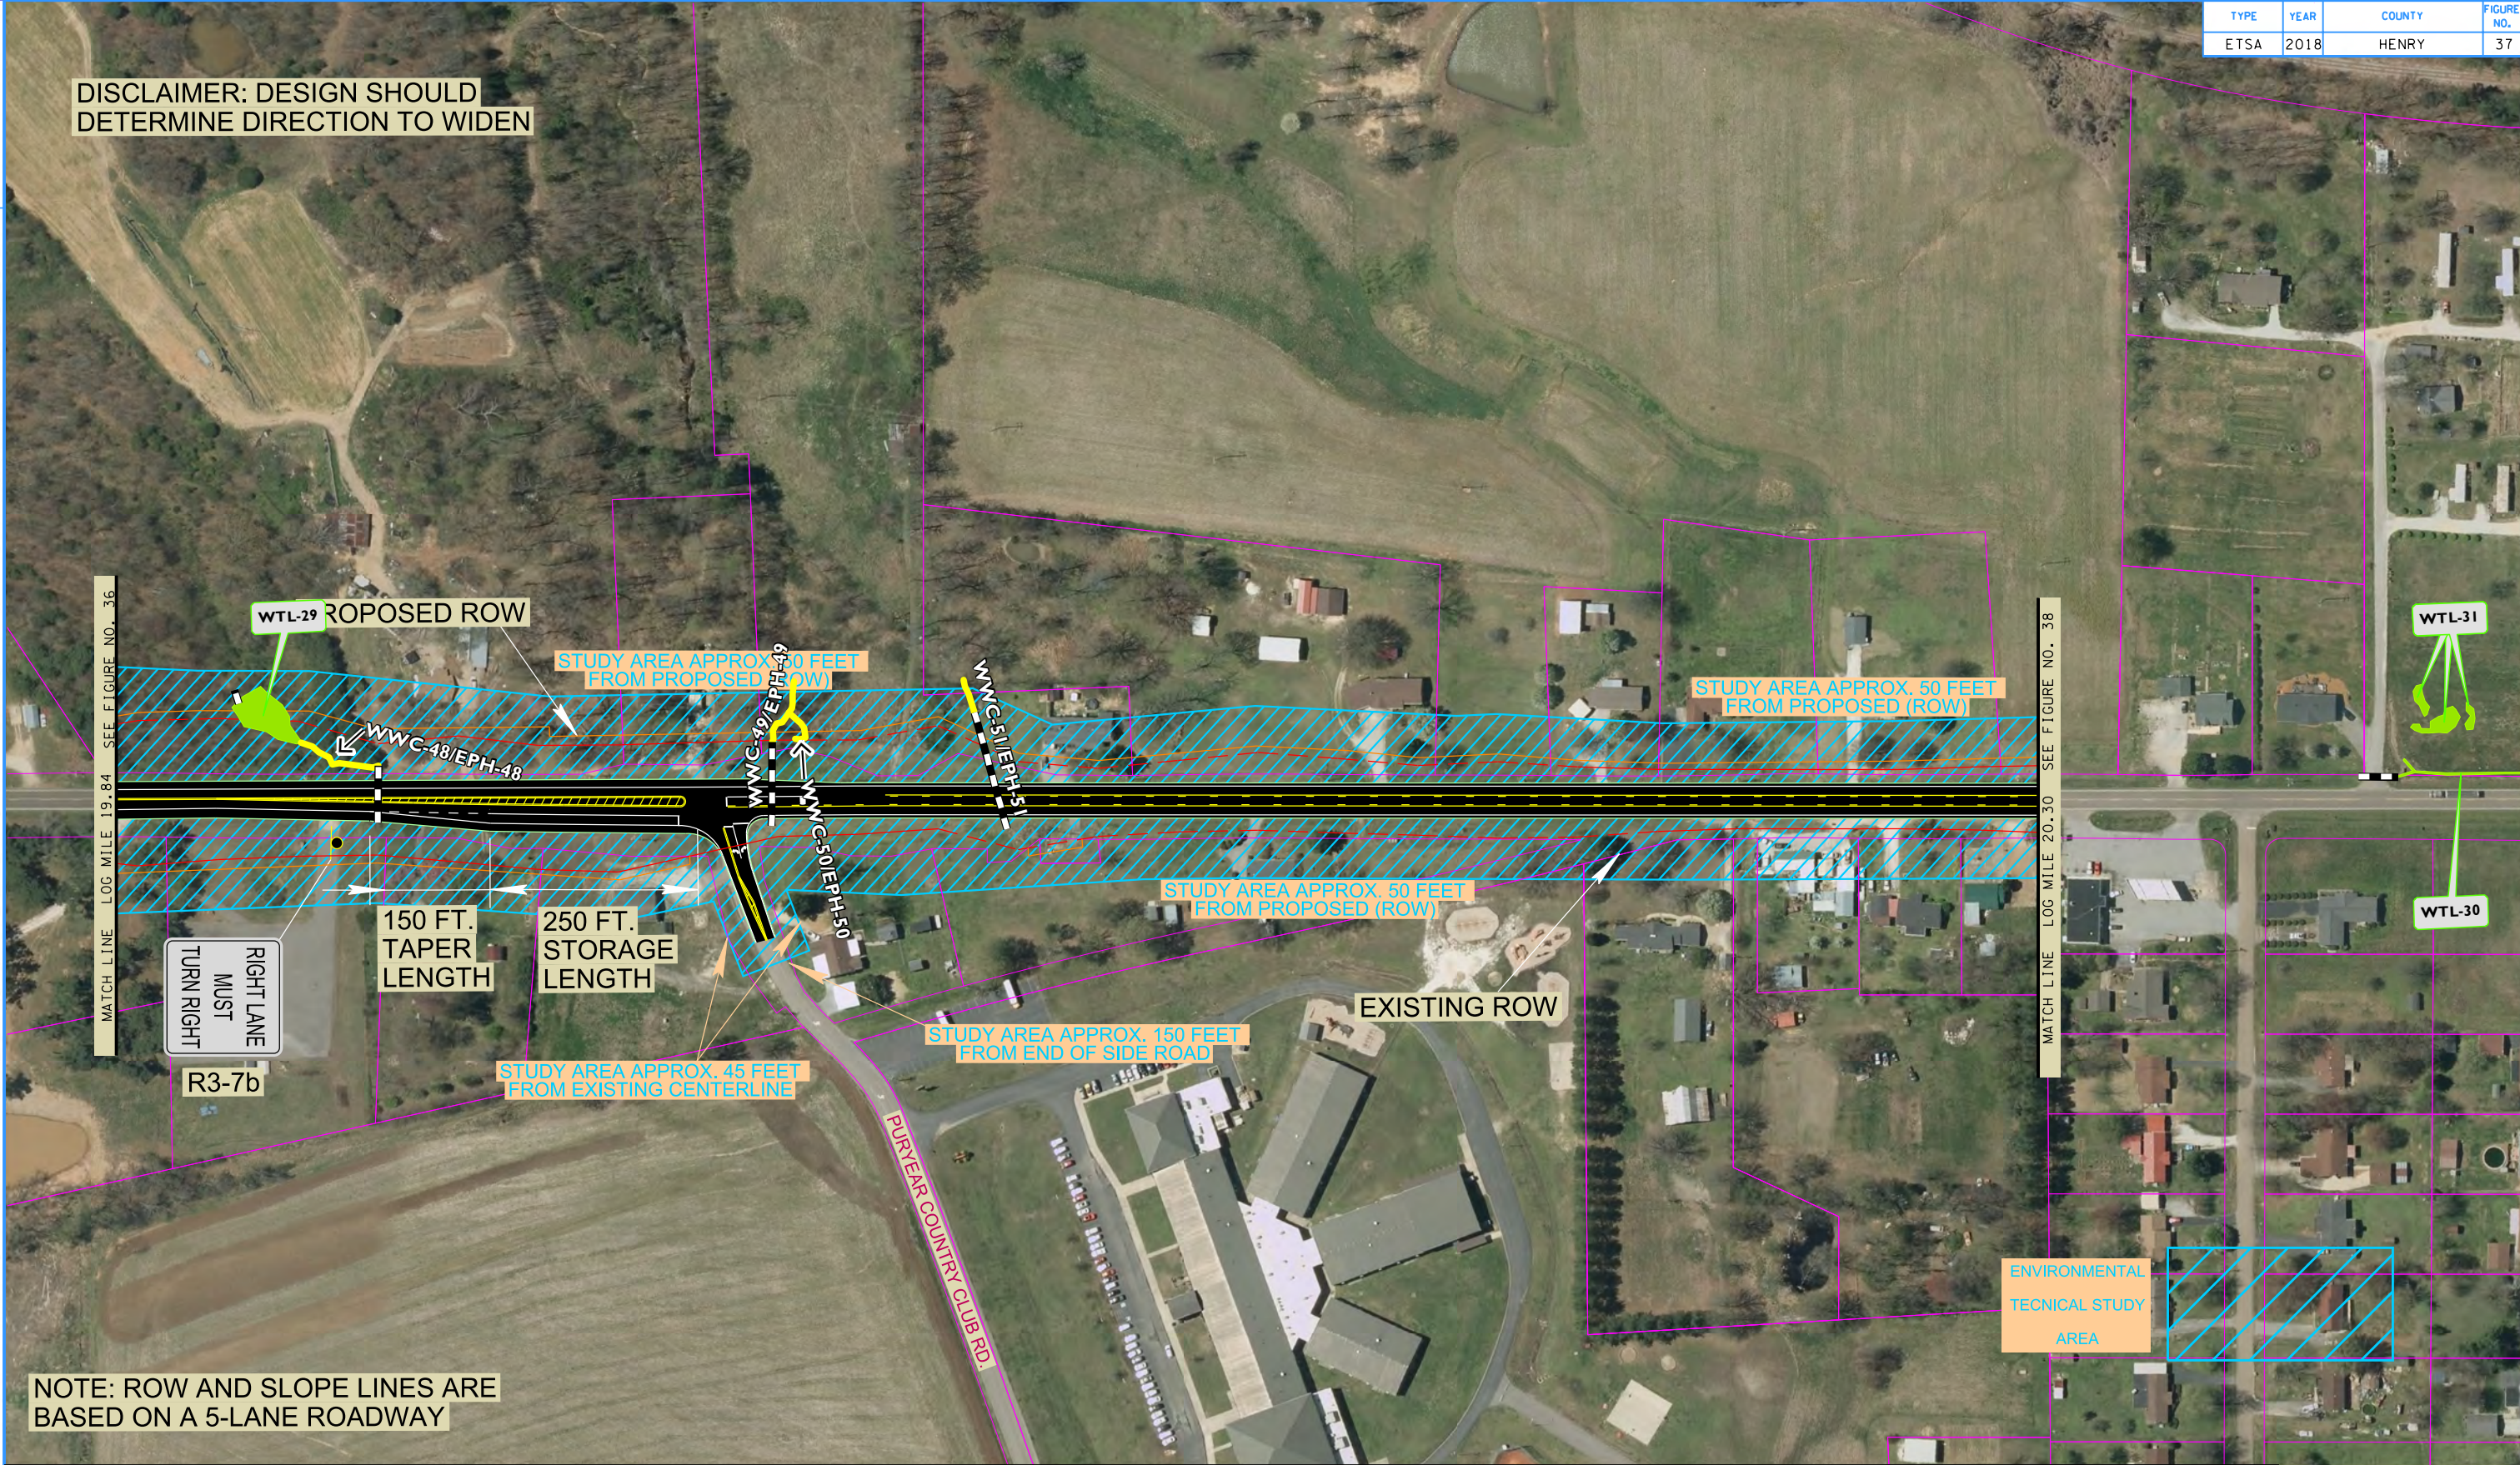
FIGURE 37
S.R. 54
L.M. 19.84 to
L.M. 20.30

ENVIRONMENTAL TECHNICAL STUDY AREA

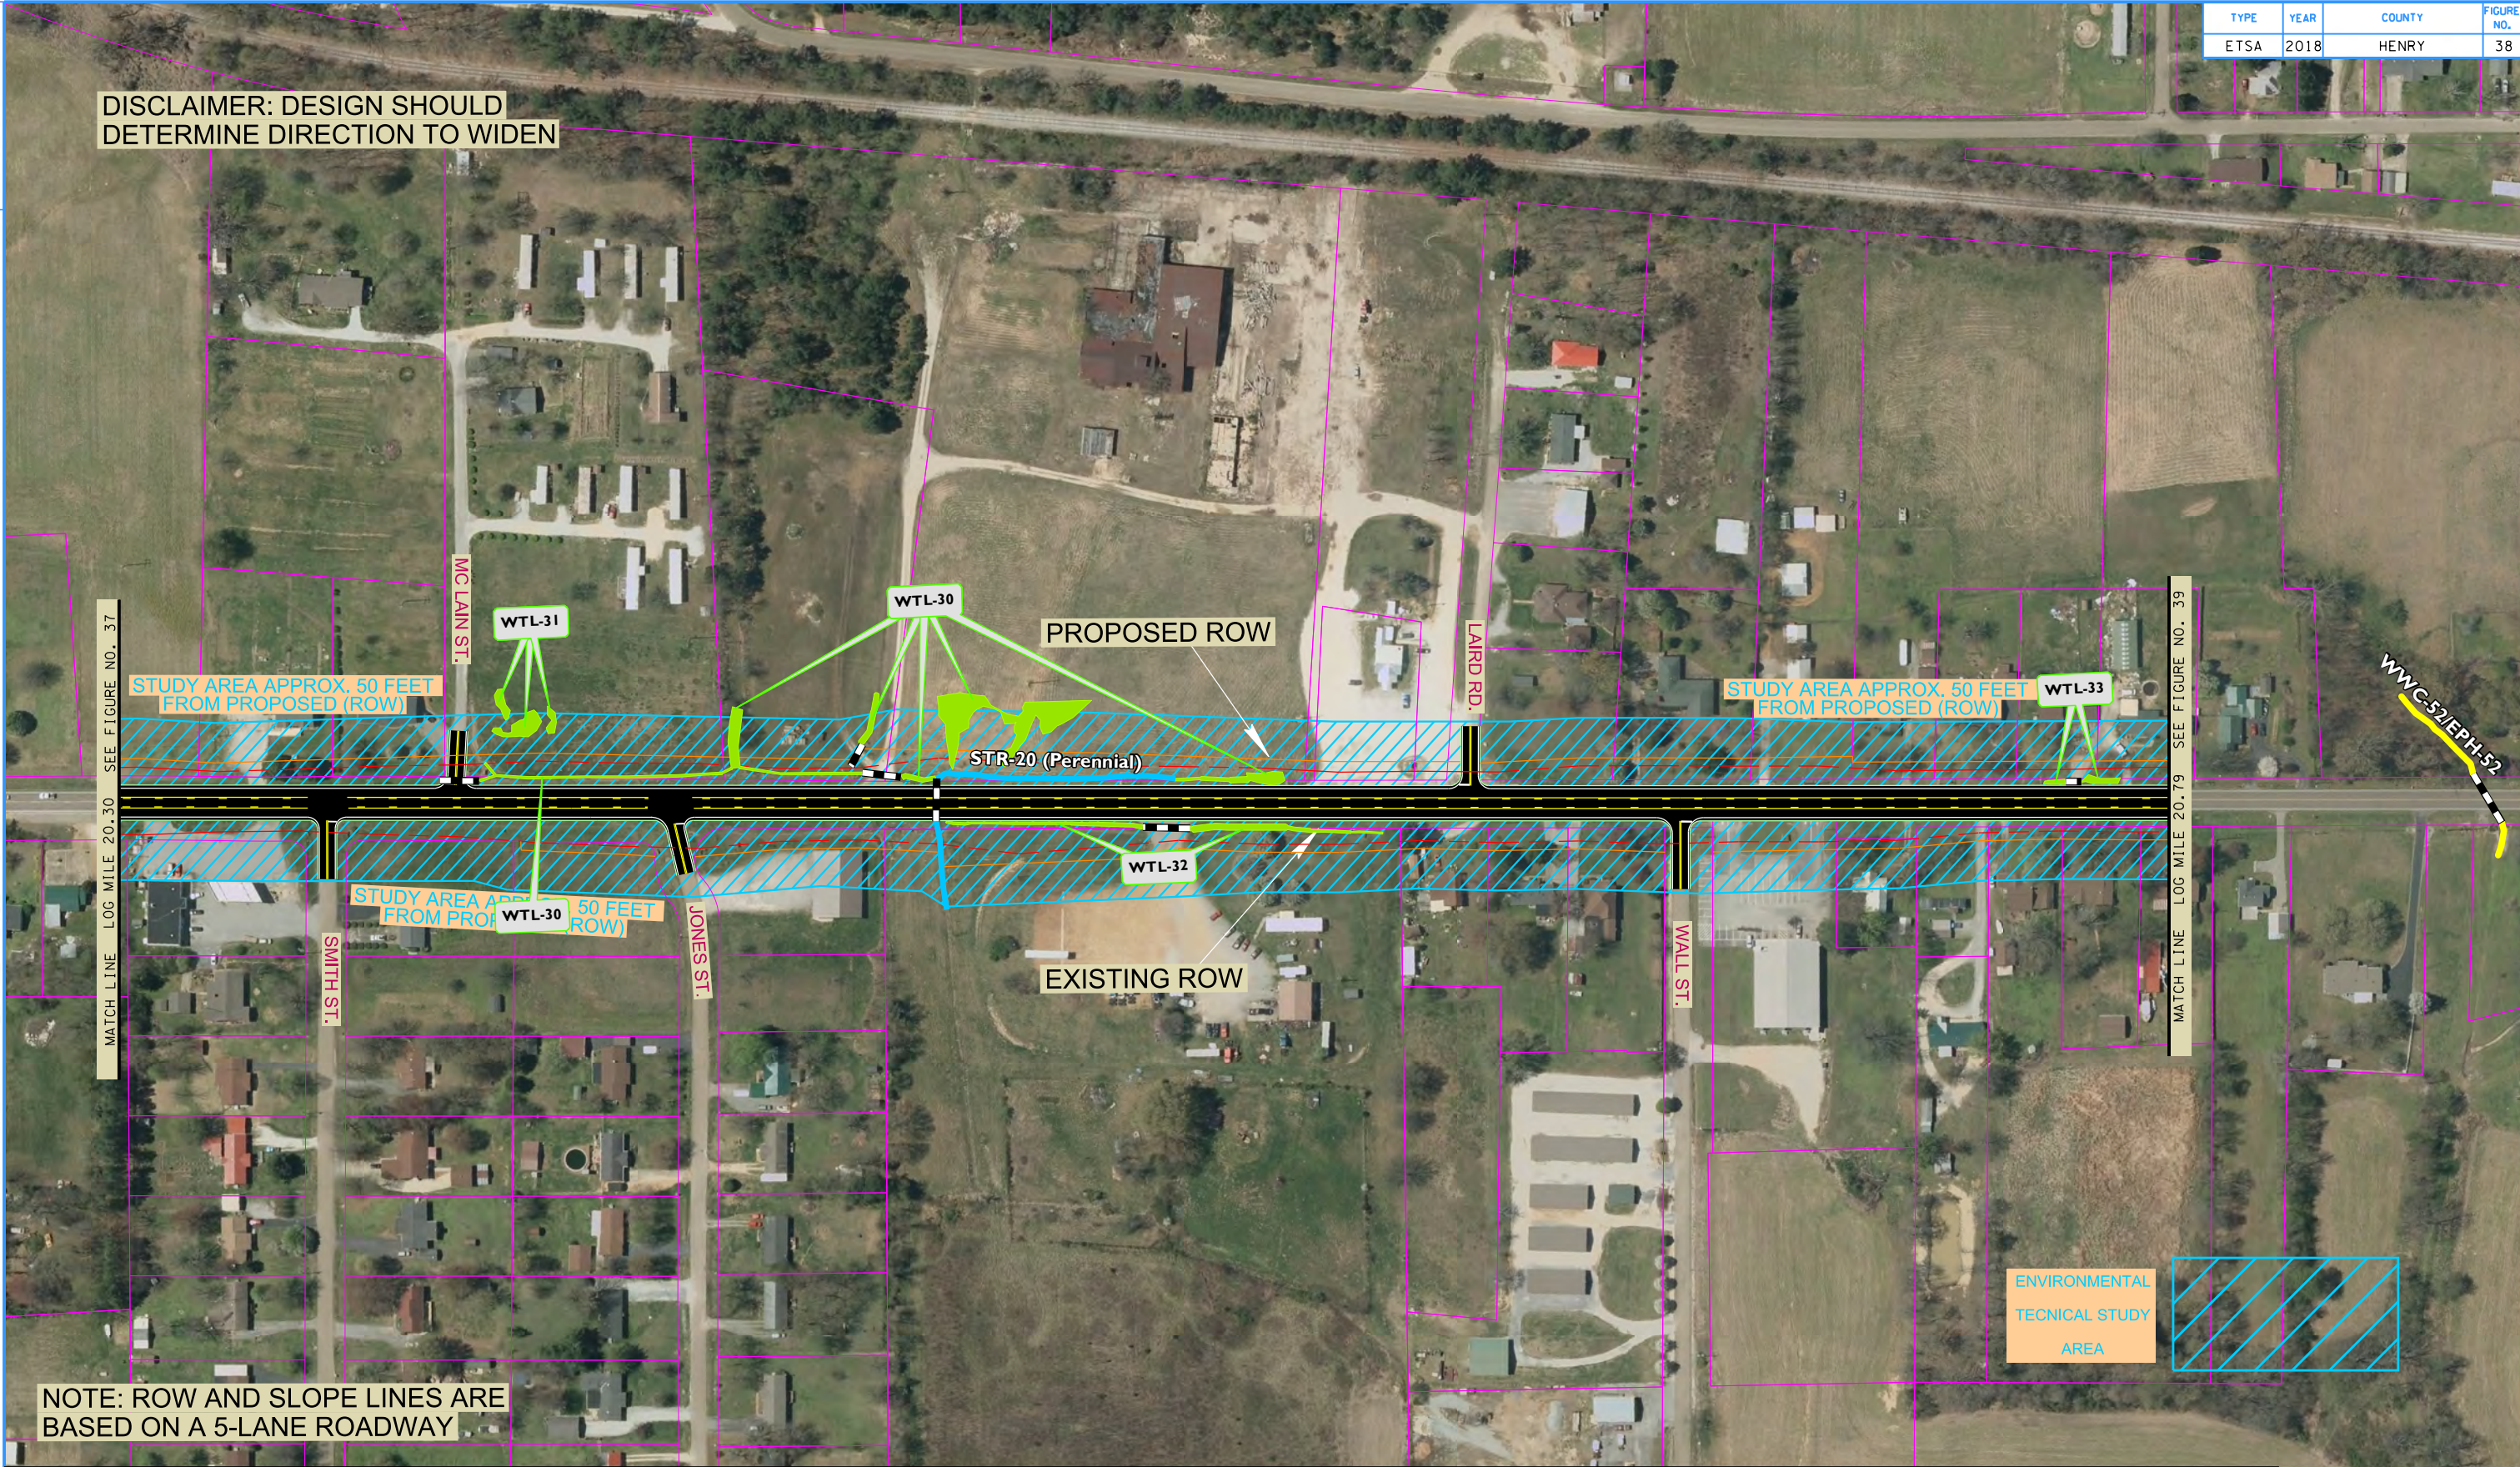
FIGURE 38
S.R. 54
L.M. 20.30 to
L.M. 20.79

ENVIRONMENTAL TECHNICAL STUDY AREA
