Right-of-Way Reevaluation, State Route 54 (US Highway 641), From State Route 69 (Wood Street) in Paris to Crossland Road/Brannon Lane (North of Puryear), Henry County, Tennessee, PIN 101886.00, Federal Project No. NH-54(26), State Project No. 40003-1213-14

Date: 05/19/2022

Environmental Commitments

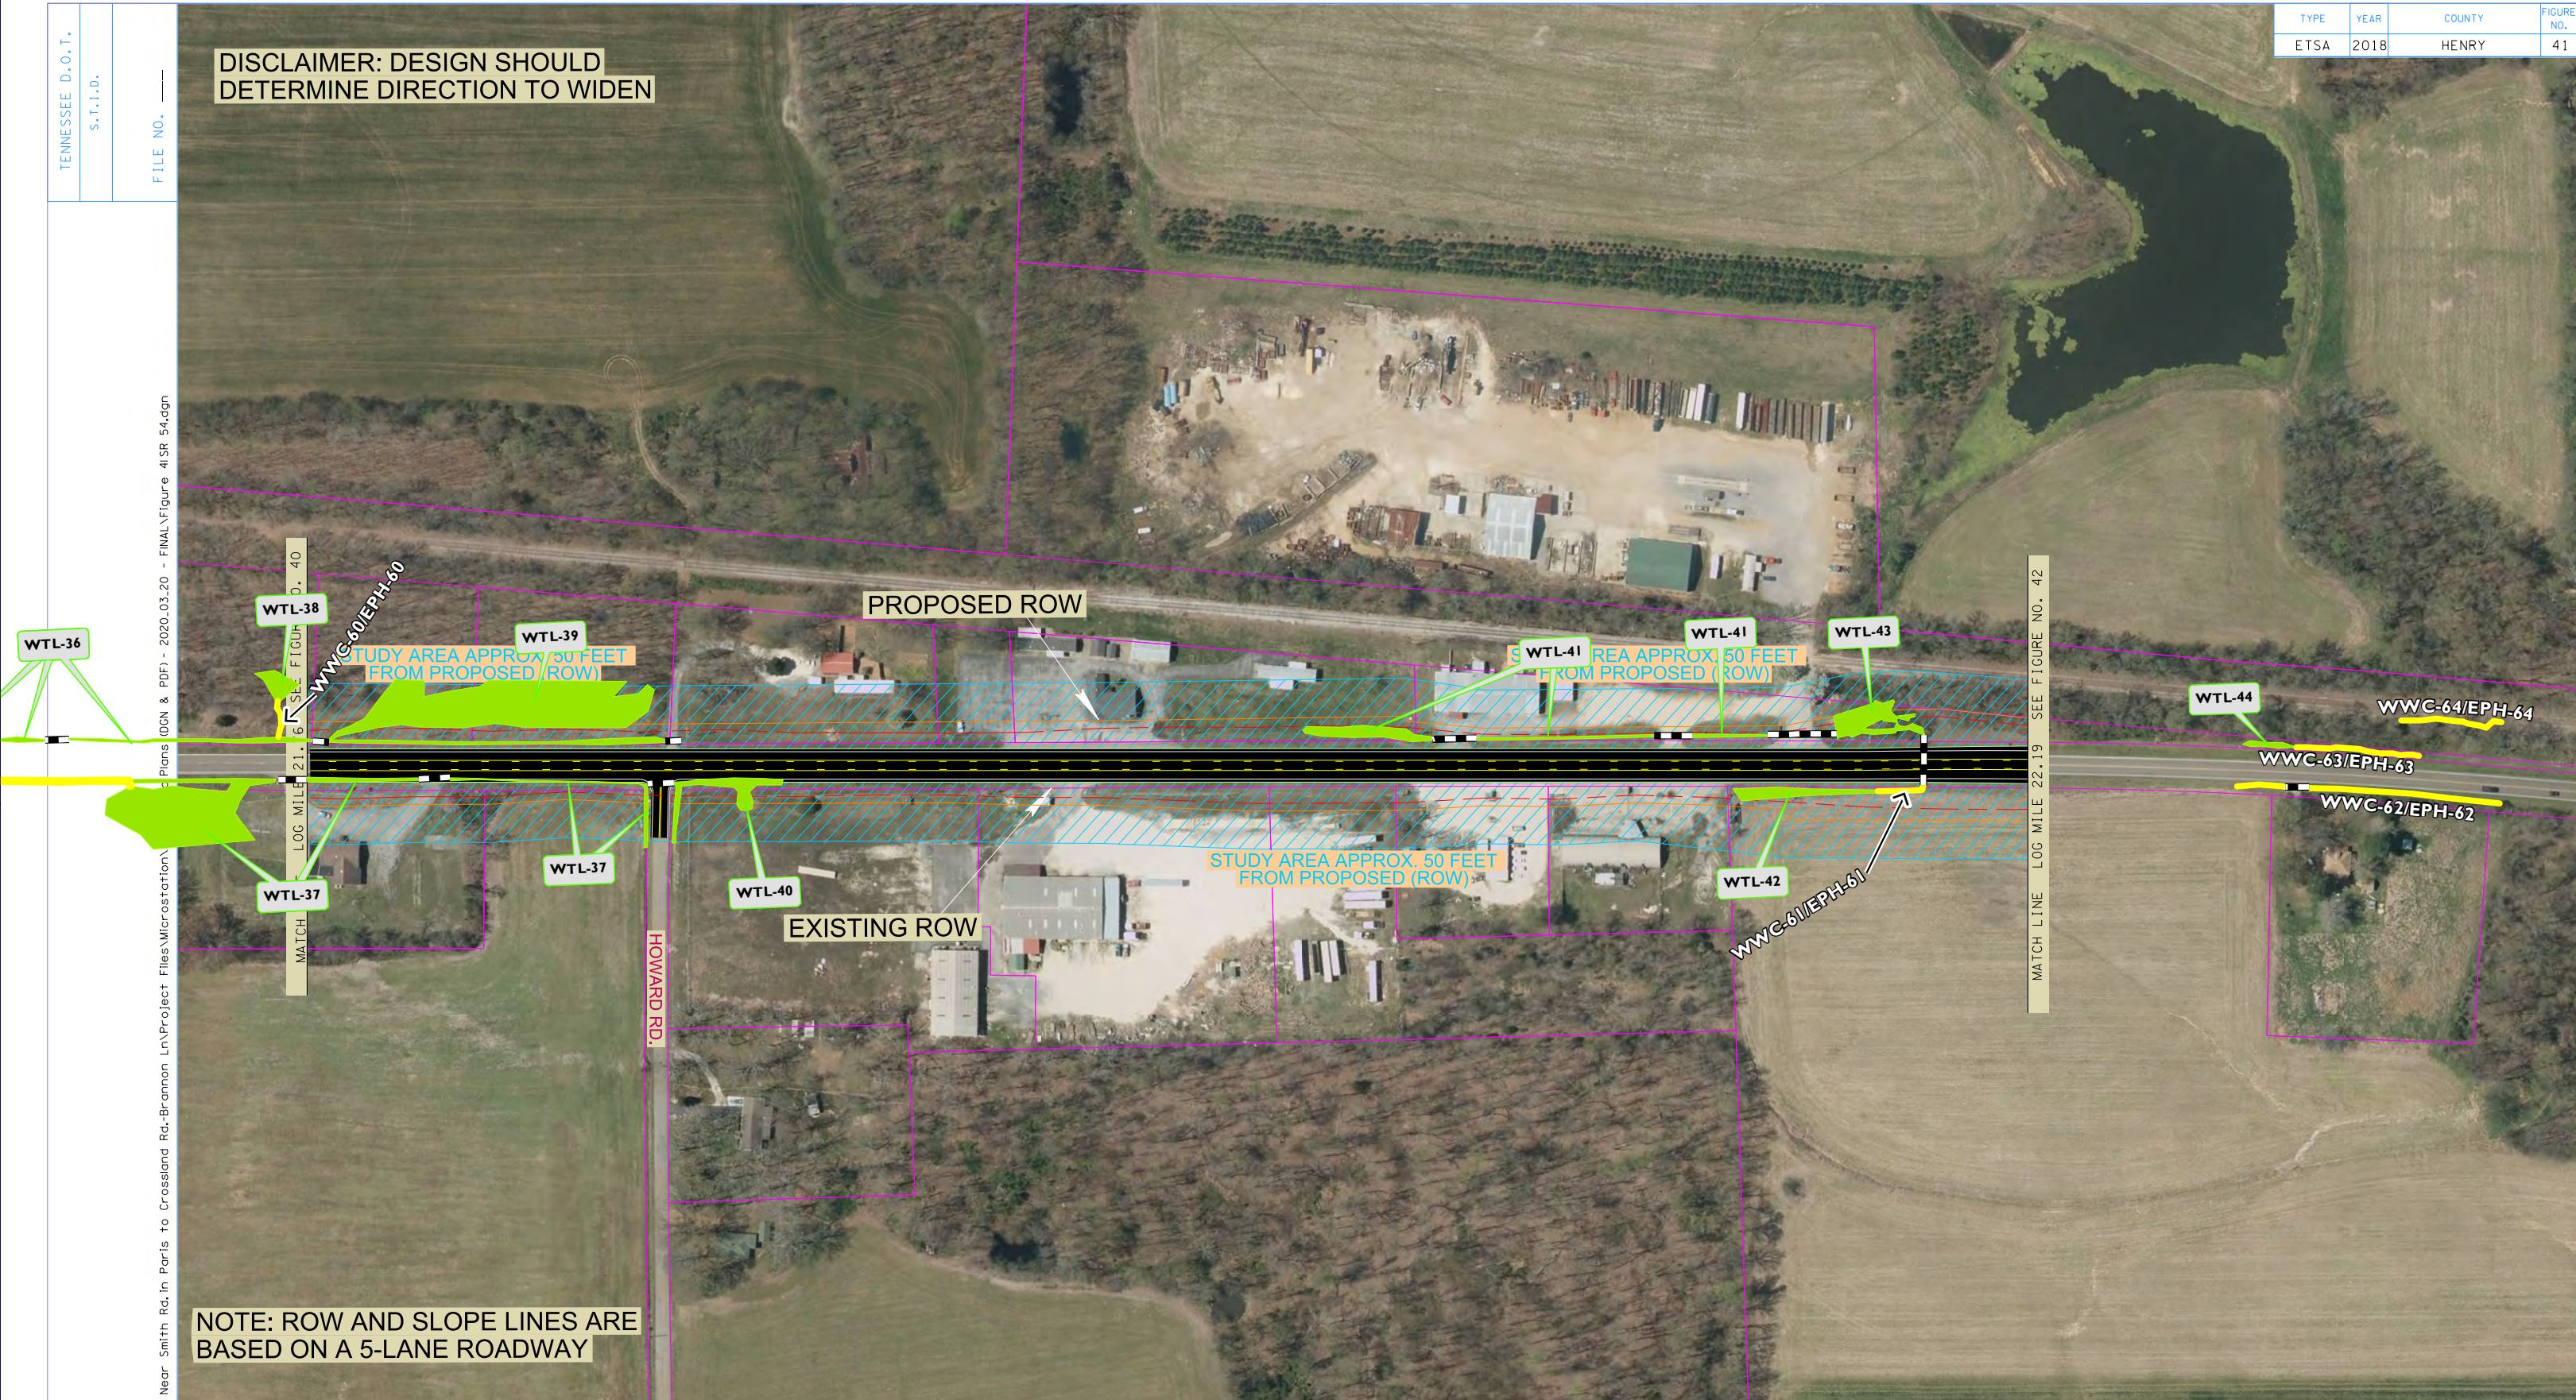
DISCLAIMER: DESIGN SHOULD DETERMINE DIRECTION TO WIDEN

NOTE: ROW AND SLOPE LINES ARE BASED ON A 5-LANE ROADWAY

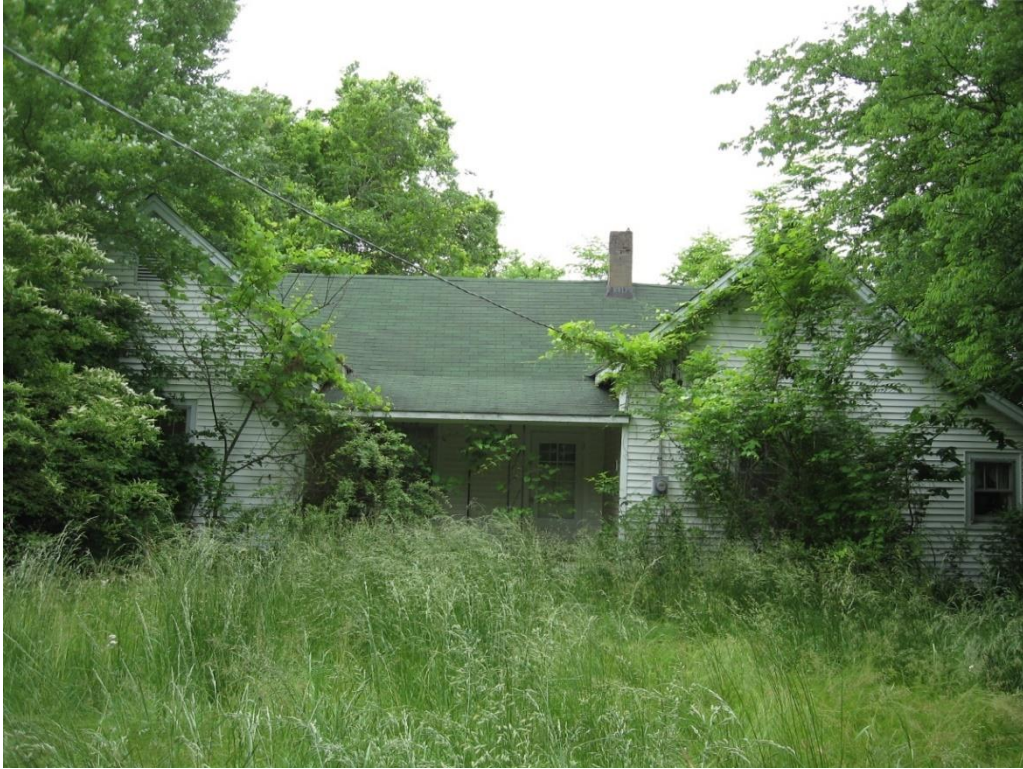
Figure 94: TA-5, view north.

Built ca. 1940, this dwelling has two projecting bays on the main façade divided by an incised porch. This is a variation of a vernacular gabled ell dwelling of the early 20th century. The house has added vinyl siding but retains other features. No historical information was obtained for this property but it appears to have been part of a farm which presently consists of 132 acres. The outbuildings associated with the dwelling are common forms of the mid-20th century. In the opinion of the Consultant, this property does not possess sufficient historical or architectural significance to meet National Register criteria.

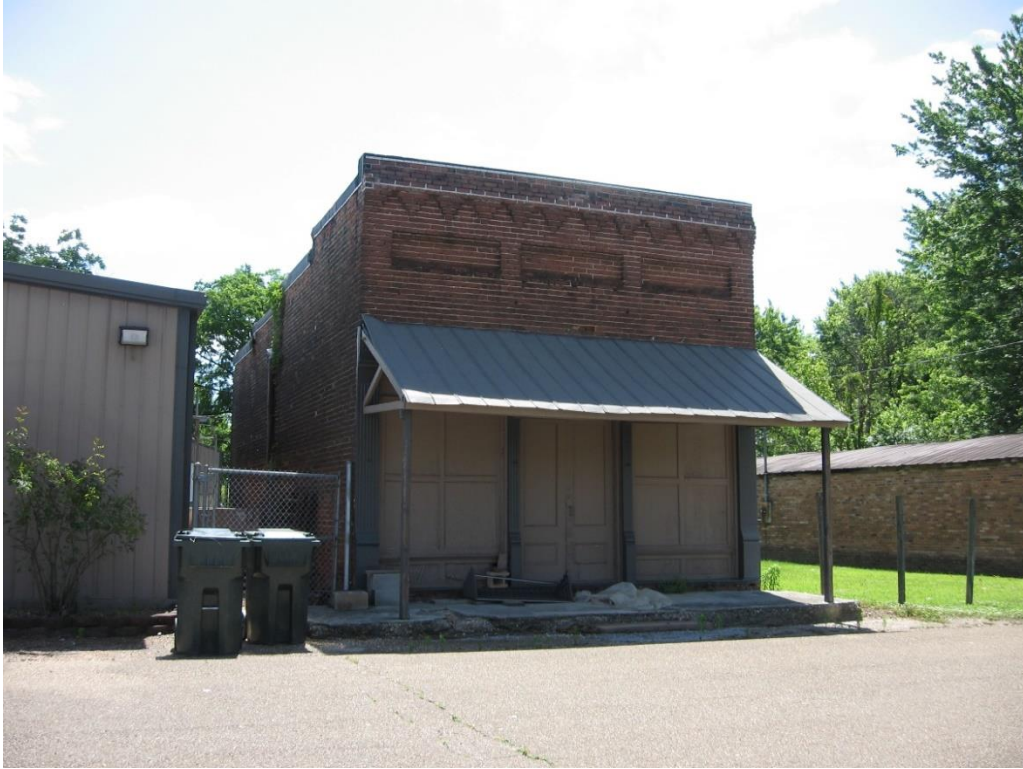
Figure 101: TA-6, view southeast.

Built ca. 1910, this is the only early 20th century commercial building surviving on the east side of the railroad tracks in Puryear. It retains much of its original design but the glass in the storefront has been removed and replaced with plywood. In the opinion of the Consultant, the building lacks sufficient architectural significance and integrity to be National Register-eligible. The building is separated from the potentially eligible Puryear Commercial Historic District due to the intervening railroad tracks and distance.

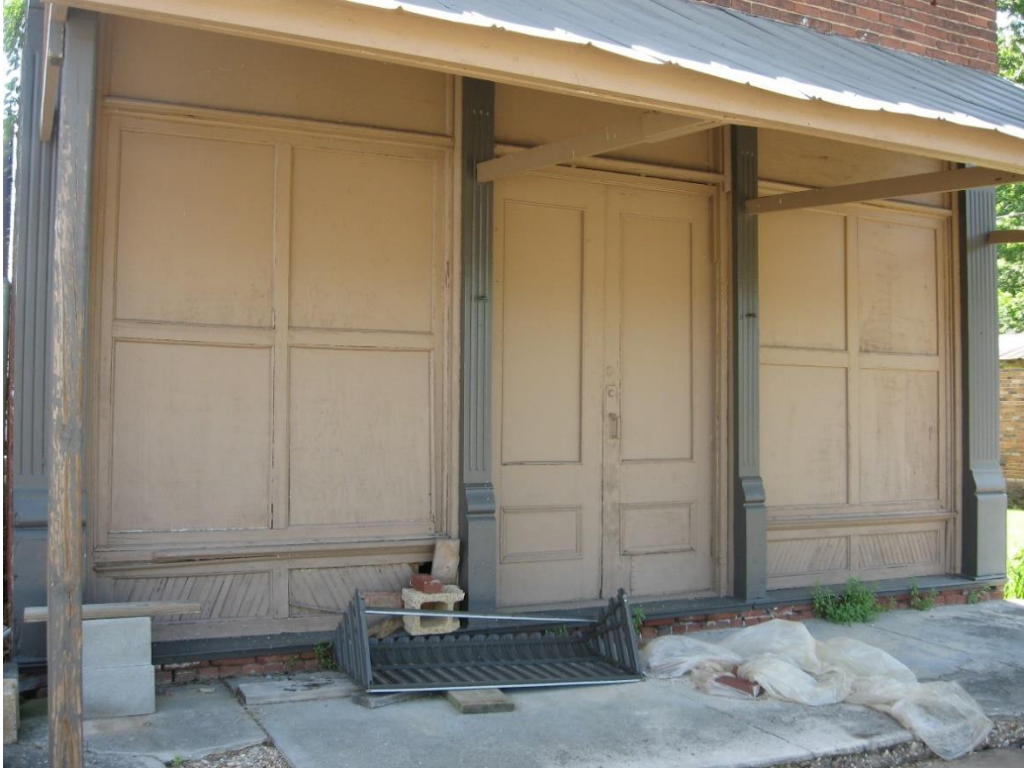
Figure 103: TA-6, storefront.

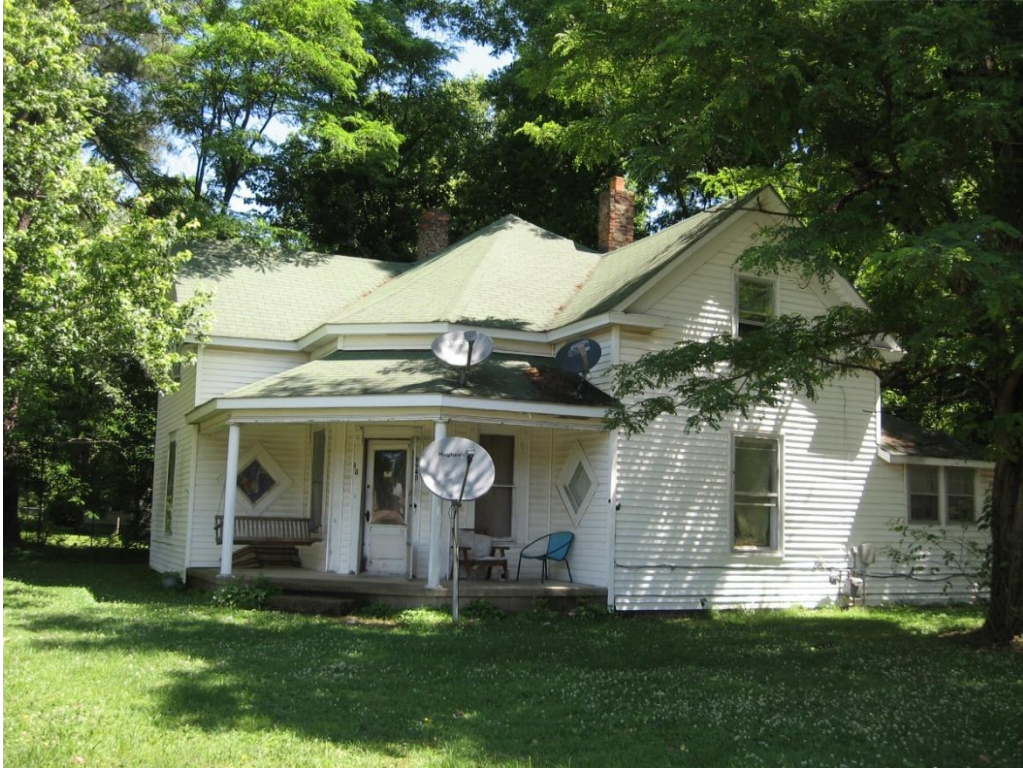
Figure 104: TA-7, view north.

This is a ca. 1910 one-and-one-half-story, frame, Folk Victorian dwelling with a gable and hip roof of asphalt shingles, an exterior of vinyl siding, and a concrete block foundation. The plan is asymmetrical, consisting of a hipped-roof center with projecting gabled wings to the south and west. The main entrance is in the middle section and has an original single-light, single-panel, wood door. A curved porch spans between the two gabled wings and has two ca. 2010 fluted aluminum posts. Original one-over-one, wood-sash windows flank the door. There is a diamond-light, fixed window in the side wall of each gabled wing. On the dominant elevation of each a gabled wing there is a one-over-one, wood-sash window on the ground floor and the upper half floor. The dwelling has interior, brick chimneys. On the east elevation of the dwelling there is a one-story hipped-roof wing with three small, six-over-six, wood-sash windows and a secondary entrance with a nine-light wood door. Over the door is a frame canopy with knee brace brackets.

When this property was assessed in 2003 the TDOT determined that the property did not possess sufficient architectural significance and integrity to meet National Register criteria. Since the original survey the original wood porch columns have been replaced with aluminum posts. The Consultant concurs with the original assessment of non-eligibility for this property.

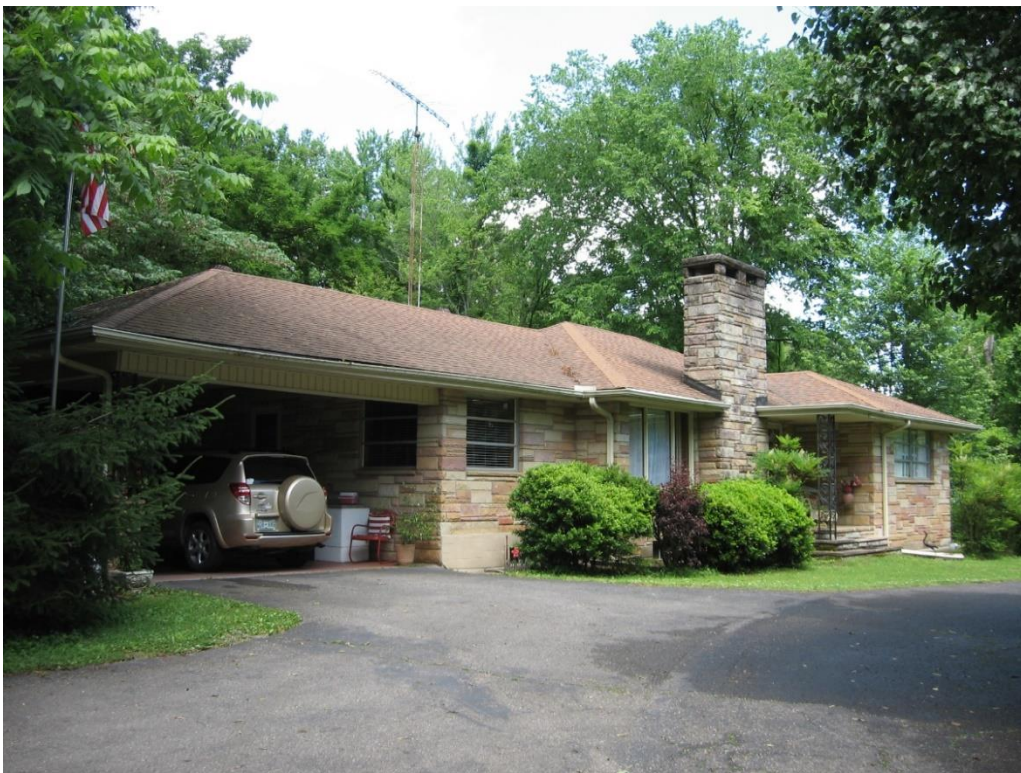
Figure 109: TA-8, view northwest.

This is a cross-hipped Ranch-style dwelling with a three-part hip roof of asphalt shingles, an exterior of stone veneer, and a slab concrete foundation. The exterior of the dwelling has a chimney of Bedford limestone and an overall veneer of Crab Orchard stone. The façade (E) is asymmetrical with an integral carport at the south bay and a slightly projecting central section with three fixed, single-light, vertical, wood windows. At the entrance is an incised entry porch with a wrought iron column. The façade has a prominent exterior wall stone chimney, and a projecting bay at the north elevation. Windows are original tri-part horizontal jalousie aluminum design. The rear elevation has similar windows.

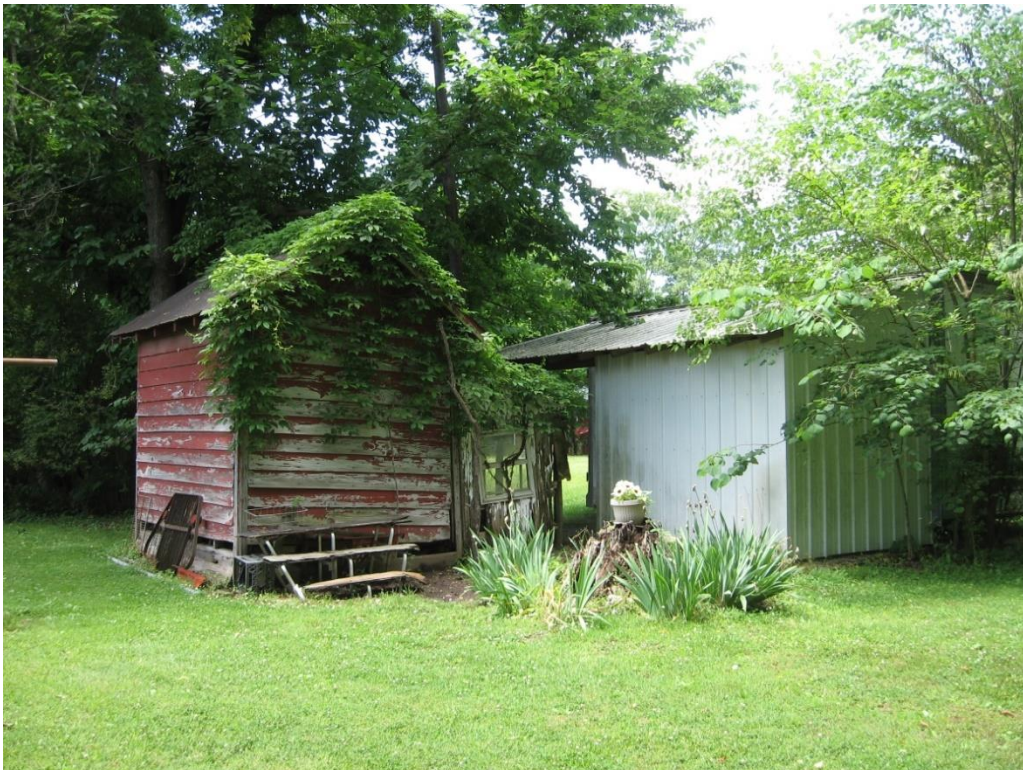
The property has two frame outbuildings with metal roofs; a ca. 1955 wood shed with weatherboard siding and a ca. 1990 metal shed.

Figure 113: TA-8 outbuildings, view south.

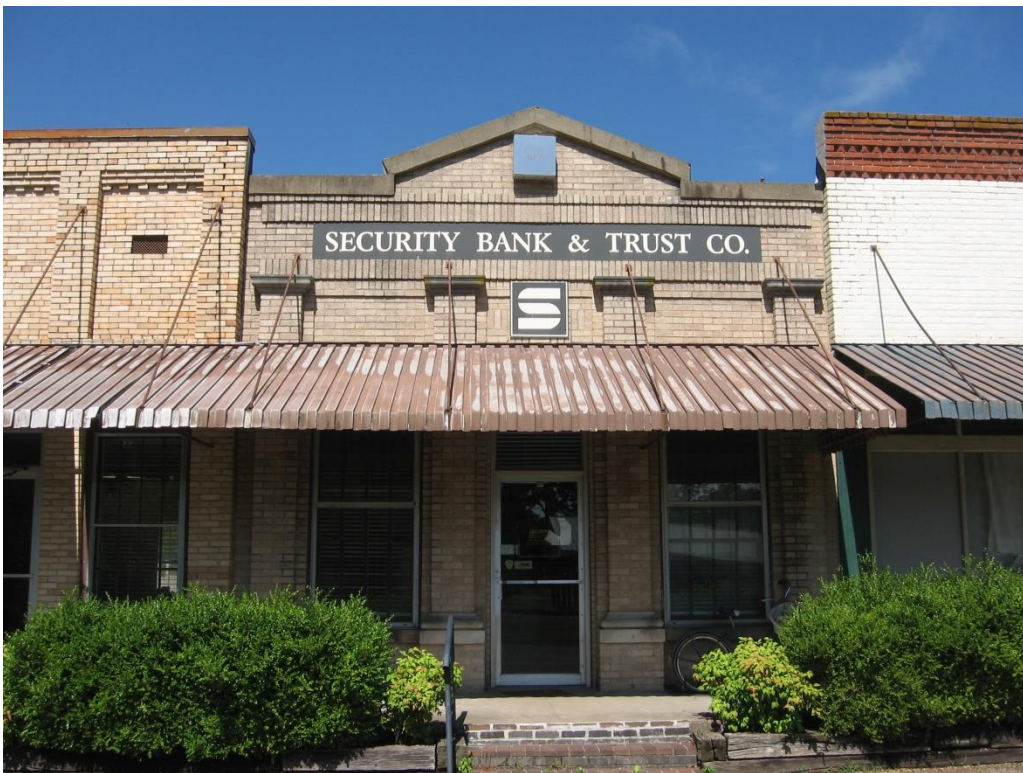
Figure 120: 110 S. Front Street, view W.

110 S. Front Street: One-Part Commercial Block building designed with Neo-classical influences and built in 1923 as the Farmers Bank. The storefront has a ca. 1970 aluminum and glass door, original sixteen-light display windows, and brick bulkheads. The door and window bays are divided by brick pilasters with concrete Doric capitals. The upper façade has a corbelled brick panels and a stepped parapet at the roofline. Across the width of the storefront is a ca. 1960 metal canopy.

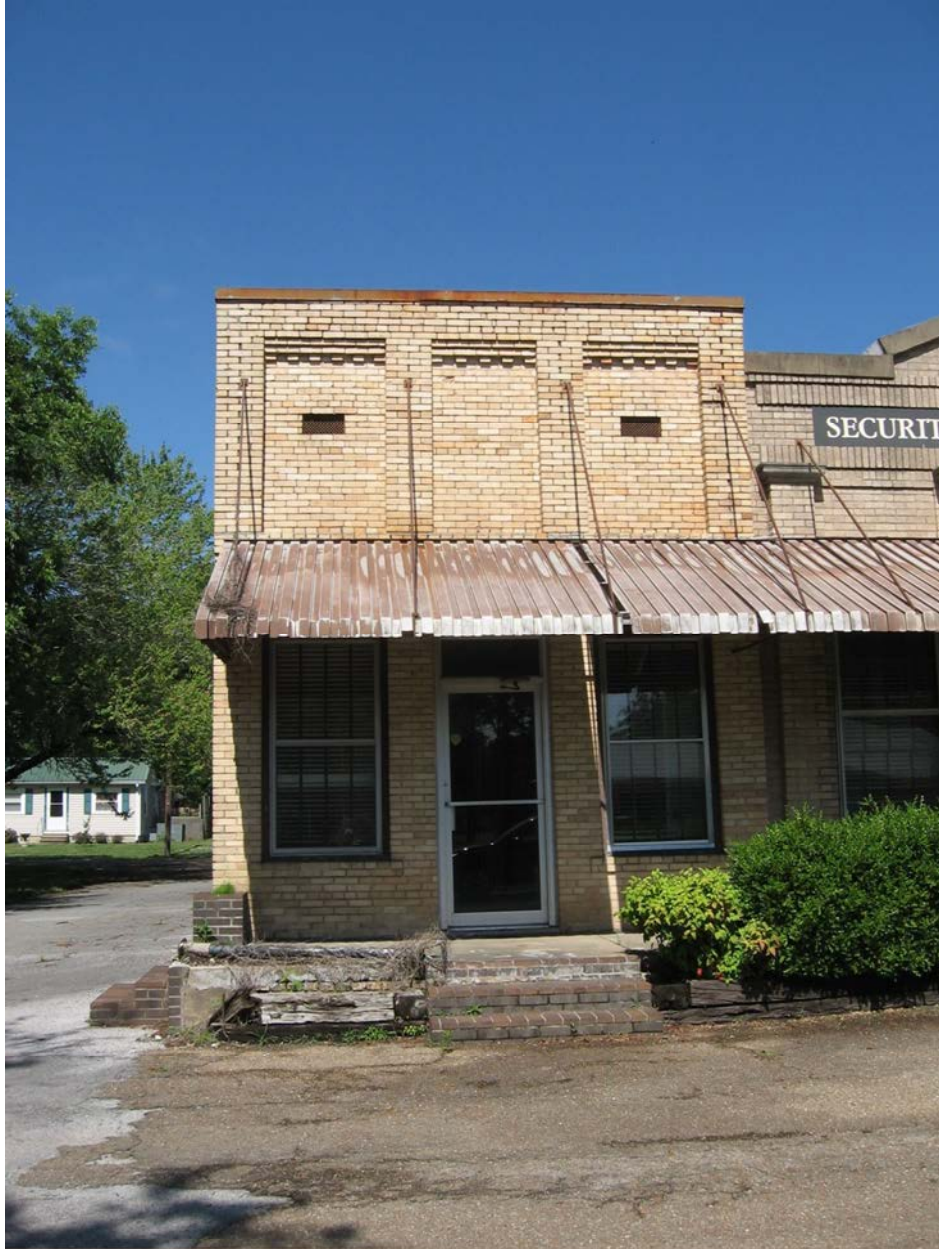
Figure 121: 112 S. Front Street, view W.

112 S. Front Street: One-Part Commercial Block building built in 1923. The storefront has a ca. 1970 aluminum and glass door flanked by original sixteen-light display windows which rest on brick bulkheads. The doors and windows are set within two-course brick arches. Across the width of the storefront is a ca. 1960 metal canopy. The upper façade has three recessed panels divided by brick pilasters. The panels have corbelled brick and at the roofline is a flat parapet.
