## 11 Chemical overexposure – Inspection #1302266

A **38 year old male** employee was fatally injured when he became **exposed to an oxygen deficient atmosphere**. The victim, a Stage Technician, was an employee of a live show theater company and was responsible for venting cold liquid carbon dioxide (fog) onto the stage. The CO2 would give a large cloud to mask the actor being lowered through the stage, on a device called a toaster/actor stage lift, to the basement below. As it became time for the fog effect on stage, the stage Manager missed the cue, and the victim was not responding on the radio when the Stage Manager called for him. At this point, another employee was instructed by the Stage Manager to go down into the basement to get the victim. When the employee went into the basement, he found the victim convulsing down on the ground near the back of the basement next to the toaster/actor stage lift. Three employees were taken to the hospital; two employees were released early the next morning and the victim was admitted and died four days later.

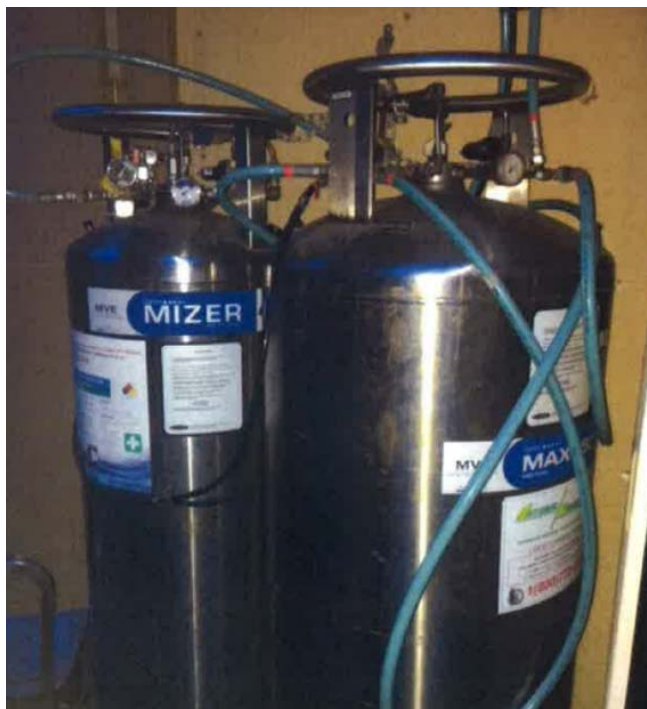
Photo 2 of 3 – Shows the two high flow bulk CO2 tanks. The CO2 is used to keep the fog cold so it will last longer. The two tanks were stored inside and should be stored outside.

The investigation concluded that the employer installed a MVE Carbo-Max 750 high flow bulk CO2 tank in the basement. The basement was below grade and did not have alarms or monitoring equipment to warn the employees of high CO2 levels or low oxygen levels. The employer had a purge valve installed on the fog effect CO2 system that was in the basement and had the CO2 purged into basement. The employer instructed the victim to vent the CO2 into the basement to charge the system with cold CO2 prior to release, which normally only takes 20 seconds. The employer also advised the victim that the fog effect was not strong enough during the previous night's performance and told him to make sure the CO2 system that produces the fog effect was fully charged and ready when needed. The victim had several duties, which required him to be upstairs and downstairs several times during a short period. Due to the employer talking to the victim and the fact that he was not downstairs until right before the fog effect was needed, it is most likely that the victim started purging the CO2 from the system 14 minutes before the cue for the fog effect so that he could make sure the system had cold CO2 and was ready for the fog effect when needed. The victim had purged the CO2 into the unventilated basement for approximately 14 minutes filling the basement area with CO2 and creating an oxygen deficient atmosphere. Also, based on information gathered, it appears he had purged half of the liquid CO2 into the basement, which was approximately 300 pounds. Several other employees exposed themselves knowingly to the oxygen deficient atmosphere to rescue the downed victim, becoming victims themselves, because they were not properly trained in the hazards of CO2 and proper emergency response.

1910.1200(f)(10)	<p><b>The employer did not ensure that workplace labels or other forms of warnings were prominently displayed on the container or readily available in the work area throughout each work shift.</b></p> <p>In that, the labeling on the MVE Carbo-Max 750 HF liquid carbon dioxide storage vessel located in the basement was not prominently displayed.</p>
------------------	---

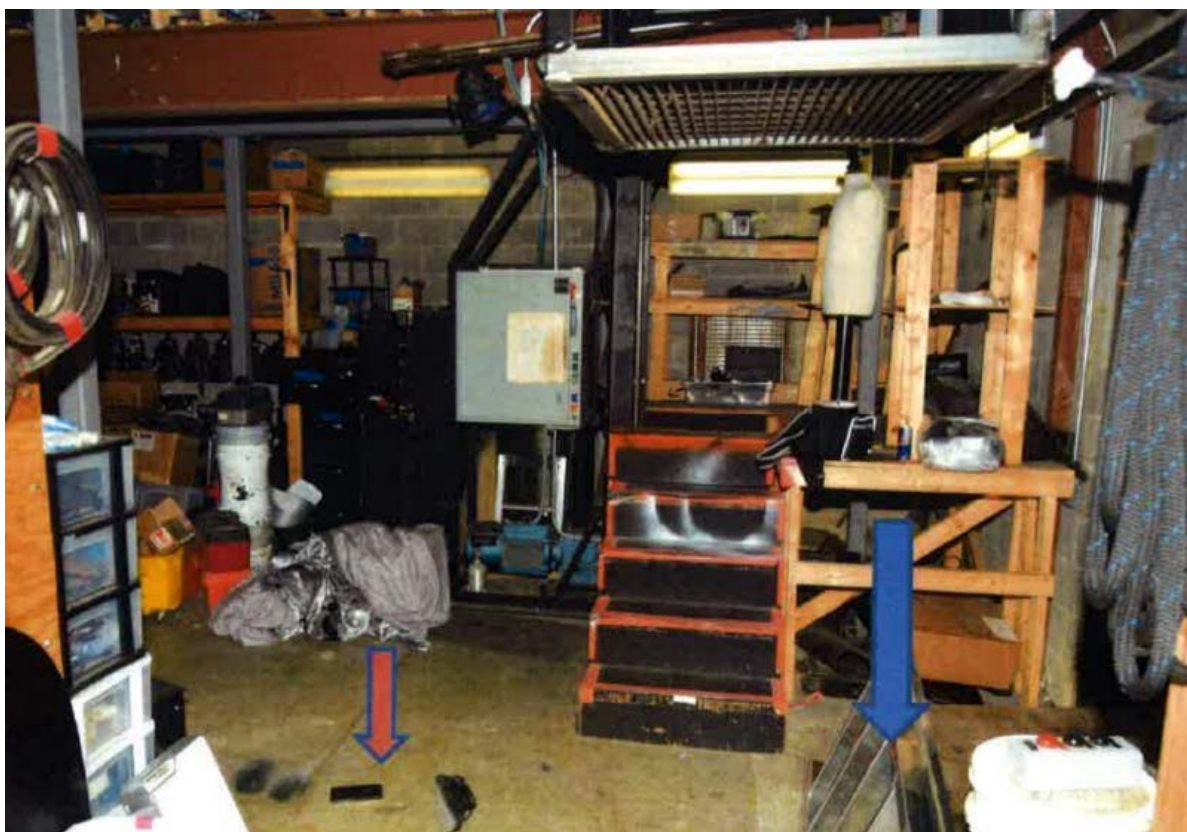
Photo 3 of 3 – Shows a view of the basement area where the victim was purging the CO2. In the photo are the stairs to the platform that was accessed by the actors and stage tech. These stairs were used to get into the stage lift and to access the purge valve on the fog effect system. The red arrow indicates the location where the victim was found; the

<p>improper storage and use of carbon dioxide cylinders:</p> <p>a) Employees were exposed to an asphyxiation hazard from purposefully purging carbon dioxide (CO<sub>2</sub>) piping into an unventilated work area (basement);</p> <p>b) Employees were exposed to an asphyxiation hazard from potential CO<sub>2</sub> collecting in an unventilated work area (basement) when releasing CO<sub>2</sub> to create low roll fog stage effect and when releasing CO<sub>2</sub> during actor stage lift operation;</p> <p>c) Employees were exposed to an asphyxiation hazard from potential unintentional CO<sub>2</sub> release (leaks) from a MVE Carbo-Max 750 HF storage container located in the basement below the stage; and</p> <p>d) Employees were exposed to an asphyxiation hazard from potential unintentional CO<sub>2</sub> release (leaks) from four CO<sub>2</sub> storage containers located on the North and South sides of the stage.</p> <p>Among other methods, one feasible and acceptable abatement method to correct this hazard is to store all liquid carbon dioxide storage vessels outside the building and pipe the carbon dioxide in as needed, to install gas detection and alarm systems for general monitoring and notifying building occupants of a carbon dioxide gas release. Where all liquid carbon dioxide storage vessels are stored indoors or below grade areas, to post carbon dioxide warning signs where all liquid carbon dioxide storage vessels are stored indoors or below grade areas, and to run venting lines from the liquid carbon dioxide storage vessel to the outside of the building and vent or purge the tank to the outside of the building. (As Referenced in: National Boiler Inspection Code NB12-0304, Part 1, Supplement 3: Installation of Liquid Carbon Dioxide Storage Vessels S3.2 General Requirements, S3.4 Gas Detection Systems, S3.5 Signage, and S3.6 Valves, Piping, Tubing and fittings: Safety Relief/Venting Lines.)</p>

1910.28(b)(II)(ii)	<p><b>Each flight of stairs, having at least 3 treads and at least 4 risers, was not equipped with stair rail systems and handrails.</b></p> <p>In that, the employer had stairs leading from the basement floor to the platform for the actor stage lift and did not have stair rail systems in place.</p>
--------------------	---
