14 Struck by wheel loader – Inspection #1302402

A **55 year old male** employee was fatally injured when he was **struck by** the bucket of a wheel loader while walking between two saw mills. The incident occurred at approximately 5:50am and it was still dark, before the sun rose. The victim was talking to other employees at the in-feed end of Mill #5 before he started walking towards the in-feed end of Mill #6. It was dark and he was wearing a black or dark-colored overalls and a jacket or hooded sweatshirt.

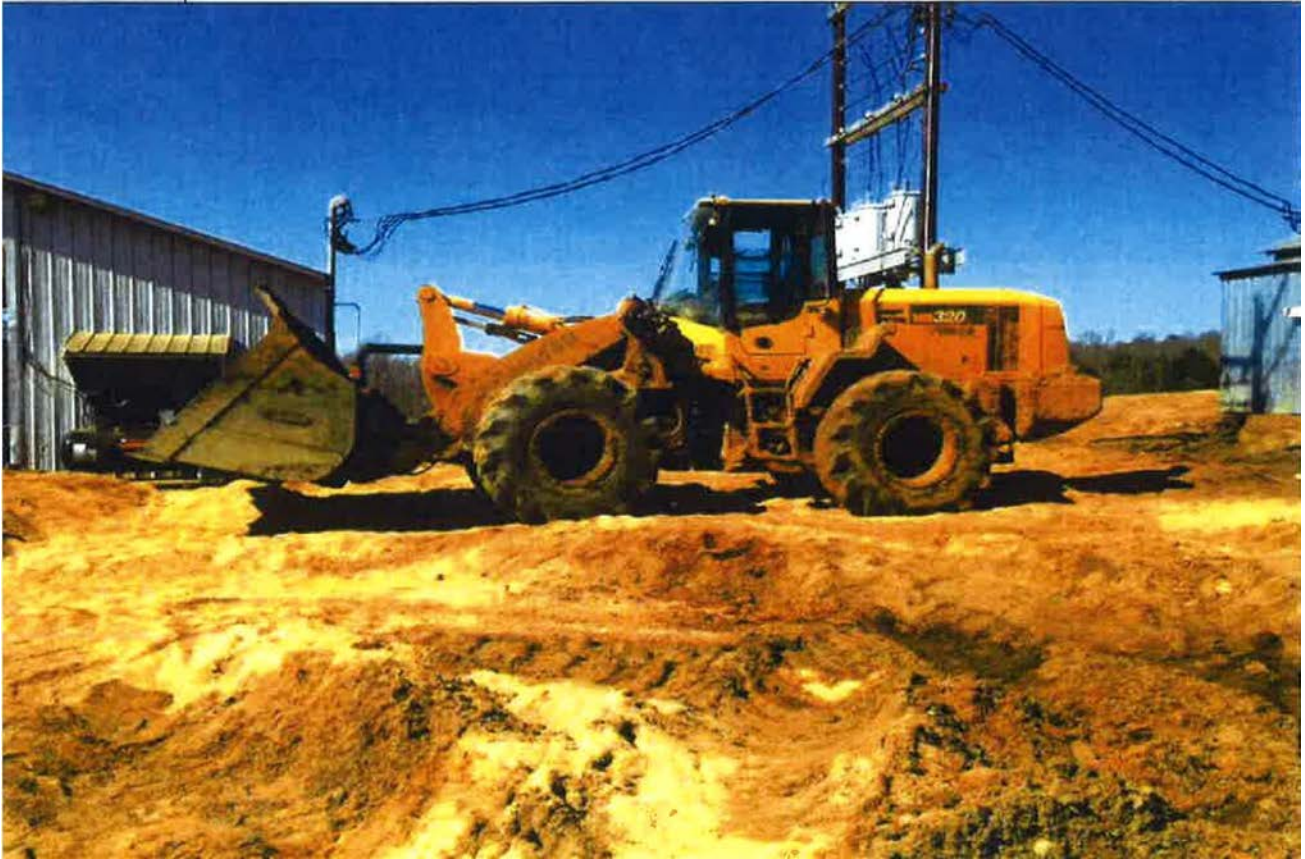
Description: View of the Komatsu WA-320-7 wheel loader in the approximate position and configuration as when the incident occurred.

The loader operator arrived at the sawmill at approximately 5:15am, checked his Komatsu WA320 wheel loader, including the lights, and started moving bucket loads of sawdust from the sawdust pile at the in-feed end of Mill #6 to the recycling pick-up pile. He wanted to get ahead of the mill before the workday started; he had moved about 20 buckets before the incident occurred. He was straightening out from making a right turn to get a load of sawdust and got a call on the radio from a lift driver who told him he might have run over someone. He stopped the wheel loader and checked underneath the wheel loader and saw the victim.

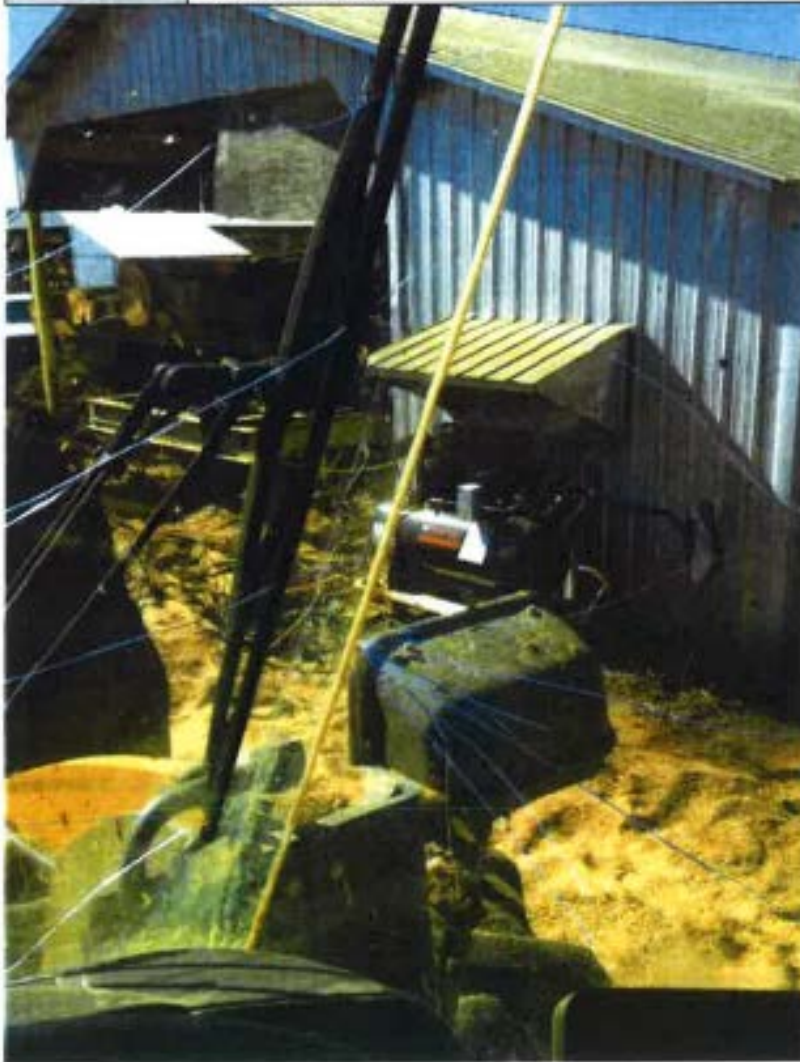
Description: View of the front windshield of the Komatsu WA320 wheel loader, showing the numerous cracks.

TCA 50-3-105(1): The employer did not furnish employment and a place of employment which were free from recognized hazards that were causing or likely to cause death or serious physical harm to employees:

In that the front windshield of the Komatsu WA320 wheel loader had numerous cracks, interfering with the operator's visibility.
