20 crushed/caught in—Inspection #1311286 Bush Brothers & Co

A 41 **year old female** was fatally injured when she was **crushed between** a pallet lift and the frame of the machine.

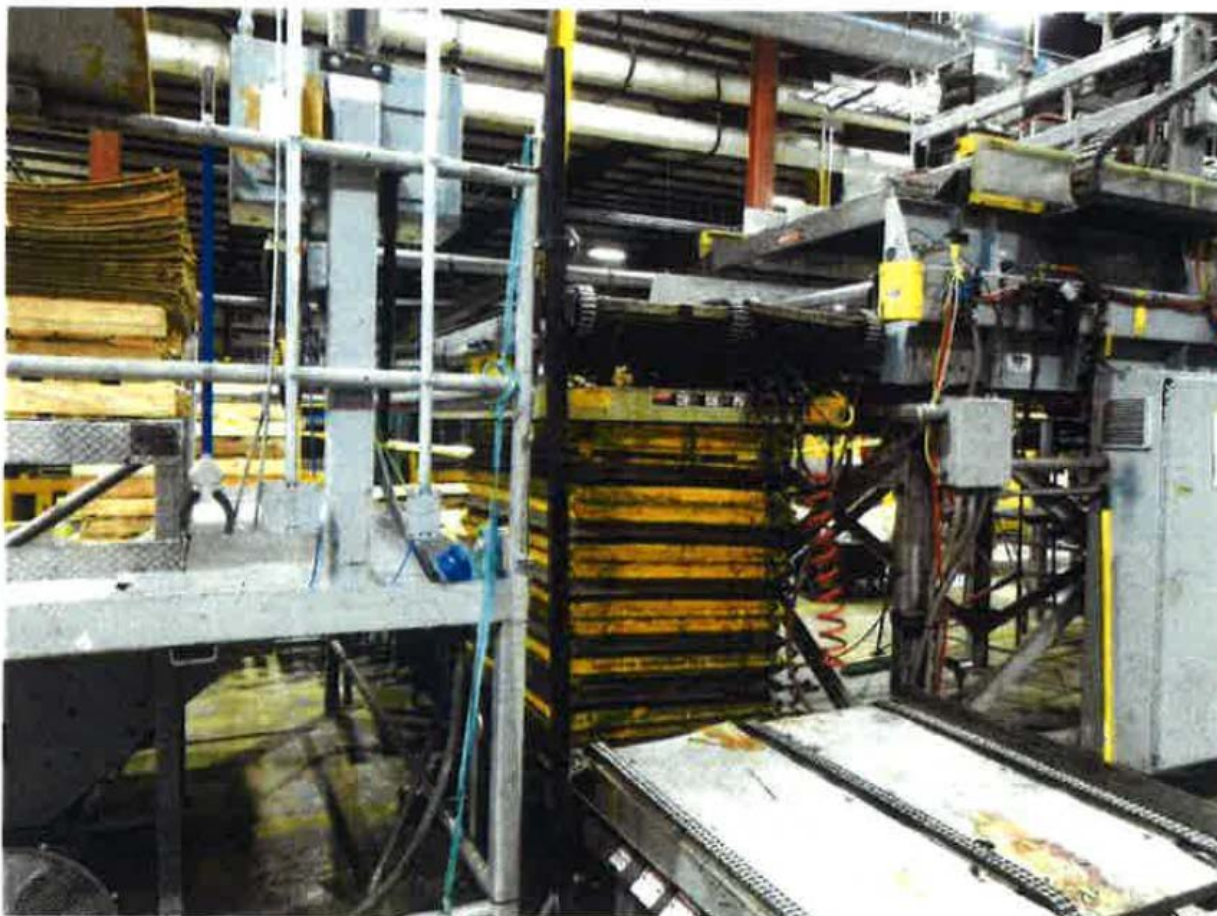
Photo shows the scissor-lift platform in the up position. The decedent was removed, and the machine was turned off and locked out in this position.

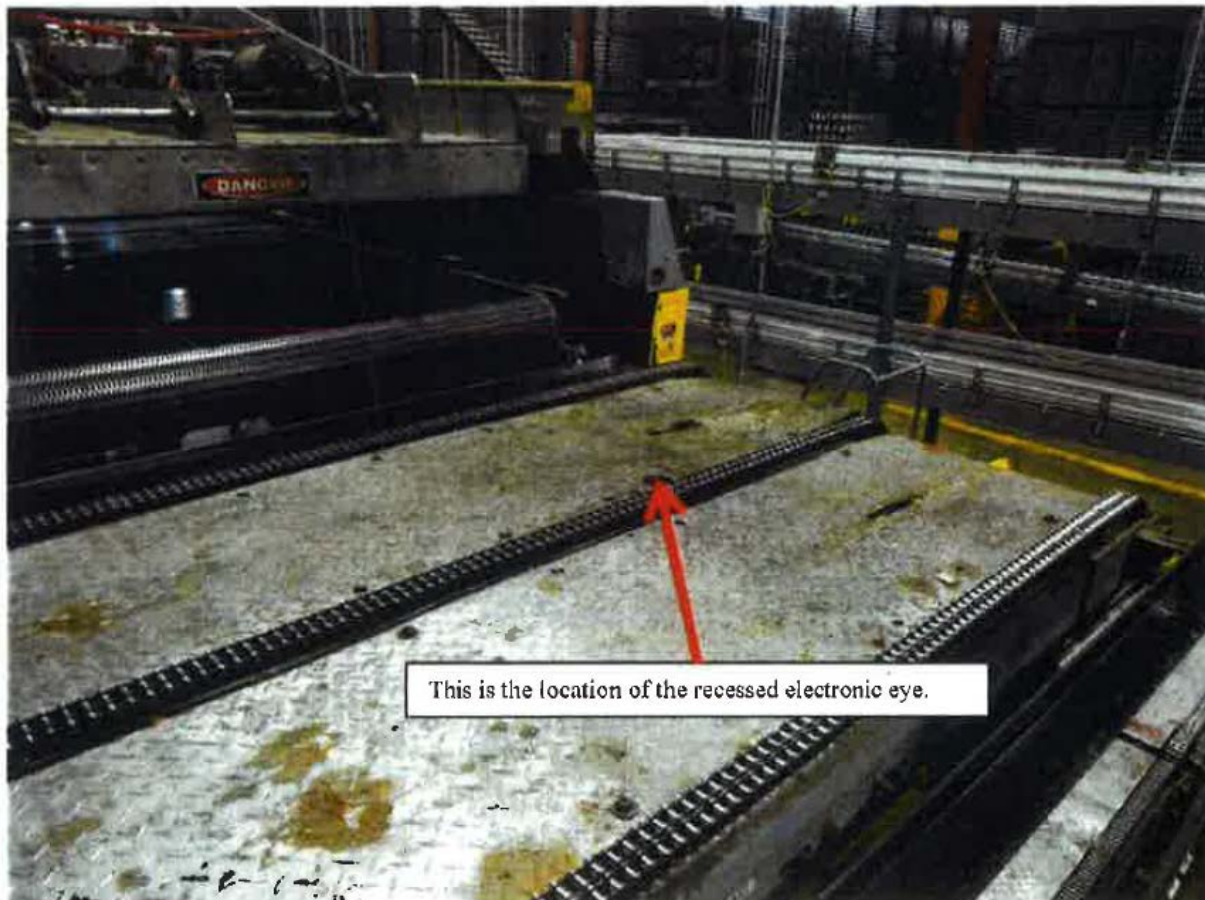
Photo shows the top of the scissor-lift platform that the decedent was cleaning at the time of the incident. The arrow denotes the location of the recessed electronic eye.
