**37 Crushed by/caught in—inspection # 1353125 Carlex Glass**

A **61 year old male** was fatally injured when his head became **caught between** the frame of the forklift and a metal windshield rack. The victim was employed as a production associate who operated a powered industrial truck.

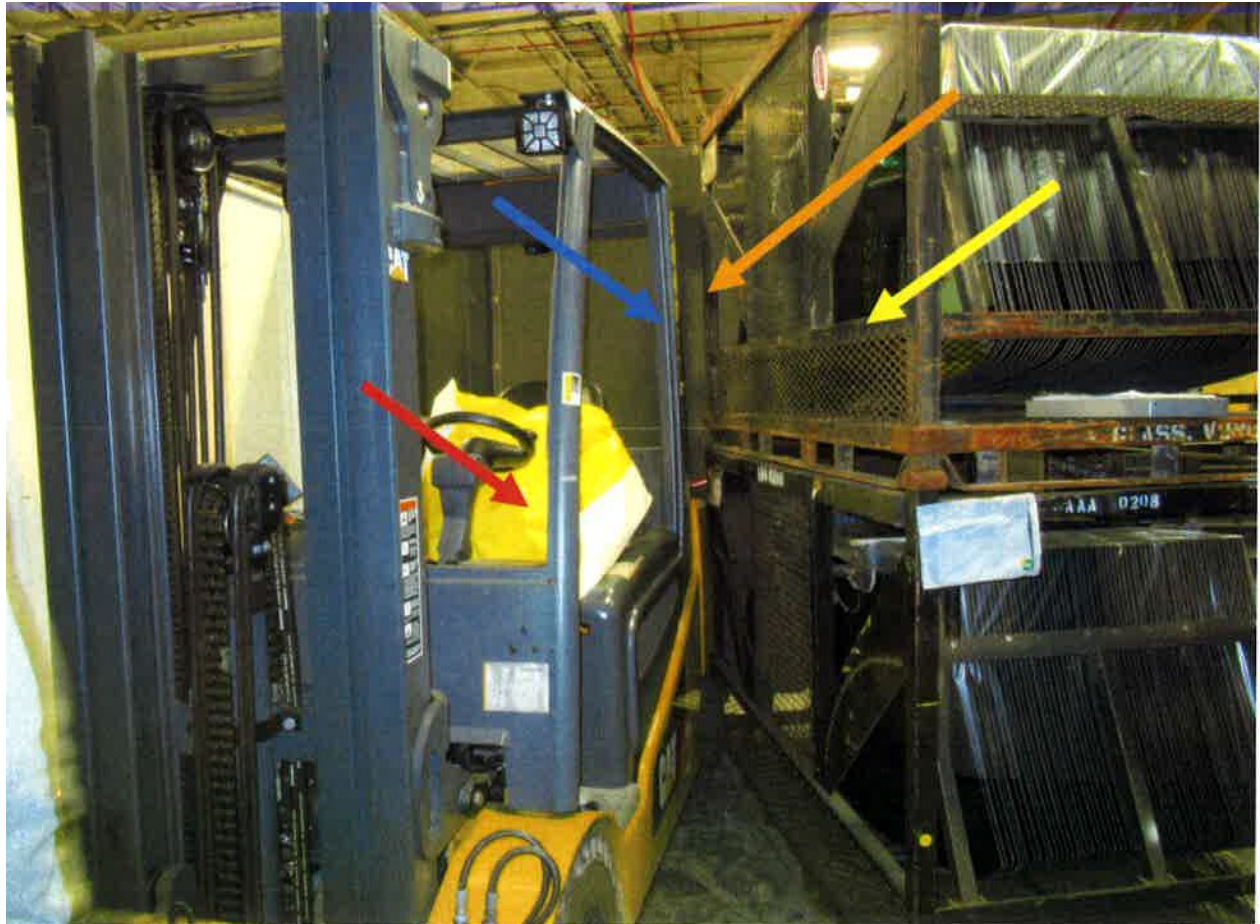
The red arrow indicates the forklift. The yellow arrow indicates the windshield rack. The blue arrow indicates where the victim's head came in contact with the forklift. The orange arrow indicates where the employees head came in contact with the windshield rack. The windshield rack had been moved towards the rear of the forklift and away from the fork lift so aid could be rendered to the victim.

It was determined that the transmission of the forklift was in forward gear and the wheels of the machine were cut all the way to the right. As such, the rear of the machine would have pivoted to the left, towards the windshield rack creating a pinch point between the upright roof support of the forklift and the rack. The victim's head was caught in between the rear roof support on the driver's side of the forklift and the double stacked metal windshield rack.

In that an employee was exposed to crushed-by hazards when his head was caught between the upright roof support of a forklift and a windshield rack as he did not keep his head and body inside the cab while traveling.

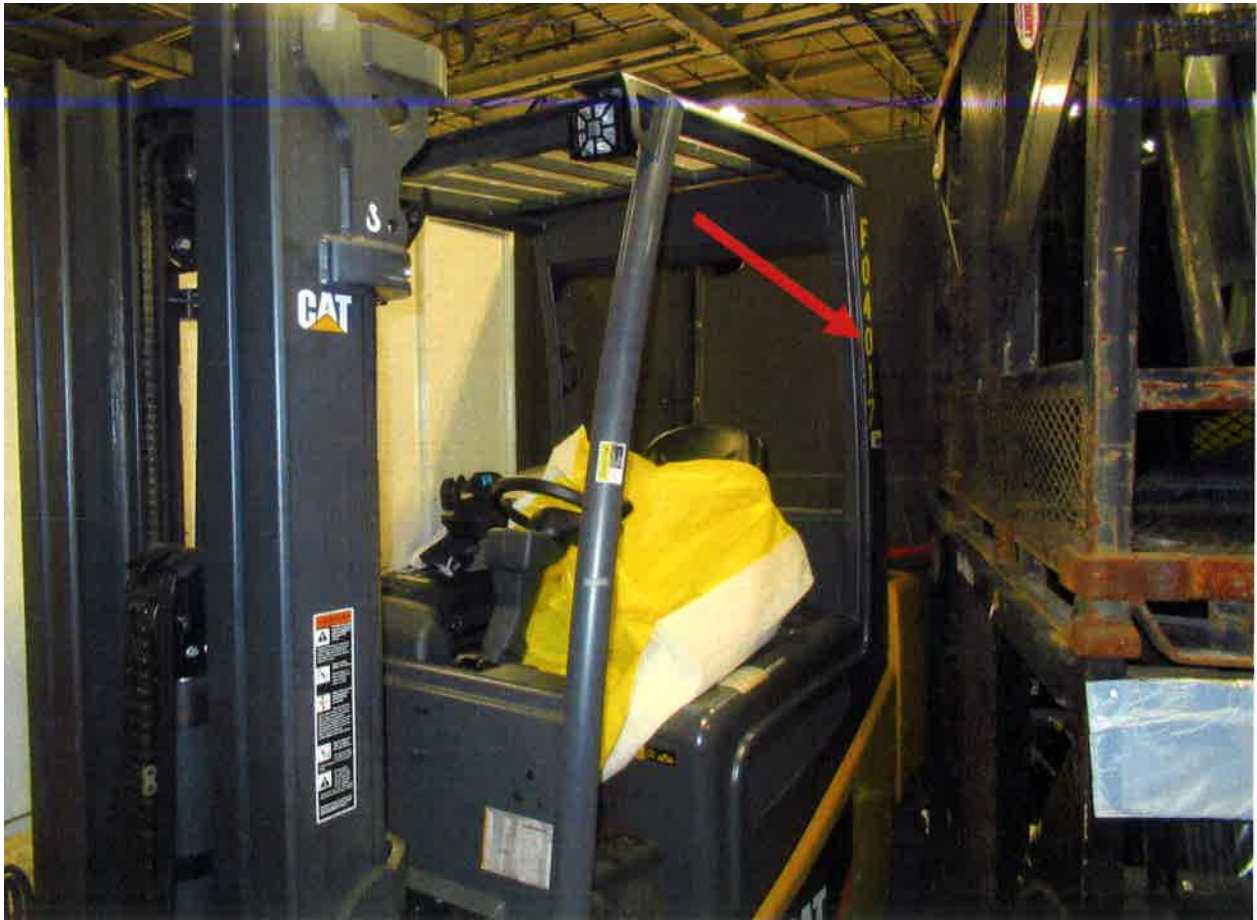
The red arrow indicates the portion of the upright of the forklift where the victim struck his head.
