Project Title: Ducktown Basin Museum Building and Site Restoration

**DUCKTOWN BASIN MUSEUM & BURRA BURRA MINE PROGRAMMING STUDY
DUCKTOWN BASIN MUSEUM & BURRA BURRA MINE STATE HISTORIC SITE
DUCKTOWN, POLK COUNTY, TENNESSEE
SBC #160/000-01-2014**

July 22, 2019

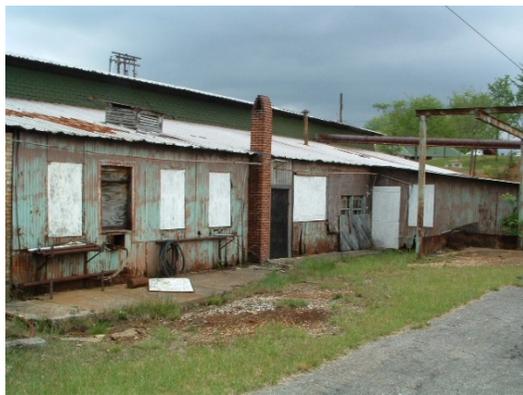
Machine Shop – Corrugated Metal Panel Additions

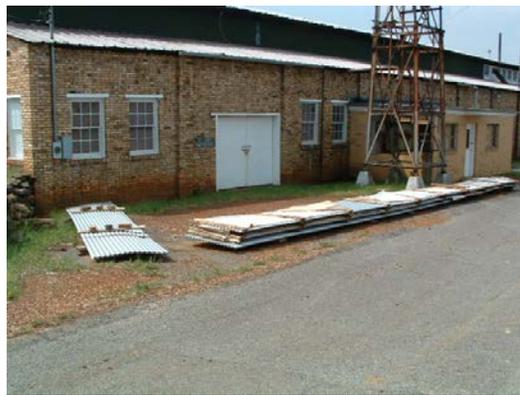
A lintel is failing at the west door on the north façade as a large section was removed. Also, at this location, the existing site topography directs water into the building as the clay tile drain under the payment no longer works.

Machine Shop – West Door

drain (pipe) ending at the cliff, repair the steel channel lintel at the north pair of doors, replace the door to the foreman's office with flush hollow metal door and repair its door frame

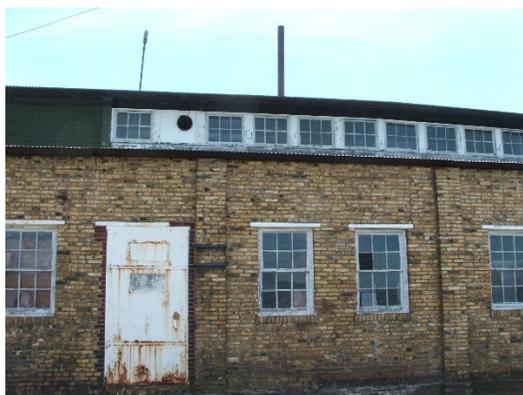
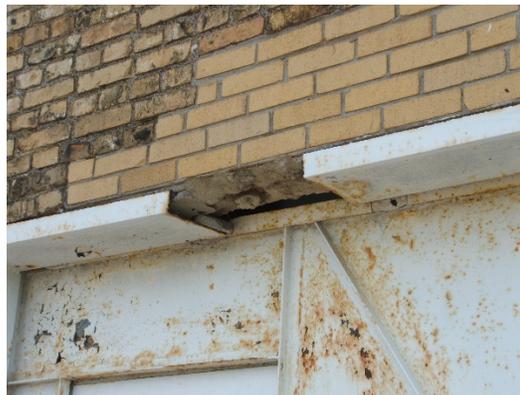
Machine Shop – Monitor Windows

Exterior: rebuild the missing/repair the deteriorated monitor windows, rebuild the missing ventilator monitor on top of the remaining light monitor, repoint the deteriorated or missing mortar joints and cracks in the masonry, replace and paint all deteriorated metal siding/paint, replace the missing wood windows and frames, reglaze the windows as needed. install a new grated trench drain at northeast pair doors and connect to the ditch/ drain by digging up the road and install a new storm

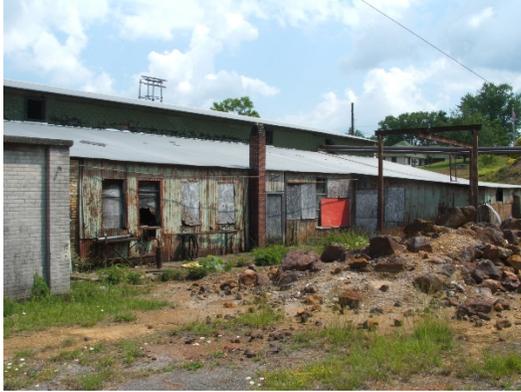
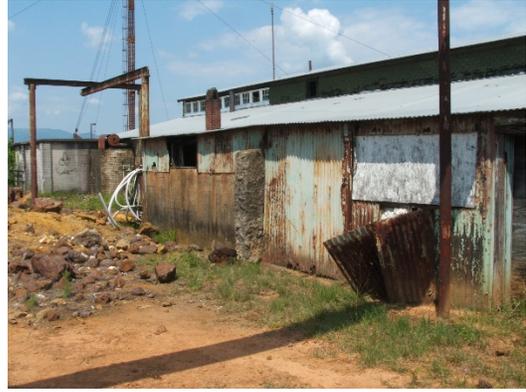
The bulk of the building envelope is in reasonable condition though the existing windows are deteriorated and the rear shed additions are severely deteriorated. The

Machine Shop – Rear Additions

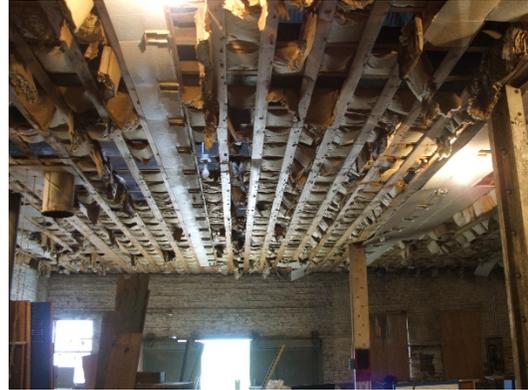
Machine Shop – Dropped Ceiling

Carpenter storage: remove the plywood ceiling and replace the deteriorated wood flooring and its framing.

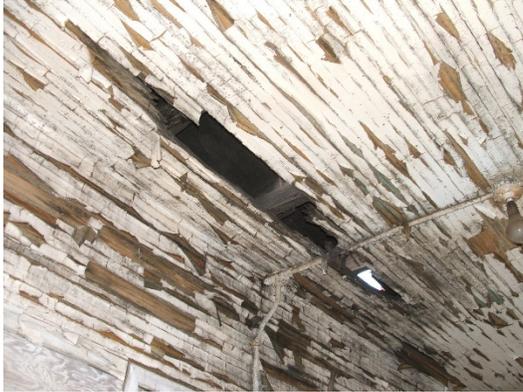
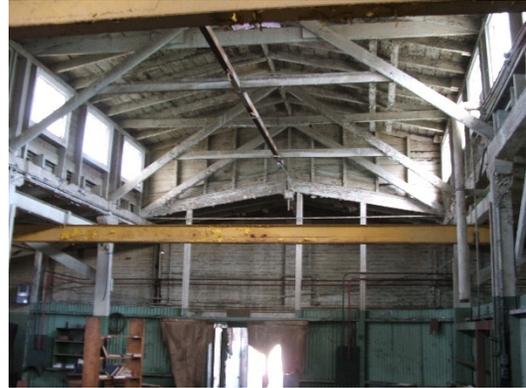
The paint is peeling throughout the building. Based on the age of the building, the paint likely contains lead. Also, the existing plywood and bead board ceilings have fallen in several places.

Change House – Peeling Interior Paint

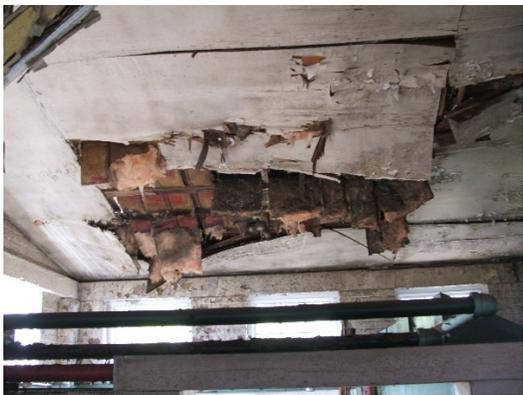
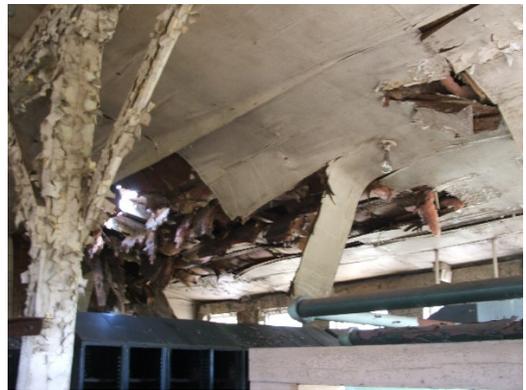
Change House – Falling Ceilings

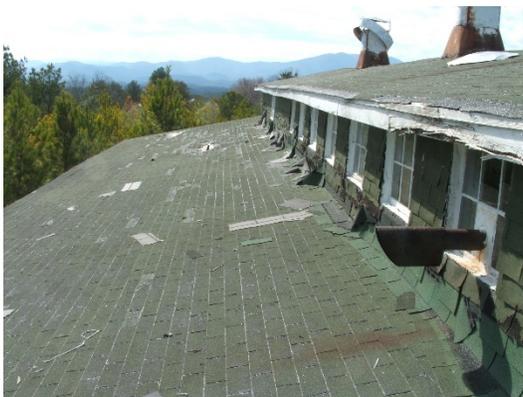
Windows are broken and/or deteriorated at several locations around the building.

Change House – Monitor Windows

Replace approximately thirty (30) deteriorated or missing monitor windows (in lieu of new lighting), repoint the masonry as needed where the mortar is deteriorated or missing, rebuild/patch the acetylene metal door, provide a new hinge at the acetylene door, and rebuild the brick wall between the office and acetylene storage room. Replace the existing front doors with new ones to match original construction drawing. Remove hardware cloth over lower windows

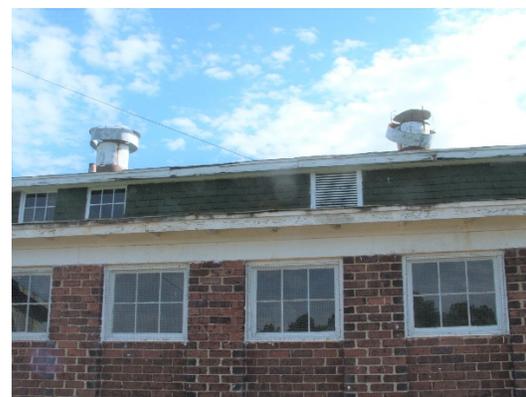
Change House – Lower Windows

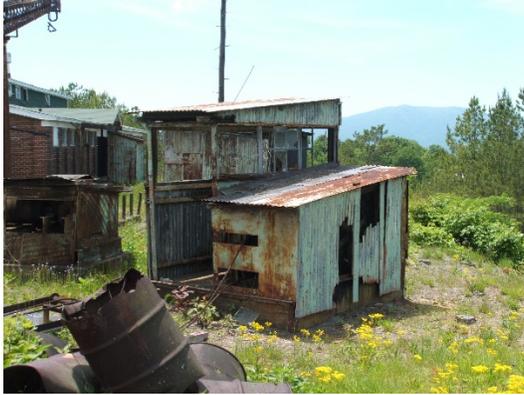
Crane Operators Booth

Today one sash remains and the building is severely deteriorated.

Replace all deteriorated wood framing, replace approximately fifty-percent of the deteriorated corrugated metal siding, replace the deteriorated/missing wood windows and paint exterior

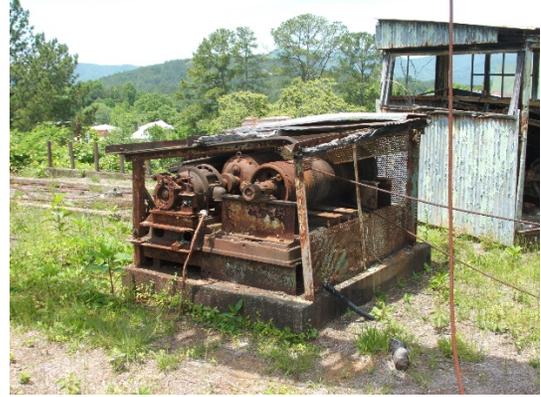
The 50 square foot Crane Winch House is a small steel frame structure resting on a concrete slab that housed the motorized winch to lift the cables on the crane arm. Wood framing members rest on top of the steel roof framing to attach the corrugated metal siding. Pierced steel plates are attached on the end of the structure facing the crane. The structure and the equipment inside are severely deteriorated.

Replace the deteriorated wood framing and corrugated metal roofing and siding, refurbish the pierced metal plates, and paint the exterior.

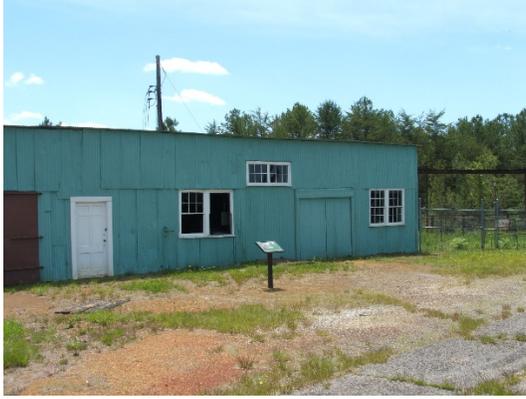
Plate Shop

This 2,300 square foot, one-story structure with shed roof is covered on its roof and sides with painted corrugated metal siding. Recently restored, there are several areas where select parts were not painted, the wood doors and windows are deteriorated, or broken out. A support for a rear porch roof is missing and should be replaced.

Exterior: replace two broken window sash, rebuild rotting window sash, remove the rust and paint the unpainted braces and small equipment shed, etc. at the west elevation, replace the deteriorated pair of wood doors and frame on the west elevation with new painted hollow metal doors and frame, install a new pipe support for rear/south porch where missing, paint the concrete block addition to match the metal siding, and reglaze the windows in the concrete block addition.

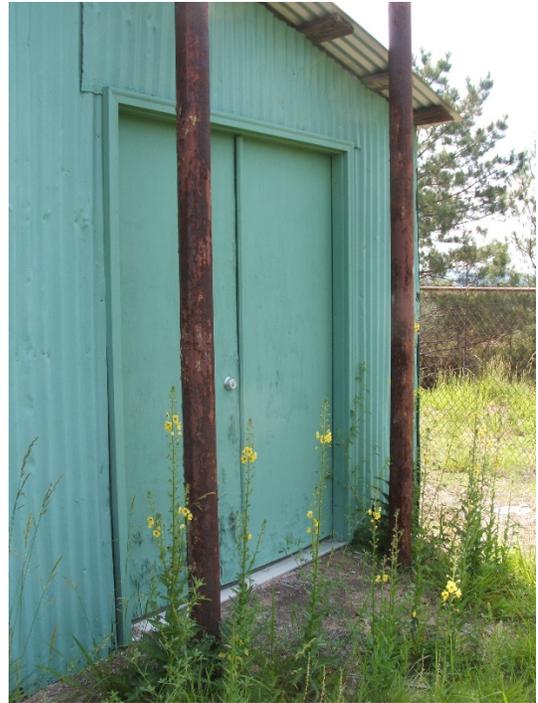
Plate Shop – Rotting Wood Doors and Frame

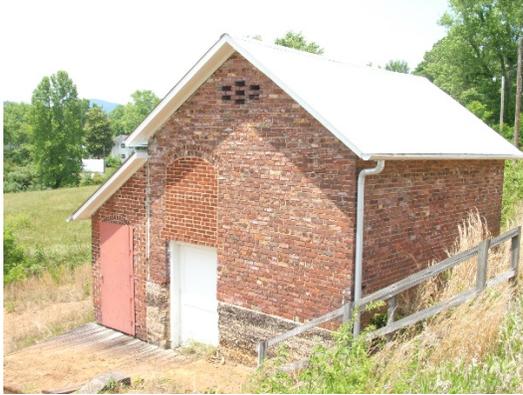
The 600 square foot Powder House is a one-story brick structure with metal roofing. The wooden steps and landing below outside the entry door are deteriorated. A former brick window over the door has been filled in with brick. Minor repointing is needed on select mortar joints. The nearby oil tank is rusted.

Exterior: replace the wooded stairs and landing, repoint the open and deteriorated mortar joints as needed, reopen the former window opening and install a new window frame and sash, and remove the rust on the adjacent oil tank and repaint.

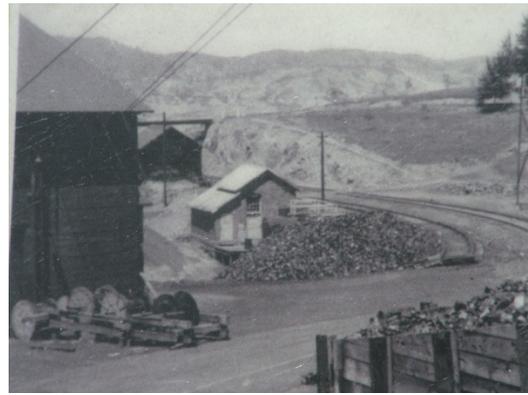
Powder House – Historic Image with Window

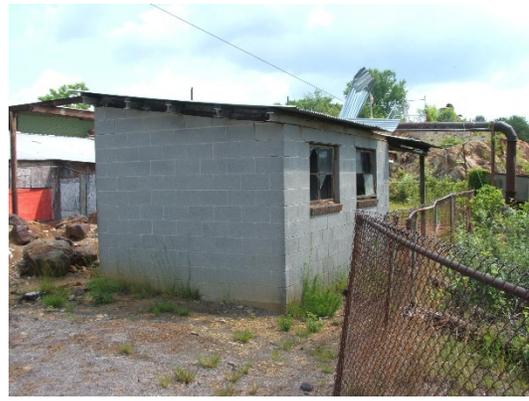
Steam Cleaner Shed

There are cracks within the masonry units.

Repoint the concrete block as needed, remove the rust and repaint the doors and frames as well as the windows, scrape the shed porch framing and repaint, and replace the old corrugated roofing to match newer roofing.

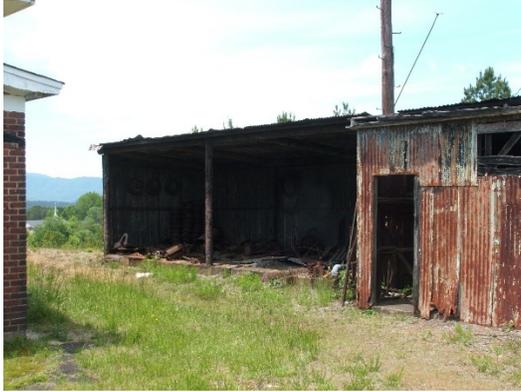
Open Parts Storage Shed

Although there is some nostalgic quality to its advanced state of decay, both structures are in danger of blowing away.

- 1) Open Parts Storage Shed: replace corrugated metal siding and roofing where deteriorated. Underpin the foundation at the corner where erosion has undercut the building. Remove the rust, scrape flaking paint and repaint.
- 2) Enclosed Parts Storage Shed: reframe the smaller wood-framed structure using pressure treated lumber. Match existing adjacent framing system in spacing and installation. Rebuild the wood shelving as needed. Replace portions of the metal siding where deteriorated or missing. Provide a new door with corrugated metal siding. Prep and paint the exterior to match historic colors.

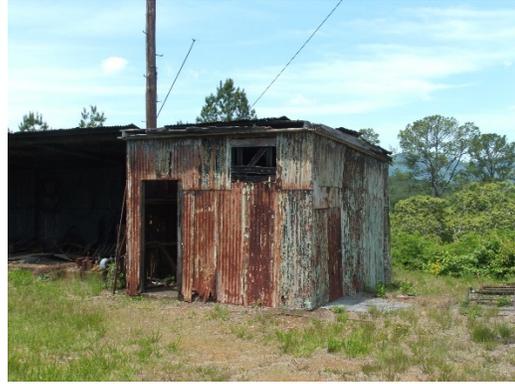
Enclosed Parts Storage Shed

The wood structure is highly deteriorated and parts of the siding have either blown away or rusted off.

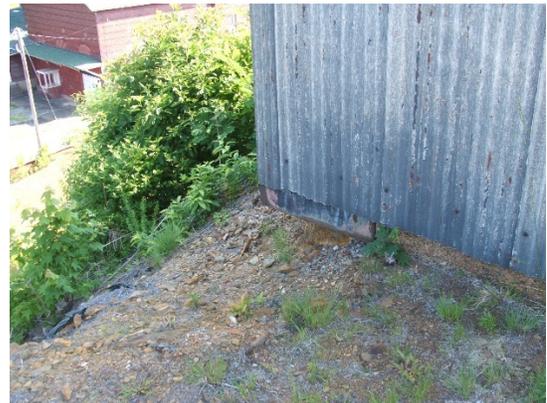
Open Parts Storage Shed – Erosion at Corner of Building

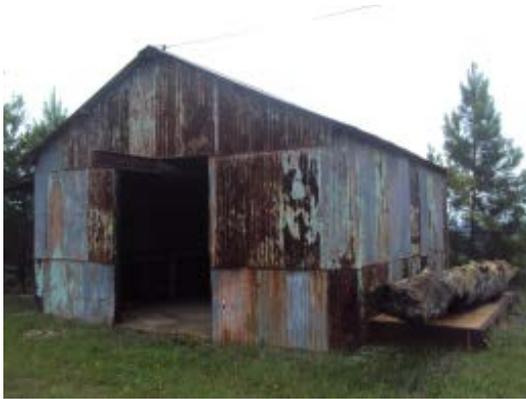
Drill Repair Shed

This small(440 square foot) one-story, gable roof shed is constructed of corrugated metal siding on steel framing on top of a concrete slab floor. The concrete slab is cracked and the door removed.

The structure is somewhat deteriorated and parts of the siding are rusted.

Reinstall the bollard outside the door, remove the paint on the exterior and repaint, fill the cracks in concrete slab, replace all deteriorated metal siding where rusted through or pin holes with new siding to match, reroof the open shed porch and repaint the exterior.

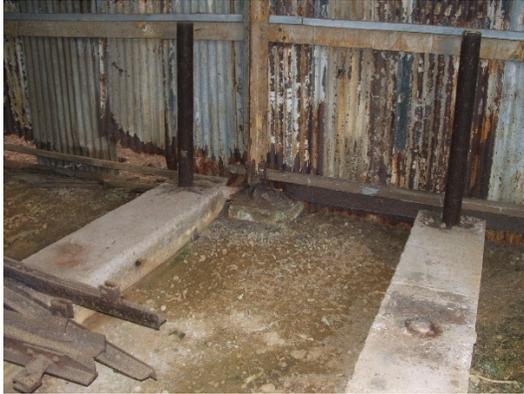
Parts and Equipment Shed – Concrete Curbs

The connection of the steel columns to the concrete footers are severely deteriorated. Several panels of the metal siding are missing or deteriorated.

Remove any tree or tree limb with ten-feet of the structure, pour concrete pedestals around the connection of the steel columns and footers where rusted, replace the deteriorated and missing corrugated metal panels. Paint the exterior.

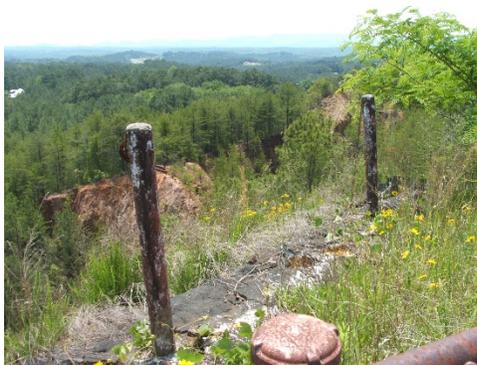
Original Overlook Fence

There are approximately three fence systems built over time to protect workers and visitors from falling into the mine collapse. Originally, steel pipe bollards with steel cable (possibly from repurposed guy wire cables from the crane) were erected, later a chain link fence and most recently a taller chain link fence with barbed wire at the top.

Remove the middle chain link fence and fill the post holes with topsoil. Remove the latest fence and replace with a pre-painted aluminum security fence, 7-foot tall.

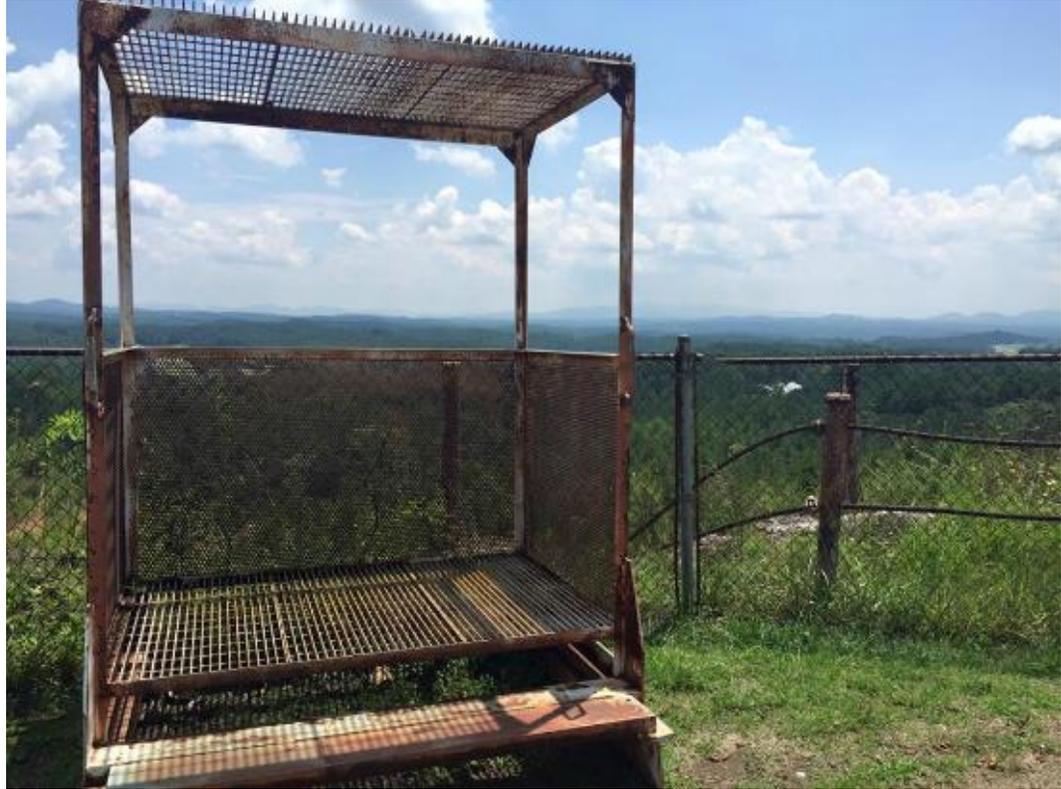
Viewing Platform

It is the understanding of the author that the ground this platform rests on (including a large portion of the parking lot) is on fill.

As the trees grow up the sides of the collapse, the view down into the collapse and the resulting pond that has partially filled the hole has diminished and a higher, larger viewing platform is needed.

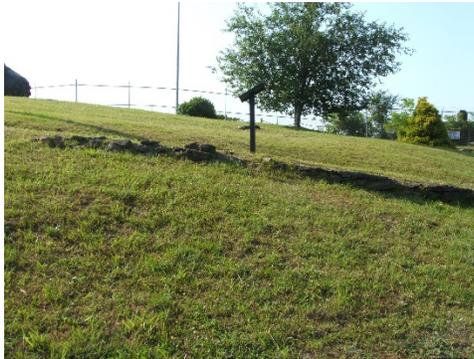
Stone-Lined Walkway

The walkway from the Museum/Mine Office is comprised of a slag mixture paved surface lined with mortared stone curb. The stone curb is deteriorated and the walk surface is covered with grass.

The grass and topsoil on top of the paved surface should be removed for the Association to repave it with a slag mixture. The loose stone should be reset using and supplemented with additional stone as needed.

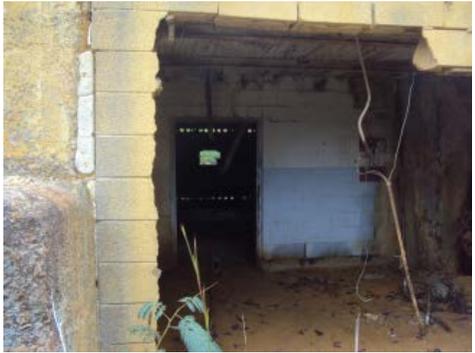
slab. Their condition is deteriorated not safe for occupancy. The associated stone and concrete wall is deteriorated.

Ore Bin Foundation – Opening in Block Wall

At the deteriorated open areas of the foundation's concrete block wall, reinstall a concrete block masonry infill wall with secured louvered metal access panels to close off the area. Seal and paint.

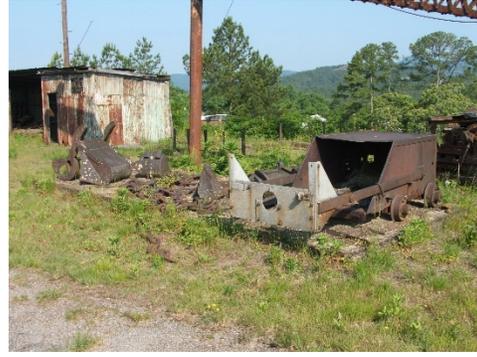
Remove Rust Off of Exposed Equipment.
