I-40 Crossing I40 / SR 53

Inspection Date(s): 05/22/2025 - 05/22/2025

IDENTIFICATION	
(1) State Names	47 - Tennessee
(8) Structure Number	80I00400015
(5) Inventory Route	1
(2) Highway Agency District	Region 3
(3) County Code	80 - Smith

Inspection Team's Summary

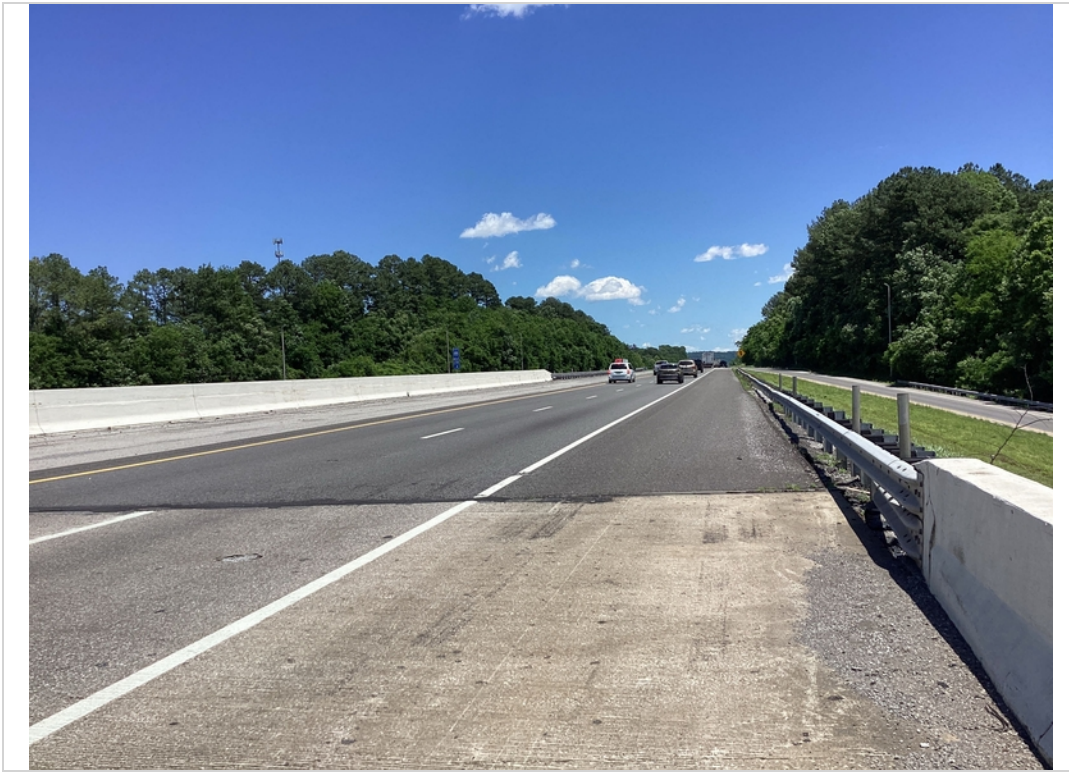
R B approach

The approach alignment is good. The approach asphalt is in good condition. The approach embankment is in good condition. The approach joints are in fair condition with some moderate impact damage.

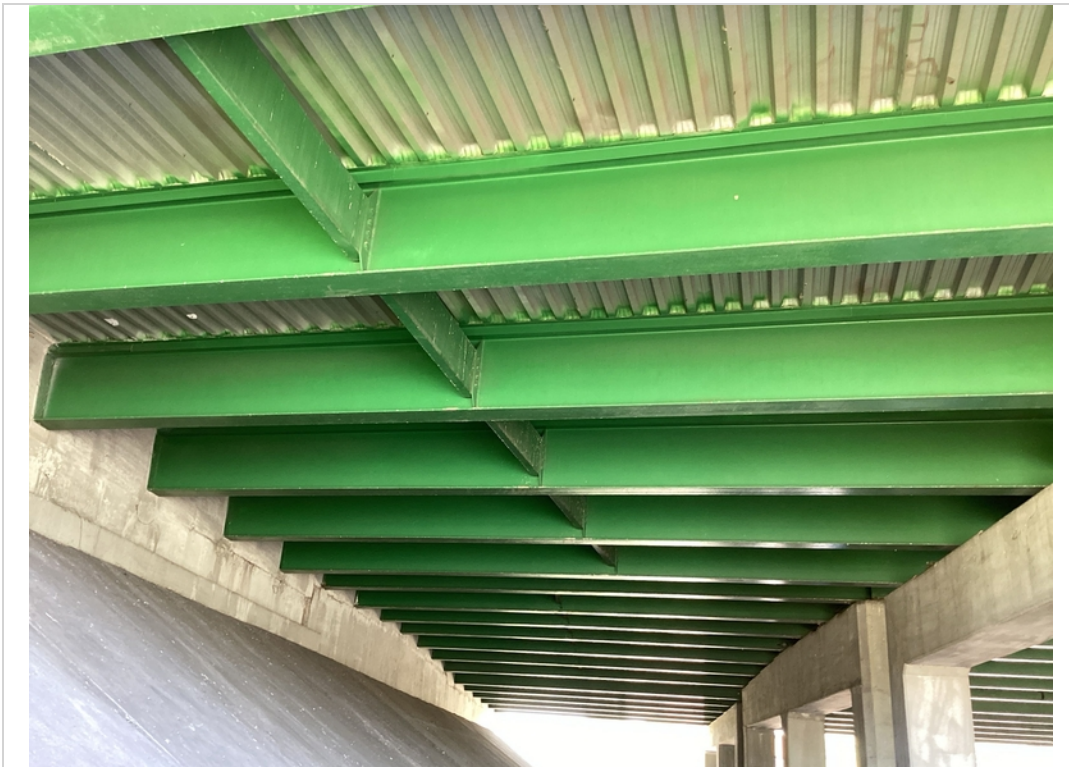
Span 3

The deck is in GOOD condition. The concrete-wearing surface is in good condition with an isolated minor spall in span 1 and some minor cracks in all three spans. The underside of the deck is in good condition with isolated minor cracks with efflorescence in the overhang areas. Two isolated areas on both sides of span 1 are holding water. The current deck condition rating is good (7).

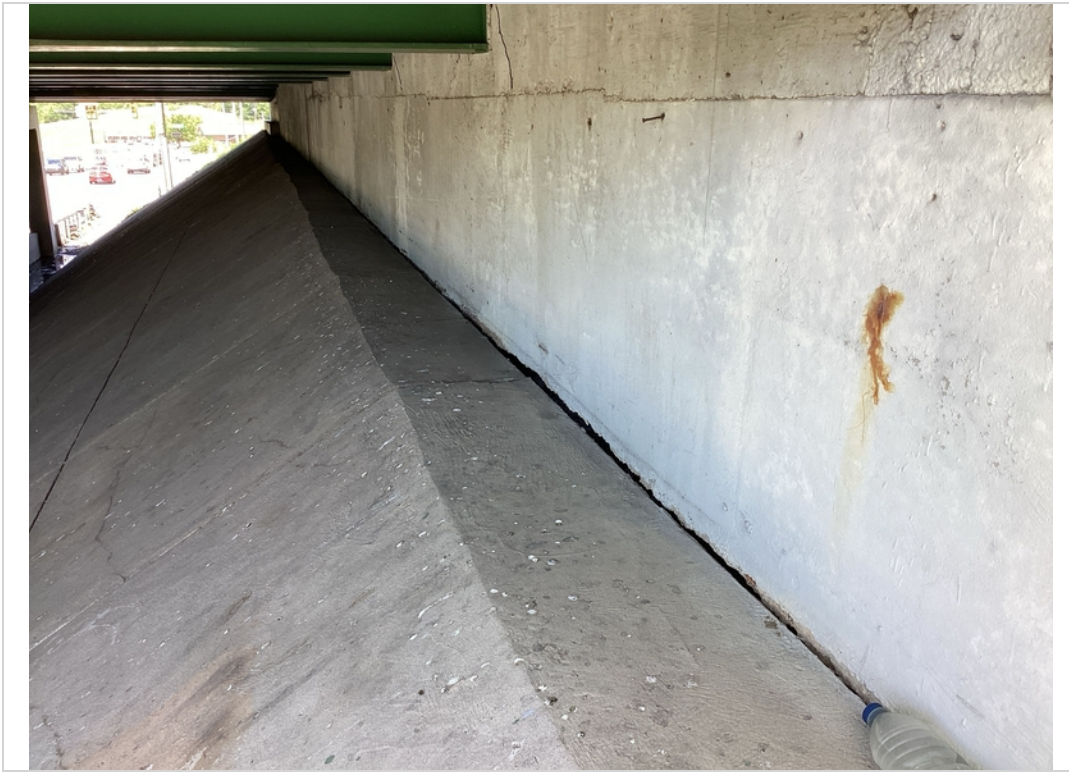
Abutment 2

The substructure is in GOOD condition. The abutments are in good condition with isolated minor cracks. The backwalls are in good condition. The wingwalls are in good condition. The bent caps are in good condition. The bent columns are in good condition. The current substructure condition rating is good (7).

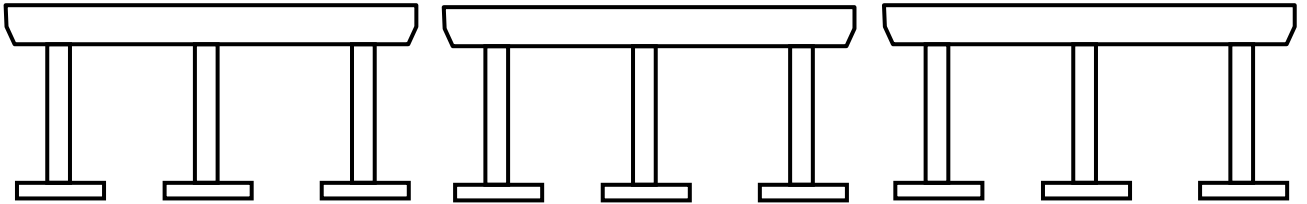
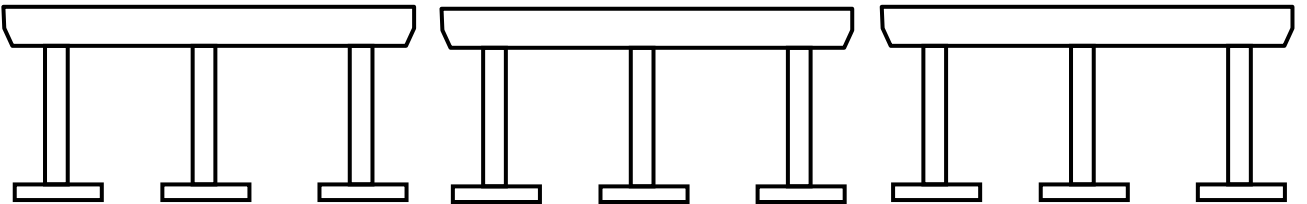
BENT # 2

CAP	GOOD	
COLUMNS	GOOD	
FOOTING	N/V	
BEARINGS	GOOD
