### **33 Electrocution---Inspection #1343126 David H Elliot Construction**

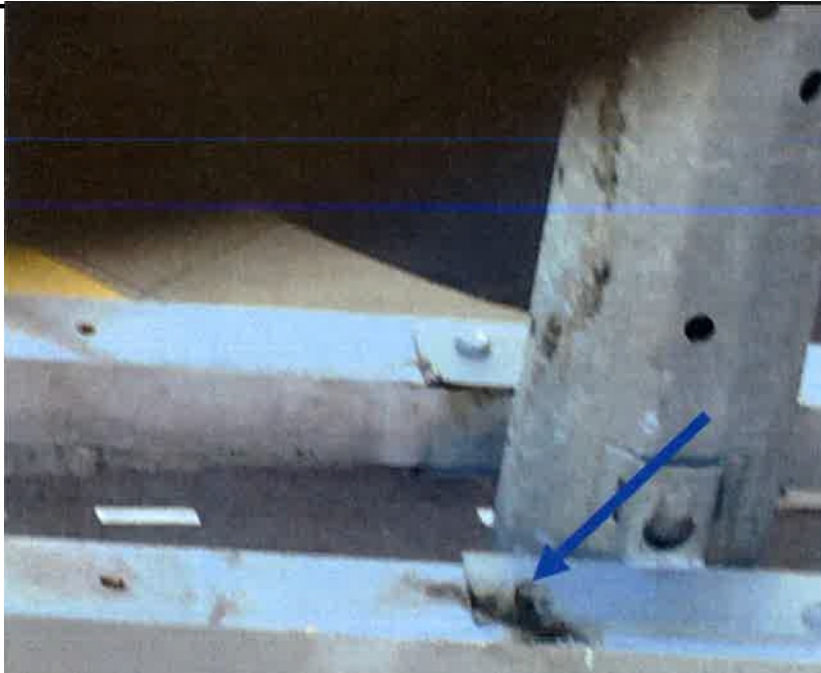
**Description:** This photo shows the insulator where point of contact was made. Not visible from the photo, but the aluminum wire was burned in two at the (blue arrow)

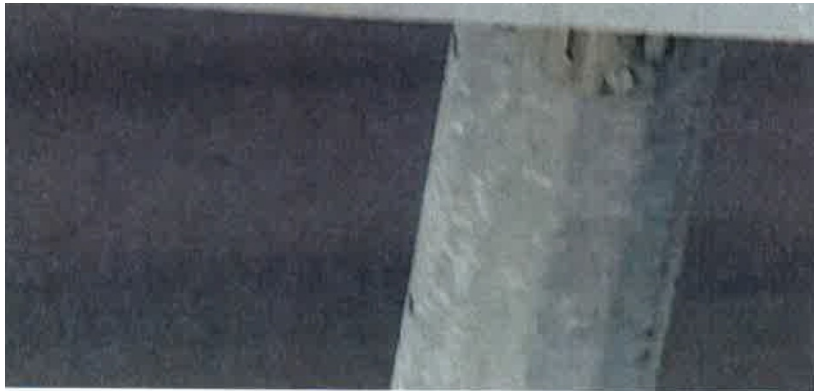
This photo shows the bolt that secured the fiberglass cross arm to the utility pole (blue arrow) that was the ground point of contact.
