3 Struck by vehicle--Inspection #1375536 Cedar Ridge Landfill Inc.

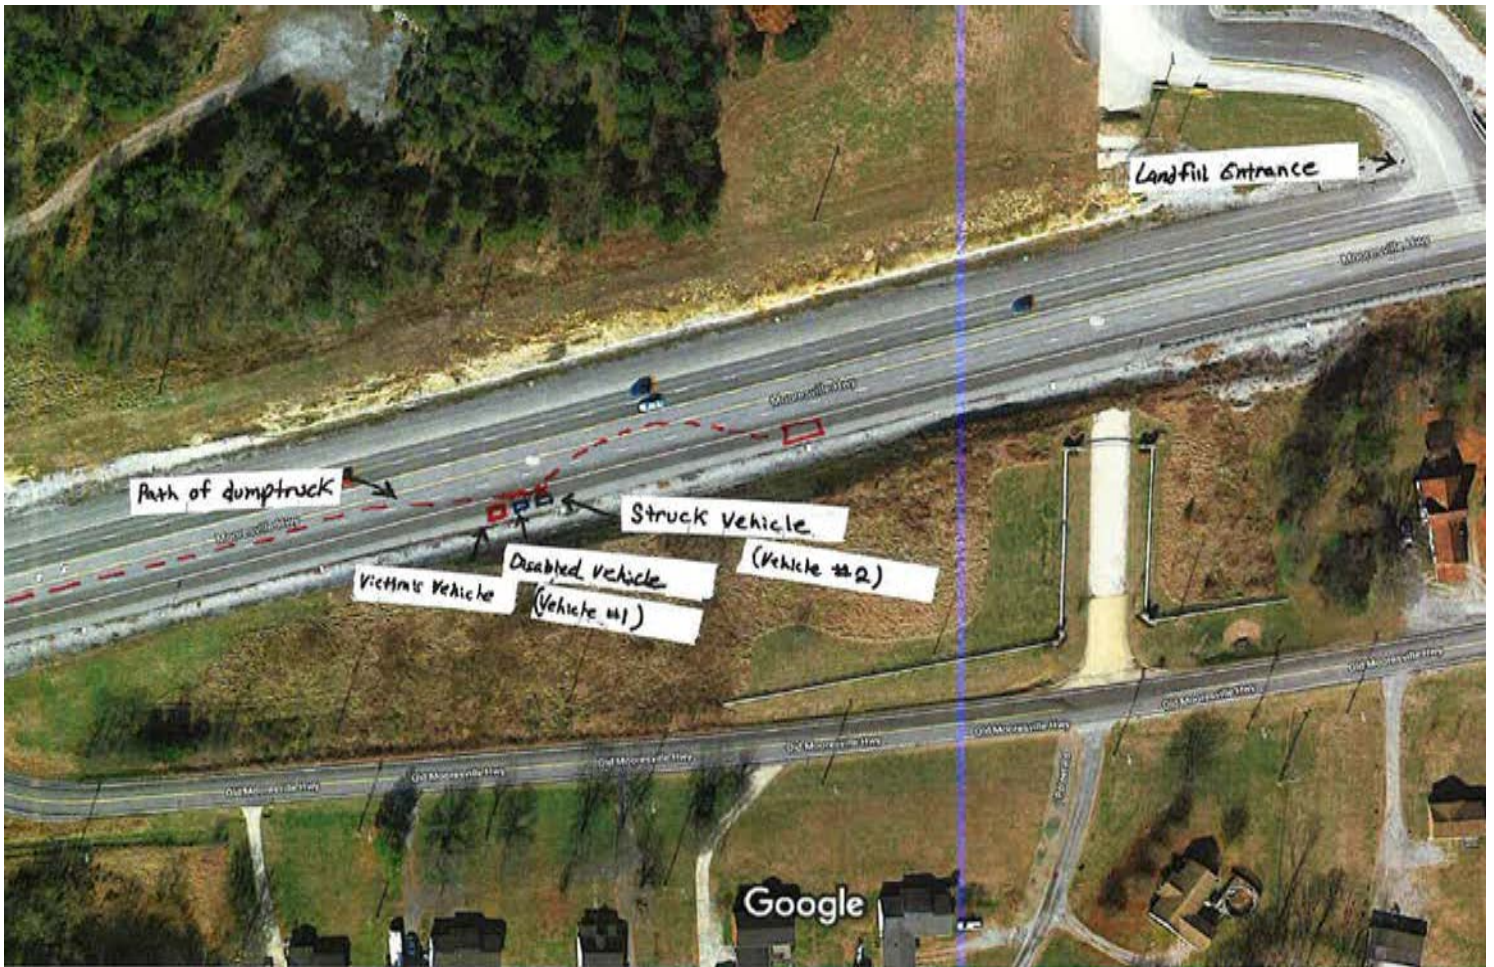
The red arrow indicates the location of the victim when he was struck by the truck as marked by THP. The red star indicates the location of the victim when he was struck according to the eye witness. The yellow star indicates the location of the witness at the time of the incident. The yellow arrow indicates the location of the vehicle that was struck by the dump truck. The orange arrow indicates skid marks left on the road by the dump truck after it struck the vehicle. The red circles indicate the position of the wheels on vehicle #1. The yellow circles indicate the position of the wheels of vehicle #2.
