A 30 year old male employee was struck by a dumpster that was being lifted into a garbage truck with a winch.

Struck By Dumpster—Insp # 1668340 Bass Waste Removal and Recycling

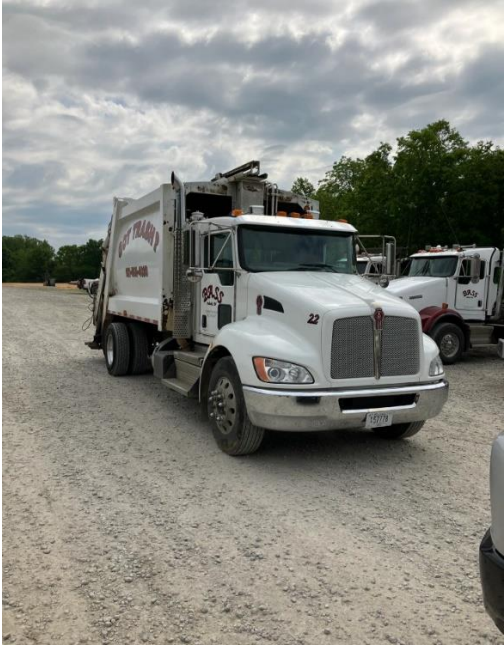
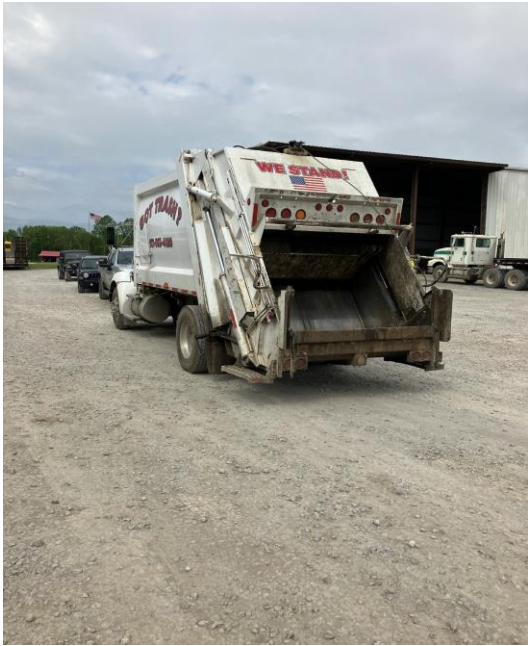
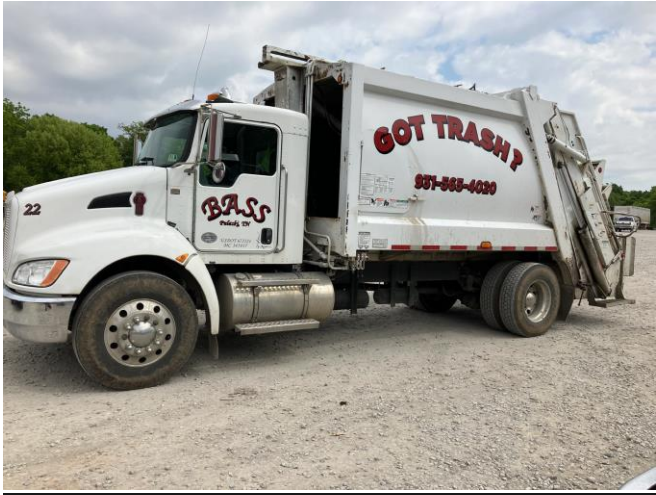
Based on the information obtained, the victim was standing by and operating the rear manual controls located at the back passenger side when the dumpster attached via cable was being lifted from behind the truck. The dumpster hit the ground and pivoted from one end and swung towards the victim. As a result, the victim was struck and pinned by the dumpster while standing in between the dumpster and the garbage truck. It is believed that the accident resulted due to the locking mechanisms located on the back of the truck not being utilized and secured before the lift was made.

On the day of the inspection, the locking mechanisms on the truck were inspected for functionality. The owner of Bass Waste demonstrated that the mechanisms would open and close/lock in place. During the demonstration, the mechanisms were functioning properly. Neither mechanism was loose, the clasp located at the top secured the bars as intended, and there was no damage to the system.

In that both locking mechanism on the garbage truck are/were not utilized to secure the waste container to the garbage truck before beginning the emptying process, exposing employees to struck by and crushing hazards.
