**2025 ANNUAL REPORT**  
to the  
**TENNESSEE STATE BUILDING COMMISSION**

Prepared by Tony Guzzi, Chief Experience Officer  
Andrew Jackson's Hermitage | Andrew Jackson Foundation  
4580 Rachel's Lane, Hermitage, TN 37076  
615.889.2941 ext. 225 | Fax 615.889.9289  
[tguzzi@thehermitage.com](mailto:tguzzi@thehermitage.com)

**February 16, 2025**

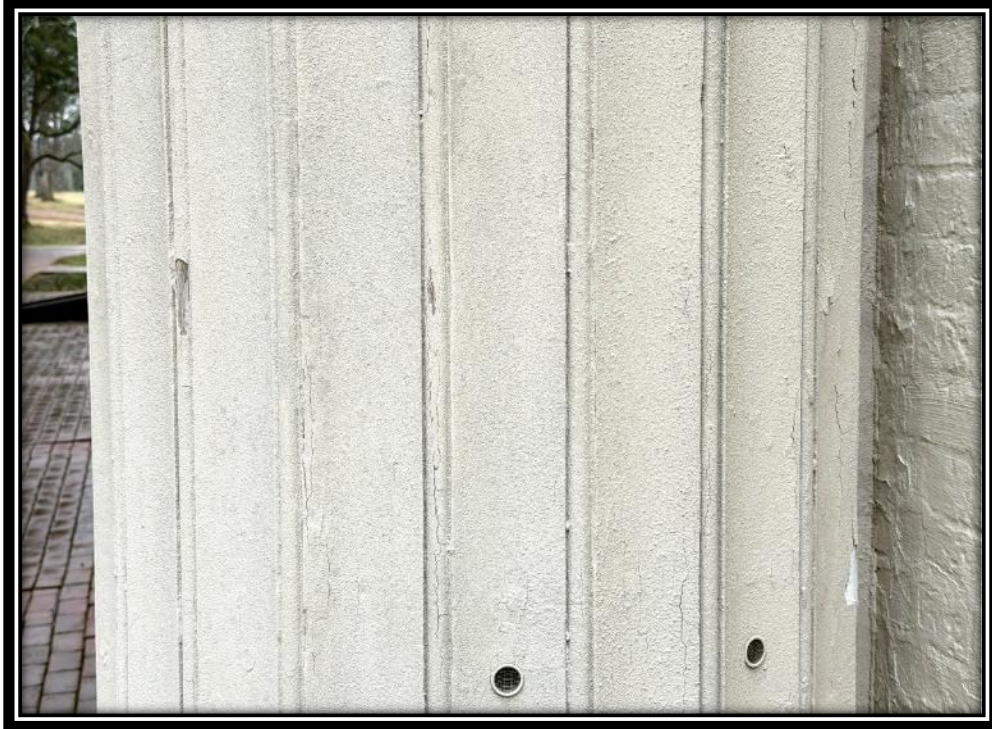
*The sand painted finish on the front columns of the Hermitage mansion is cracking and paint is beginning to fail in areas, December 2025.*

In calendar year 2026 and beyond, the Andrew Jackson Foundation must continue to maintain these investments by the State of Tennessee. Upcoming significant maintenance and preservation work includes repainting the mansion's front columns and entablature with sand, repainting the roof, structural inspections of the mansion's second floor porch structures, replacement of deteriorated non-original porch floor decking, upgrading interior lighting for better visitor access and protection of the historic collection, and replacement of the hall and stair carpets in the main hallways. The AJF is prepared to move forward with work on these projects as funding becomes available.

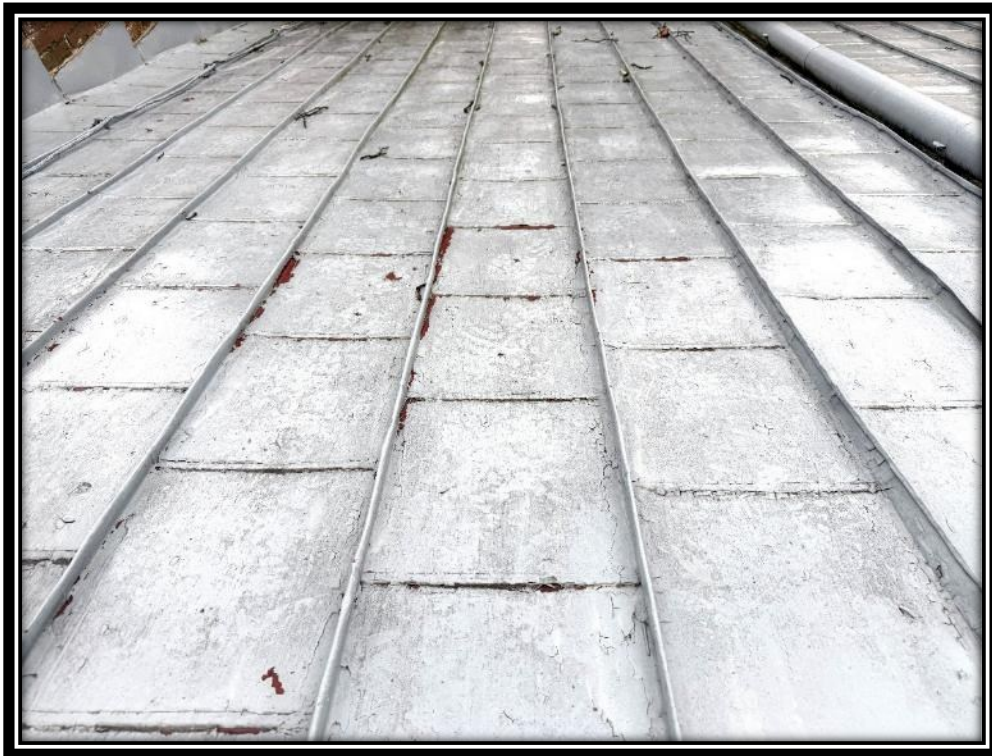
Roof paint on the Hermitage's west wing roof shows cracking and chipping, December 2025.

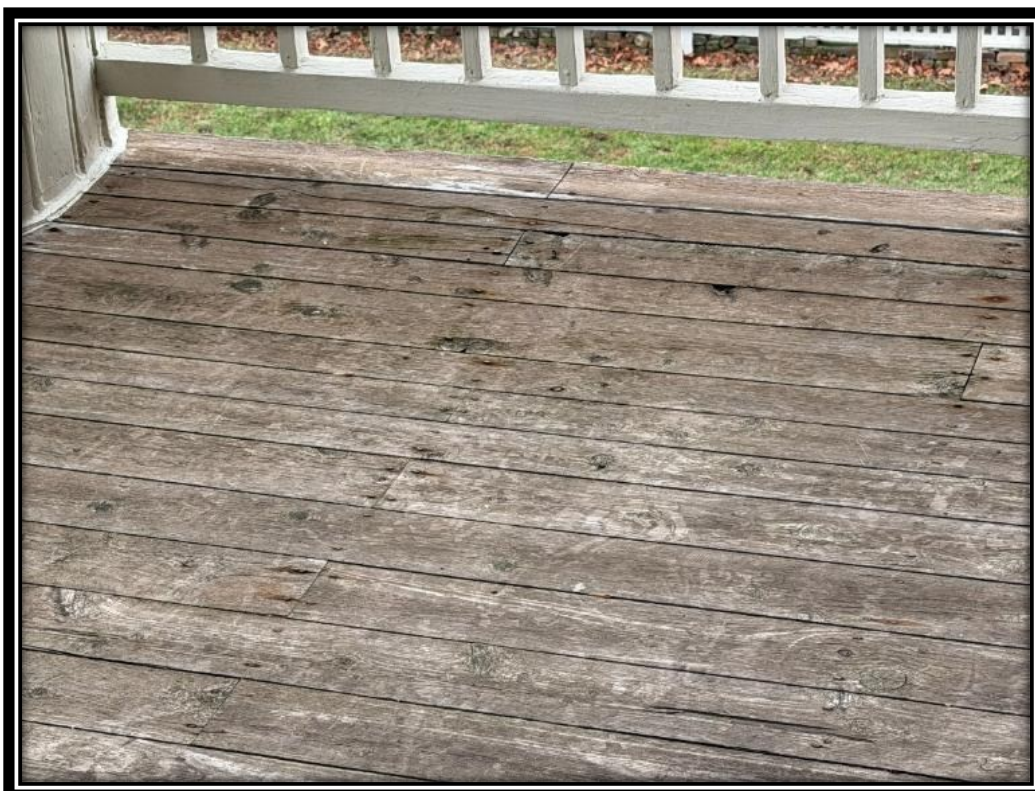
*The Hermitage mansion has two second-floor porches with deteriorating floorboards. The beam and joist support structure under the floors should also be inspected.*

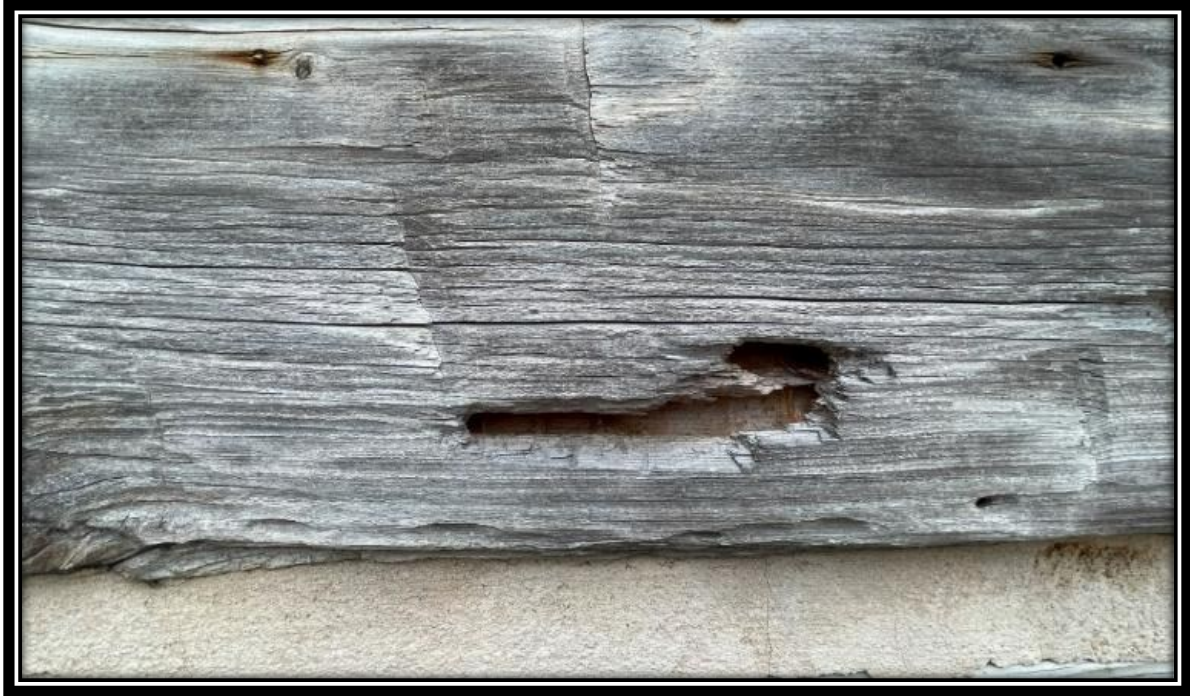
*Before, typical log damage at Alfred's Cabin that requires patching to keep water from pooling inside the log cavity, December 2024.*

This c.1841 log cabin originally housed part of Jackson's enslaved population. Alfred Jackson, who was born enslaved at The Hermitage, lived in the cabin as a freeman beginning in the 1870s or 1880s until his death in 1901. In summer 2024, the Tennessee Historical Commission awarded the AJF a federal preservation matching grant for Alfred's Cabin. The total award was \$30,000 that the AJF was required to match with \$20,000 of its own funds. This preservation project included laser scanning Alfred's Cabin to create digital floor plans and elevations for architectural and record keeping purposes (drawings available upon request). Physical preservation work included replacement of deteriorated non-original gable siding, replacement of the unstable non-original south pen ceiling, minor log patching, and replacement of failed daubing joints. Centric Architecture designed the repairs and the AJF selected David Wyllie Construction as contractor. The project concluded in September 2025 under budget at \$46,000.

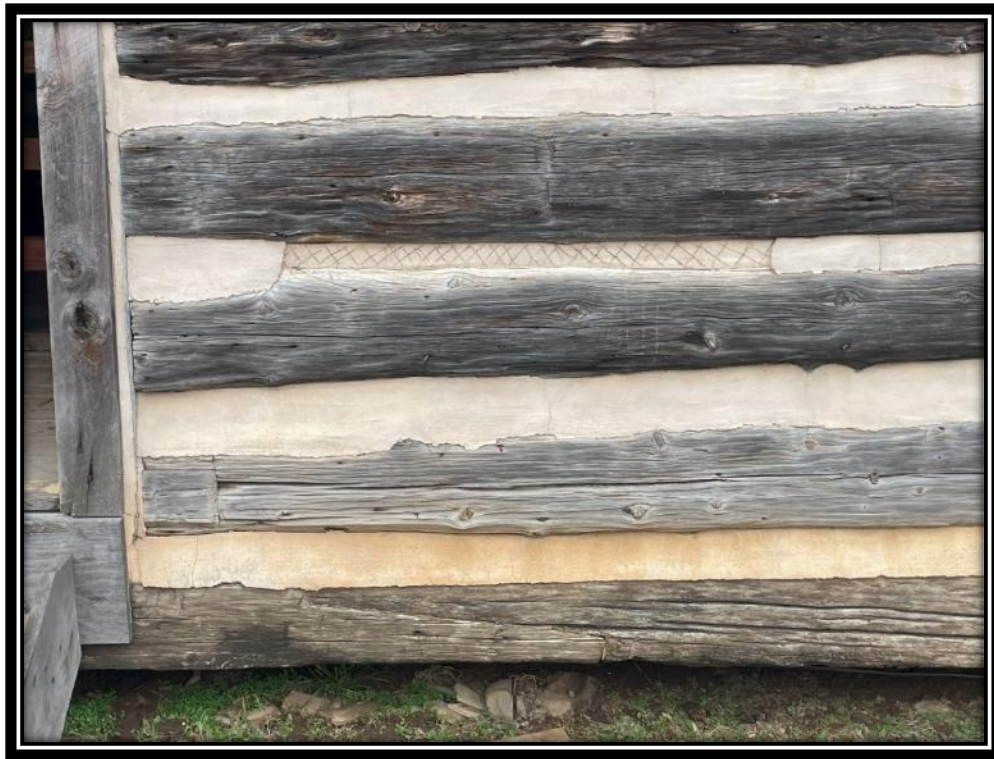
*Typical daubing deterioration at Alfred's Cabin, December 2024.*

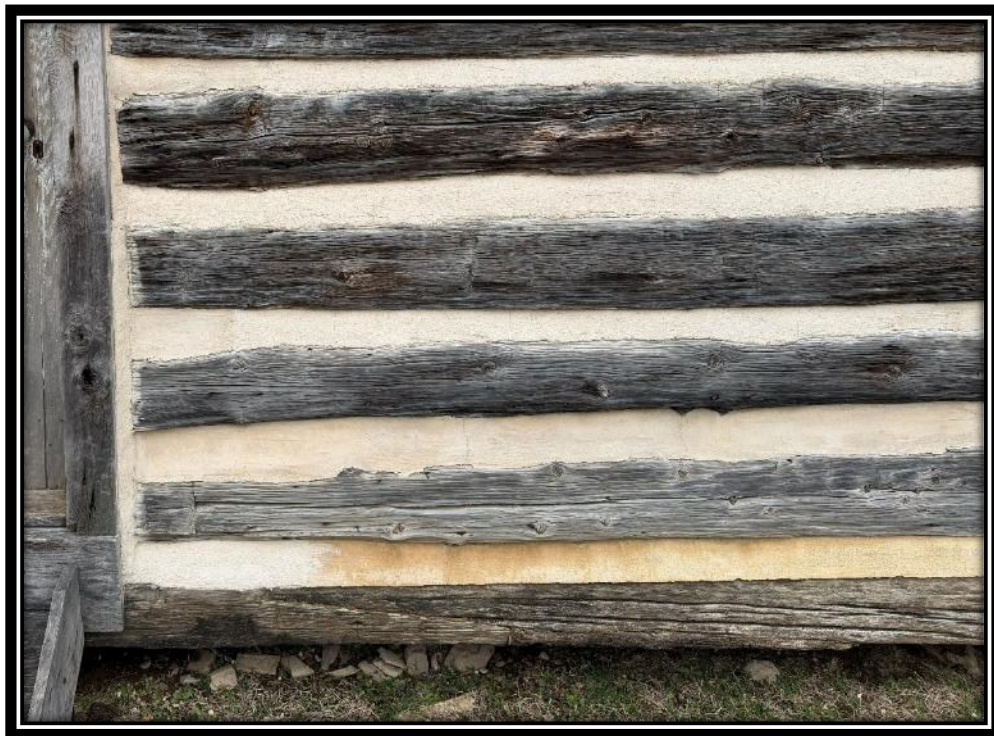
*Daubing on Alfred's Cabin after repairs, December 2025.*

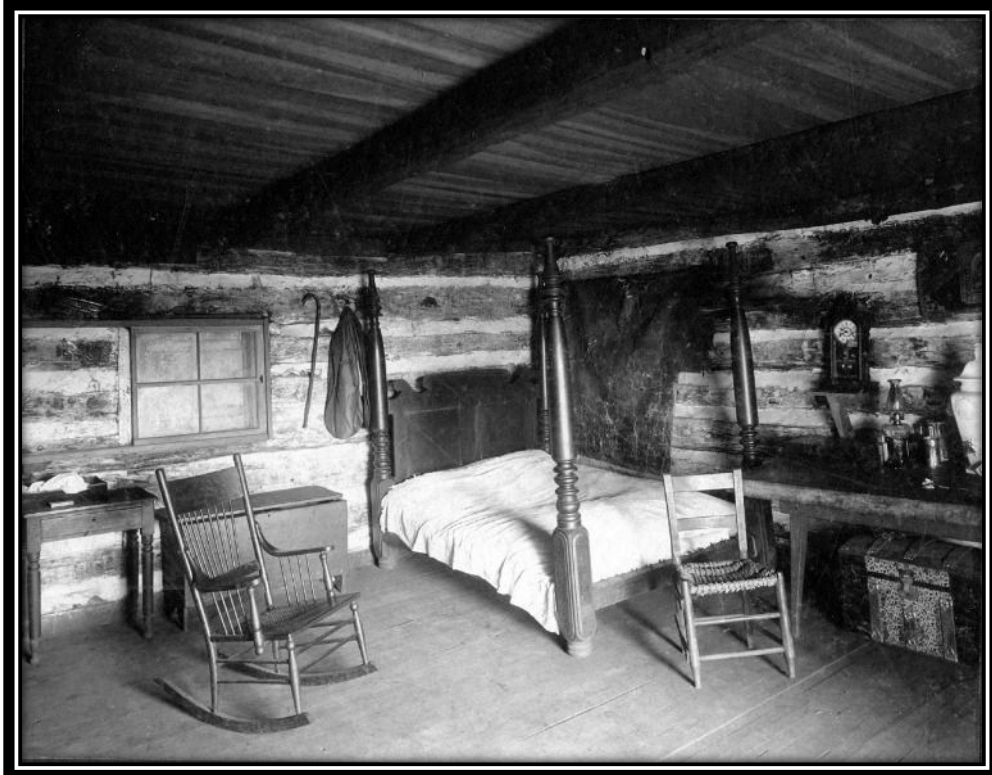
*Tulip poplar plank ceiling of in the south pen of Alfred's Cabin as it looked c.1901.*

*The non-original bead board ceiling in Alfred's Cabin was replaced with a historically appropriate Tulip Poplar wood plank ceiling, December 2025.*

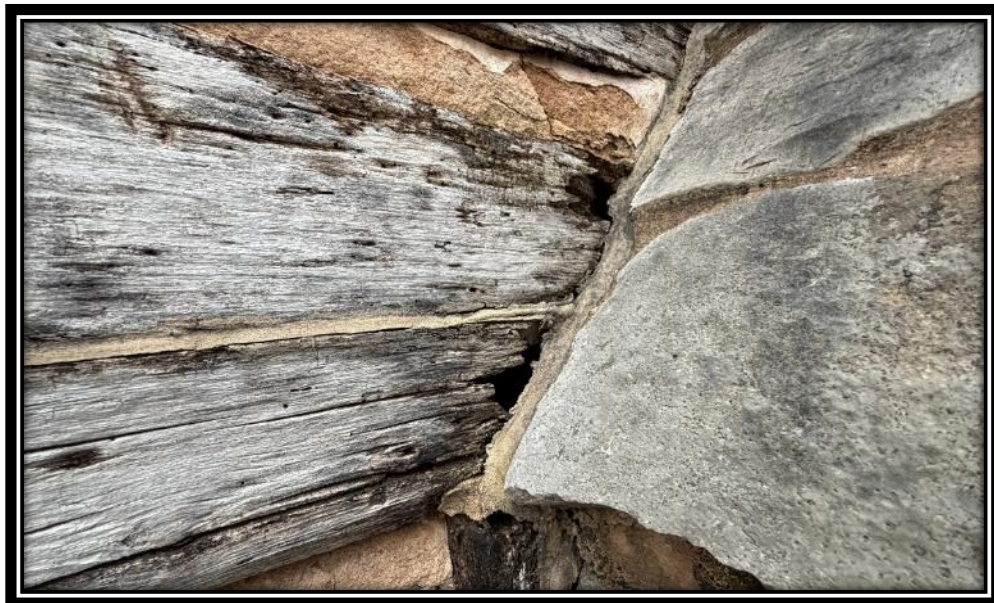
*North elevation of Kitchen showing deteriorated log end at Kitchen chimney that requires patching, December 2025.*

In summer 2025, the Tennessee Historical Commission awarded the AJF a federal preservation matching grant for the First Hermitage Farmhouse and Kitchen. The total award was \$21,000 that the AJF is required to match with \$14,000 of its own funds. These funds will be used to replace deteriorated daubing joints, patch logs as needed, and replace failed elastomeric sealant joints between the chimney openings and log ends. The work will be completed in the spring or summer of 2026.

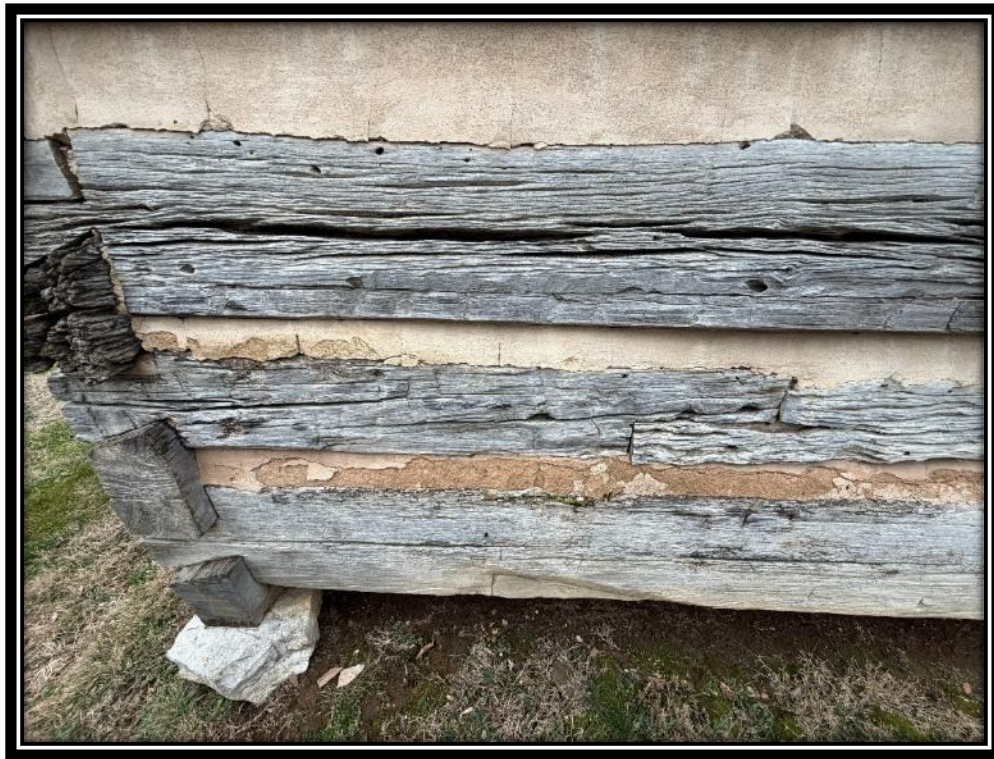
*Deteriorated daubing on the north elevation of the First Hermitage Farmhouse, December 2025.*

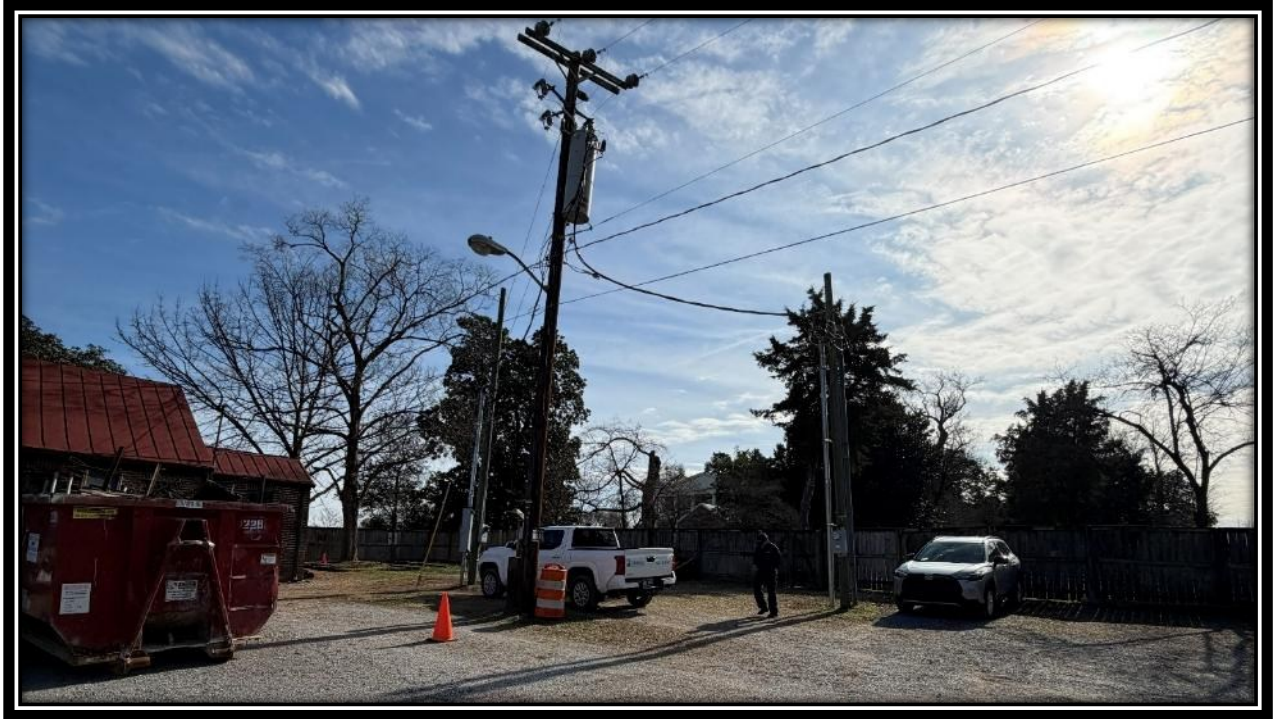
*Above ground electrical service poles stand just 250 feet from the Hermitage mansion, December 2025.*

In November 2023, the AJF Board of Trustees approved funding for the burial of electrical lines that run through the Hermitage Historic Core. In November 2024, this project was temporarily halted to make certain the burial project would not interfere with construction of the visitor comfort building. In October 2025, a revised version of the project that accounts for the visitor comfort building location and for burial of the electrical line to the Cabin-by-the-Spring was approved to move forward. The revised project is estimated to cost \$1.4 million. Kimley-Horn will manage bidding and construction administration on this project. The project is expected to go to bid in April or May 2026.

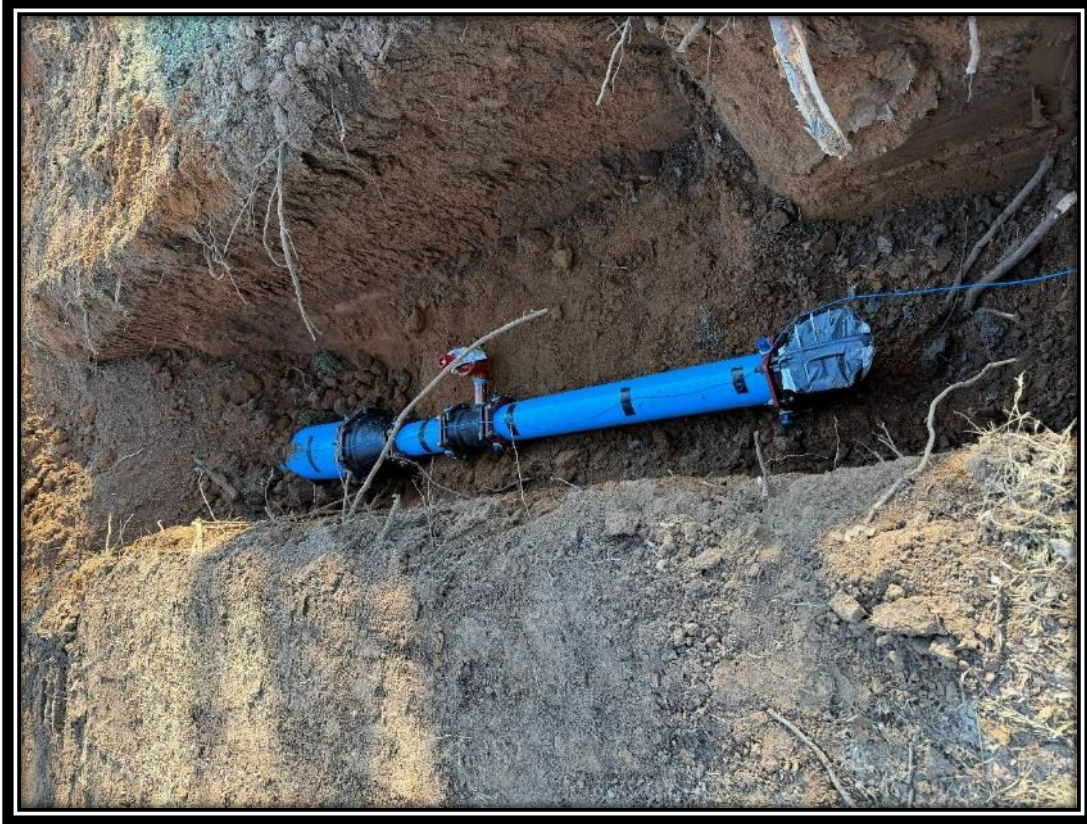
*Reducing valve and backflow connection on the new water line at its end point at the Site Operations Facility, December 2025.*

The Hermitage campus is served by one eight-inch water supply line that travels nearly 4,000 linear feet. That line supplies seven buildings, four fire hydrants, three sprinkler systems, and multiple irrigation systems. Water pressure and volume onsite is barely sufficient to operate automatic flush valves and irrigation. The entire Hermitage campus is presently deficient in terms of modern National Fire Protection Association code requirements. To address this problem, the AJF Board of Trustees designated \$900,000 of a \$6.2 million fiscal year 2026 State of Tennessee appropriation for water infrastructure upgrades. In January 2025, the AJF hired Barge Civil Associates to design these improvements that will serve existing and future needs. In May 2025, the AJF hired Wellspring Builders as the general contractor through a competitive bid. Wellspring began work on the waterline installation in fall 2025, with completion expected by April 2026. The new twelve-inch water supply line will travel 3,500 linear feet in total and tie into the existing eight-inch line to deliver the needed volume and residual pressure to the property's fire hydrants. The forty-year-old fire hydrants at the Hermitage mansion will also be replaced as part of this project and a fifth fire hydrant will be added at the Site Operations Facility.

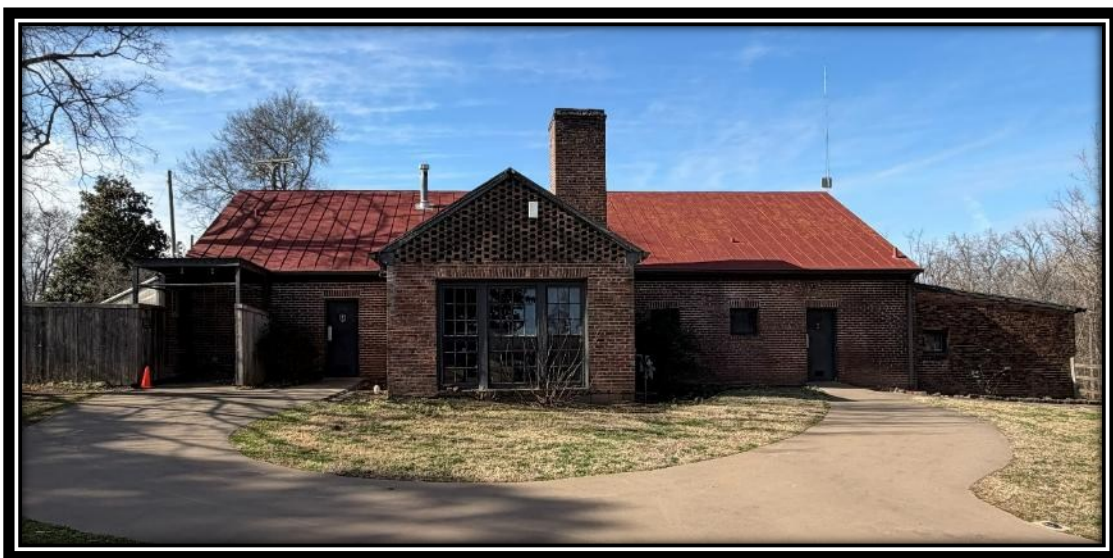
*The Maintenance Building East Elevation, December 2025.*

The Ladies' Hermitage Association built the Maintenance Building in 1930, after a fire in late 1929 destroyed multiple barns, workshops, and public restrooms. The Maintenance Building housed firefighting equipment, a carpentry shop, a boiler room for site heating, and public bathrooms. In 1936, a small greenhouse was added to the building and in the early 1950s, the boiler room was enlarged and a staff breakroom wing added. This building rests on a stone foundation and has a mix of concrete and wood floors. The walls are solid brick. The roof has a wood structure covered with standing seam metal. Since the early 1950s the building has not changed. Today, most of the Maintenance Building's original functions have been replaced by modern systems and its current uses as greenhouse, carpentry shop, offices, and preservation and archaeology storage will be replaced by the Site Operations Facility. The public restrooms in the Maintenance Building are woefully inadequate for modern visitors and are not ADA accessible. The visitor comfort building that is being developed will take the place of these restrooms in 2027.

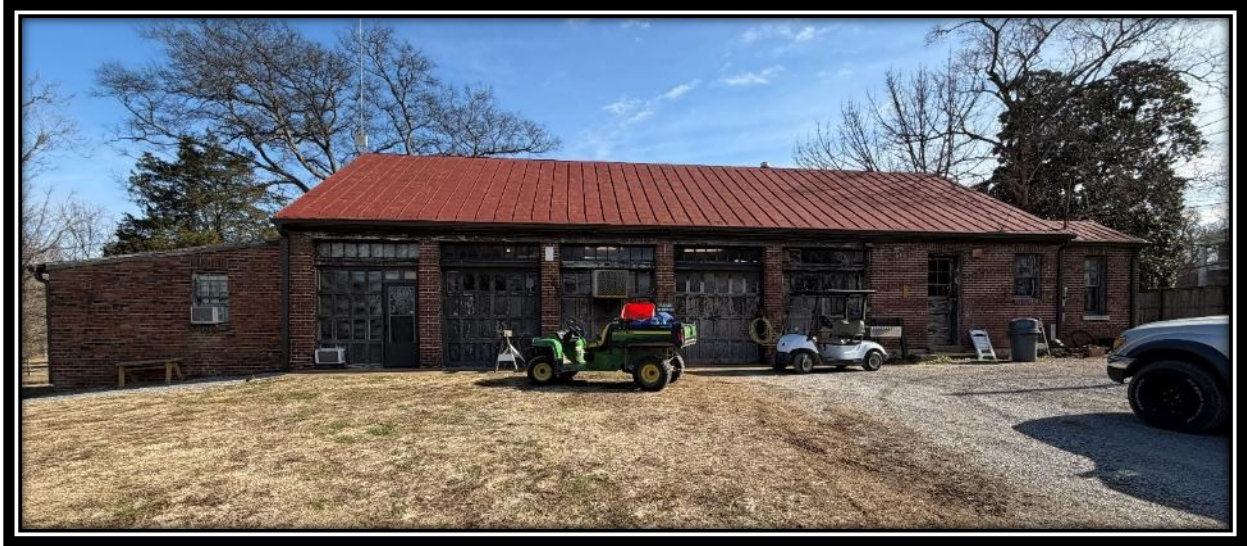
*The Maintenance Building West Elevation, December 2025.*

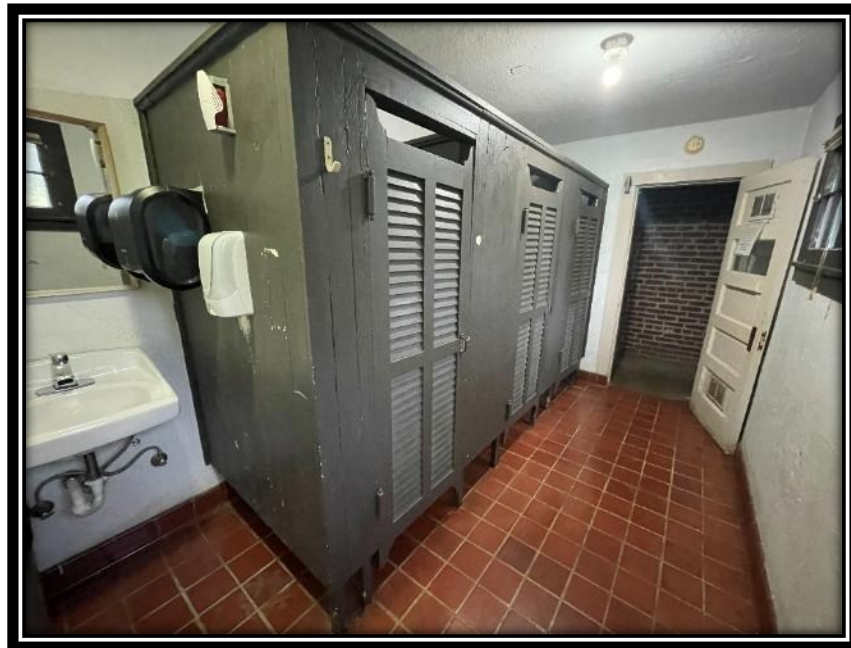
*Antiquated non-accessible Maintenance Building  
women's public restroom, October 2025.*

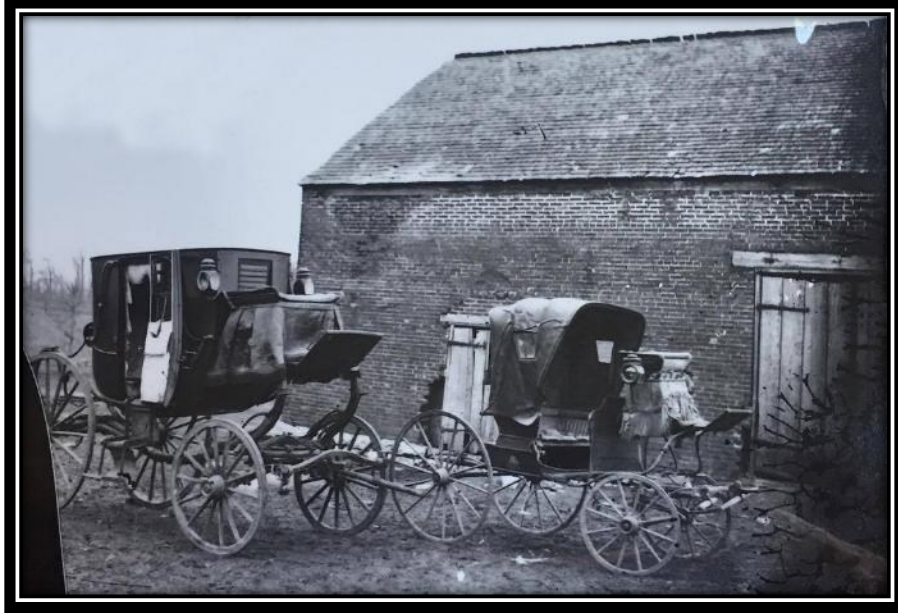
*C. 1867 photograph of the Carriage House and Stable, destroyed by fire in the early 1870s.*

Lastly, the Maintenance Building stands on the site of Andrew Jackson's brick Carriage House and Stable that was built in 1833 and destroyed by fire the early 1870s. Archaeologists found the location of this historic building site in October 2024. That excavation located the building's foundation and proved that the foundation continues underneath the Maintenance Building. Demolishing the Maintenance Building will allow historians and archaeologists to better understand Jackson's Carriage House and Stable and inform guests about one of the most important aspects of Jackson's life, his love of horses, horse racing, and horse breeding.

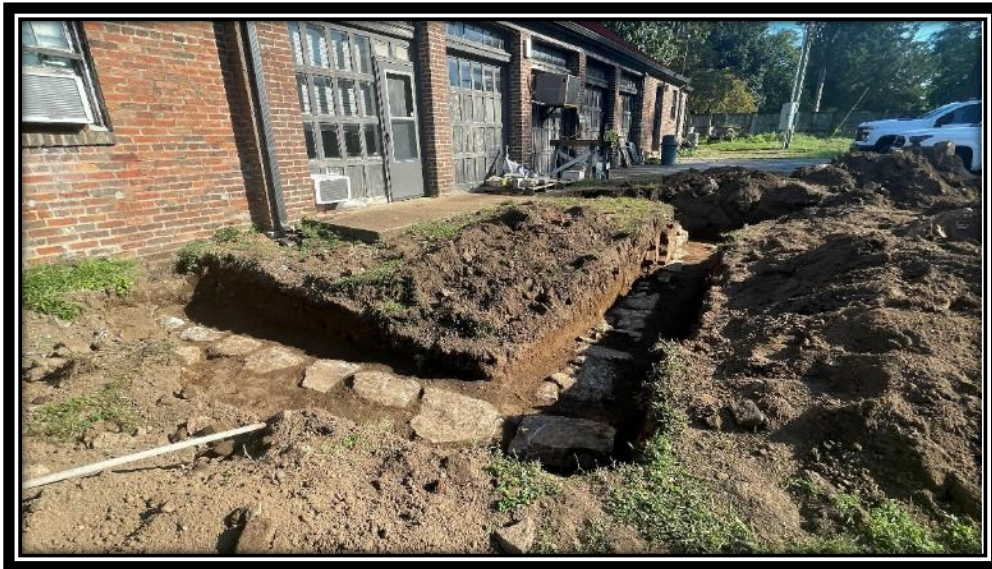
*Exposed foundation of Jackson's brick Carriage House and Stable proves it continues under the Maintenance Building, October 2024.*

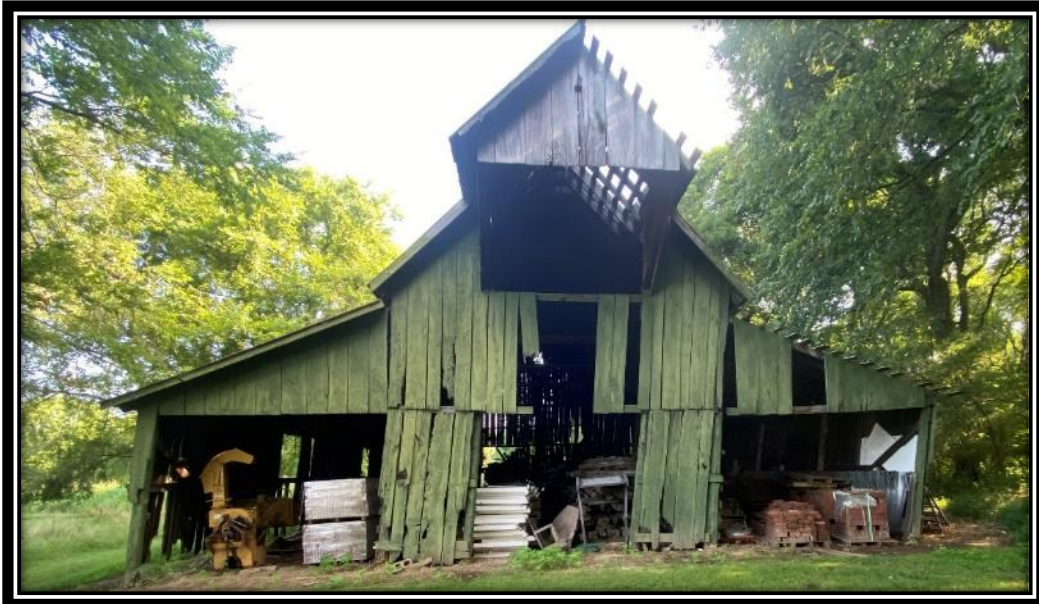
*East Field Barn condition September 2025. Note lean of building to the east and missing metal roof panels and wood siding, September 2025.*

Built in 1941, the East Field Barn housed hay and equipment for the Ladies' Hermitage Association's cattle farming operation. The structure is a standard three bay pole barn clad with wood siding and a metal roof. Cattle farming as a revenue source for the AJF ceased in the early 1980s. Since that time, the East Field Barn has been used to store hay, farm equipment, and the preservation collection comprised of architectural fragments of wood, brick, and stone from various buildings. Today, the East Field Barn is structurally unstable and in danger of collapse. Its current functions will be subsumed by the Site Operations Facility.

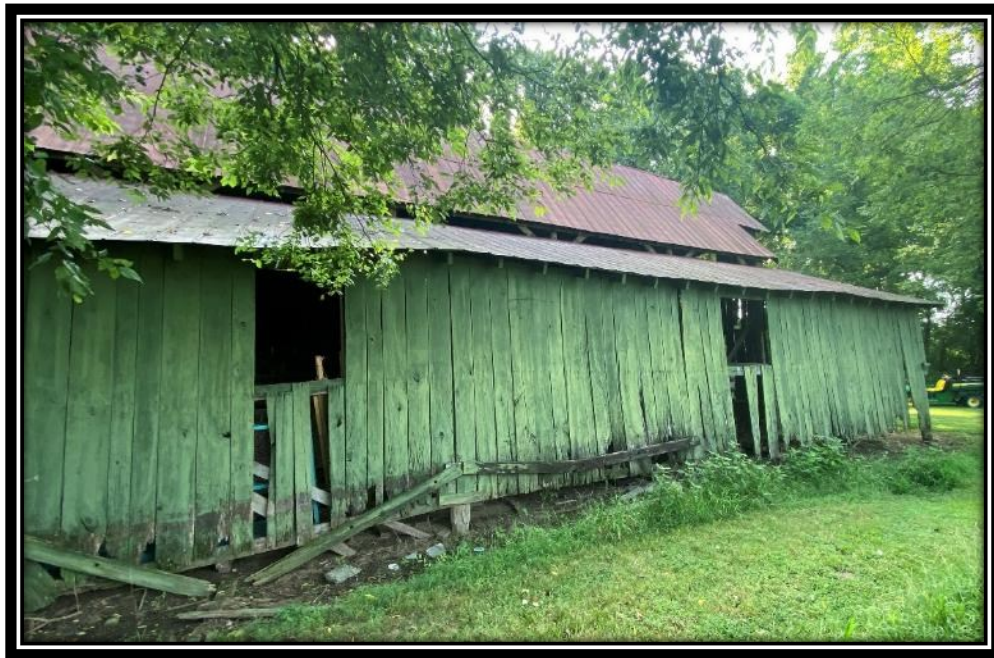
*East Field Barn, west elevation, note that the wall is lifted up due to the building's lean to the east, September 2025.*

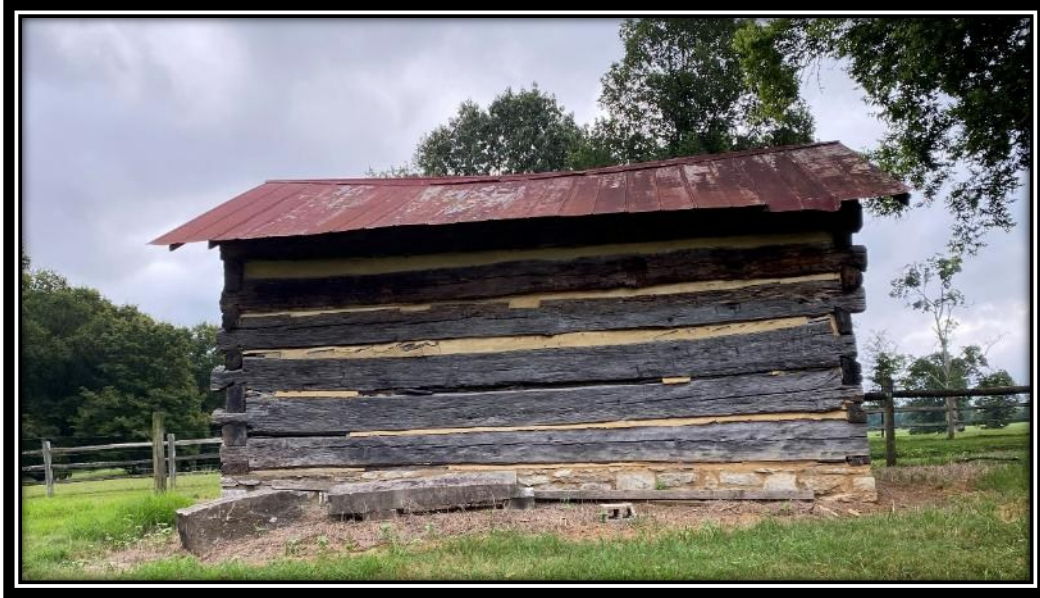
*West elevation Hunter's Hill Log Carriage House, September 2025.*

In 1930, this log structure was moved to The Hermitage from a nearby property historically called Hunter's Hill. The building was purchased by the Ladies' Hermitage Association as a quick fix for storage after a 1929 fire destroyed multiple barns, workshops, and public restrooms. This building was used for storage for decades but now stands empty. This building is comprised of logs resting on a continuous stone foundation. The roof is wood framed and covered with sheet metal.

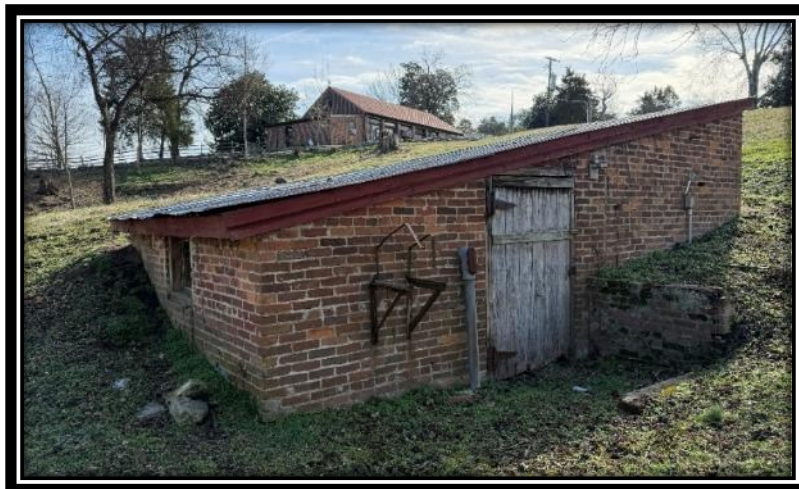
*The Pumphouse's north and west elevations, December 2025.*

The Pumphouse is a simple brick and concrete building that was built into the hillside above a man-made fire pond. The Works Progress Administration built the building and the fire pond as part of a series of projects in 1936 and 1938 to improve the buildings and infrastructure at The Hermitage. The pumphouse sheltered equipment that kept the fire pond full of water, pumped water to the Hermitage mansion in case of fire, and pumped irrigation water to the Hermitage garden. In the early 1980s, the AJF installed a private water line from Metro Nashville to supply fire hydrants and domestic water needs on the property. The man-made fire pond was then drained and removed. In 2010, the AJF abandoned its aging irrigation systems tied to the pumphouse and began irrigating with city water. The pumphouse is now an obsolete building that detracts from the historic core landscape.

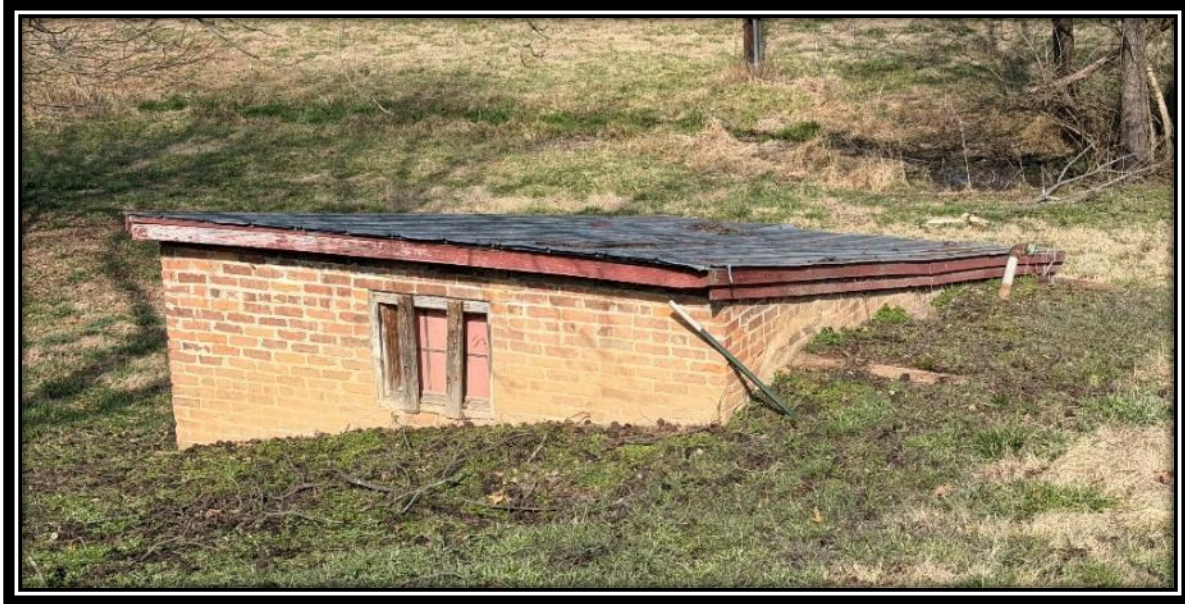
*Pumphouse south and east elevations with site of former fire pond in background, December 2025.*

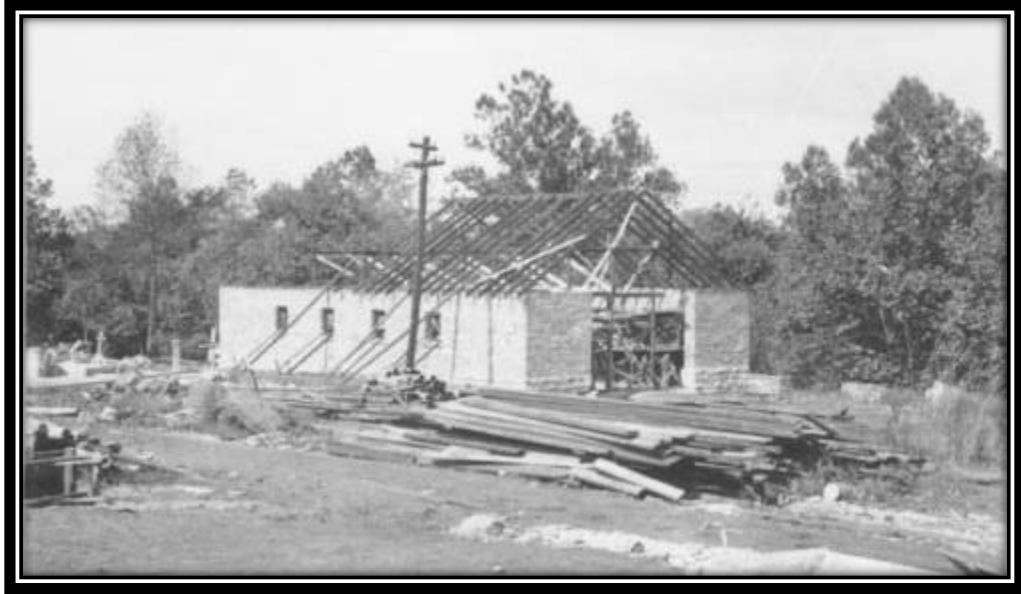
*Brick Storage Barn under construction in 1936.  
This original brick portion of the barn will be retained.*

When completed in 1936 by the Works Progress Administration, the Storage Barn was a solid wall brick barn with no attachments. The building had a stone foundation and a wood roof structure with metal roofing. The brick portion of the storage barn has been used to store agricultural and grounds equipment, supplies, and hay. By the early 1950s, the Andrew Jackson Foundation had added open storage bays to the north side of the barn and a framed storage wing on the south elevation. Once the Site Operations Facility is completed in spring 2026, the Storage Barn's current functions will move to that location. The AJF Board of Trustees voted in December 2025, to demolish the frame storage wing and open storage bays to facilitate renovations to the original brick barn that will be repurposed as a pavilion to house educational programs, school group lunches, and events. This building is located in the visitor services zone and is adjacent to the bus parking lot making it ideal for school group use. If this partial demolition and renovation of the Storage Barn is approved by the State Building Commission, the AJF will submit renovation plans to the Office of the State Architect for review and approval when they are completed.

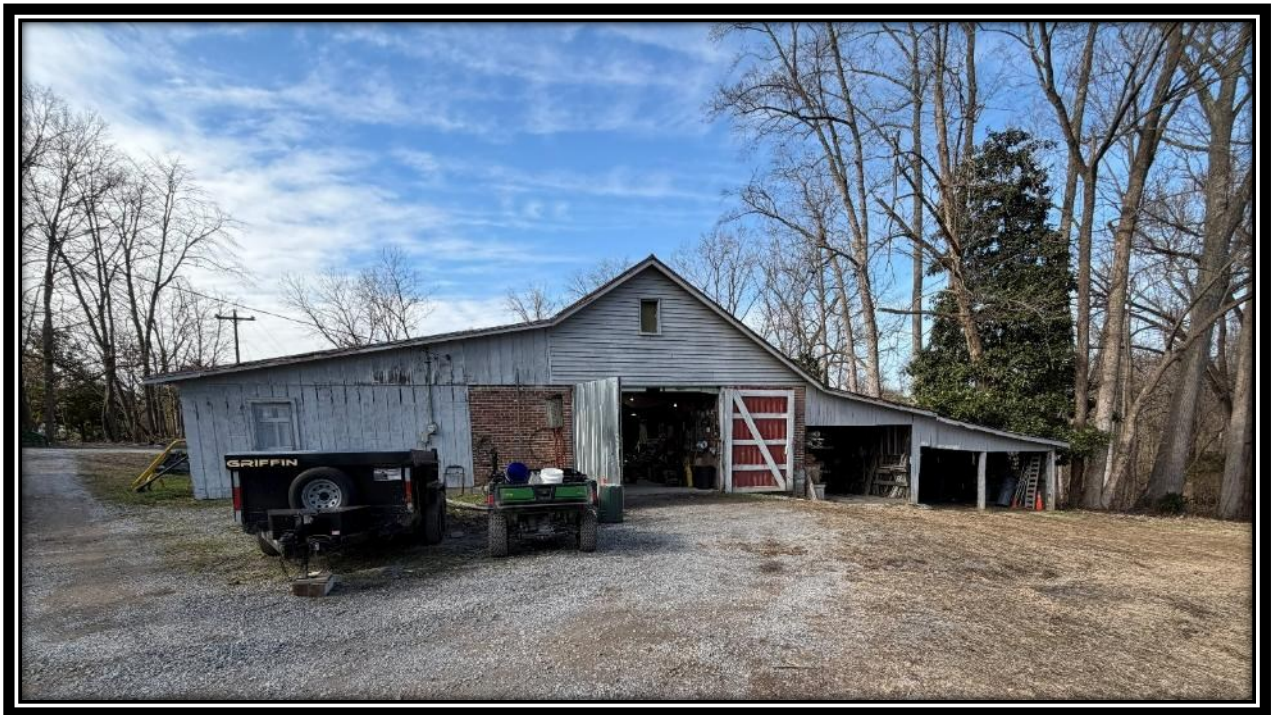
*East elevation of the Storage Barn, showing storage room on south side and open bay storage on north side that will be demolished, December 2025.*

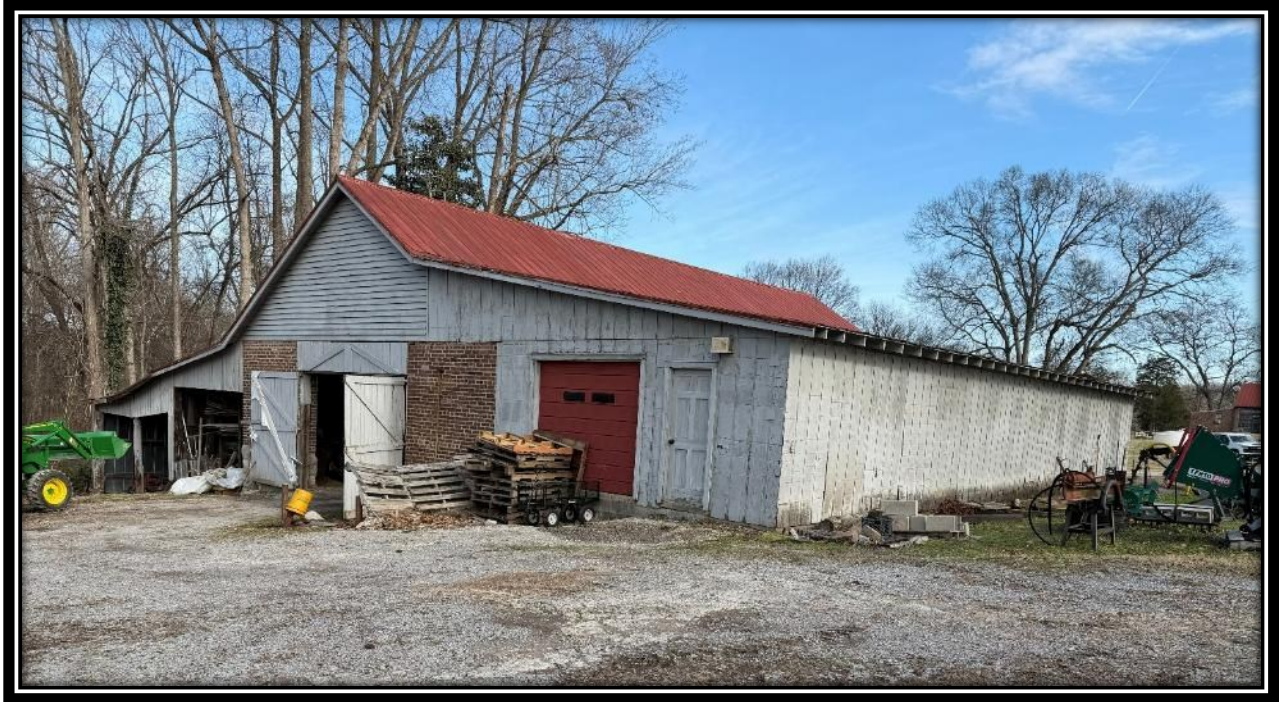
*West and south elevations of the Storage Barn, showing storage room on south side and open bay storage on north side, December 2025.*

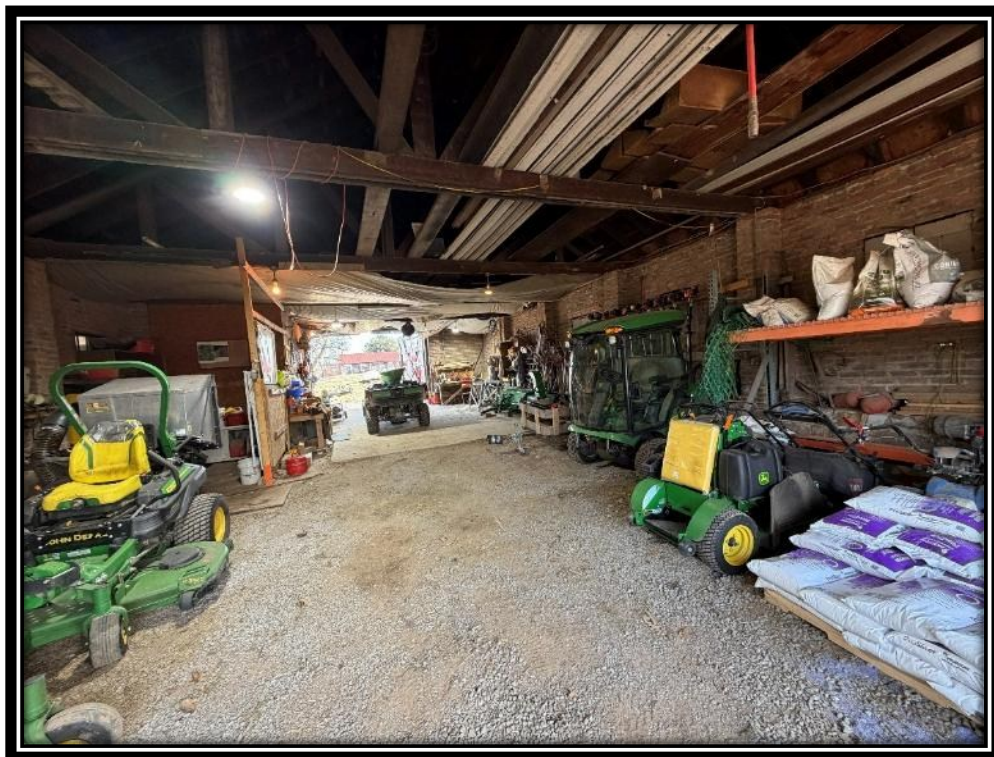
*Interior of brick portion of Storage Barn to be retained and renovated, December 2025.*

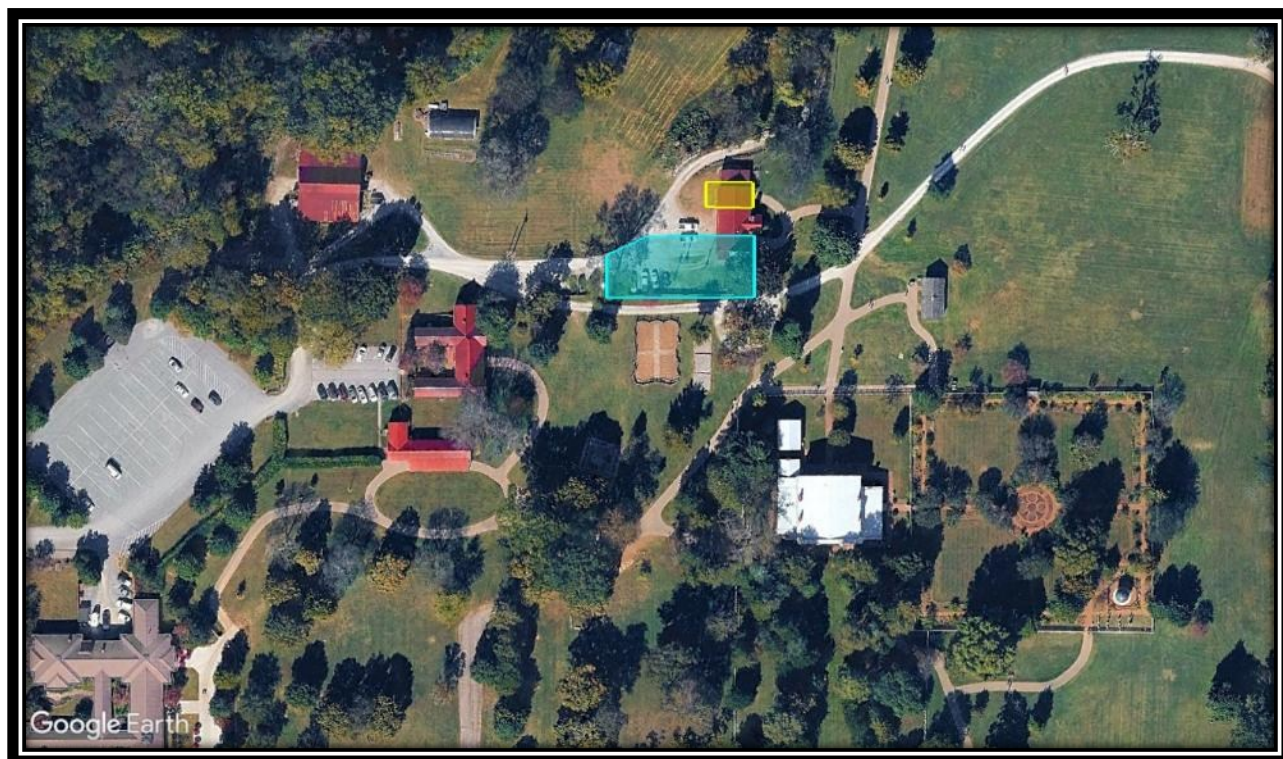
*Area in blue defines the general location the AJF Board of Trustees approved for the visitor comfort building. Area in yellow is the possible location of Jackson's Carriage House and Stable. The building with the grey roof is the Hermitage mansion.*

As previously discussed in the masterplan section of this report, the AJF has secured funding and intends to begin construction on a visitor comfort building in late 2026 or early 2027 if approved. The AJF Board of Trustees voted to approve the location of this building in December 2025. The State Building Commission is required by Tennessee code to approve all new construction on Hermitage property. If this new building is approved by the State Building Commission, the AJF will submit site and building plans to the Office of the State Architect for review and approval, when design is completed. The AJF is actively working with contract archaeologists to ensure that construction of this building does not disturb any intact archaeological sites.
