Thrown from garbage truck – Inspection #1120402

A **76 year old male** employee was fatally injured when he was thrown from the back of a garbage truck while collecting trash. On the day of the incident, the victim was riding on the driver's side rear step of the garbage truck while picking up trash in a subdivision. The truck traveled over a gravel depression in the road where a water line had been replaced causing the truck to rock side to side. The rocking motion caused the victim to be thrown from the truck falling backwards and striking his head on the ground. The victim passed away later that day at the hospital. Employees stated they were aware of the safety rules when riding on the back of a garbage truck, but during the investigation, were viewed riding on the back of a garbage truck at speeds higher than 10 mph, and distances greater than 2/10ths of a mile.

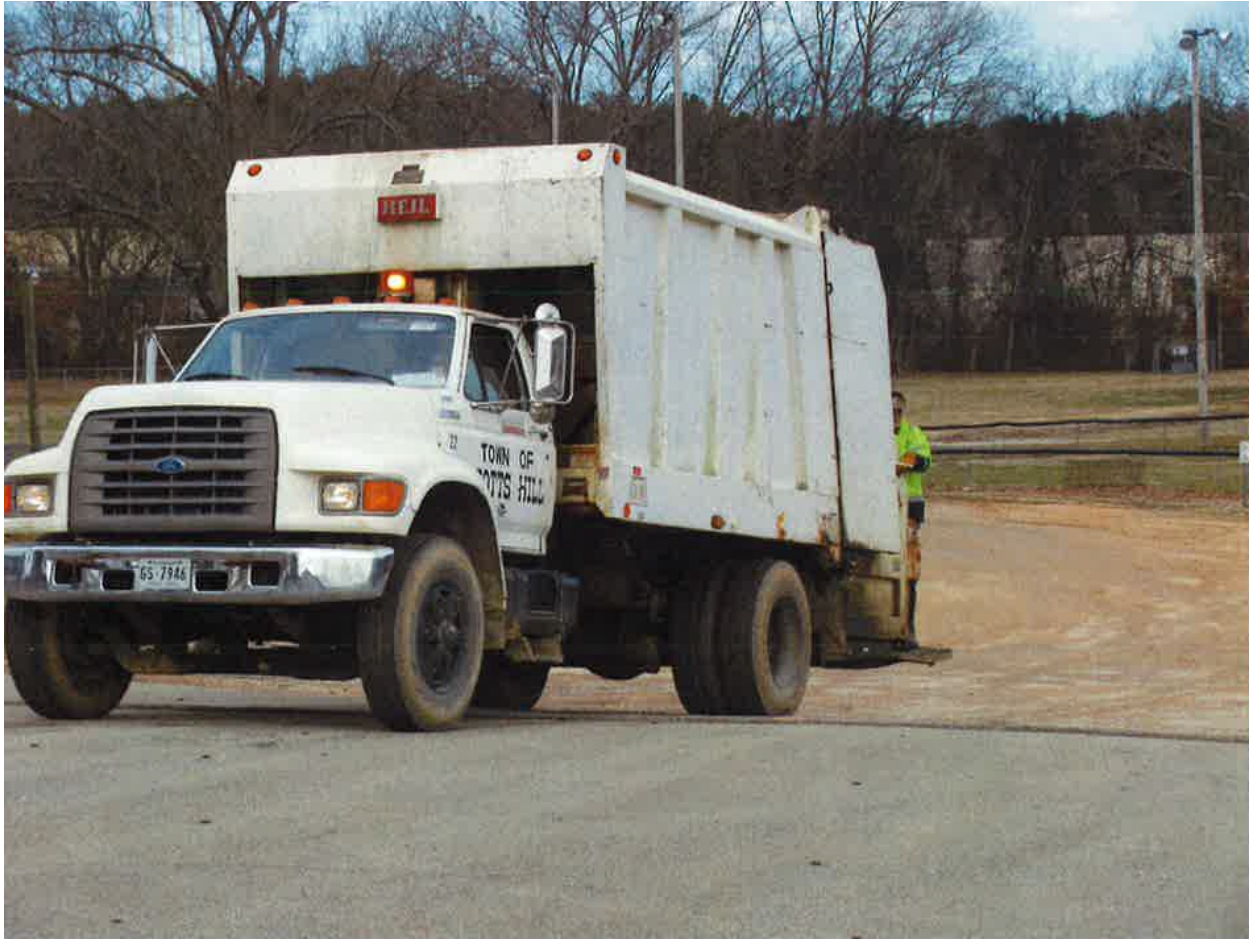
Photo 1 of 1 – Photo of the garbage truck and employees riding on the rear step.

TCA 50-3-105(1)	<p>Each employer did not furnish to each of its employees conditions of employment and a place of employment free from recognized hazards that are causing or are likely to cause death or serious injury or harm to its employees were exposed to physical harm such as a fall hazard. The employer failed to provide employees with the necessary safety training required before operating and working on a sanitation truck; and the employer failed to protect employees from the recognized hazards associated with mobile refuse-collection equipment. This hazard was most recent documented on two (2) recent occasions in Scotts Hill TN: a) On December 2, 2015, a public works employee was fatally injured when he fell from the rear steps of the sanitation truck as it was traveling between trash pick-ups.</p> <p>b) On January 28, 2016, public works employees were observed riding on the rear of the garbage truck at speeds over 10 mph and distances farther than 0.2 miles. Among other methods, on feasible and acceptable abatement method is to follow the owner's manual operating instructions or ANSI Z245.1-1992 sections 6.1.a-6.1.1, 6.2.1, and 6.2.4 that set safe operating guidelines and equipment usage which include: a) Providing instruction and training to employees in the safe methods of work before assigning them to operate or work around a sanitation truck; and b) ensuring that no person ride on the steps when the sanitation truck travels more than 0.2 miles between pick-ups and/or when the vehicle is traveling more than 10 mph.</p>
